# Proceedings of the 3<sup>rd</sup> Balkan Symposium on Archaeometry

29-30 October 2012  
Bucharest, Romania

# Study of vulnerability and characterization of stone columns from Seville (Spain)

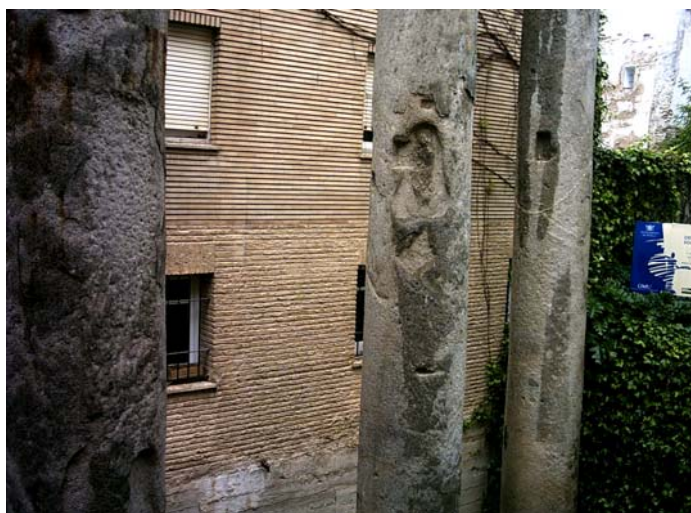
The stone columns studied are calcareous and granite stones of different sizes and shapes. Most of them are roman columns reused in different Churches, or monuments. Meanwhile only three of the columns are maintained in their original place (*Fig. 1*).

**Figure 1:** Column of granite from roman period in their original location.

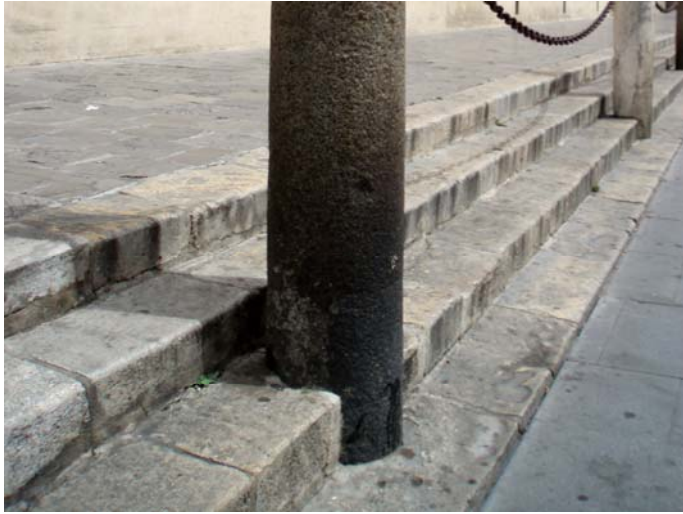
Biocrust are located in granite columns associated to vegetation and humidity, while black crust and deposits were found in any column near traffic (Fig.2).

**Figure 2:** Granite column affected by crust, deposits and iron spots.
