## IVIS2017

## Using SIMs to re-create cultural historical values in buildings from before 1945

P. Johansson<sup>a,\*</sup>, P. Wahlgren<sup>a</sup><sup>a</sup> Department of Architecture and Civil Engineering, Chalmers University of Technology, 412 96 Gothenburg, Sweden\* Corresponding author, Tel. +46 (0)31-772 19 66, email [par.johansson@chalmers.se](mailto:par.johansson@chalmers.se), [paula.wahlgren@chalmers.se](mailto:paula.wahlgren@chalmers.se)**Abstract:**

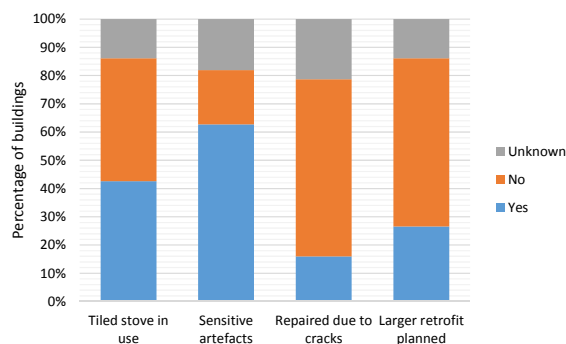
To get an estimate of how many buildings that are in need of renovation and can benefit from SIMs, an existing inventory and status assessment was used. The inventory was performed by Trafikverket (Swedish transport administration) and included site visits and interviews. In Fig. 1, the results for 94 buildings, from before 1945, are shown.

Fig 1: Information on the 94 buildings in the inventories presented in [3] and by Trafikverket.

The sensitive and vulnerable artefacts can be stoves, stucco, paintings, tiles and sculptures in the building. Larger retrofit was planned for 25 of the buildings. There is large potential for using SIMs for renovation.

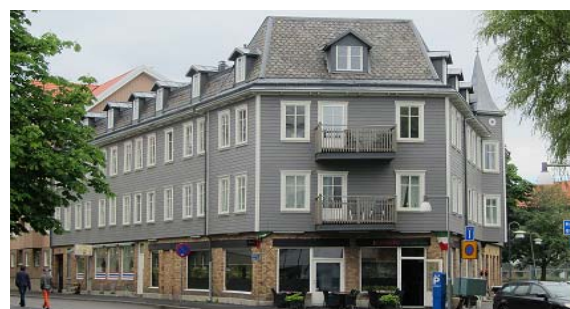
Brämaregatan 1, see Fig. 2, is a building from 1910 that has been renovated twice; in 1975 and in 2010.

Fig 2: The building at Brämaregatan in its current state, after 2010.

The building at Bråmaregatan has a brick ground floor wall, two floors with wooden walls and an attic floor (habited). At Bråmaregatan, the possibility to use VIPs or aerogel blankets is investigated along with other energy efficiency measures, see Table 1. Alternative 1 for windows is to change single-pane windows on the ground floor ( $U=5.5 \text{ W/m}^2\text{K}$ ) and alternative 2 is to change all windows (also double-pane with  $U=2,5 \text{ W/m}^2\text{K}$ ) The building and the investigation is described in more detail in [4].

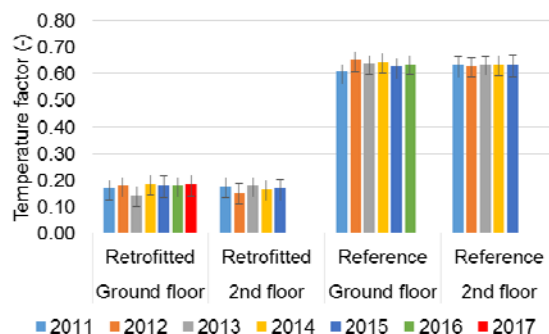
A 1930s building, Malörten, has been insulated with 20 mm VIPs on the exterior. Temperature and relative humidity sensors monitor the wall and the interior and exterior climate. The wall was finished in August 2010. Comparing the reference wall with the retrofitted wall gives an approximation of how much the thermal resistance of the wall has been improved. For this analysis the average temperature for January each year 2011 to 2017 was used to calculate the temperature factor, see Fig. 4. Unfortunately several sensors have been damaged why only one position can be evaluated for all 7 years.

Fig 4: The temperature factor of January 2011 to 2017 for the retrofitted and reference walls. The temperature factor is the percentage temperature decrease over the original wall compared to the total temperature drop over the wall. The error bars show an accuracy of the sensor of  $\pm 0.5 \text{ }^\circ\text{C}$ .

In the reference wall about 64% of the temperature drop was over the uninsulated parts. After the retrofitting only about 17-18% of the temperature drop was over that part of the wall. There is no sign of decreased insulation performance of the VIPs.
