Impact of disturbed drilling conditions on the surface integrity of a Nickel-base superalloy

V.Dutilh^{1,2}, A.Popa², G.Dessein², J.Alexis², G.Perrin¹

Abstract

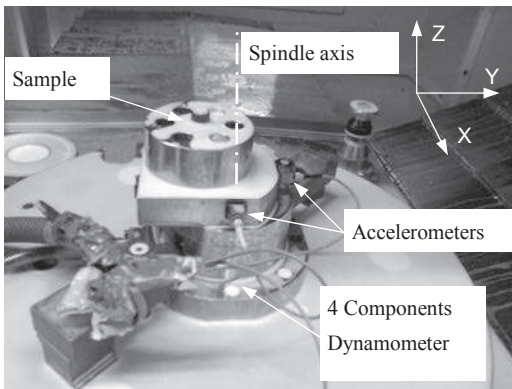
The machine-tool was instrumented by a 4 components Kistler dynamometer (Fx, Fy, Fz and Mz), and three accelerometers placed following the directions X, Y and Z. The spindle power, the position of Z axis, the intensity of the spindle and the motors intensity of the three axes are also recorded through the Siemens Profibus.

Finally, we designed an assembly to manage the drilling of 6 holes per bar and to make those holes systematically at the center of the dynamometer. In this type of dynamometer, the torque is measured by a sensor and not calculated as in a 3 components dynamometer (figure 1).

Figure 1. Experimental set up

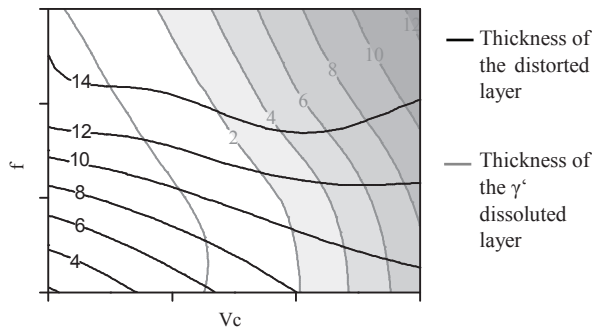
The accurate observation of the thermo-mechanically affected layer with the SEM shows that it corresponds to two layers. A layer characterized by a heavy distortion of grains and primary γ' (black curves on figure 2) and a second layer characterized by a dissolution of the primary and secondary γ' phases (grey curves on figure2). This dissolution indicates a local overheating and mechanical stresses. Figure 2 present the evolution of the thickness (μm) of the both layers compared to the cutting speeds. The thermo-mechanically affected layer is always associated with the work-hardening in sub surface, measured with the micro-hardness profile. Furthermore, the larger the thickness of the thermo-mechanically affected layer is, the deeper the influence of the work-hardening in sub-surface is. Further analysis with residual stress measurements will complete those observations.

Figure 2. Thickness (μm) evolution of the distorted and γ' dissolved layer vs. cutting speeds.

Observations carried out on each anomaly as made on figure 2, have permitted to establish a cutting domain without surface integrity damages (figure 3) with more precision than the previous one defined in paper [10].

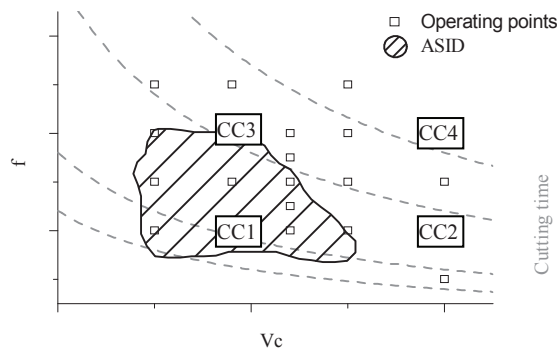
On figure 3 the Acceptable Surface Integrity Domain (ASID) is also delimited for the low speeds but this range of speeds were not explored. The upper limit for the feed axis was mainly delimited by the roughness value and the distorted layer. The upper limit for the V_c axis was mainly delimited by the apparition of the γ' dissolved layer. In paper [10] the ASID was different but it was not the same machine and the rigidity of the first machine was lower.

Figure 3. Cutting conditions and Acceptable Surface Integrity Domain

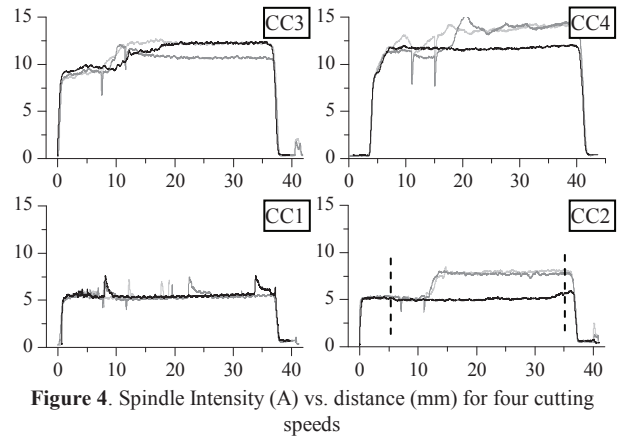
Figure 4 presents the Intensity of the spindle during the drilling for each cutting conditions tested. Spindle Intensity is used because the signal is already filtered and presents the same topography as the power. The X axis represents the distance (mm) from the entrance of the hole and the Y axis is the intensity (A) value of the spindle. The black curve represents a normal operation without lubricant interruption. The grey curves represent two different drillings (new tools for each one) with the same lubricant interruption. The

lubricant interruption can be identified with the two consecutive decrease and increase in intensity. This is a consequence of the Z axis feed stop during data processing the lubricant interruption by the numerical controller, but the tool never leaves the material.

Figure 4. Spindle Intensity (A) vs. distance (mm) for four cutting speeds

On the figure 4, for the cutting conditions 2 and 4 (CC2 and CC4), we observe that the experiments with lubricant interruption show a rapid increase in intensity compared to the normal drilling. The cutting conditions 1 (optimal operating point) do not present any change between signals. The cutting conditions 3 do not present a significant change between the curves with the lubricant interruption compared to the normal drilling. But this particular cutting condition is at the limit of Acceptable SI Domain (ASID) and in the case of normal drilling has a very important dispersion due to hazardous tool wear. Nevertheless the trials with lubricant interruption have an excellent reproducibility whatever the cutting conditions tested for the same experimental campaign are. These trials show that the combination of the cutting conditions with the lubricant interruption leads to an increase in signals amplitude (for all the measurement systems) except in optimal cutting conditions. However, the same phenomena (increased power, etc) were observed for the CC1 during another experimental campaign.

Surface Integrity examinations were carried out at 5 mm and at 35 mm from the entrance (dash lines on figure 4, CC2) on each hole which presented two different types and values of signals. Concerning micro-hardness measures, the load chosen is 0.1 kg which leads to have a print with 20 μm diagonal length. Figure 5 present two micro-hardness profiles (at 5 and 35 mm) for the CC4. This figure shows the influence in sub-surface of the drilling operation, and availability of the micro-hardness measurement as a criterion to define the surface integrity.

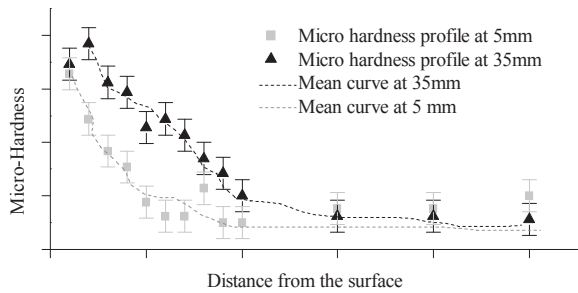
Figure 5. Example of micro-hardness profiles at 5 and 35 mm from the entrance of a hole with a lubricant interruption for CC4

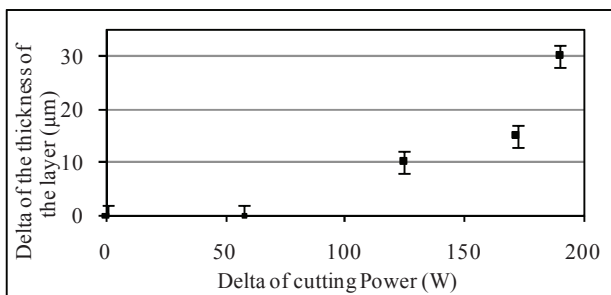
Figure 6 presents the delta between the entrance and the exit of the hole of the thermo-mechanically affected layer thickness (sum of the distorted layer and the γ' dissolution layer) compared to the delta of the corresponding cutting power. Paper [2] presents this type of analysis for normal drilling. Concerning this correlation, the power criterion is the most reliable because it takes into account the torque Mz and the axial force Fz of the drilling. Both SI criteria were added in order to be easier to measure but maybe they should be considered separately. In fact when the layer with the γ' dissolution appears, the thickness of the distorted layer seems lower than just before. Although the influence of γ' dissolved layer on fatigue life is proved, that of the distorted layer on fatigue life is not confirmed. Furthermore, some papers deal with the benefits of work-hardening on the fatigue life.

Figure 6. Delta of the thickness of the thermo-mechanically affected layer vs delta of the cutting power (between measures performed at 5 and at 35 mm from the entrance of the hole)

This type of correlation is a first step in order to establish a model able to estimate in real time the thickness affected by the drilling operation.
