# Comparison of two Nondestructive Tests in Carbon/Epoxy Composites

Marie-Laetitia Pastor<sup>1</sup>, Christian Garnier<sup>2</sup> and Christophe Pescay<sup>1</sup>

**Abstract:** An investigation of two nondestructive methods (ultrasounds and infrared thermography) is carried out. The defect detection by both methods is first examined. The determination of the position and the dimensions are studied. And finally, the feasibility and the time of the experimental protocol setting up are analysed. The aim is to compare two nondestructive methods: ultrasounds and infrared thermography applied to composites samples. So, three different specimens are tested. It appears that the majority of the defects is detected very quickly with infrared thermography compared to ultrasounds method. However, certain defects are not visible by infrared thermography.

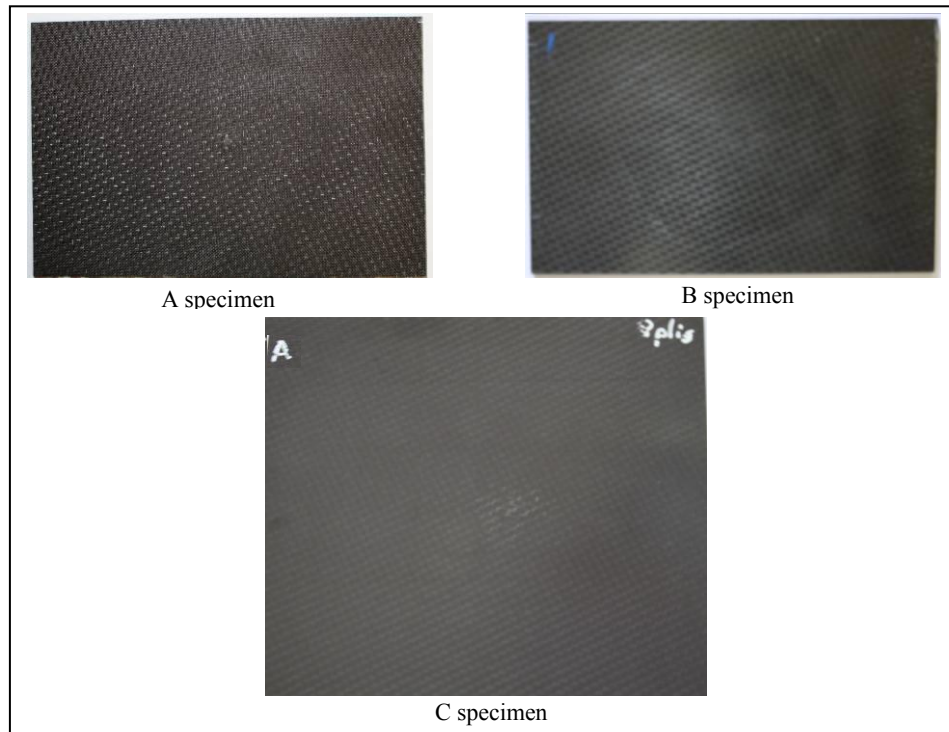
**Fig. 1 Geometries of the three tested specimens.**

Three specimens with different defects are tested ([Fig. 1](#)). A and B specimens have approximately the same dimensions. They are 150 mm long and 100 mm wide. However defects are different. The defect present in A specimen is a delamination located in the middle of the plate. This defect was experimentally produced. The defect in B specimen is a peel ply located between two plies. This defect was intentionally inserted in the

composite. So the form and the position of the defect are well known.

Dimensions of C specimen are 170 mm long and 150 mm wide. Several identical defects are present in the composite. The position and the diameter of the defects are plotted in [Fig. 2](#). The defects are Teflon coated fibre glass. These defects were intentionally inserted in the composite.

The specimens are carried out from 8 woven plies carbon/epoxy composite. Specimens are rectangular

plates with a thickness almost equal to 2.8 mm. Different known defects are inserted in the specimens.

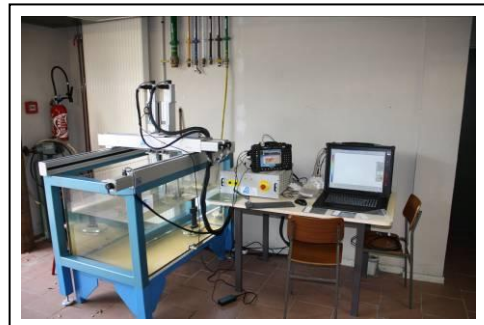
**Fig. 3 Ultrasounds device.**

in the material and to capture the reflected waves (Fig. 3). In order to improve the propagation of the sound waves, a gel is applied to the material. The ultrasounds tests are performed at 5 MHz with celerity equal to  $2600 \text{ m}\cdot\text{s}^{-1}$ . The first fast ultrasounds test is carried out to adjust the software parameters in order to detect the most precisely possible the defects in the tested specimen. The operator moves the transducer on all the surface of the specimen and looks at the reflected sound signals. For the tested specimen size, the ultrasounds tests last approximately 30 min.

A transducer connected to a portable sound encoder called Omniscan enables to propagate the sound waves

The inconvenient of ultrasounds is that in order to detect the more precisely possible the defects (location and dimension), it is necessary to sweep all the surface of the specimens. It is very long and tiresome. Moreover, it is important to adjust perfectly the Omniscan in order to determine defects dimension and position otherwise the effects edge can appear.

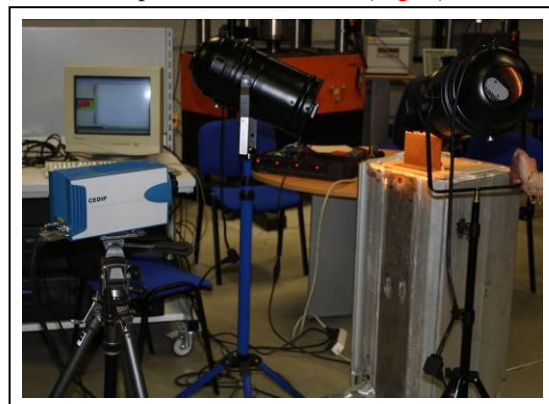
**Fig. 5 Thermography IR device.**

The temperature field is captured by an infrared CEDIP camera which features a focal plane array of 320×240 pixels. The thermal resolution of the camera is about 20 mK. Two halogen lamps are located at 300 mm from the specimen and heat it (Fig. 5). The

acquisition frequency of the films is equal to 50 Hz and the films last 30 s. The specimen is heated during 10 s

by halogen lamps. The temperature recording includes the heating time (10 s) and the beginning of specimen cooling (20 s).

Periodic heat energy, generated by halogen lamps, is transferred to the material [9-11]. Thermal waves are propagated by conduction inside the material and are reflected on the boundaries. The wave reflection is disturbed by defects. The IR camera measures temperatures which are modified due to defects.

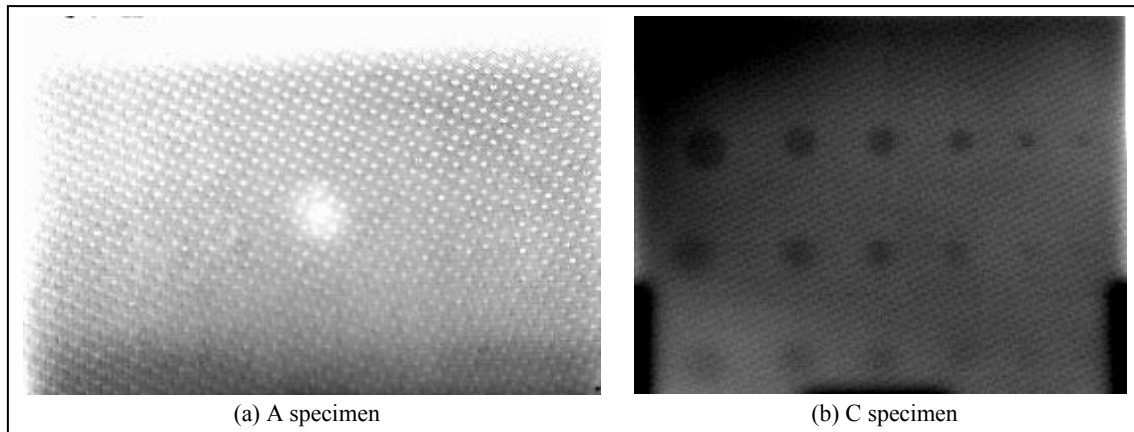
**Fig. 6** Defects detected by thermography IR in two tested specimens.

Infrared thermography tests are highlighted defects in both specimens (Fig. 6). The peel ply was not

detected by thermography IR. This is certainly due to the fact that the peel ply is well stuck to composite

fibres. Thus, they constitute one and only one material and consequently it has the same conductivity as the resin. The experimental protocol was improved in order to try to detect the defect but that is not sufficient. So, this method presents some limits.

For A specimen, the delamination was detected by thermography IR very quickly (around 10 s) and very easily. After one test, the defect was detected (Fig. 6a). The specimen is heated on the same face as the temperature field is measured. Like with the ultrasounds method, the dimension and the localisation are determined. The defect is circular and the diameter is approximately equal to  $12 \pm 2$  mm. It is located  $70 \pm 1$  mm from the right side along the x axis and  $41 \pm 1$  mm from the bottom along the y axis. The measurements precision depends on the pixel size and the image quality. It was checked that the measurement method is reproducible by taking several measurements on a well-known specimen.

For C specimens, defects were detected by heating them on the back face and by measuring the temperature on the front face. With thermography IR, defects diameters are always underestimated compared

to theoretical diameters inserted in the specimen. The major inconvenient with thermography IR is that the small diameters are not correctly detected. The defects are visible but the diameters determination is not exact. There is an error on the diameter size only for the smallest one. The error is equal to 50%. The defect position along y axis is determined at  $\pm 1$  mm. They are the same ones as the theoretical values. Nevertheless, there is an error on the defect position along the x axis. The error is all the more important since the defect diameters are small. For defects which are 4 mm in diameter, the error is equal to 40%. For defects which are 15 mm in diameter, the error is equal to 3%. It is interesting to remark that all the defects of C specimen were detected.

The major advantage of the thermography is the experimental time. In 30 s, it is possible to know if the specimen or an industrial structure has a defect. However, according to the nature of the defects and/or the way in which they stick to adhesive or fibres, the thermography IR does not enable to detect them. It is important to note that for both nondestructive methods,

the defects position is not exact. Nevertheless, with thermography IR, defect dimensions are correctly determined except for small defects. In fact, under 6 mm, defects are detected with difficulty. The advantage of ultrasounds is that the defects depth can
