A Coefficient Clustering Analysis for Damage Assessment of Composites based on Pulsed Thermographic Inspection

Yifan Zhao*, Lawrence Tinsley, Sri Addepalli, Jörn Mehnert, Rajkumar Roy

EPSRC Centre for Through-life Engineering Services, Cranfield University, Cranfield, MK43 0AL, UK

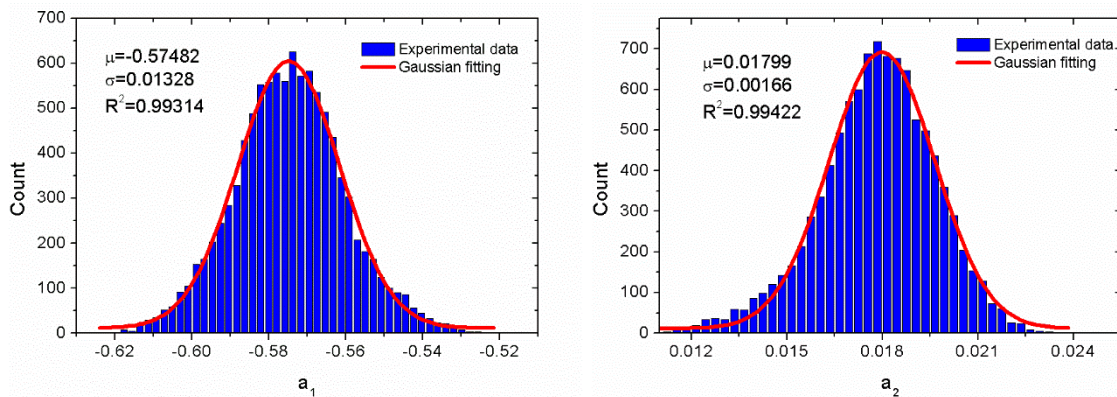
Fig. 5: The distribution of the coefficients for the damage-free specimen with corresponding Gaussian fitting.

100 pixels was sampled and the model (4) was fitted for each pixel. Fig. 5 shows the distribution of the first order coefficient a_1 and the second order coefficient a_2 with corresponding Gaussian fitting respectively. It is clearly shown that both coefficients are located within a narrow range with an approximate Gaussian distribution. The standard deviation of the fitting, σ , is 0.01328 and 0.00166 respectively, which is relatively very small comparing with the mean of distribution, μ , which is -0.57482 and 0.01799 respectively. The value of R-Square, as the indicator of approximation level, is 0.99314 and 0.99422, respectively.

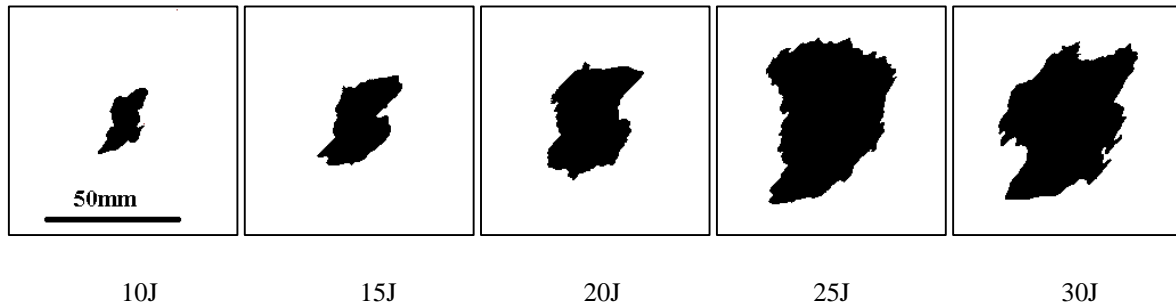
Fig. 10: Visualisation of the detected defect area for all specimens in the binary form.

Fig. 10 shows the visualisation of the detected damage area (black colour) in the binary form by converting the classification results into the spatial domain. To quantify the measurement, Table 3 presents the calculated properties of the detected damage area for each specimen, where the compactness measures the shape. Compactness was calculated by

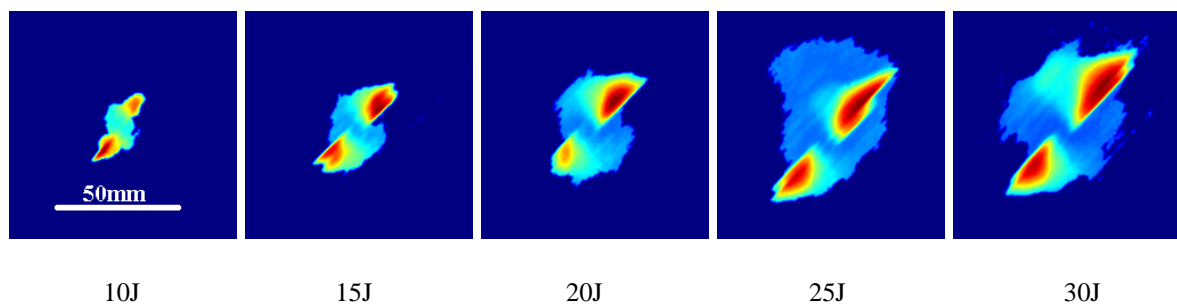
Fig. 12: Reconstructed data visualisation of damage across a range of samples: based on the d_{xy} values from the CCA method.

Once the raw data sequence is converted into polynomial coefficients, and has undergone the coefficient clustering step transforming them into d_{xy} , these values can then be plotted back in the spatial domain, providing a new and alternative visualisation of the detected damage areas, as can be seen in Fig. 12. It has been observed that there are consistently two areas (top right

and bottom left) that have high values of d_{xy} for all specimens with impact damage. This phenomenon may be caused by the mechanism of the weight-drop machine itself.
