O'Grady et al., *Cogent Arts & Humanities* (2018), 5: 1553326  
<https://doi.org/10.1080/23311983.2018.1553326>

# Interdisciplinary approaches to understanding and preserving mudbrick architecture in regional and diachronic contexts

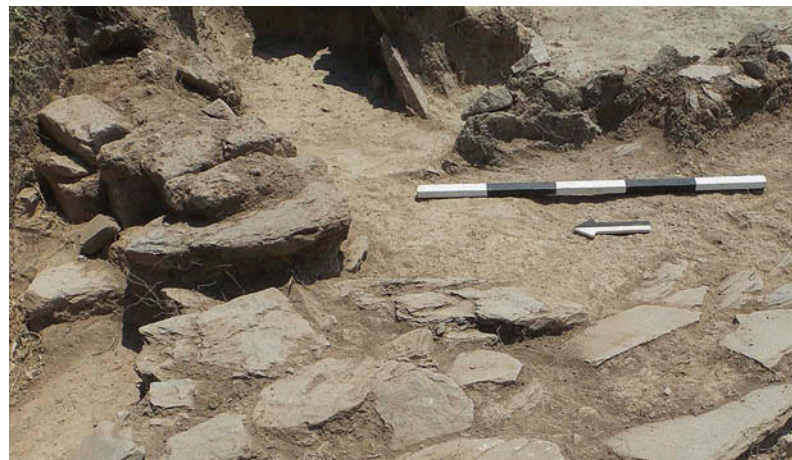
**Figure 2.** Two courses of mudbrick preserved *in situ* on top of stone socle recovered from Kaymakçı (KAP 97.545).

While research at Sardis dates to the 1970s, investigations at the Middle to Late Bronze Age site of Kaymakçı (see Figure 1) began in 2012. Three years of excavation on site under the KAP provides critical information about the extent and nature of local mudbrick construction. Excavation and analysis of recovered material reveal evidence of older earthen architecture traditions dating to the second millennium BCE. Despite poor preservation characterizing most architectural evidence of mudbrick, increasing diversification of methods of investigation in recent years (e.g. Love, 2017) enables collection of new, meaningful information regarding production technology and choice. Archaeological data indicate that stone foundations and mudbrick superstructures define normative architectural traditions. While there is an extensive mudbrick corpus, there is limited archaeological evidence for *in situ* construction. The best-preserved evidence consists of two courses of mudbrick superstructure sheltered from postdepositional degradation and weathering by a fortification wall (Figure 2).

Most, but not all, mudbrick finds show evidence of surface accretions developed during weathering from air and wind exposure (see Figure 2). Many exhibit uniform calcium (Ca)-rich surface coatings ranging between 0.001 and 0.005 m in thickness, similar to those found on ceramic, stone, and bone artifacts excavated from the site. The presence of Ca-rich surface accretions confirms that, while the site is situated on/or near bedrock, the clay matrix of Kaymakçı soils retains moisture for extended periods. Exposure to substantial wind and water following abandonment is most likely responsible for weathering on mudbrick structures at Kaymakçı. This is analogous to observed damages associated with derelict modern structures preserved in the area today.

coatings, suggesting a frequent maintenance cycle. This differs from ancient mudbricks recovered from Kaymakçı, which incorporate a finer range of aggregate, lower percentage of organic temper, greater variance in standard brick size, and high-fire sintering (see Table 1 and Figure 2).

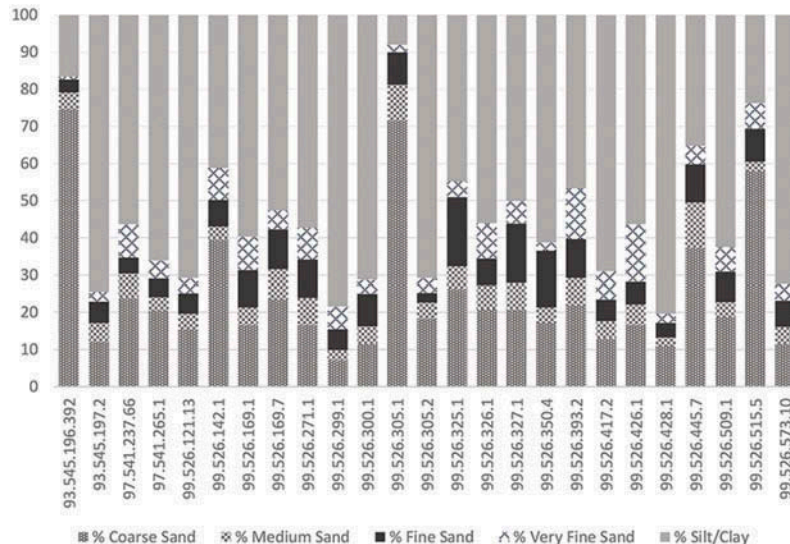
**Figure 3.** Percentage representation of sand and silt/clay particles in mudbricks from Kaymakçı.

Fluctuating ratios of material components contribute to observed variation in mudbrick recipes rather than resource diversification. Disparities might stem from small-scale production units, wherein each used particular recipes and operated locally or for short periods to produce needed bricks for a particular housing block. Differential mixing within single batches of mudbrick may also be the source of variability. Currently, the relationship between mudbrick composition (whether homogenous or heterogeneous) and their geospatial location in individual walls or structures is unclear, as excavation has only revealed individual bricks rather than complete mudbrick courses. Whatever their origin, such variation is discernible in macroscopic and microscopic observation, as well as in particle-size analysis, which reveals high variation in sand and silt/clay component ratios (Figure 3). Following Love's (2017) methodology, field-laboratory analyses on sun-dried mudbricks used a nested set of sieves to distinguish between coarse (500 µm), medium (250 µm), fine (125 µm), and very fine (64 µm) sand, and silt/clay fractions and determine particle distributions. While "ideal" brick recipes usually contain up to 25–45% clay (Love, 2017, p. 354; Rosen, 1986), Kaymakçı mudbrick recipes diverge significantly from this ratio, a trend observed when comparing between bricks within the same architectural feature (Figure 3).

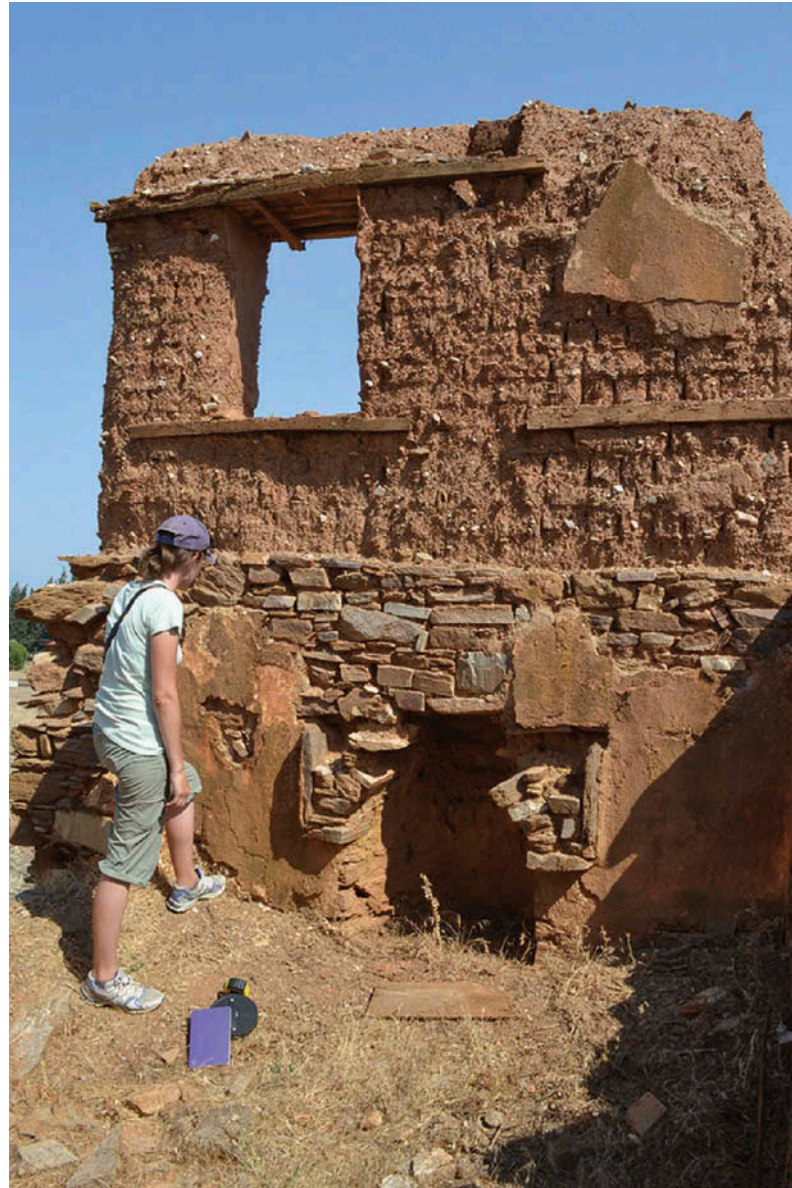
**Figure 4.** Typical vernacular mudbrick architecture where mudbrick is laid across stone foundations and wood beams provide support; please note areas where original plaster surfaces are preserved, Eski Haciveliler.

Most structures in Eski Haciveliler have stone foundations, some with extant mudbrick superstructures, wooden support beams, and, where preserved, layers of plaster covering the mudbrick (Figure 4). Both single- and two-story residences are found in the village, allowing in the latter case for the demarcation of storage, social, and family spaces. Found predominantly in the lower village, single-story dwellings are oriented toward courtyards and enclosed by walls that close the structures from the street (Luke & Cobb, 2013, p. 164). Through interviews with Haciveliler inhabitants, Luke and Cobb (2013, p. 164–6) highlight the importance of air movement, scent, and light in understanding how inhabitants organized and used their space. In addition, preserved sections of the buildings are extremely valuable documents recording the use of raw materials and manufacturing technologies used in construction through exposure of internal stratigraphic components. Therefore, mudbrick architecture from Eski Haciveliler and its orientation/interaction with the surrounding environment inform our understanding of building function, as well as degradation and post-abandonment processes at Kaymakçı, in spite of observed differences between ancient and contemporary bricks.

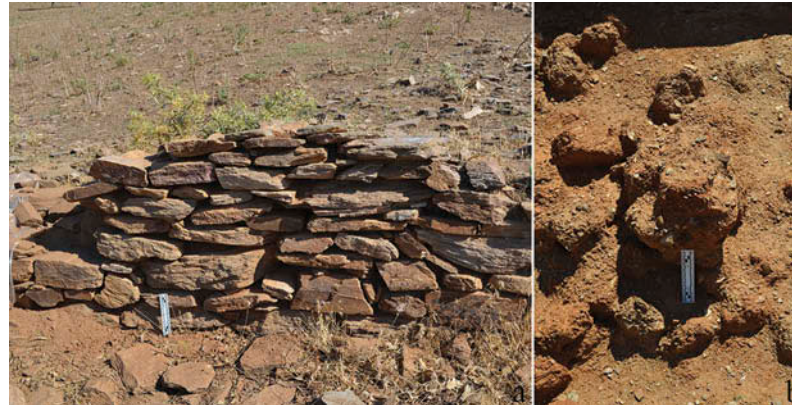
**Figure 5. Eski Haciveliler conservation laboratory testing sites: (a) fieldstone masonry wall (south side) surrounding the schoolhouse perimeter and (b) mudbrick wall (west side) from the schoolhouse.**

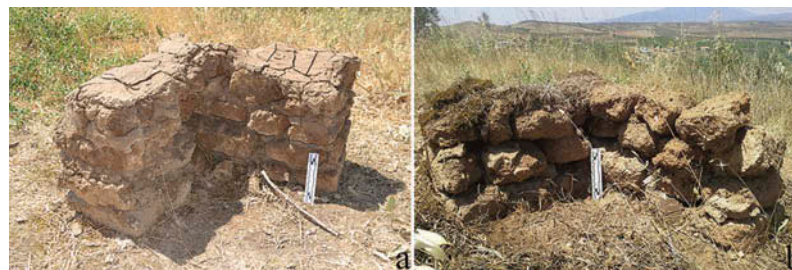
**Figure 6.** Tekelioğlu experimental L-shaped mudbrick wall: (a) just after construction in July 2013 (southeast side) and (b) 11 months later in June 2014 (southeast side).

Following the end of the 2013 field season, local colleagues continued to monitor the wall—wetting and photographing daily for an additional 2 weeks during the dry season. Thereafter, the wall was inspected on variable intervals (2–3 times per week, once per week, once every other week). Throughout this period, we were in regular discussion with our collaborators and made protocol adjustments based on their observations and knowledge of the environment. This dialogue was critical and resulted in the removal of the plastic covering 4 weeks after the date originally

scheduled due to unexpectedly high temperatures. The wall stabilized in November 2013 and remained in place with very little damage until March 2014, when grazing cattle caused significant damage. Following this incident, our local partners partially reconstructed the wall. Assessment in June 2014 (Figure 6(b)) indicated substantial color alteration and complete failure of all mud coatings applied between mudbrick courses, despite the high Ca-content of soils used. This is unsurprising as the mud coatings did not contain added binders (lime or cement) and reflects the need for semiannual (or more frequent) maintenance—critical information for preservation planning of the archaeological site. While we observed significant structural instability, most damage could be attributed to the April event when referencing our archive of digital documentation condition images.

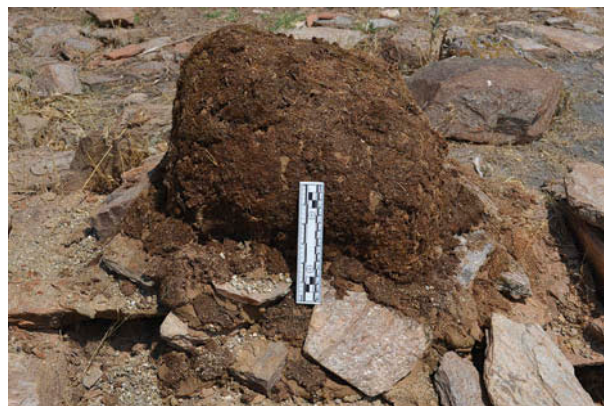
**Figure 7. Soft vegetative cap applied to vertical and sloped surfaces of mudbrick (north side) at Eski Haciveliler.**

Soft capping experiments at Eski Haciveliler tested vegetative capping materials applied to horizontal and vertical/near vertical mudbrick surfaces secured to a stone foundation. The soft vegetative cap incorporated the following layers placed on top of premoistened mudbricks in this order: mud coating, fine sand, geotextile, mud coating, gravel, mud coating, and vegetation (Figure 7). Following daily wetting and photo-documentation, the completed cap slowly dried for the following 15 days. This process of daily wetting and photographing continued at varying intervals until the end of the dry season. From mid-September 2013 to May 2014, the soft cap was watered and photographed weekly to document changes and characterize the cap's ability to protect the underlying mudbricks. Unsurprisingly, the Eski Haciveliler vegetative cap was unattractive in appearance and vertical/near vertical areas failed to achieve robust plant growth. According to images and verbal reports from collaborators, the vegetation component began to fail on the southern side as early as January 2014. This makes sense given the northerly winds associated with the site. In subsequent months, vegetation on the south side detached from most vertical surfaces. Furthermore, evidence of small mammal or insect damage appeared at the interface of the mudbrick with the stone-masonry substrate.

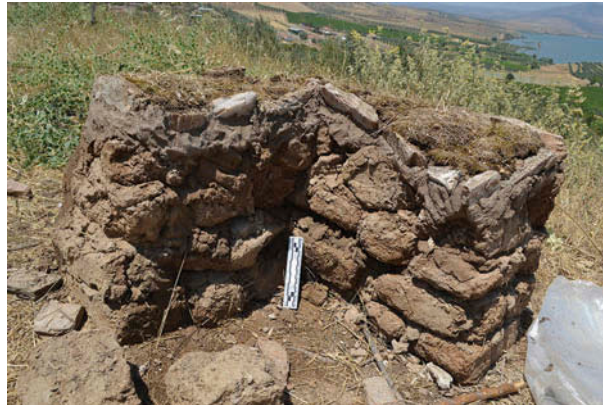
**Figure 8. Soft vegetative cap applied Tekelioğlu experimental L-shaped mudbrick wall (top surface) directly after application.**

In contrast to the Eski Haciveliler field trial, the soft cap system only protected the top horizontal surface of the experimental mudbrick wall in Tekelioğlu. Prior to installing the cap, thin sedimentary stones were set perpendicularly along the wall perimeter for protection using a lime–cement–soil–sand mortar mixture (5:1:2:6) using T4 soil. Following setting of the stone perimeter, we placed soft vegetative cap layers on top of the mud-coated, premoistened mudbricks using sand, geotextile, gravel, mud coating, gravel, dry soil, and vegetation (Figure 8). The completed cap was wetted, documented, and covered with a wet towel and plastic sheet to control drying. Local collaborators remoistened the towels daily for 15 days and at varying intervals thereafter, until the end of the dry season.
