Yin, X, Lawrence, R & Maskell, D 2018, 'Straw bale construction in northern China: Analysis of existing practices and recommendations for future development', *Journal of Building Engineering*, vol. 18, pp. 408-417.
<https://doi.org/10.1016/j.jobe.2018.04.009>

1 **Straw bale construction in northern China –**
2 **Analysis of existing practices and**
3 **recommendations for future development**

18 This paper makes recommendations for future straw bale design in northern
19 China based on an inspection of existing buildings. The issues identified with
20 existing construction details were subjected to computational simulation analysis
21 which identified shortcomings in existing practice and proposes revisions to
22 design detail in order to accommodate the environmental conditions in northern
23 China. The paper provides a unique insight into current straw bale practice in
24 northern China and proposes a practical and environmentally sound solution to
25 the pollution crisis in this region.

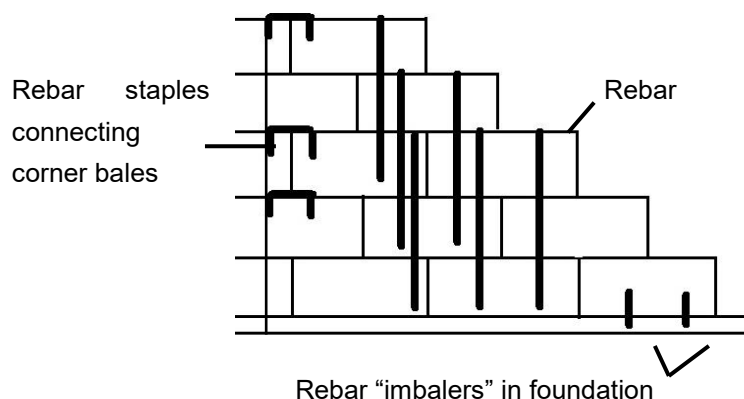
203 Figure 4. Pinning system for loading bearing straw bale walls with 3 tie bales laid
204 flat (24).

188 In some international examples pins are incorporated to provide structural stability
189 between bales (24). Although the effect of pins is not accounted for in the
190 structural design of in-fill straw bale construction (23), the elements are still
191 essential for the practicality of bale stacking of the walls (6). There are different
192 forms of pins in current practice. Rebar staples and all-thread steel rod with
193 pointed tips are used in load-bearing straw bale construction in the USA (Figure
194 4). The system is simplified by using natural shaped hazel studs by Jones (6). The
195 irregular shapes of hazel studs provide similar effects as the all-thread steel rod.
196 Because of the wide availability of the raw material, the modification is considered
197 to be a cost efficient and environmentally friendly solution (6). To achieve better
198 integrity of straw bale walls, bales are tied up at corners of first layer of the walls

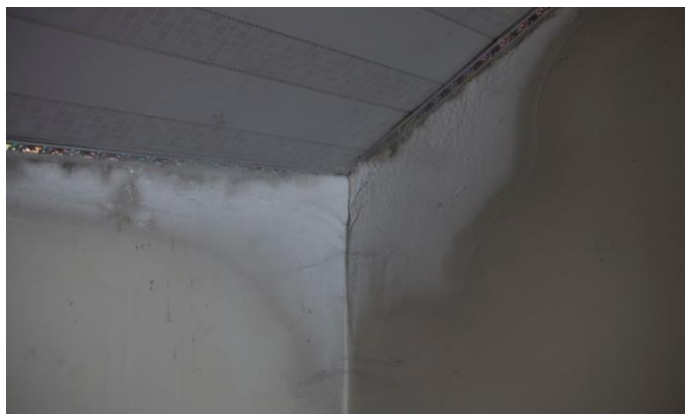
492 Figure 11. Condensation at the junction of the north wall and the west wall inner
493 corner of one of the straw bale house in Jiamusi.

482 Firstly, condensation was found on the internal corner in the inhabited straw bale
483 houses. The surface temperature on the internal corner is lower than the freezing
484 point and the liquid condensation developed into frost during the visit (Figure 11).
485 According to the owner of the farmhouse, the condensation is serious on the
486 internal surface of sidewalls. The owner also reported that the frost appears from
487 late December to early January when the lowest air temperature appears annually.
488 However the problem was never happened on the internal surface of either the
489 south wall or the north wall.

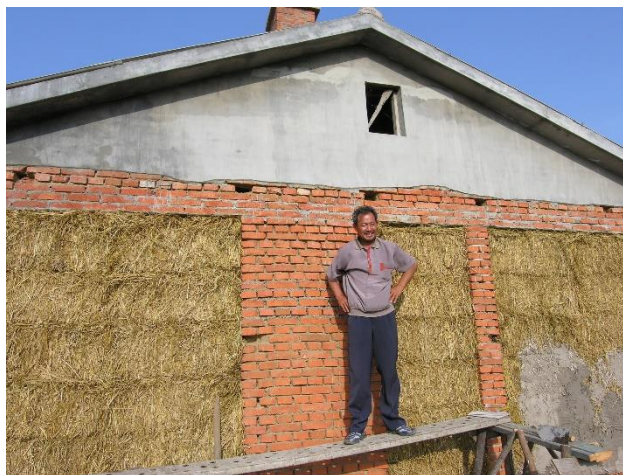
506 Figure 12. Detailing beneath external rendering of gable end in the ADRA straw
507 bale building project in Jiamusi. (33)

497 A second problem is linear cracking on external surface of gable ends. The cracks
498 were observed both on the inhabited house and the uninhabited house. It is
499 important to appreciate the detailing of gable ends to understand the cracking
500 issues on the walls. Making use of the photograph which was taken in 2006, the
501 construction beneath the external plaster can be appreciated (Figure 12). The
502 construction of gable end is similar to the construction of non-opening area of
503 south walls and north walls (Figure 2).
