# VIBRATION INDUCED FATIGUE FAILURE IN PIPING SYSTEM

A project report submitted in partial fulfilment of the  
requirements for the award of the degree of  
Master of Engineering (Mechanical)

Faculty of Mechanical Engineering  
Universiti Teknologi Malaysia

JUNE 2013

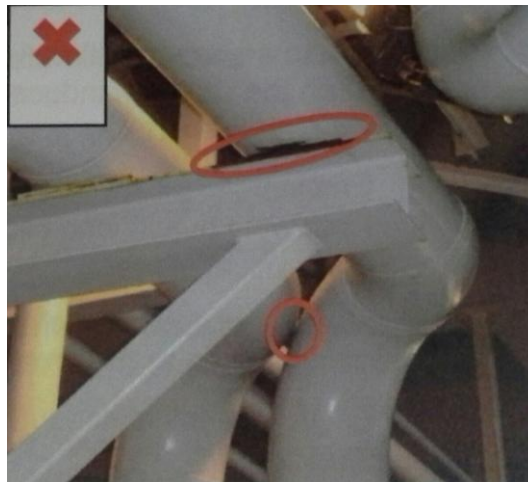
**Figure 1.1** Pipe fretting due to vibration and no reinforcement plate at rest support (Energy Institute, 2008)

Failure in piping system as failure due to fatigue which may lead to plant shut down is a concern in industry. There are 3 basic for vibration: mechanical induced vibration, flow induced vibration and acoustic induced vibration. Vibration could cause piping system to fret, fatigue or even transfer the vibration to the structure. Figure 1.1 and 1.2 below show examples of pipe fretting due to vibration.

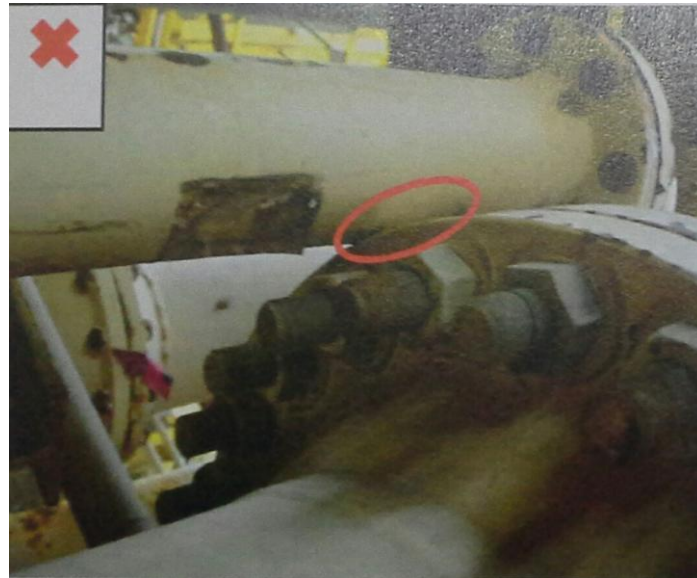
**Figure 1.2** Fretting damage caused by clash between pipes (Energy Institute, 2008)

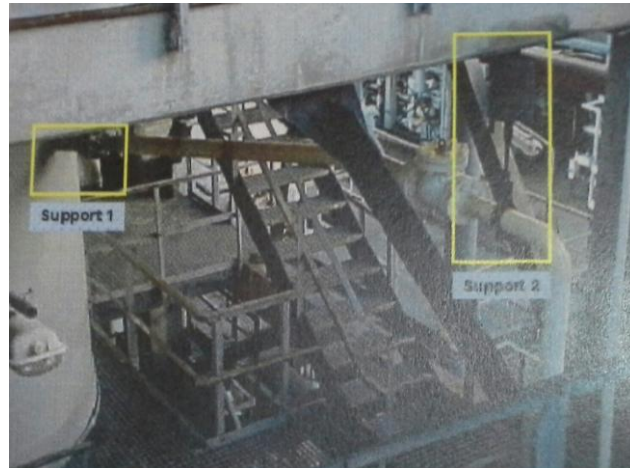
**Figure 1.3** Additional support in piping system to brace the piping structure (Energy Institute, 2008)

These guidelines provided methodology to predict and assess the likelihood of failure of a pipe system. Whenever a likelihood of failure is predicted, additional supports such as shown in figure 1.3 shall be added to brace the pipe structure or viscous damper such as figure 1.4 shall be added to reduce the vibration level. The industry uses these standards as a basis for safeguard of piping from suffering from damages. Continuous work should however be done to improve the accuracy of these standards and to prevent any tragic incident from happening.

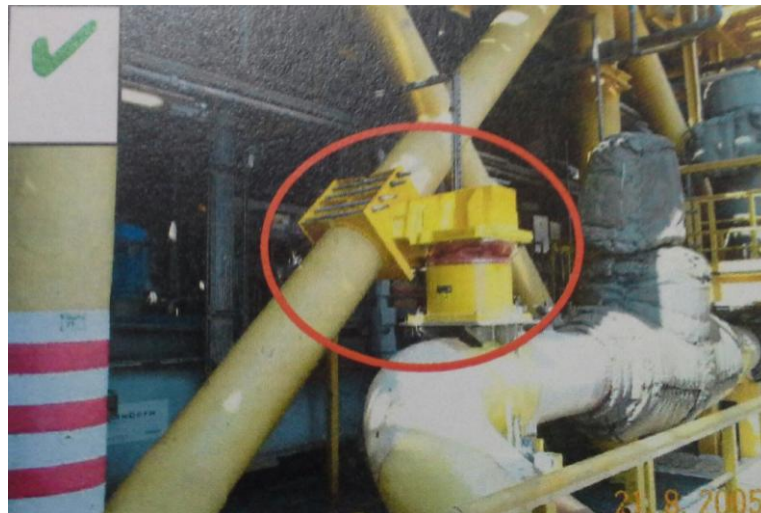
**Figure 1.4** Viscous damper added to reduce the vibration level of piping system (Energy Institute, 2008)
