MECHANICAL PROPERTIES OF CONCRETE CONTAINS WASTE TIRES EXPOSED TO HIGH TEMPERATURE

Abstract: Concrete contains crumb rubber and steel fiber from waste tires has recently gained interest among researchers as an alternative material to be used in the construction field. Mechanical properties of the concrete containing crumb rubber replacement and steel fiber at high temperature was investigated experimentally. The waste crumb rubber was chemically treated by using sodium hydroxide (NaOH). Water cement ratio of Treated Rubberized Steel Fiber Concrete (TRSF-Con) was modified to get similar strength as Normal Concrete (NC). A microstructure analysis using Scanning Electron Microscopy (SEM) test was conducted to investigate the bonding of crumb rubber in the concrete mix at ambient and high temperature. The TRSF-Con has performed satisfactory on reducing the growth and crack width compared with normal concrete when exposed to high temperature. The concrete containing crumb rubber and steel fiber have high potential to be utilized as insulating or reinforcement materials for non-structural composite member, which ensure the elements of the structure will not collapse for a prescribe peri

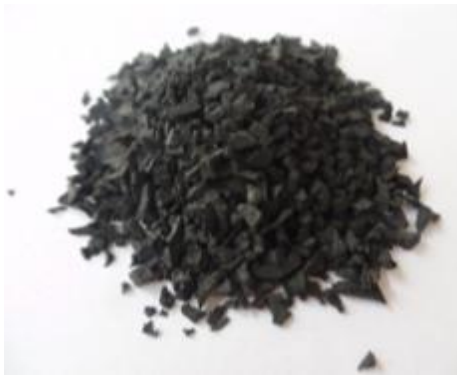
(a) Crumb rubber

In this research, Ordinary Portland Cement (OPC) was used for Normal Concrete (NC) and Treated Rubberized Steel Fiber Concrete (TRSF-Con). The natural fine aggregate passing through 4.75 mm while crush coarse aggregate passing through 10 mm and retained at 5 mm were used. The crumb rubber was treated with Sodium Hydroxide (NaOH) for 20 minutes and rinsed with water then dry for 24 hours at ambient temperature. This process was done to remove the impurities and dust on crumb rubber surface. Figure 1 (a) shows a crumb rubber that passing through 4.75 mm were used as fine aggregate replacement while Figure 1 (b) shows a steel fiber with diameter of 0.30 mm with average length of 2.35 cm.

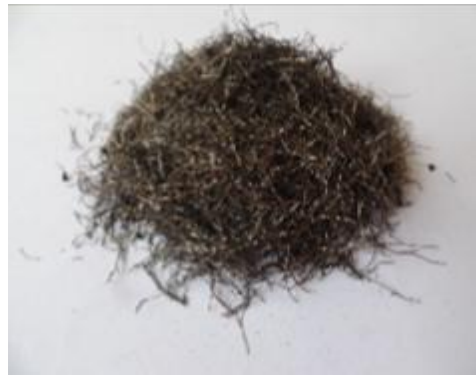
(b) Steel fiber

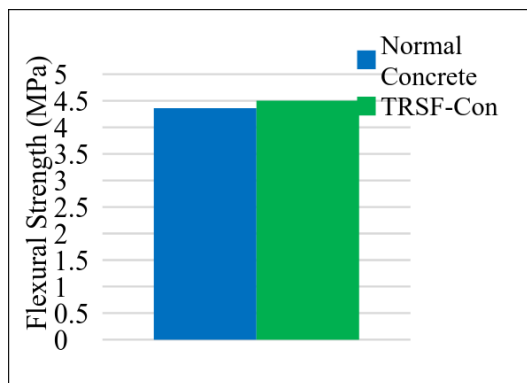
Figure 9: Flexural strength for fine crumb rubber after modification of water cement ratio

After modification of water cement ratio, the flexural strength of TRSF-Con has increased with 3.2% and gives approximately same flexural strength as NC as shown in Figure 9. This has proved that the ideal size of crumb rubber that can be used as a fine and coarse aggregates replacement in concrete mix is between 3 mm to 10 mm. This was supported through the finding by Topcu and Bilir where, it shown that 4 mm size of crumb rubber with 180 kg/m³ aggregate replacement is an ideal replacement (Topcu and Bilir, 2009).
