Case study of impacts of DRENURBS Project on Bonsucesso Creek

By Janaína A. Evangelista¹, and Professors Márcio B. Baptista², Priscilla M. Moura³ and Sylvie Barraud⁴

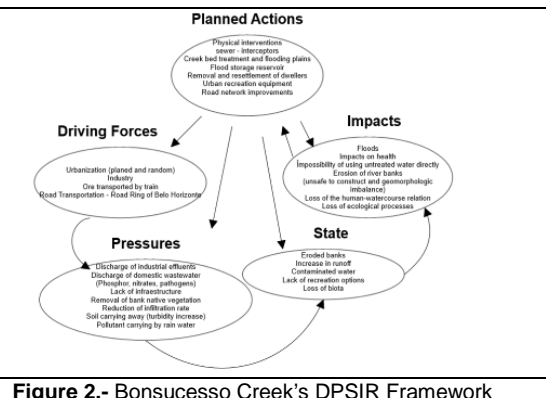
Bonsucesso creek basin comprises two main watercourses, namely Bonsucesso and Olhos D'água. The basin has an area of 11.92 km² and a Thalweg extension of 22.6 km. This watercourse is a right side tributary of Arrudas River located in the South of the municipality of Belo Horizonte (Figure 1). The analyses based on the studies on Sanitation and Environmental Diagnosis (Belo Horizonte, 2002), by the basic and executive projects of DRENUSBS Program (Belo Horizonte, 2009), and field surveys. Such surveys were carried out on August 3, 2011, after the construction a contention reservoirs and before interventions on the river channels, and on November 12, 2011, after finishing the most part of those interventions. Based on the diagnosis performed by the city of Belo Horizonte for planning DRENURBS projects, it was possible to detect the driving forces, pressures, state and impacts shown in the Figure 2. The action indicated are the ones performed by the city according to the basic and executive projects.

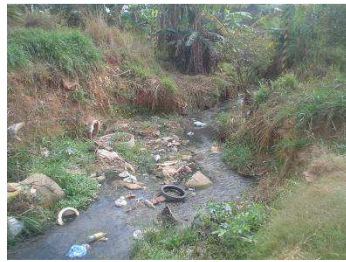
a) Wastewater and solid waste

The degradation showed in the studies and confirmed by during an inspection visited done in August 3, 2011, indicated the existence of further erosion processes in some places (Figure 3b); and place were solid waste had been disposed (Figure 3c); contamination of clean water by wastewater that was being discharged untreated into the watercourses in many places, and solid waste disposed alongside the banks (Figure 3a); many houses with no driveway for garbage trucks; and the lack of recreation public areas.

Figure 3: – Photos of Bonsucesso Creek

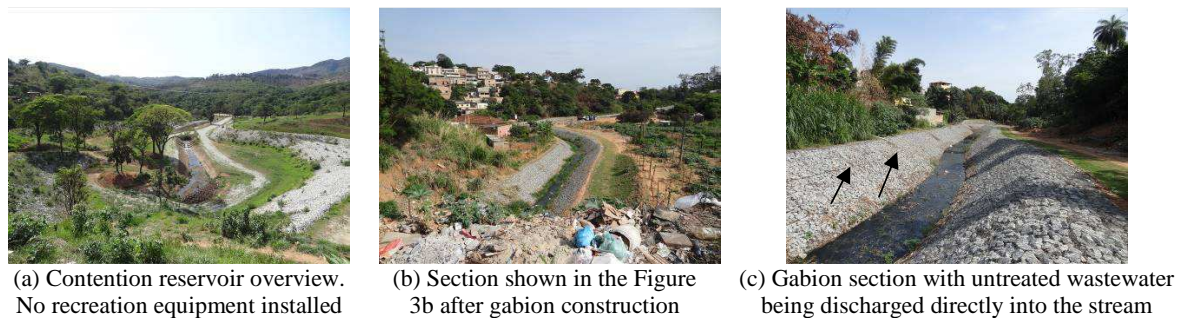
In the visit made on August 3, 2011, one of the contention reservoir had been constructed, however the recreation equipment planned in the project had not been installed, and the surrounding area was fenced, i.e., there was no place available to be used by the population. Such situation remained unchanged until the visit made on November 12, 2015 (Figure 4a.). The bedded rockfill planned solution was implemented only in a small upstream section with the existing concrete canalization. The designed solution was changed to a trapezoidal channel in mattress shaped gabions (Figure 4c). The floods did not happen after that work shown in the Figures 4b and 4c. The problems related to eroding processes were solved, however with the loss of fluvial geomorphology dynamic processes caused by the stiff contention of the banks. Another important aspect to be pointed out is the strong impact on the landscape that was not accomplished one of the preconditions of the program, which was the landscape architectural integration. In no section visited on November 12, 2015, there was recreation equipment installed. Changes in the road network were restricted to the dam area, and therefore, according to the dwellers and community leaders, the driveways for the access of garbage trucks had not been constructed.

Figure 4: – Bonsucesso Creek after the intervention
