Energy Rehabilitation of Social Housing in Vulnerable Areas**Case study: a 1950s Building in a Medium-sized Mediterranean City****Ruá María José¹, Huedo Patricia¹, Cabeza Manuel², Saez Beatriz², Civera Vicente¹**¹*Mechanical Engineering and Construction Department*²*Industrial Systems Engineering and Design Department. Jaume I University***Abstract**

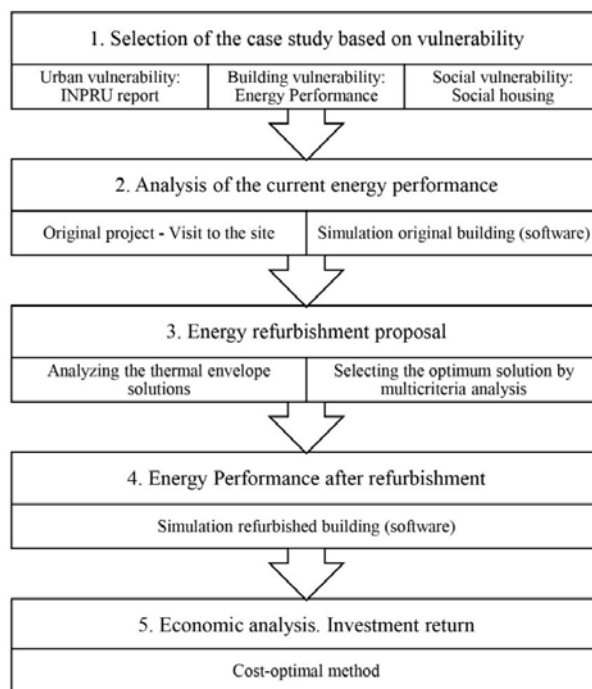
Figure 1. Methodology

Some stages were followed (see Figure 1) to undertake this work. First, the case study was selected according to three main pillars. On the one hand, the urban area was selected based on a previous work in which vulnerable urban areas of the city were defined. On the other hand, the building’s poor energy performance was the main observed feature. Finally, the building’s social housing condition guaranteed vulnerable dwellers, e.g., low-income citizens.

Once the building was selected, a diagnosis of its current state was made by analysing the scarce available project information and visiting the site to collect complementary and necessary information. This permitted the building to be simulated in officially recognised software to determine its energy performance. The third stage consisted in analysing the refurbishment solutions and selecting the optimal solution according to a multicriteria analysis after bearing in mind the actual conditions the building was in by looking for a real applicable one.

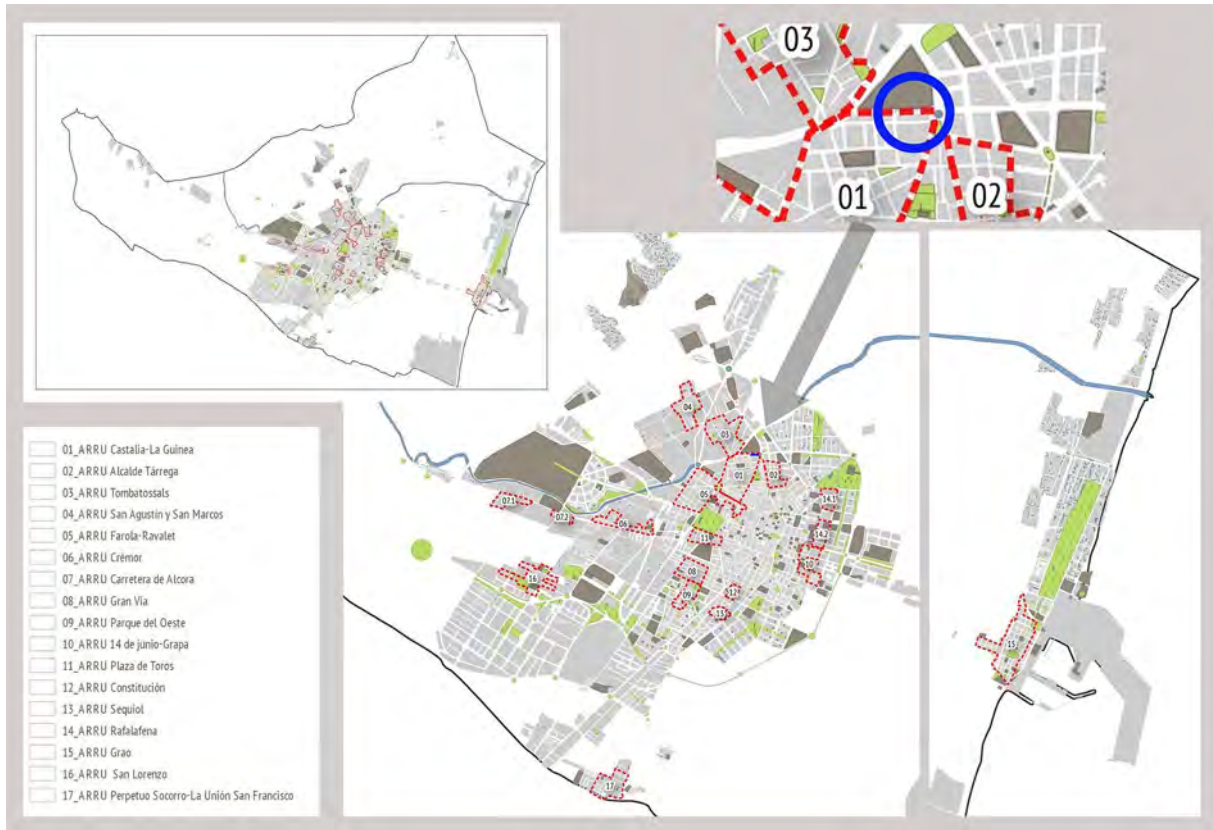
Figure 2. Situation

The development of the new Land Use Plan of the city of Castellón de la Plana (Spain) needs to define ARRUs. This definition was created by using 29 *ad hoc* selected indicators of vulnerability. They were grouped into four categories: urban (4), building (4), socio-demographic (16) and socio-economic indicators. The ARRUs were those areas where all the categories concurred, so they presented multidimensional vulnerability. As a result, 17 ARRUs were defined in the city (García Bernal et al., 2017; Ruá et al., 2017). The building used as a case study in this work is included in one of the ARRUs. The defined ARRUs are indicated in Figure 2. The selected block of buildings is included in ARRU 01. The location of the block is indicated in the top-right corner of Figure 2.

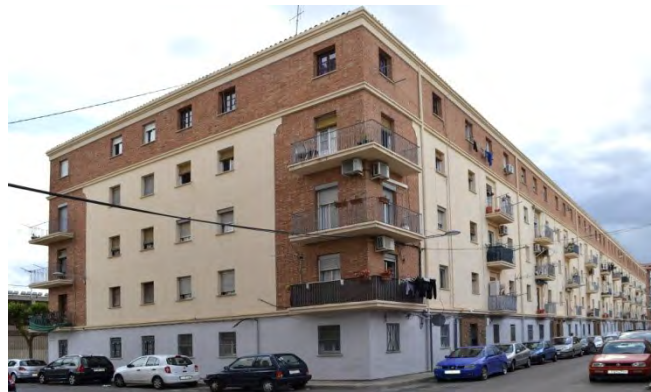
Figure 3. General view

The block of buildings was built in 1959 as social housing by Ministry of Housing subsidy. The group is formed by 12 buildings, the north façade, with odd numbers 1 to 11, to Huesca Street, and opposite the Castalia football stadium. The south façade is in Martínez Tena Street, numbers 2 to 12. Figure 3 shows a general view of the block of buildings. The block forms an internal courtyard and each building is formed by one ground floor and four upper floors, with two dwellings per floor, which means 10 houses per block and 120 houses in all, which account for 2339 m².

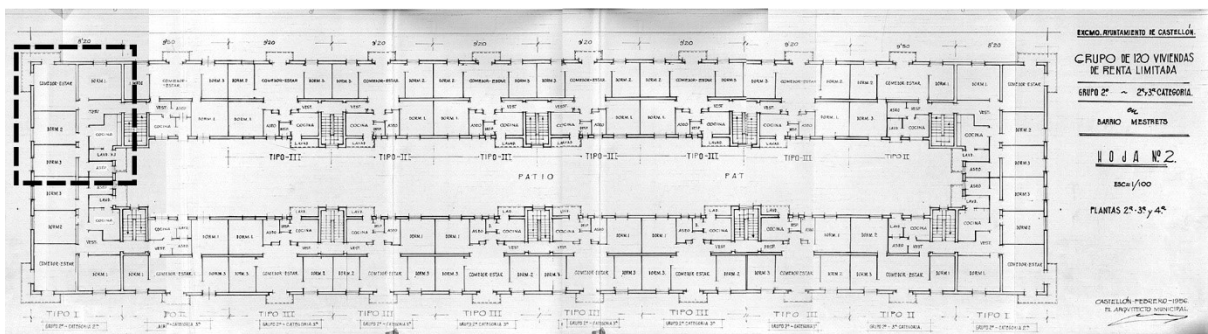
Figure 6. Second Floor (Original plans)

There are four buildings in the corners of the block, while the rest are terraced buildings which present better energy performance as they are less exposed to the outer environment. The building located in the north-west corner (357° north) is the worst in energy performance terms. In order to simplify simulation, only this building was simulated. There are three types of housing, as seen in the original plans presented in Figure 6, where the selected building is indicated. Figure 7 shows the floor plan, with dwellings types I and II, included in the building selected in the block. Dwelling type III is included in the terraced buildings in the block.

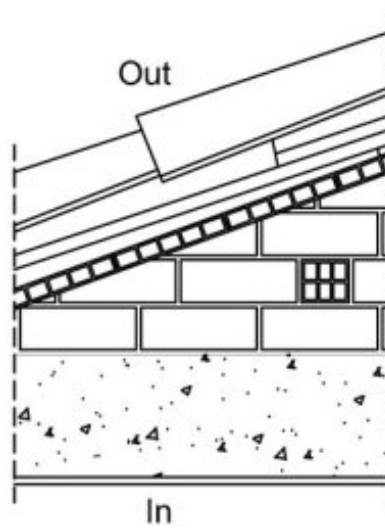
Figure 11.

<p>Façade 2</p>	<p>Bearing wall formed by double leaf brick: continuous outer coating with cement mortar + exterior masonry wall of ceramic solid brick of 1 foot-thick with cement mortar joints + inner skin of hollow ceramic brick 4 cm-thick with cement mortar joints + plastering. Exposed area: N 190.64 m²; W 100.63 m²; E 57.84 m²; S 169.51 m²</p>	<p>1.29</p>	<p>Figure 8</p>
<p>Windows</p>	<p>Wood carpentry with single glazing.</p>	<p>Carpentry: 2.20 Glazing: 5.50</p>	<p>Figure 9</p>
<p>Roof 1</p>	<p>Flat roof ventilated, trafficable: Finishing ceramic tiles + mortar layer 5 cm + bituminous sheet + ventilated air chamber + reinforced concrete one-way slab 30 cm, ceramic hollow plot + plastering. Exposed area: 38.83 m².</p>	<p>1.37</p>	<p>Figure 10</p>
<p>Roof 2</p>	<p>Gable sloping roof ventilated 16°: finishing ceramic gables + mortar layer + ceramic tiles for roof slope + ventilated air chamber + reinforced concrete one-way slab 30 cm, ceramic hollow plot + plastering. Exposed area: 116.03 m².</p>	<p>1.05</p>	<p>Figure 11</p>

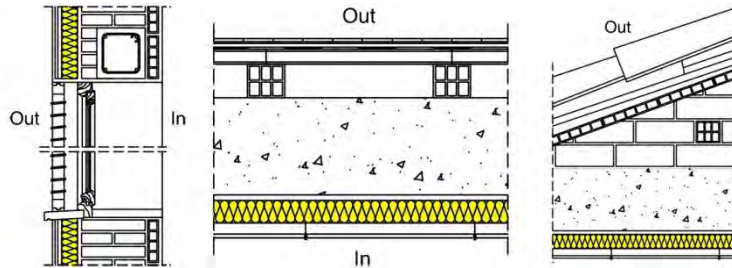
Figure 13. Façade, sloping roof and flat roof refurbishment solutions

Table 3 shows some constructive solutions (Huedo, Mulet & López-Mesa, 2016), along with their advantages, disadvantages and features by bearing in mind the technical, environmental, economic and heritage perspectives. The selected solutions are shaded in grey in Table 3 and represented in Figure 13. For façades, inner insulation (FI) was ruled out because of the dimensions of rooms. It would mean reducing the areas of rooms as they could not fulfil the minimum required dimensions according to new standards. Therefore, the outer solution with the External Insulation System was adopted in this case because it was more convenient than the ventilated façade,

and fell in line with different criteria. The convenience of this solution is supported by other studies (Sierra-Pérez, Boschmonart-Rives & Gabarrell, 2016) and can be applied to both façade types.

For roofs, the inner solution proved more convenience when looking at advantages and disadvantages. The same solution involving mineral wool and finishing plaster board could be applied to roof 1 (SRI) and roof 2 (FRI).

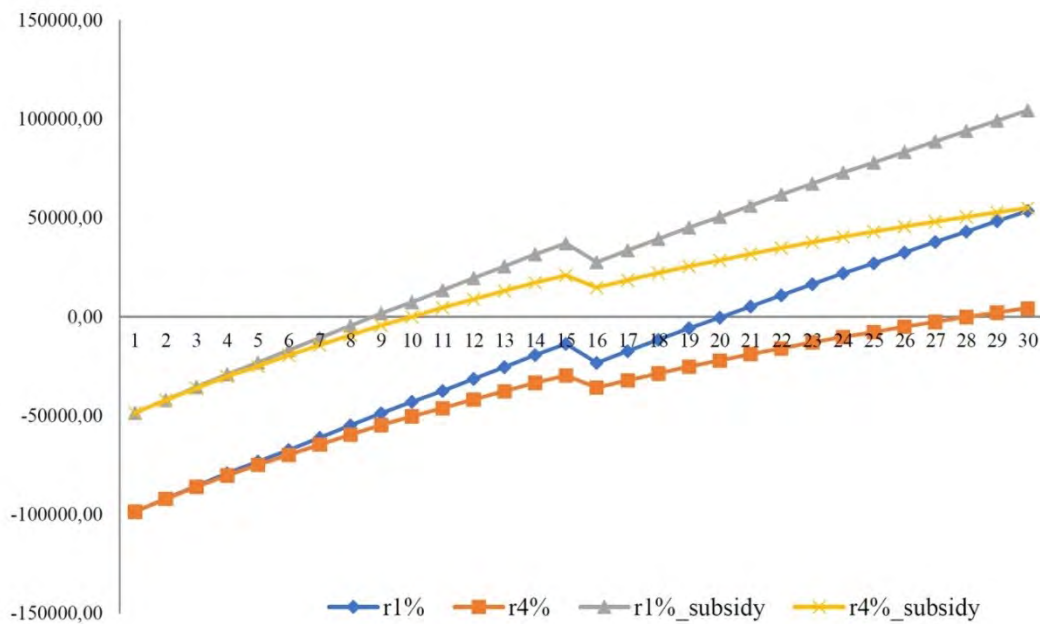
Figure 14. Façade, sloping roof and flat roof refurbishment solutions

The graphic represented in Figure 8 shows the accumulated NPV for two discount rates, 1% and 4%. NPV is €53,184.12 for 1% and is €4,736.1 for 4%. With the starting hypothesis of Table 5, we can see that the investment starts to be positive from year 20 and 28 for the 1% and the 4% discount rate, respectively. This is not a surprising result if we consider the private costs and only the carbon price a social cost.

Some subsidies can be considered in the calculations, if we bear in mind that the building is included in an ARRÚ, as mentioned in Section 3.1. This would result in a more optimistic scenario with a shorter payback, as calculated in previous studies (Alguacil et al., 2017). For example, estimating a hypothetical subsidy of €5,000.00/dwelling, the investment would be returned in less time, as seen in Figure 14.

The economic analysis conducted by the cost-optimal method shows an initial investment of €10,519.56/dwelling. With the starting hypothesis, the NPV is positive. The cumulative NPV shows that, in both cases, the NPV is over zero after 20 years. This term would be shorter if subsidies could address the building. Its location in an ARRU means that it is an area that should be prioritised to address potential subsidies. Refurbishment would also benefit users' quality of life by improving the thermal comfort of their dwellings as it would make the energy poverty situation more unlikely. Besides it would increase the market price of dwellings, which is an aspect that the economic analysis does not consider.
