POST-FAILURE CAPACITY OF BUILT-UP STEEL MEMBERS

Road School
2014

Research Objective

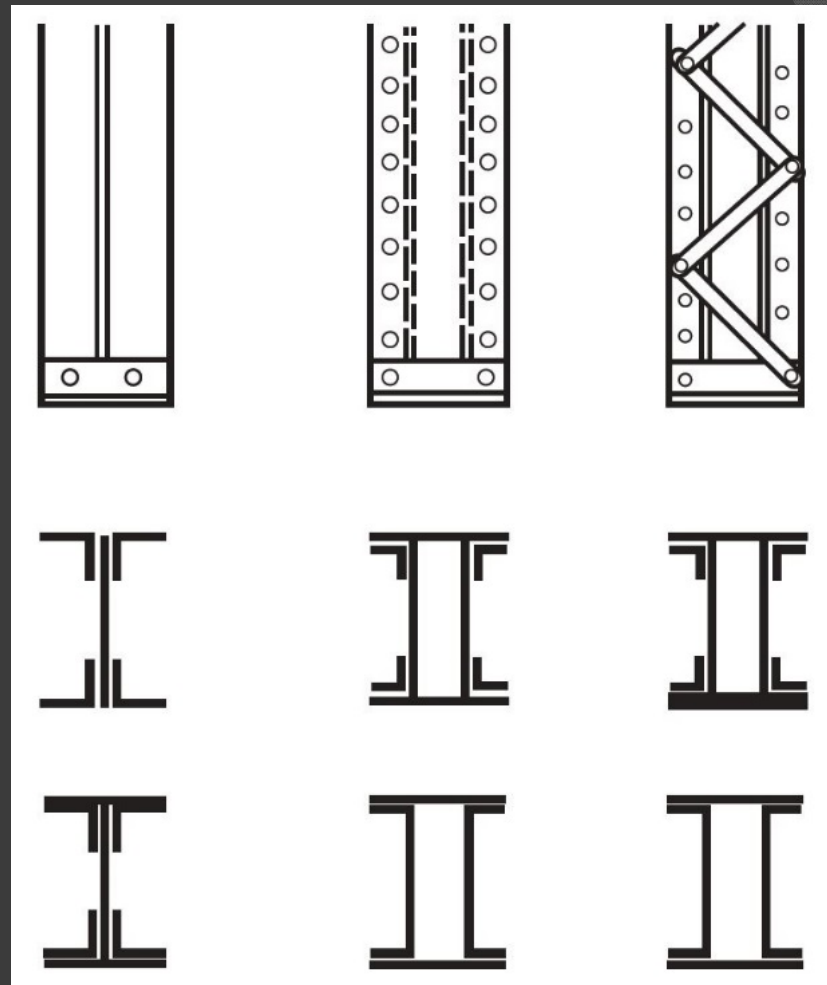
Built-up Steel Sections

- Used up until early 1960's
- Fabricated from smaller, readily available shapes
 - Plates, angles, channels, etc.
- Hot riveted components together

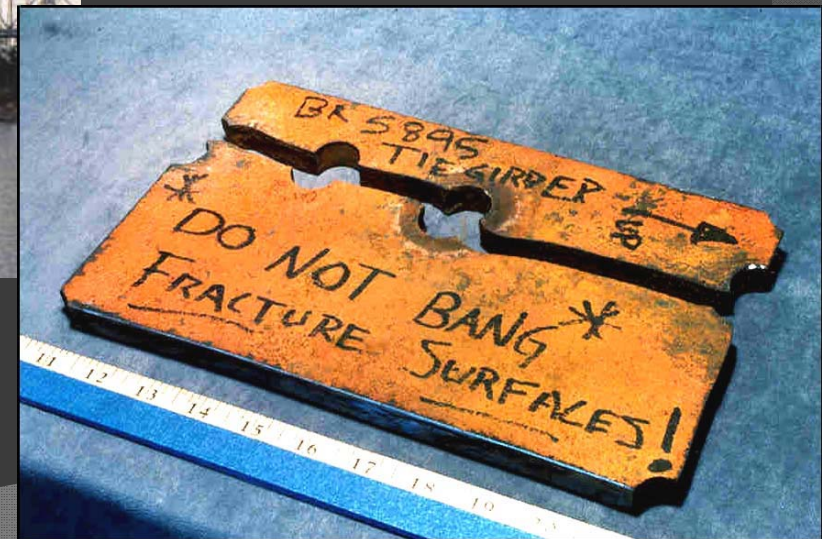
Tie-Girder

Built-up Member Fracture

- Hastings Bridge, MN
 - Fracture in web plate of riveted built-up tie-girder

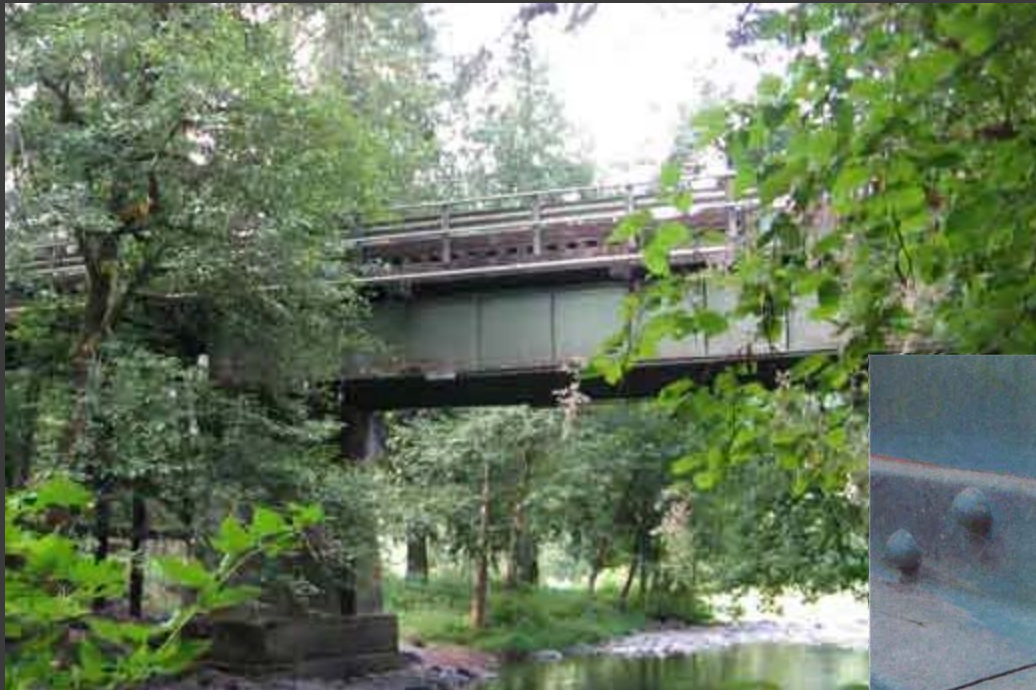
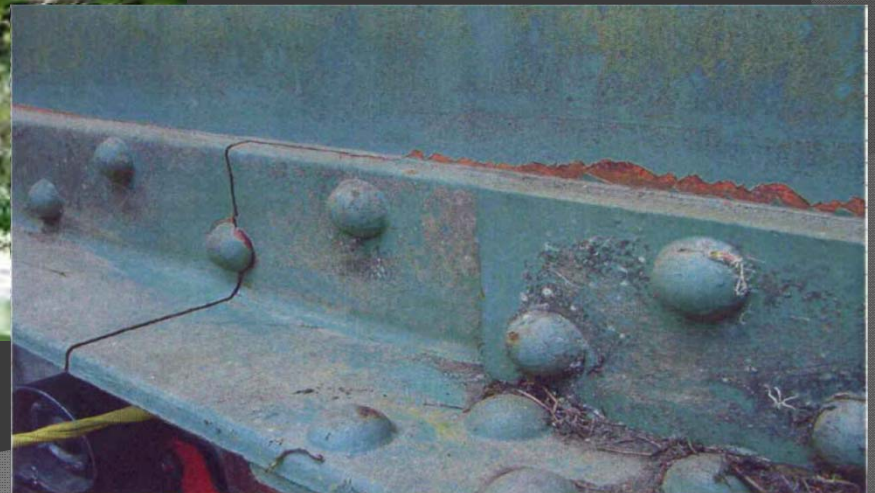
Built-up Member Fracture

- ◎ North Fork Mollala River Bridge, OR
 - Fracture in bottom flange of riveted built-up two-girder bridge

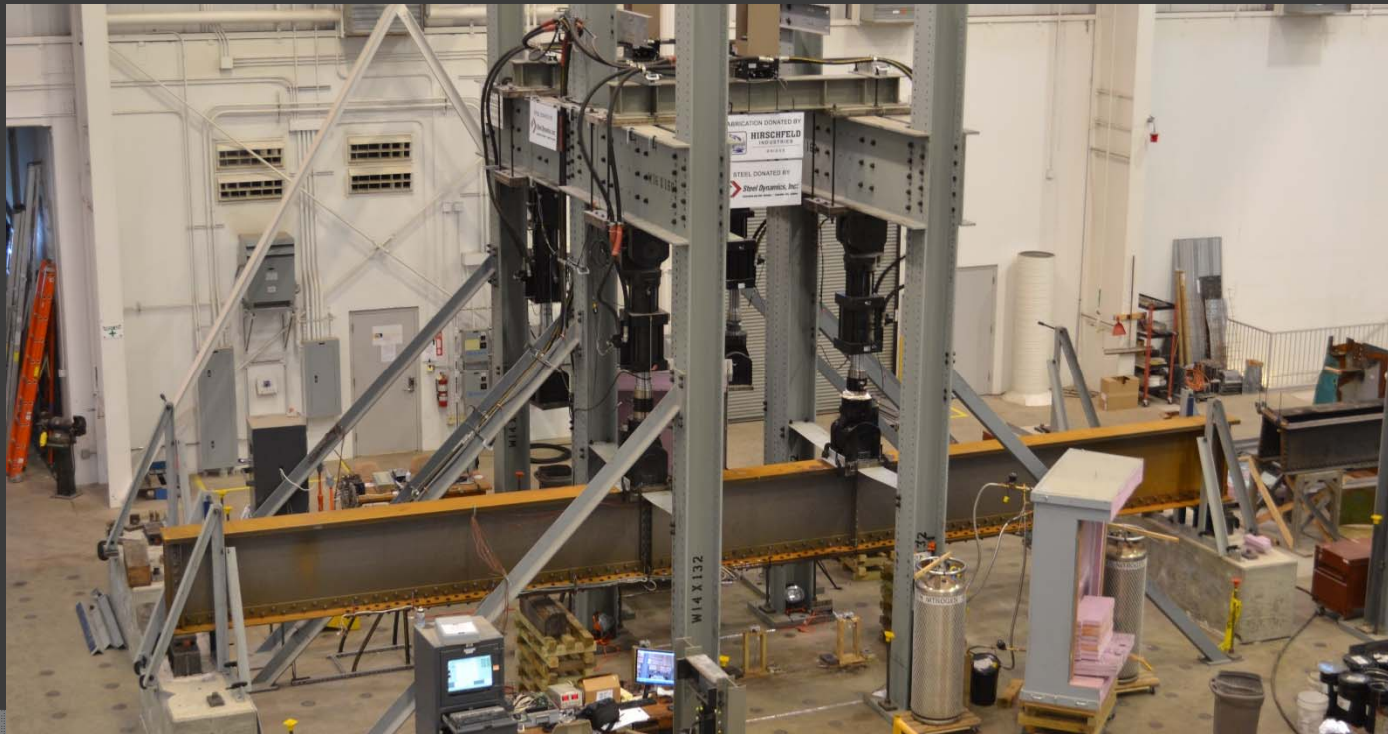
Specimen Selection

- ◎ Full scale experiments
 - Riveted vs. HS bolted
 - Historical specimens vs. new fabrication

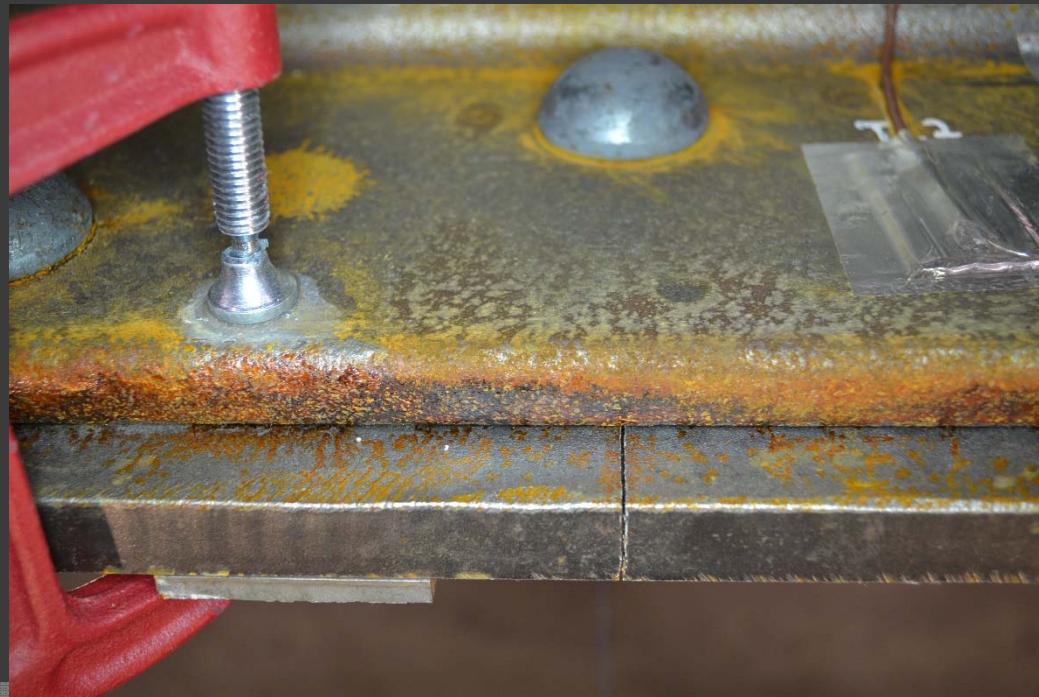
Fracture Test Results

- Only 1 of 7 specimens fractured
- All other specimens failed in fatigue

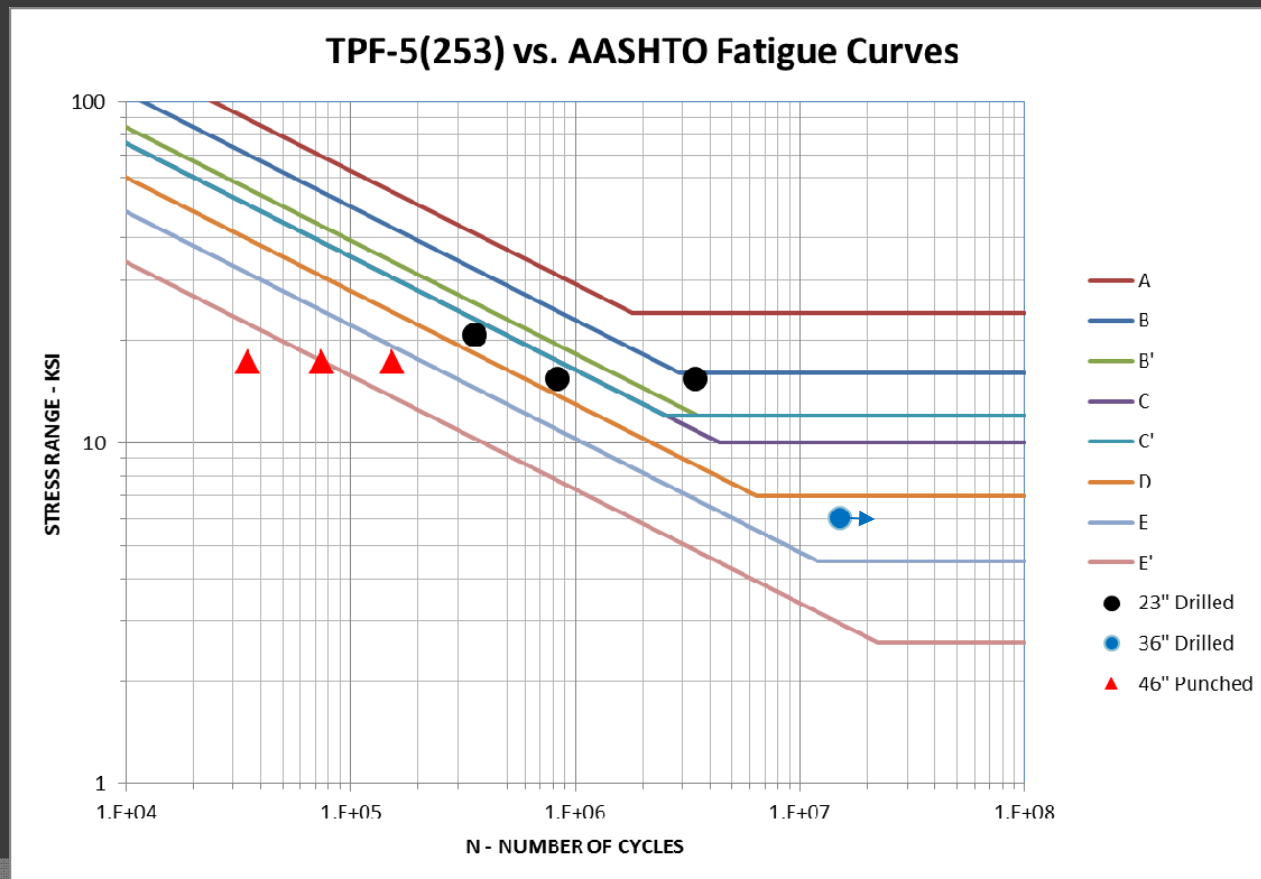
Fatigue Test Results

- Net section stress AFTER 1st component failure
- N is measured only AFTER 1st component failure

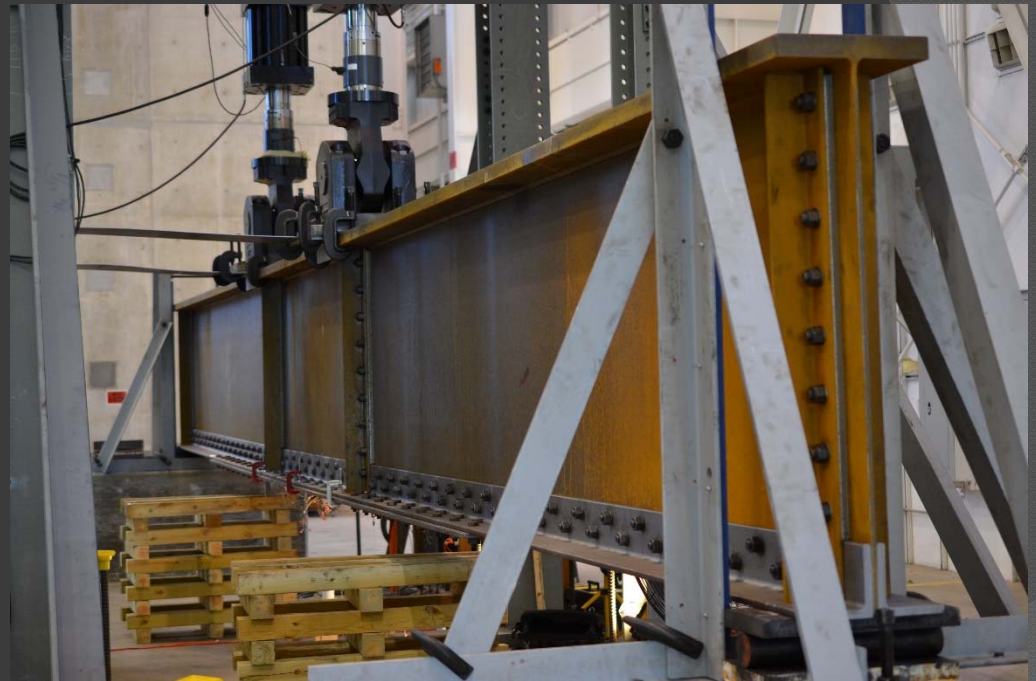
46" Specimen

- ◎ 46" web plate
- ◎ 40' span length
- ◎ Single cover plate
 - Initially notched
 - Fatigue crack growth to critical crack length
- ◎ Fracture Load
 - 180 kips per actuator
 - $0.55F_y$ of net section

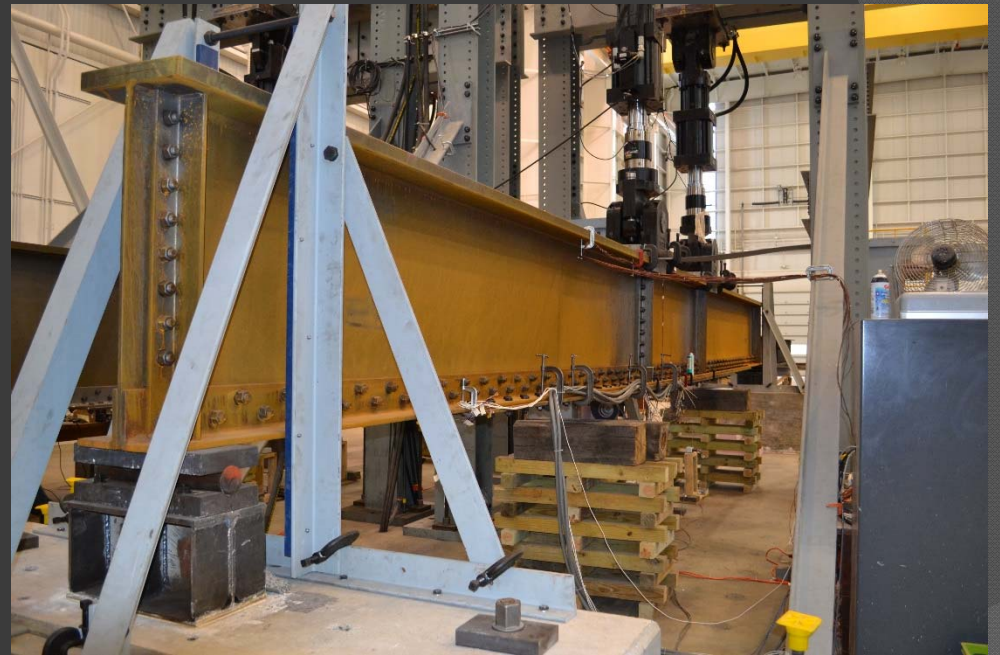
36" Specimen

- ◎ 36" web plate
- ◎ 40' span length
- ◎ Double cover plate
- ◎ Upper cover plate
 - Initially notched
 - Fatigue crack growth to critical crack length
- ◎ Fracture Load
 - 200 kips per actuator
 - $0.55F_y$ of net section
