## I-65/I-70 SOUTH SPLIT PAVEMENT RECONSTRUCTION: DOCUMENTATION & QUANTITATIVE ANALYSIS USING TIME LAPSE PHOTOGRAPHY

Steven Lavrenz, Teresa Morris, Darcy Bullock

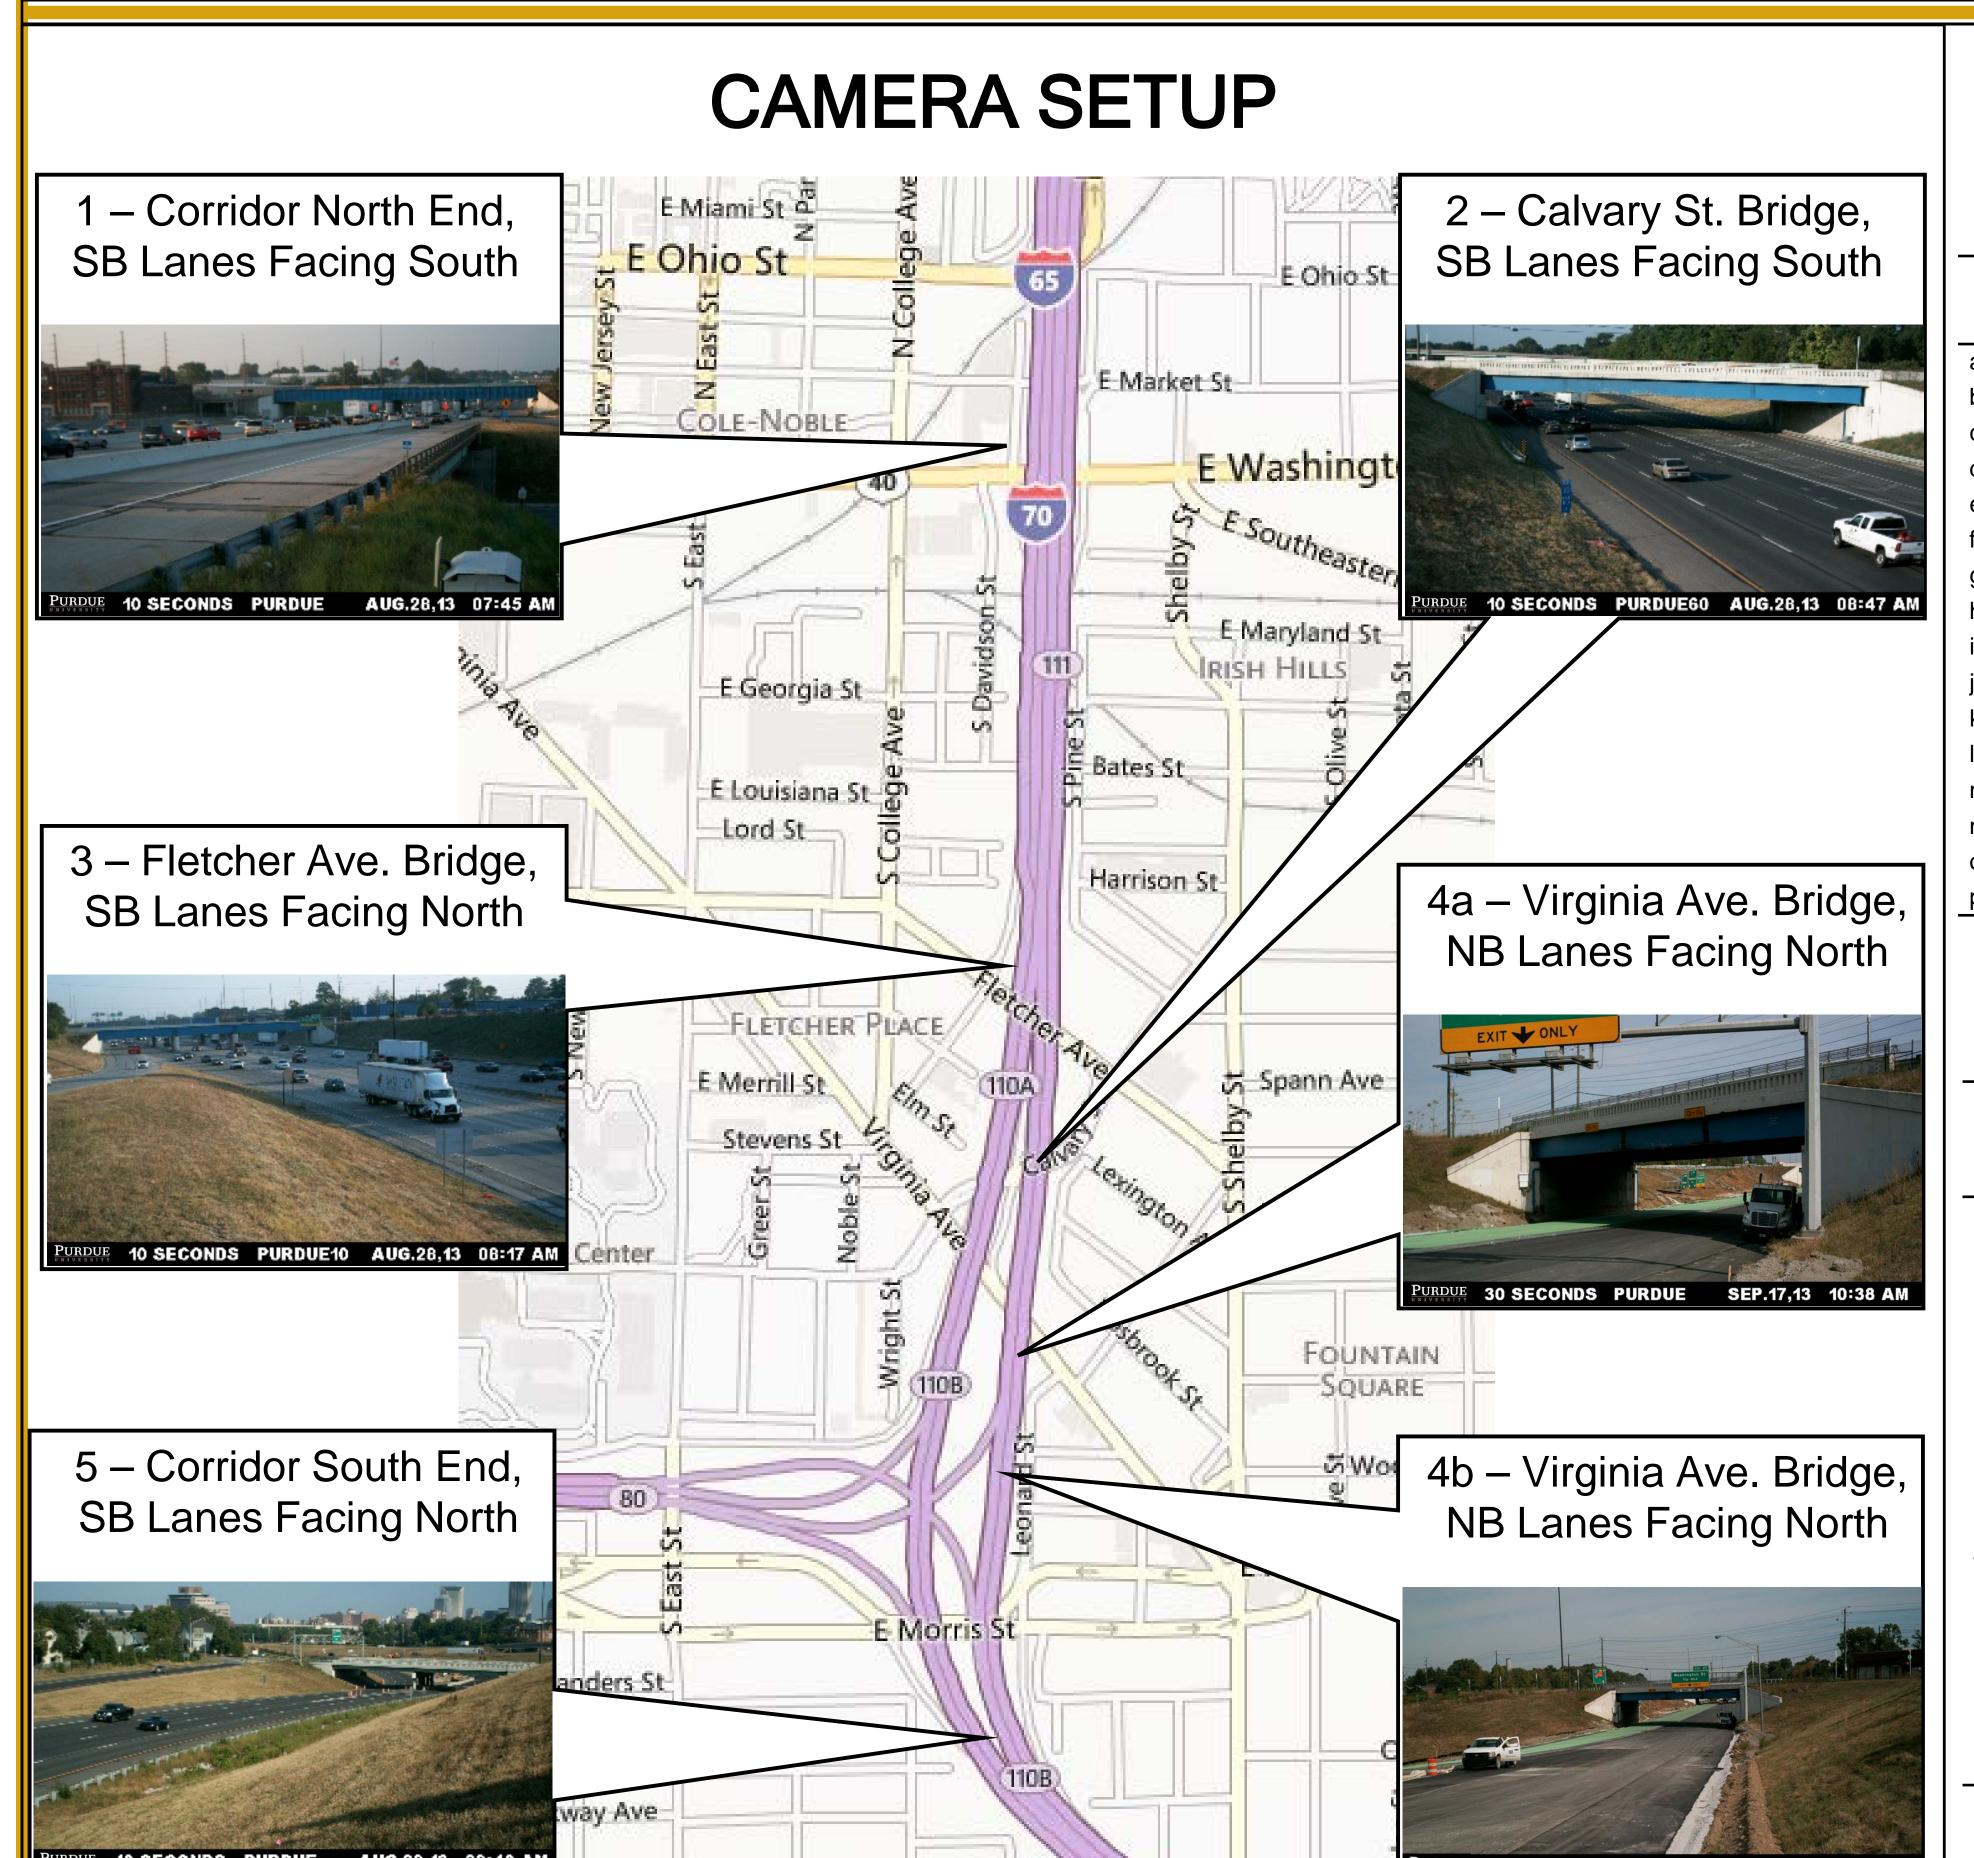
Layout of the I-65/I-70 south split corridor, showing the locations of time lapse cameras

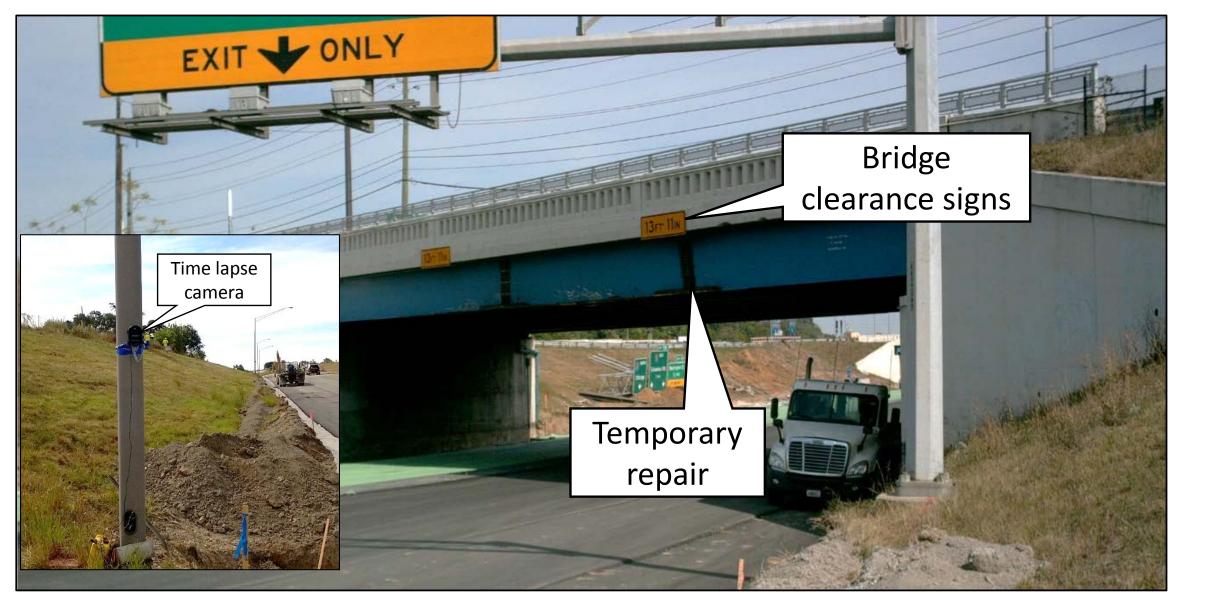
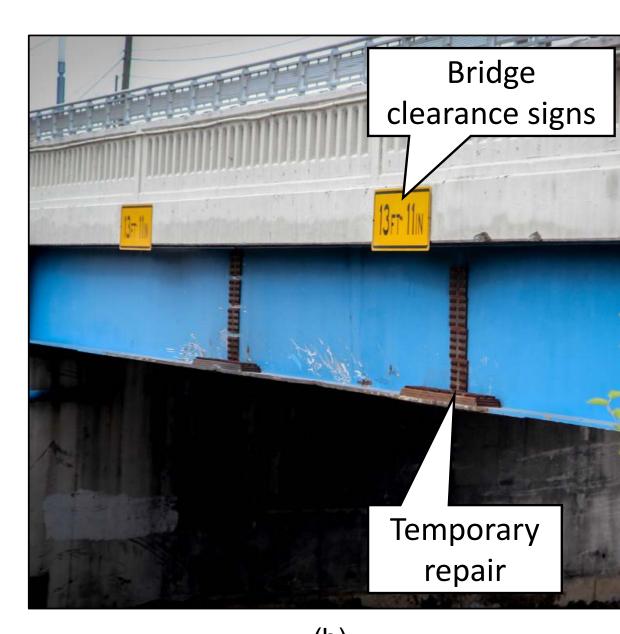
Documenting shots for the camera installation, showing (a) the camera's field of view (Camera 4a), (b) close-up of bridge repairs and low clearance signs which precipitated the project

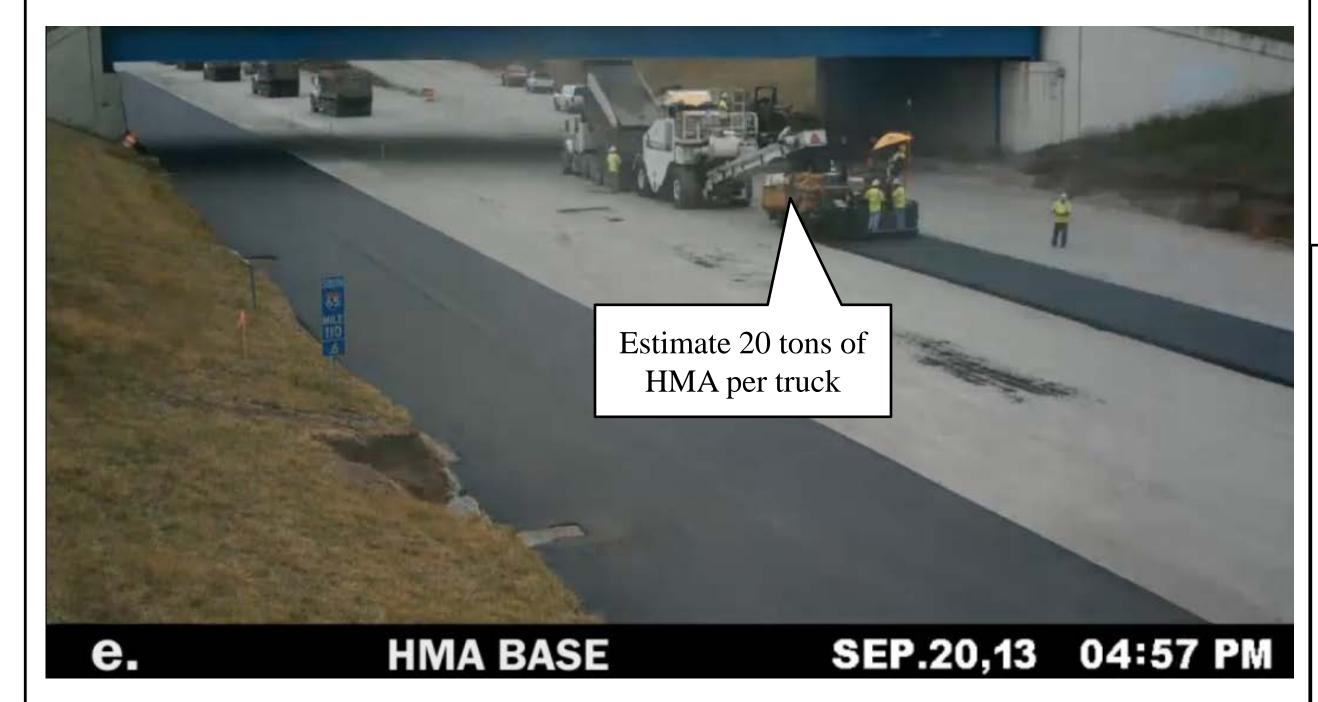
Major activities are identified, and quantities are estimated, from a combination of video and project documents. The example shown here is from Camera 2.
