Fatigue degradation and electric recovery in Silicon solar cells embedded in photovoltaic modules

Marco Paggi¹, Irene Berardone², Andrea Infuso² & Mauro Corrado²

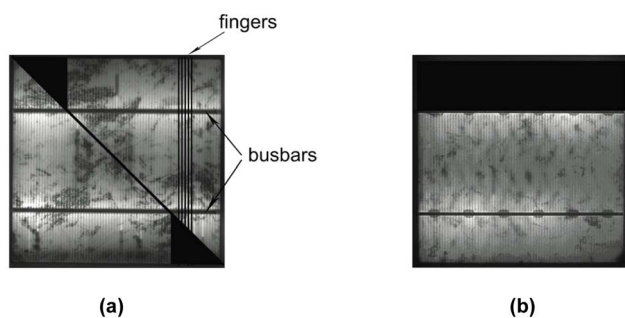
Figure 1 | Geometrical criterion showing the expected amount of potentially inactive cell areas depending on the orientation of the crack with respect to the busbars^{3,8}: 6% of potentially inactive cell (a); 25% of potentially inactive cell (b).

Cracks on the millimetre or centimetre size are mostly invisible by naked eye but they can be localized according to the EL technique¹³. Such cracks can lead to electrically inactive cell areas thus reducing the power output of the module and the fill factor¹⁴. This takes place via the following mechanisms, i.e.: a linear decreasing of the short circuit current by increasing the inactive cell area^{3,15,16}, and an increase in the series resistance of the cell due to cracking^{3,5}. For instance, experimental results⁵ have shown an increase in the series resistance of the cell of about 7% due to cracking with a corresponding power-loss of 4% and a fill factor reduction of 3%. Other experimental investigations³ have shown that cracks inserted in solar cells by the application of a uniform pressure to simulate snow can lead up to 1.5% of power loss. After the subsequent application of 200 humidity freeze cycles according to standard specifications¹⁷, such cracks propagate, the electrically disconnected areas increase in size and up to 10% of power loss has been reported. Potentially, if a crack crossing an Aluminium conductor (called finger) is sufficiently open, then the finger may fail and the electric flow to the busbar in case of normal operating condition, or from the busbar in case of forward bias condition as in the EL testing, would be interrupted. Therefore, portions of Si cells can be potentially deactivated by cracks and their impact on power-loss reasonably depends on their inclination and position with respect to the busbars, see Figs. 1(a) and (b). For instance, a crack parallel to the busbar on the upper side of the cell could lead up to 25% of electrically inactive area (Fig. 1(b)). According to this pure geometrical criterion which does not take into account neither physical

mechanisms such as thermo-mechanical deformation, nor the fact that the cells are embedded in the composite PV module, worst-case scenarios have been predicted by considering all the experimentally detected³ or numerically simulated⁸ cracks as perfectly insulated lines.

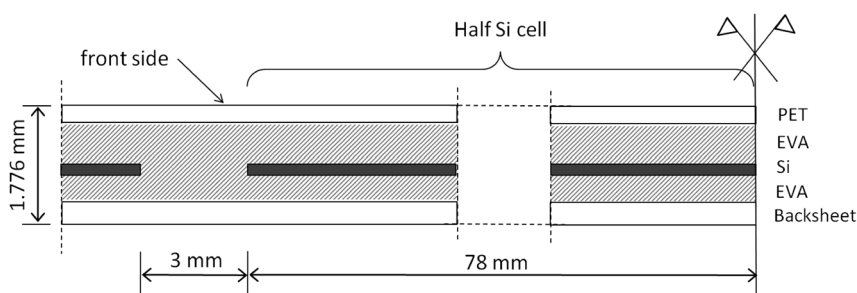
Figure 2 | Sketch of the cross-section of the PV module near the symmetry line.

To make an insight into the mechanisms leading to these coupling effects, a bending test on a rectangular PV module has been performed in the laboratory by monitoring cracking at different deformation levels by EL imaging. A semi-flexible module made of 2 rows of 5 monocrystalline Si cells each is used. The dimension of the cells is 156×156 mm. The partially symmetric arrangement of the layers through the thickness (0.265 mm of polyethylene terephthalate, 0.600 mm of epoxy-vinyl-acetate, 0.166 mm of Silicon, 0.400 mm of epoxy-vinyl-acetate and 0.345 mm of backsheets) and the different Young moduli of the materials lead to Si cells just above the neutral axis of the cross-section (see Fig. 2). This type of module, which has a certain degree of flexibility, can be used in many applications where the substrate we would like to bond the module is curved. In order to induce a tensile stress state inside solar cells, the curvature imposed to the module is such that the convex side after bending corresponds to the PET side (front side in Fig. 2).

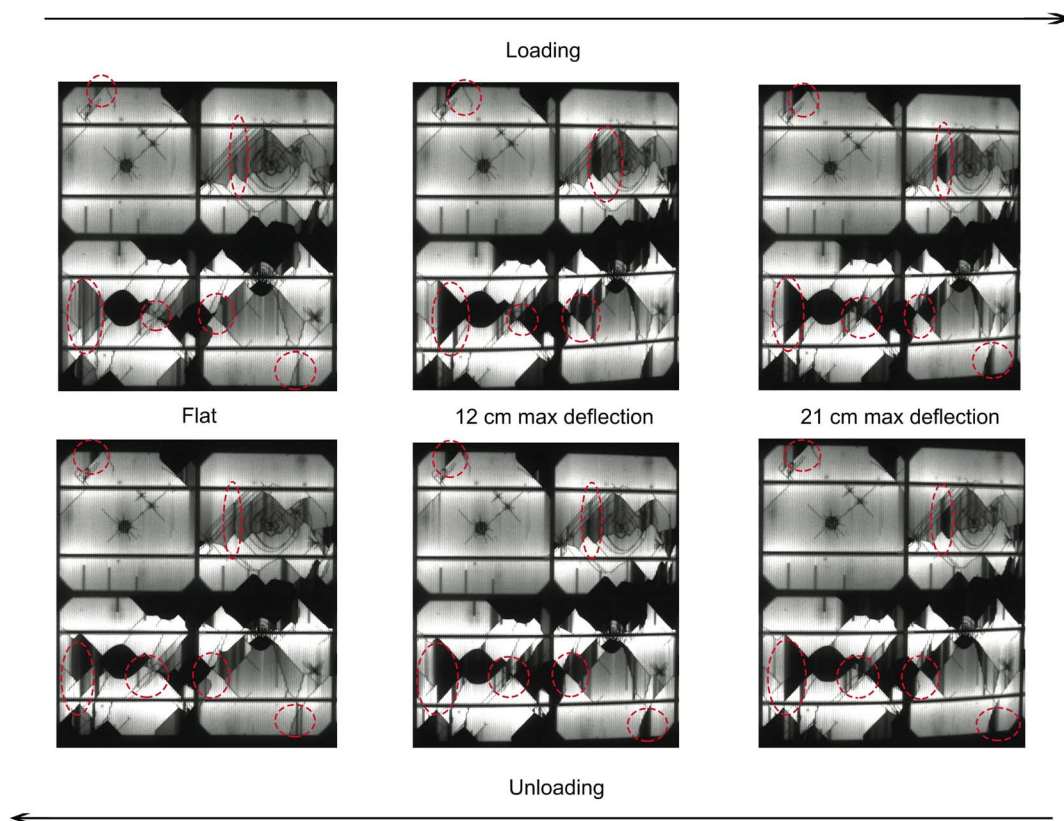
Figure 3 | Evolution of EL signal during bending loading and unloading for different deflections.

To create pre-existing cracks and study their evolution depending on the imposed flexure, moderate impacts have been made with PMMA balls of 4 cm of diameter at a velocity of 6 m/s. In this way, cracks are introduced by an indentation effect. The EL images of four solar cells in the middle of the panel are shown in Fig. 3.

Location of impacts can be clearly distinguished by the circular dark spots from where diagonal cracks, influenced by the crystallographic planes of cubic face centred monocrystalline Silicon, depart. These patterns are completely invisible by naked eye and can only be determined by the EL technique. In some cases, large electrically insulated cell portions, appearing as dark areas, are present. Other portions, circled with dashed lines, show regions isolated by cracks but still partially conducting from the electrical point of view. This can be well explained by the assumption that their crack opening is smaller than a critical value for complete electric insulation and by a compressive stress state inside the cells due to residual thermo-elastic stresses induced by cooling down the module from the lamination temperature at 150°C to the ambient temperature at 20°C .

By increasing the mid-span bending deflection (upper row in Fig. 3, loading direction from left to right), cracks open and additional insulated dark areas appear, thus confirming that the electrical behaviour of cracks does depend on the elastic deformation. Very interesting is the unloading stage (lower row in Fig. 3, unloading direction from right to left), where cracks come into contact and conduct again. Hence, although globally the amount of damage is increased during the cycle since the final EL image is more dark than before, an electric recovery due to crack closure is reported.

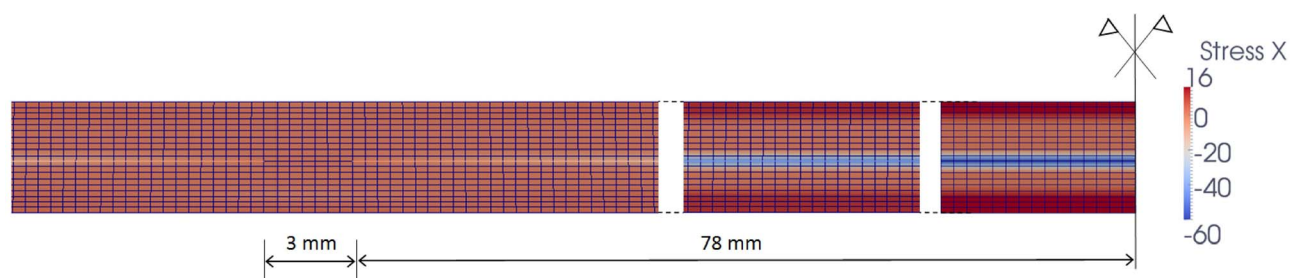
Figure 4 | Contour plot of the horizontal stresses inside the PV laminate in the portion near the symmetry line.

To assess the residual stress and deformation states inside the PV module, a 2D plain strain finite element (FE) model of the layered composite in the plane of bending has been analyzed using the Finite Element Analysis Programme FEAP²³. Taking advantage of the structural symmetry, one half of the module has been analyzed by introducing symmetry boundary conditions on the symmetry line. The opposite edge of the module is simply supported in the direction orthogonal to the longitudinal axis. The thermal expansion coefficients of the plastic layers, EVA and Silicon are, respectively, $\alpha = 5.04 \times 10^{-5}$, 2.70×10^{-4} and 2.49×10^{-6} . The other elastic parameters are as in Ref. 24. Due to its thermo-visco-elastic behaviour, a Young modulus of EVA equal to 1 MPa has been selected, which is the lowest value in the considered range of temperatures according to experimental results²⁴. In any case, a possible variation of the Young modulus of EVA from 1 to 10 MPa is inducing an increase of about 10% in the compressive stresses inside Silicon. The FE computations

estimate a compressive stress field in the Si cells variable from 0 MPa at their borders up to 60 MPa in their centre (see the contour plot in Fig. 4). Therefore, this residual stress field is beneficial for the module since any initial crack or defect present in Silicon would be closed by compression.

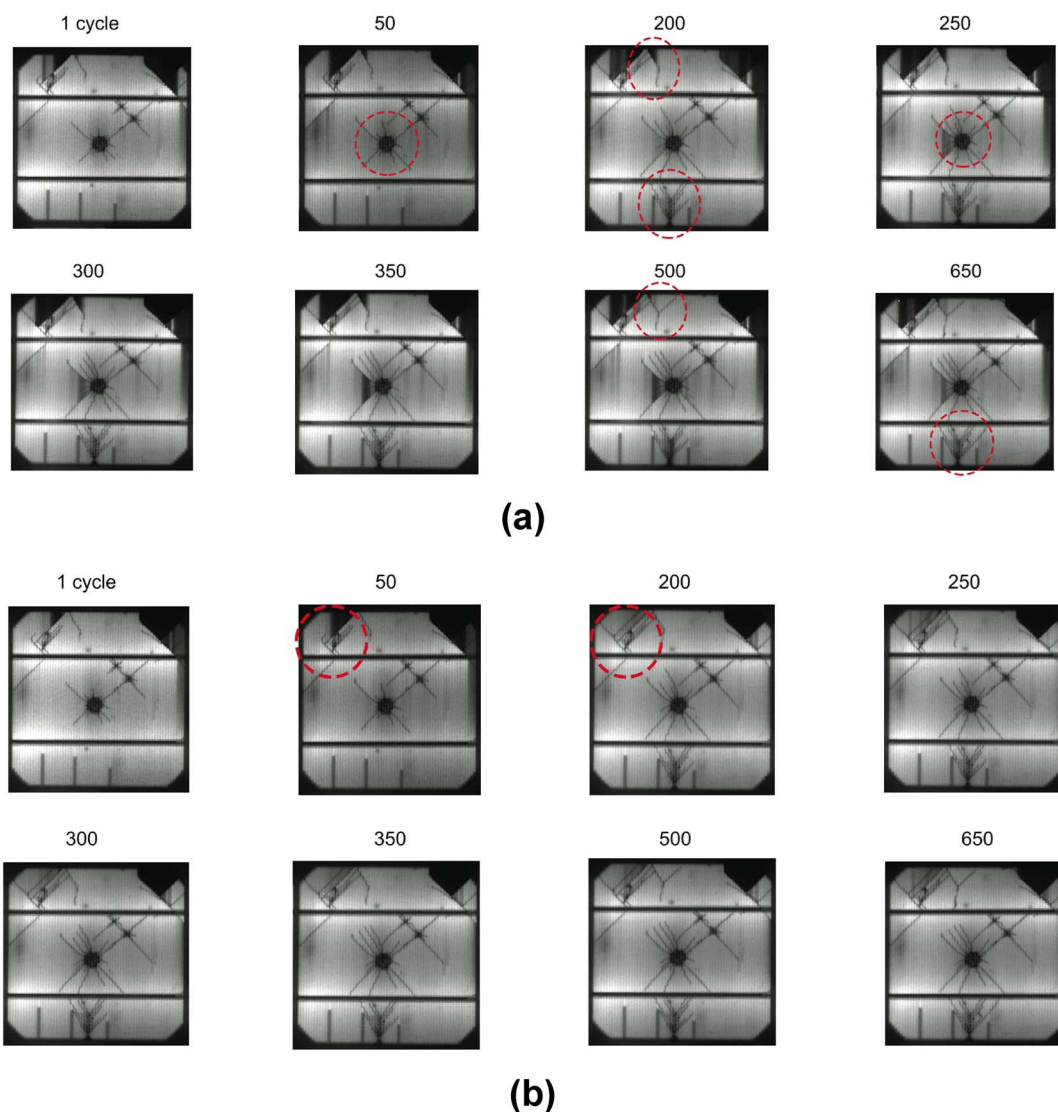
Figure 5 | Fatigue degradation of the electric response and increasing crack pattern at different bending cycles. EL images are taken at the maximum deflection point of the module ($\delta = 21$ cm) (a) and at the unloaded configuration ($\delta = 0$ cm) (b).

The evolution of degradation by increasing the amount of bending cycles (from zero to a maximum mid-span deflection of 21 cm per cycle) has also been monitored and it is shown in Fig. 5(a), where EL images of a significant cell of the module have been recorded at the point of maximum deflection for 1, 50, 200, 250, 300, 350, 500 and 650 cycles. The cyclic tests have been conducted in the ambient temperature (20°C). Regarding the EL measurement procedure, to

During the first 50 cycles we report a propagation of cracks around the dark central point of impact. Crack propagation further takes place from 50 to 200 cycles, with the appearance of new cracks from the lower border of the cell, originating from an edge crack. No crack

propagation takes place from 200 to 250 cycles, although the EL intensity between diagonal cracks diminishes, thus implying a material degradation and a reduction of electric conductivity across the cracks. This trend continues further by increasing the number of cycles, with also further crack propagation (cycle 300) and coalescence of two propagating cracks (cycle 350). At 500 cycles, a new crack is originated from an initial one on the upper side of the cell as a result of a crack-branching mechanism. After the appearance of this new crack, the dark EL area just on the left of it becomes conductive again. This can be explained as the effect of the phenomenon of strain localization, frequently observed in brittle materials, which corresponds to a stress relief in the surrounding cracks when a major crack propagates¹⁸. Therefore, with the appearance of a new crack, the previous one in the surrounding is relaxed and it experiences a reduction of its relative opening displacement.

Finally, strain-localization can be evidenced again by comparing in Fig. 5(b) EL images for 50 and 200 cycles, see the circled areas. The propagation of a diagonal crack to the left relieves the deformation in the Si area, the diagonal crack on the right experiences a reduction in crack opening and the EL image of Silicon above becomes brighter.

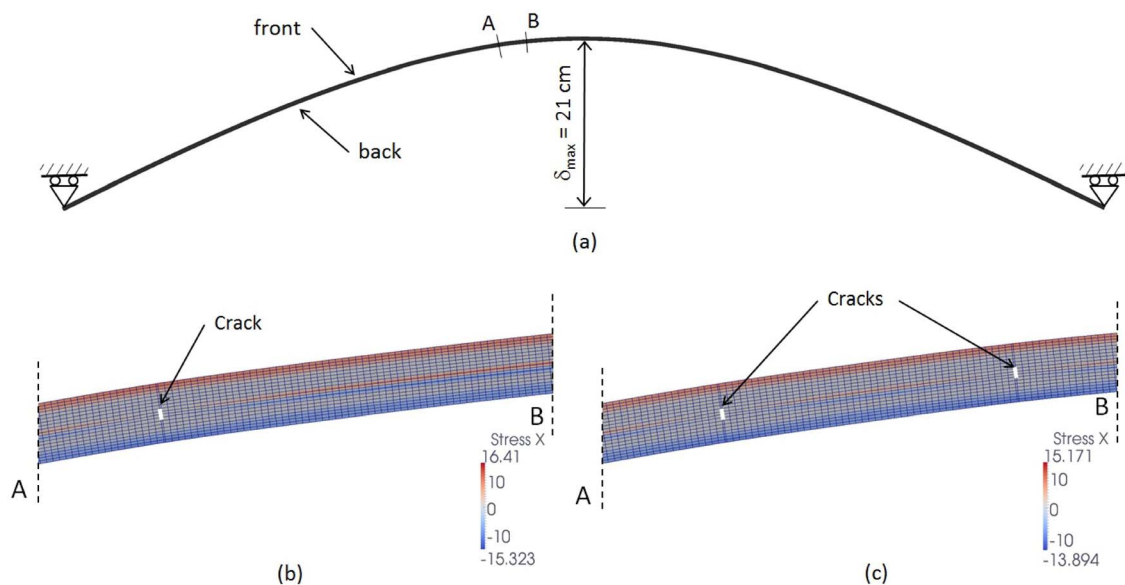
Figure 6 | Structural scheme (a); contour plot of the horizontal stress field in case of one single crack (b); contour plot of the horizontal stress field in case of two cracks (c).

To confirm the effect of a new crack on the crack opening of a pre-existing crack in case of a brittle material embedded in the laminate, a FE study based on nonlinear fracture mechanics is proposed. For more details about the CZM, see Ref. 9. In the 2D approximation of the PV module shown in Fig. 6(a), one or two cohesive cracks (distant 0.9 cm from each other) are introduced in the Si cell placed near the symmetry line (see Figs. 6(b) and 6(c)). In the numerical simulations, the PV module is loaded by imposing a displacement to

the middle cross-section up to $\delta_{\max} = 21$ cm as shown in Fig. 6(a). Residual thermo-elastic stresses are not considered here for the sake of simplicity. If the stress relief takes place, then it would happen also in the presence of residual thermo-elastic stresses. A very low cohesive peak stress of $\sigma_{\max} = 0.2$ MPa is considered to simulate a very low cohesion due to a severe state of damage. The contour plots of the horizontal stress field superimposed to the deformed meshes of the portion of the module where cracks are placed are shown in Figs. 6(b) and 6(c). Stresses are slightly reduced by the simultaneous presence of two cracks and the crack opening of the pre-existing crack reduces from 11 μm to 9 μm . Therefore, the effect of strain localization induced by the propagation of new cracks supports the hypothesis of unloading effects at pre-existing cracks that might come into contact, thus leading to a recovery of their electric conductivity.

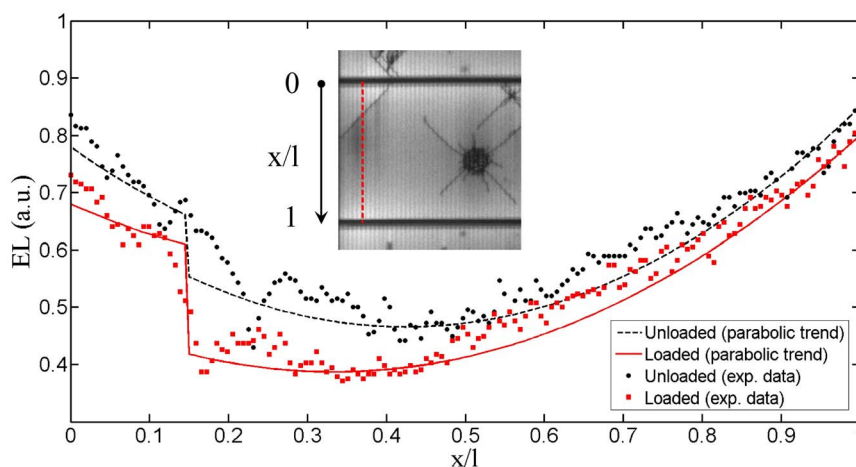
Figure 7 | EL data along a cross-section passing through a crack for 50 cycles in the loaded and unloaded configurations.

The phenomenon of electric recovery due to crack closure already noticed in the case of the first cycle can be observed also after several cycles. For instance, comparing the EL data along a cross-section perpendicular to the busbars and passing through a crack in the loaded and unloaded configurations for 50 cycles (Figs. 5(a) and (b)), we obtain the diagram in Fig. 7. Values of EL close to unity correspond to very bright Si areas, whereas values close to zero are dark “electrically inactive” zones. As visually emphasized by the superimposed parabolic trend with a discontinuity of first type in

correspondence of the crack ($x/l = 0.15$), a jump in the EL data takes place and it is higher for the configuration at maximum deflection where the crack opening is reasonably larger.

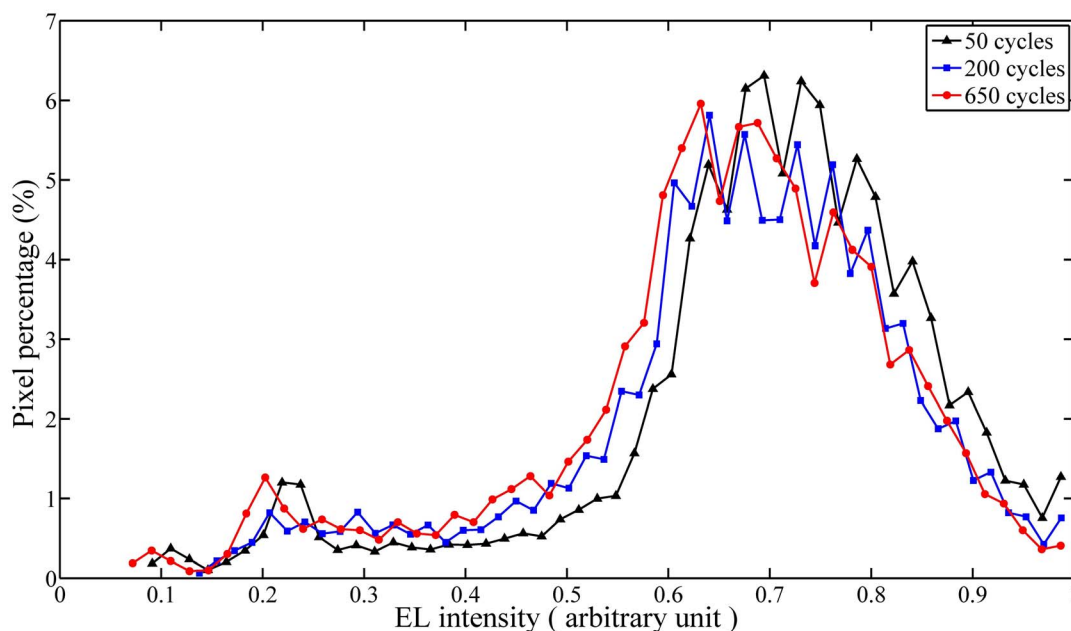
Figure 8 | EL distributions for different number of bending cycles at maximum deflection. Note the shift of the distributions to the left by increasing the number of cycles, a trend consistent with the progression of fatigue degradation.

A quantitative analysis of EL images at maximum deflection (Fig. 5(a)) shows that the statistical distribution of pixels having a given EL intensity is particularly skew-symmetric, with a long tail for EL intensities less than 0.5 (Fig. 8). Moreover, although the difference between EL images by increasing the number of cycles is apparently marginal, i.e., only a few cracks propagate and some regions become darker, the EL distributions quantify the fatigue degradation trend. By increasing the number of cycles, in fact, the EL distribution shifts to the left. For high EL intensities, the pixel percentage is diminished by increasing the number of cycles. Exactly the opposite trend takes place in the low EL intensity range, i.e., more pixels become darker.
