Int. J. Morphol.,
33(4):1386-1392, 2015.

Safe Areas for the Placement of Standard Shoulder Arthroscopy Portals. An Anatomical Study

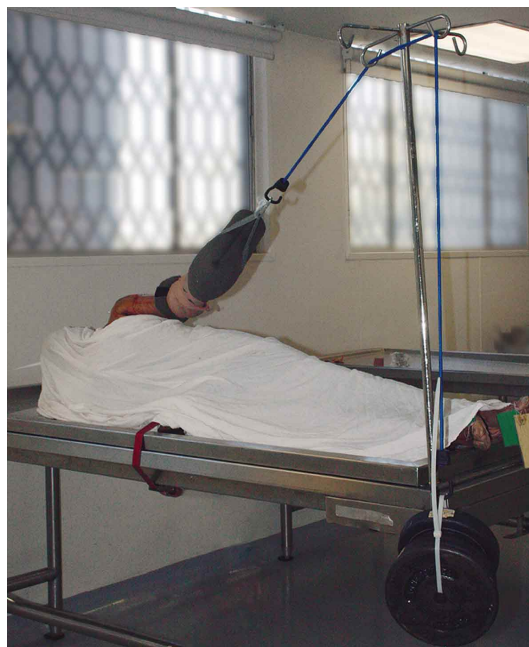
Fig. 1. Positioning the body for the placement of arthroscopic portals. Anterior view.

The standard surgical protocol for the body position, upper limb traction, as well as portal location and positioning was followed. The body was placed in the lateral decubitus position, the upper extremity was placed in 15° abduction, and traction was applied downward with a weight of 9.71 kg (20 lbs) (Fig. 1). Subsequently, bony landmarks of the acromion, clavicle and acromioclavicular joint were identified and marked using a surgical marker. Finally, the SPP, and SAP were placed following the classic description in the literature (McGinty *et al.*, 2005; Meyer *et al.*; Gumina *et al.*). Although there are other shoulder portals (not evaluated in this study), SPP and SAP are the most commonly used.

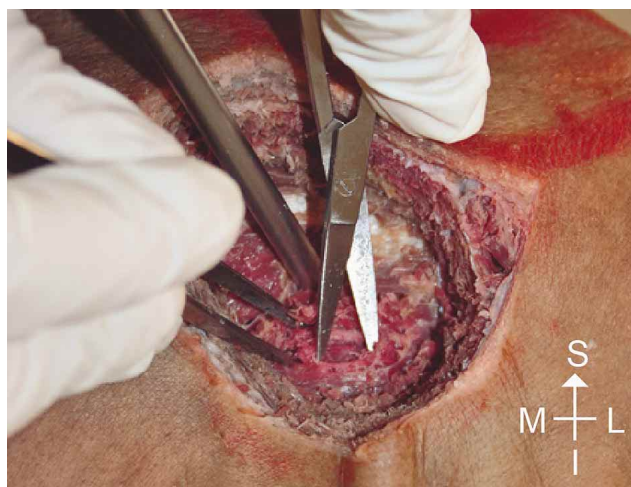
Fig. 2. Punch dissection technique used to evaluate the small microvasculature near the SPP (standard posterior portals).

After placing the SPP and arthroscopically identifying the rotator triangle references, the SAP was placed. Following portal placement, the dissections were performed using the "punch technique" (this is an original dissection technique devised by the authors). This technique involves dissecting each anatomical plane (dissecting between adipose tissue, muscle fascia and muscle fibers) within a radius of 2.5 cm, with the trocar (Linvatec T4930, 4 mm in diameter) considered as the center (Fig. 2). This technique allows for the better establishment of the *in situ* relationship between the trocar and the neurovascular structures at risk of being injured. Topographically, all anatomical planes were dissected down to the joint capsule.

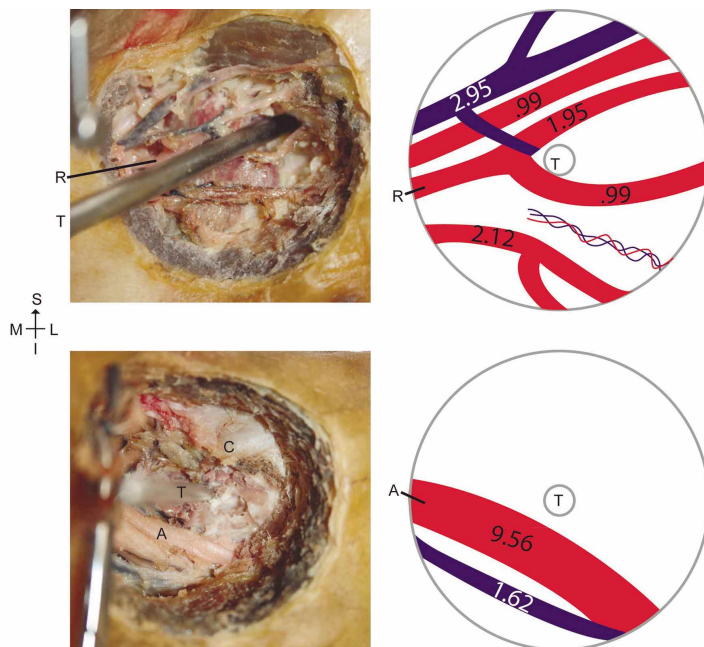
Fig. 3. Vectorization of the photographs of dissections performed, translated to the vectorization format. The left shoulder dissection is shown such that it is possible to identify the trocar (T), axillary artery (A), the deltoid branch of the thoracoacromial artery (R), and the coracoid process (C). The SAP was placed using the inside-out technique, and the photographs were taken at an angle between 15° and 30°.

A circle and a clock hand system were used to graphically represent the neurovascular structures found in the dissection punch. In this system, 12 o'clock represents

the upper end, 6 o'clock the lower end, and 3 and 9 o'clock represent the extreme right and left of the circle, respectively. The arterial, venous and nerve structures encountered during punch dissections were plotted.

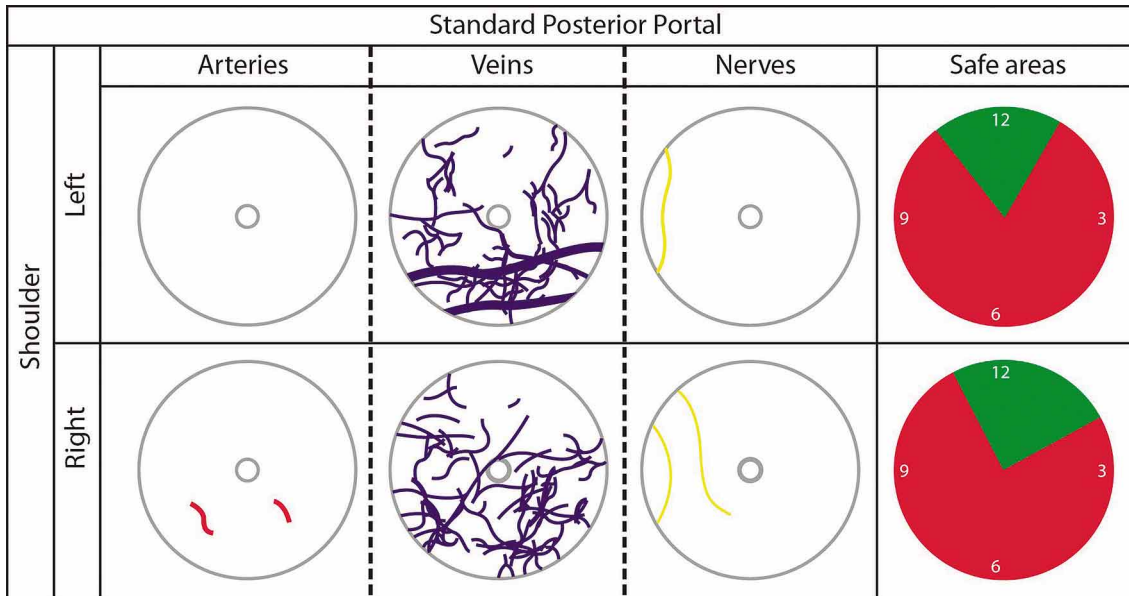
Fig. 4. Neurovascular structures at risk during posterior approaches and their relationship with the trocar (central circle). The safe areas (green) represent the lower density of digitalized structures inside the dissection circle.

Standard posterior portal. In 15.38% (n= 2) of the dissections, we found two arterial structures: branches of the suprascapular artery and the circumflex scapular artery. A total of 88 venous structures of the superficial and deep venous plexus were observed in relation to the subcutaneous tissue and deltoid and infraspinatus muscles (Fig. 4). We also identified the lateral supraclavicular nerve from the cervical plexus in 3 cases. The morphometric and topographic parameters of the structures mentioned above are summarized in Table II.

Quantification of the small-diameter structures found while performing a posterior approach has not been reported in the literature. Together, these structures could represent a source of intra-articular bleeding, which complicates visualization when performing a posterior approach. The presence of a safe area for SPP is located between 11 and 1 o'clock for left shoulder and 11 and 2 o'clock for the right shoulder.

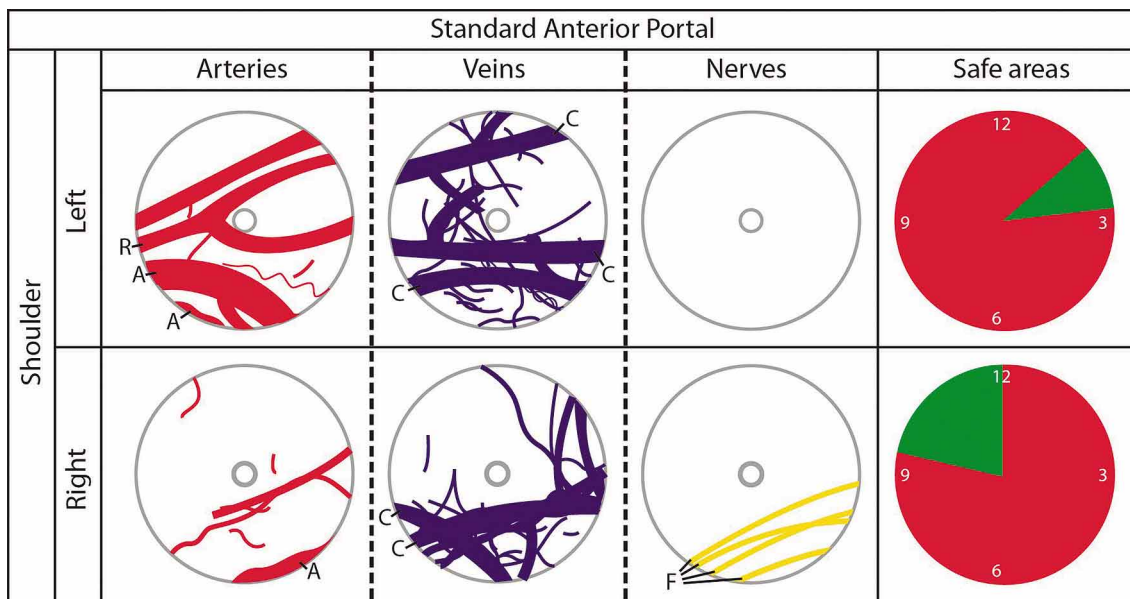
Fig. 5. Neurovascular structures at risk during anterior approaches and their relationship with the trocar (central circle). The safe areas (green) represent the lower density of digitalized structures inside the dissection circle. Areas at risk. (A: axillary artery; F: brachial plexus cords; R: deltoid branch of the thoracoacromial artery; C: cephalic vein).

Presence of the cephalic vein, with a mean diameter of 5.06 ± 0.73 mm, was documented in 38.46% (n= 5) of the dissections. In total, 53 small-diameter venous structures at risk of being injured were found in all 13 dissections performed around this site (Fig. 5). The morphometric and topographic parameters of the structures mentioned are summarized in Table II. The characteristics of the structures at risk with a large diameter for the SAP are listed in Table I.

In the SAP, the existence of important neurovascular structures such as the deltoid branch of the thoracoacromial artery, axillary artery, and brachial plexus cords was documented. In our study, this portal represents the approach site with the greatest possibility of damaging a neurovascular structure. A hypovascular area between 2 and 3 o'clock for the left shoulder and between 9 and 12 o'clock for the right shoulder was identified.
