Microstructure and Fatigue Properties of Railway Steels for Switches and Crossings

PhD Thesis

SOMRITA DHAR

Department of Wind Energy

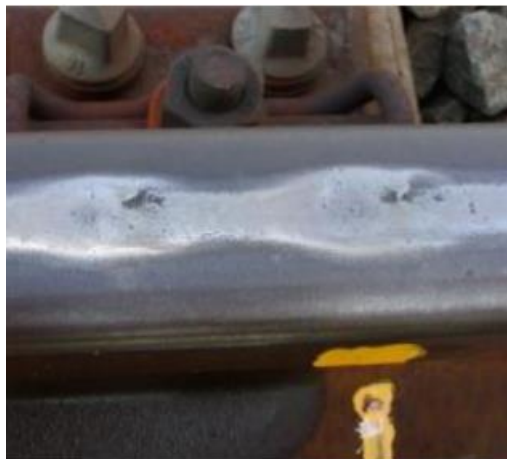
Figure 1.7: Squats formed on a normal grade rail track [62].

Squats on normal rails are surface or near surface initiated cracks occurring because of local plastic deformation due to high dynamic load leading to RCF [60-61]. Squats are visible on the running surface as a widening and a localized depression of the surface of the rail, which appears as a dark spot containing cracks with a circular arc or V-shape [62]. Figure 1.7 shows typical squat type defects on the rail surface. The cracks generally appear at shallow angles to the surface, but might propagate deep within the material causing rail break, or may cause branching moving upward leading to spallation. A lot of research has been carried out on the origin of squats [63-64] and their growth mechanisms [65-66] but still, their development is not fully understood.

Studies on squats on normal grade rails from straight tracks indicate there is a leading and trailing branch of the crack. The leading branch of the crack is shear induced fatigue crack whereas the trailing branch is driven by the transverse shear loading. Squat defects are also strongly influenced by the anisotropy of the microstructure when it grows within the material. Leading cracks are initiated by delamination or fracture of white etching surface material and the propagation is dictated by the anisotropic microstructure when growing into the railhead [63]. However, other studies indicate white etching material is not related to crack initiation on head-hardened rails [64]. Squats on premium grade steels are found to occur due to locally increased microslip under redistributing tangential contact stresses in the presence of an already initiated crack [64]. Once a leading crack is formed, a transverse failure mechanism is initiated under tangential stresses, which cause branching of the leading crack to form a trailing crack. The trailing crack of a branched squat breaks through the material texture and is related to transverse, wedge-shaped failure mechanism of the surface layer of the rail [63]. In premium grade steels, the trailing crack and the accompanying surface depression

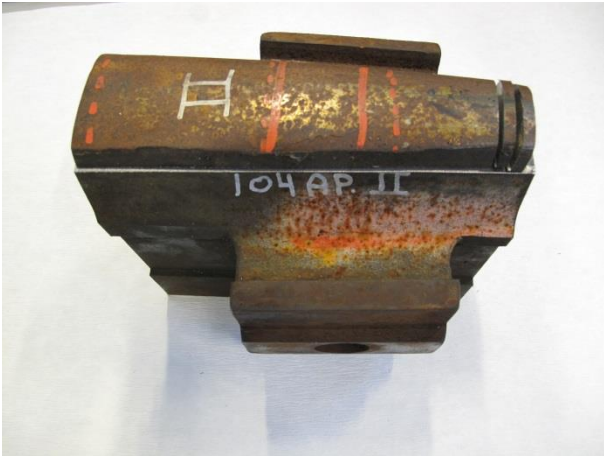
Figure 2.3: The nose of the pearlitic crossing after unbolting and separating it from the crossing showing the pieces cut out for metallurgical investigation.

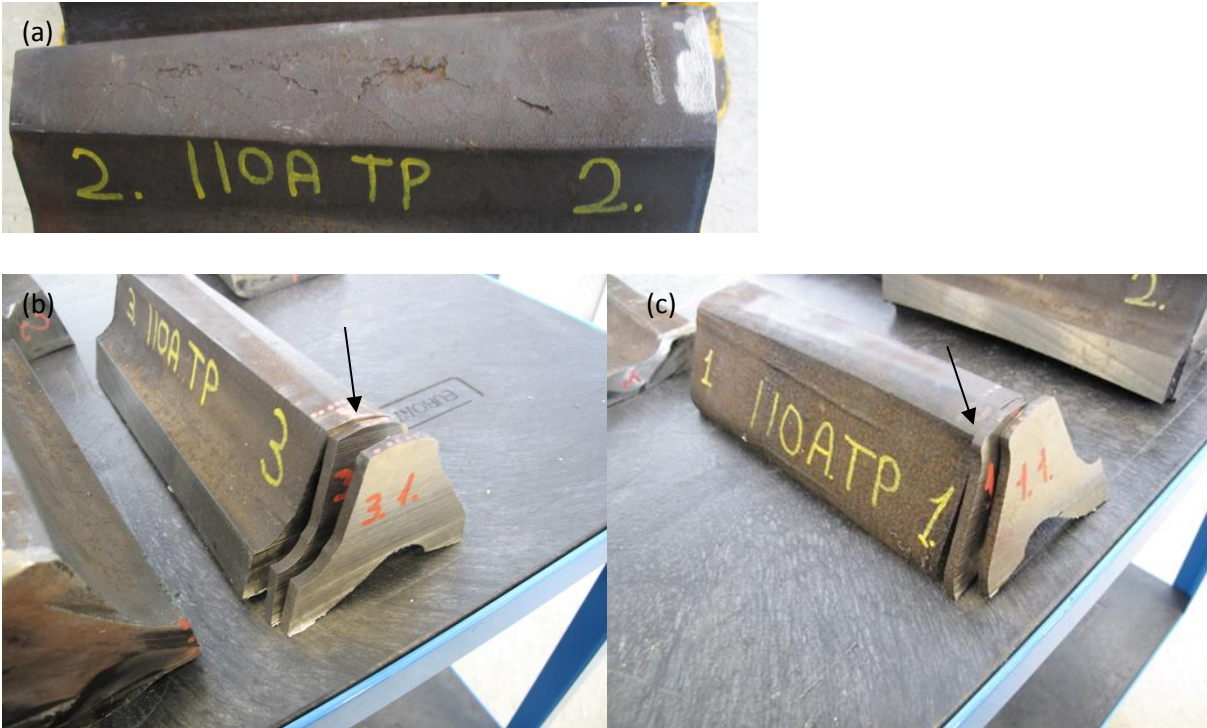
Figure 2.5: Individual components of the ATP 110 crossing after separating them (a) the nose of the crossing showing distinct visual cracking and spallation, (b) and (c) the two wing rails, the rail wheel contact area is evident from the deformation and is marked by arrows.

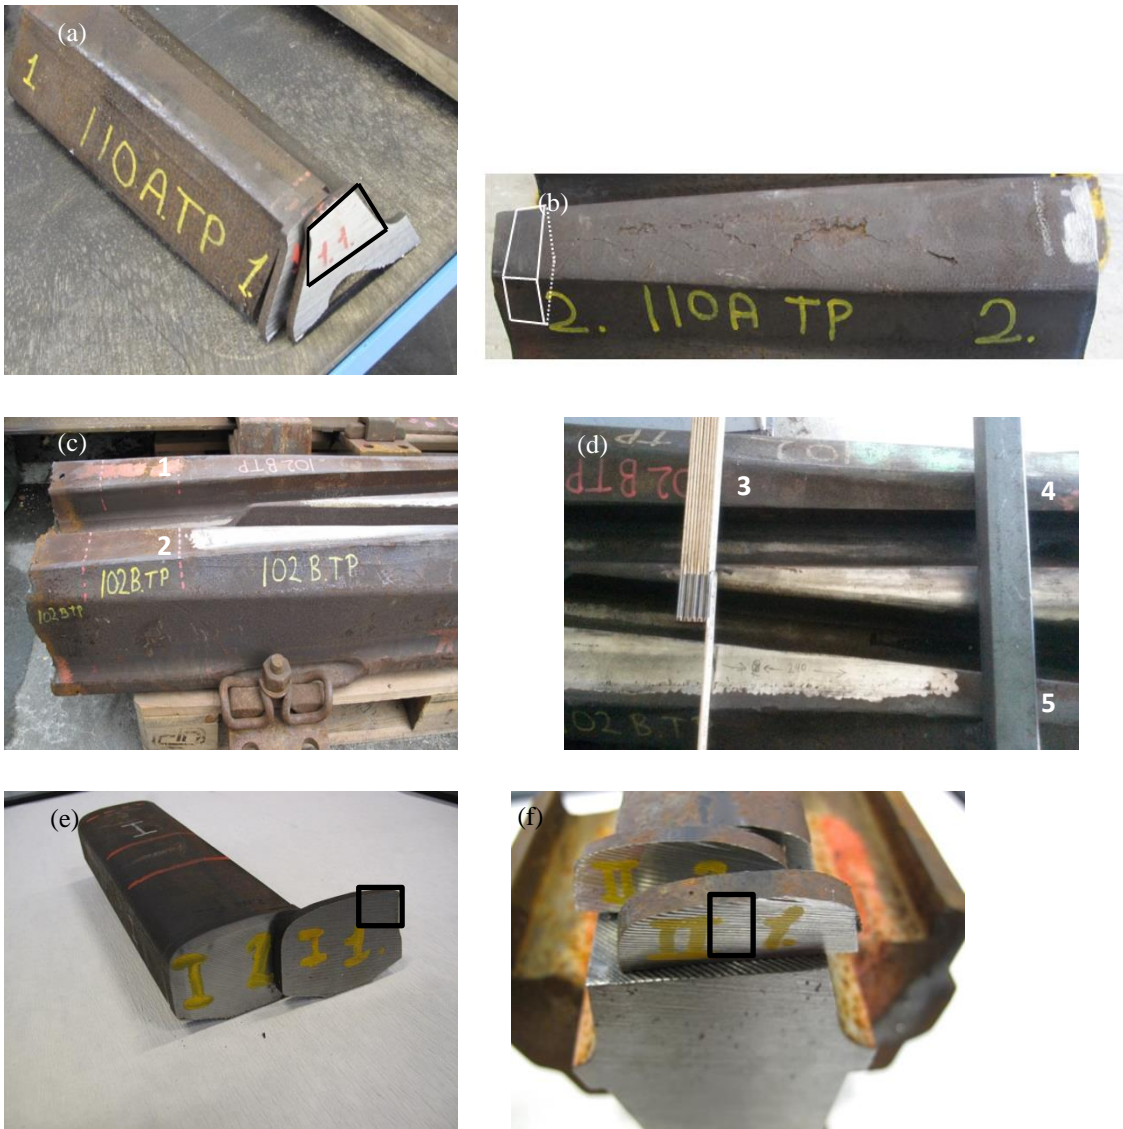
Figure 2.12: The areas where hardness measurements were made on the different components of the crossings (a) ATP 110 manganese wing rail, (b) ATP 110 manganese nose, (c) and (d) BTP 102 manganese crossing, the numbers in the figure indicate the area for hardness profile maps, (e) pearlite wing rail showing the surface of hardness measurements and (f) pearlite nose rail showing the surface of hardness measurement.

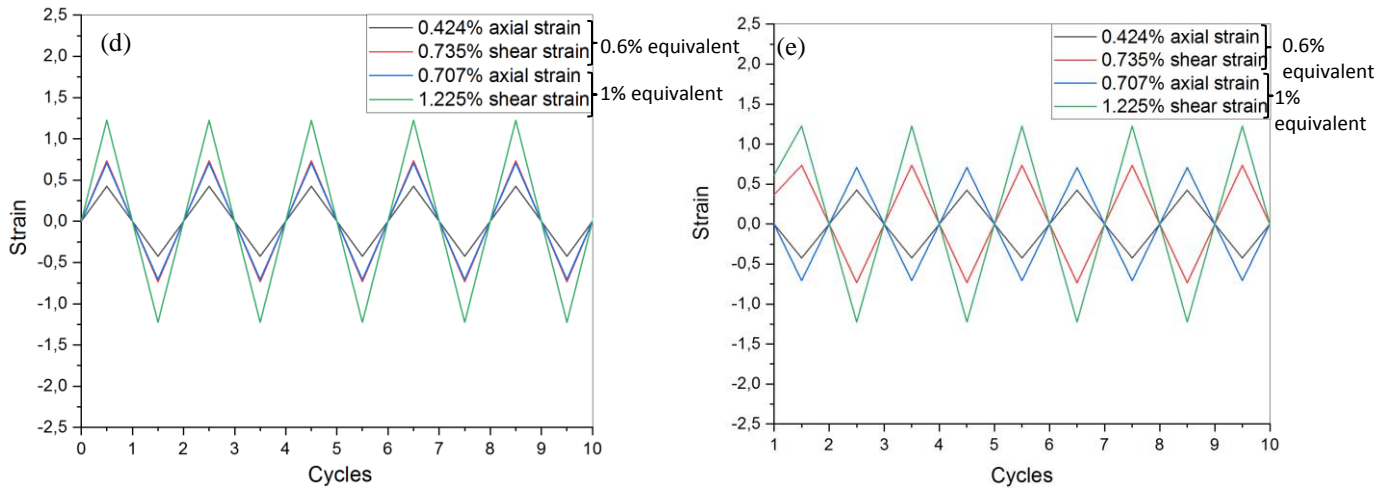
Figure 2.16: Schematic diagram of the load time history for the different conditions of fatigue testing (a) uniaxial loading at different strain amplitudes with 0 mean strain ($R=-1$), (b) uniaxial loading with different strain amplitudes and different mean strains but the same minimum strain of -1.5% , (c) pure torsion tests at different shear strain amplitudes ($R=-1$), (d) biaxial in phase tension-compression and torsion at equivalent strain amplitude of 0.6% and 1% and (e) biaxial out of phase tension-compression and torsion at equivalent strain amplitude of 0.6% and 1% .

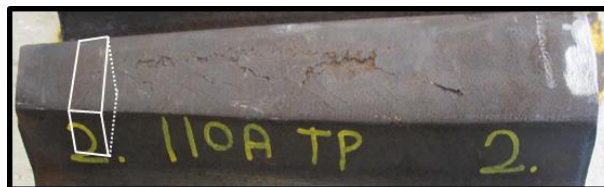
Figure 2.17: Nose of ATP 110 manganese crossing showing the region where specimen for EBSD scanning was obtained.

A Zeiss Supra-35 scanning electron microscope, equipped with HKL Channel 5 EBSD system was used in the present study. The EBSD measurements were made using an acceleration voltage of 20 kV, aperture size of 60 μm and a working distance of 13.3 mm. The focus of this study was to investigate the highly deformed microstructure near the surface cracks in the nose of the manganese crossing. A specimen was cut from a damaged nose, as shown in Figure 2.17, having dimensions 40x5x20 mm. The transverse surface of the specimen was ground with Si-C paper ranging from grain 320 to 4000 followed by polishing by diamond paste to 1 μm. The final polishing consisted of colloidal silica or OPS for 40 minutes. The specimen was scanned on the transverse surface in a square grid with a step size of 0.5μm.

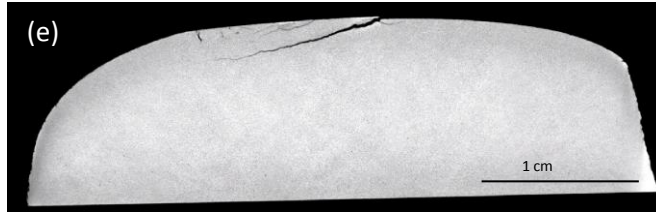
Figure 7: X-ray tomography of the crack network from one of the specimens visualized by 2D slices at different locations within 10 mm along the running direction.

Five adjacent specimens were cut out from the area shown in figure 1, which contained some spallation. Figure 7(a-e) shows 2D slices from the tomographic reconstruction for one of the five specimens. The different images are from different positions along the longitudinal direction within a length of 10 mm. From these images we can identify a big crack originating from the surface and running throughout the entire cross section of the specimen. The crack network is extensive and continuous through all the five scanned specimens, with different cracks and branches interacting with each other. These 2D images clearly show the need for a large overview in order to comprehend the crack network. For example, in figure 7(b-d) we see a sub-surface crack present, which is not evident in figure 7a or 7e. The crack shape changes continuously with location and may have connections to the surface at other locations, which are not evident from 2D slices.

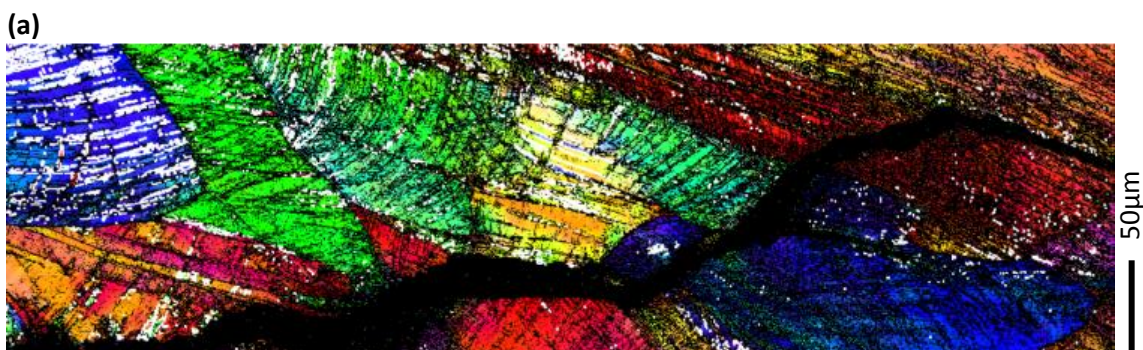
Figure 9: Maps obtained by EBSD showing the distribution of crystallographic orientations near two of the cracks within the nose. The colors correspond to the crystallographic orientation along the specimen surface normal direction, the white bands are deformation twins and the black bands are dislocation boundaries. (a) & (b) the matrix around the two cracks, (c) & (d) the area near the cracks selected for detailed analysis.

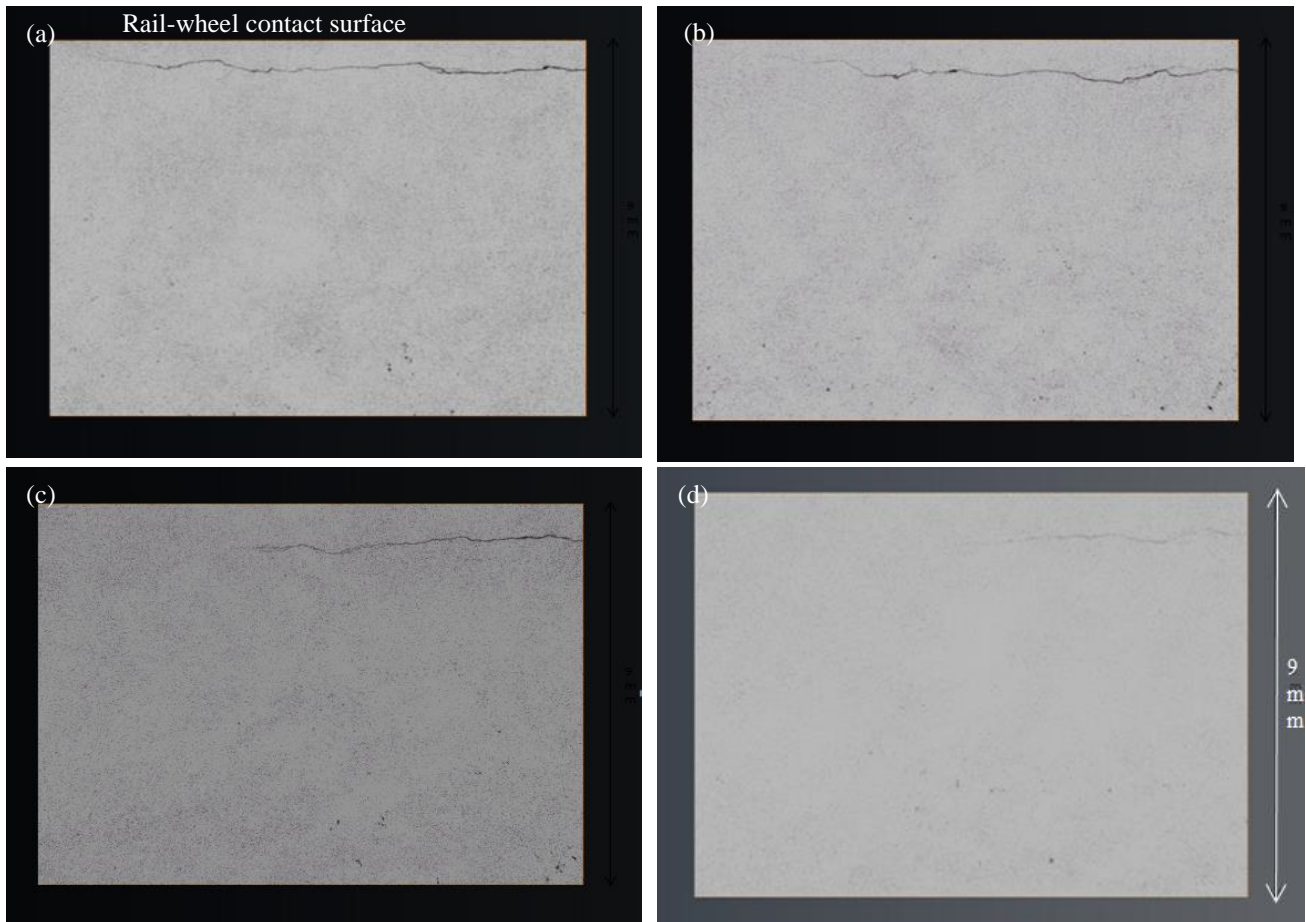
Figure 4: 2D slices showing the crack network within the wing rail at different locations along the longitudinal direction (a) at the transverse cut (0 mm), (b) 10 mm from the transverse cut, (c) 18 mm from the transverse cut and (d) 29 mm from transverse cut.

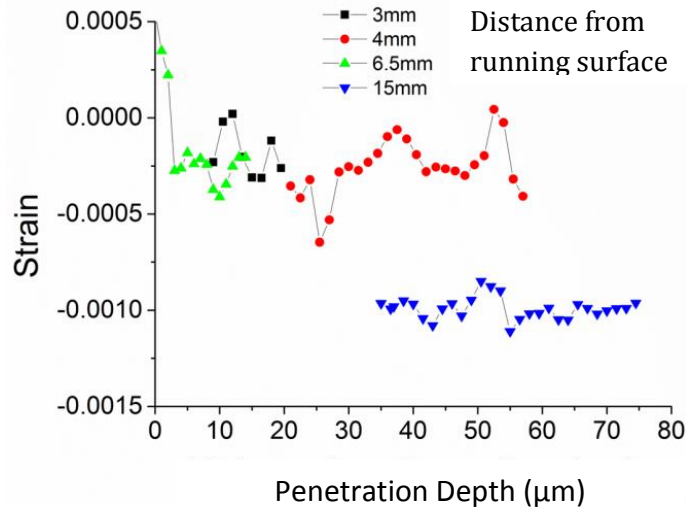
Figure 5: The residual strain measured nondestructively along the longitudinal direction to a penetration depth within the specimen of upto 75 μm at different distances from the running surface.
