## INTEGRATED APPROACH COMBINING DIRECT SURVEY AND OBSERVATION IN DAMAGE ANALYSIS IN CASE OF SOIL SETTLEMENT

This paper describes the analysis executed in the XX century parish church of San Bernardino in Sesto Calende (Va), which displays serious cracks and damage caused by soil settlements.

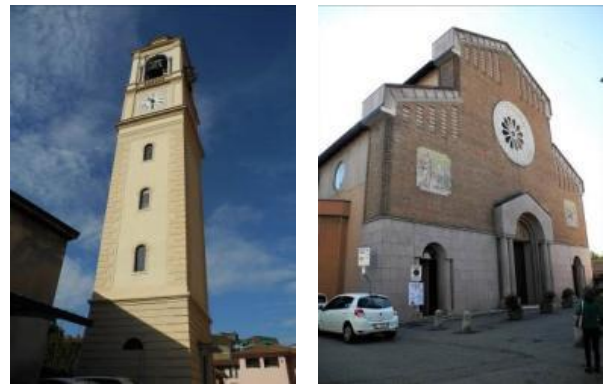
Figure 1. External views of the Church of St. Bernardino: a) The new bell tower and b) The added new façade

Between 1924 and 1930 the new bell tower was constructed, detached from the church on the South side, (Figure 1a), as the first bell tower, located on the North side, showed signs of failure during the construction works.

Until then the church had a rustic façade. In 1960, the same engineer Vittadini presented the drawings for the construction of an added reinforced concrete façade, with a self-supporting structure. The new external façade was finished in 1963 (Figure 1b).

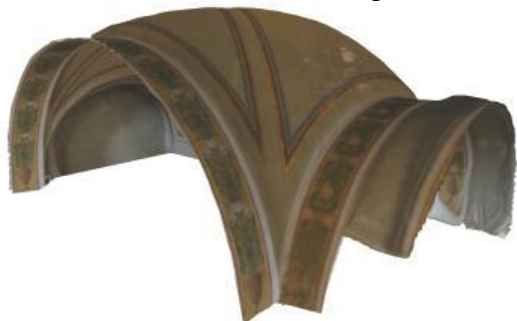
Figure 3. Photogrammetric restitution of the vault reveals that the church presents vaulted sailing ceilings

observation on-site observation and a first photogrammetric restitution (Figure 3), it has been possible to suppose that they are covered by light thin sail vaults. This masonry architecture shows the first elements realized using reinforced concrete: three rectangular beams over the central nave separating the nave from the presbytery and the apse, four semi-circular columns placed in the four corners of the central nave and the arch above the organ.

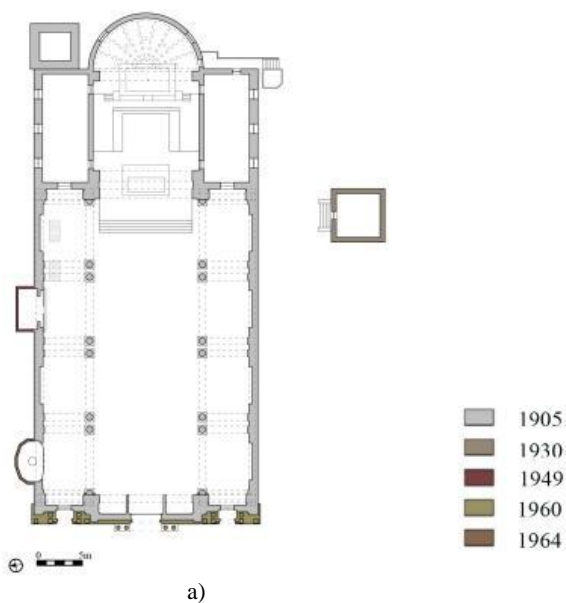
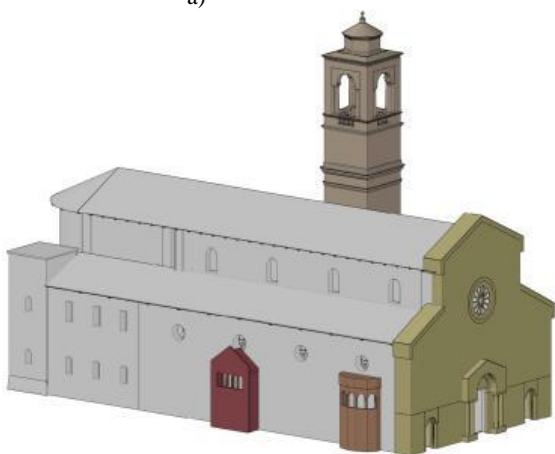
Figure 4. Historical evolution of the St. Bernardino Church: a) plan and b) a three-dimensional digital model

Regarding the foundations, there are no drawings, but only general descriptions, which indicate the presence of arches under perimeter walls and 48 wooden poles under the columns. On the South side, there is the sacristy leaning against the presbytery and the new bell tower, built in 1930 and detached from the building. The new 45 m high bell tower follows the lines of the old bell tower, doubling its height (Figure 4).

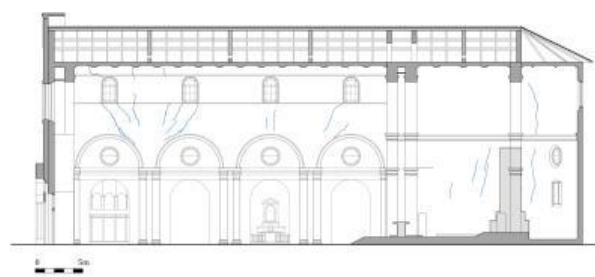
By observing these lesions in figure 5, deeper cracks arise and propagate at the corners of the windows with an inclination of 45°. The creation of cracks with this inclination is linked to the collapse of the head walls, in particular the façade and the walls of the presbytery.

Figure 5. Longitudinal section shows cracks in the wall of the nave, North side

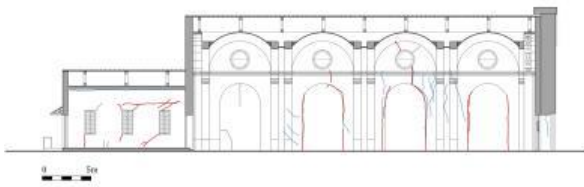
The cracks in the perimeter walls are caused first of all by the constructive discontinuity in correspondence to the niches present in the walls and there are deep cracks, that propagate diagonally up to the arches of the niches (Figure 6).

Figure 6. Section shows cracks in the perimeter, South side

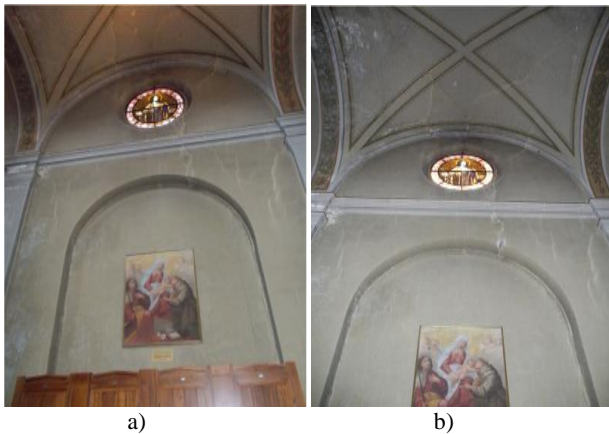
After one year of monitoring, it is possible to state that the most worrying cracks are related to the second bay from the facade on the South side. At the moment small portions of plaster fall due to a continuous movement of this bay (Figure 7).

Figure 7. Comparison of the cracks present on the perimeter walls of the south aisle a) cracks related to the southern bay II and b) cracks of the southern bay II observed one year later.

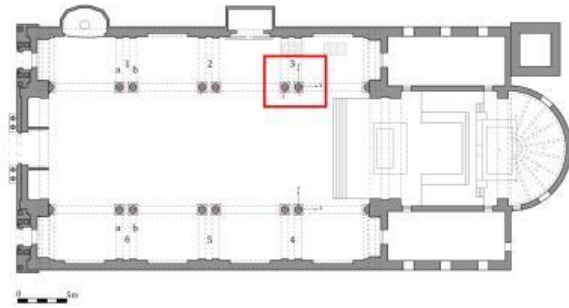
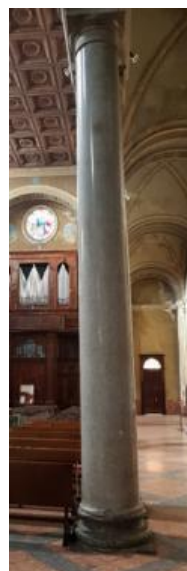
Other relevant problems regard the columns. Through an accurate observation and a basic survey, their basements present different heights: the height for basements near the facade is 12,5 cm and the ones near the altar are completely sunk showing 0,5 cm high. (Cardani et al. 2019).

This inhomogeneous soil settlement induces to the columns of both sides an out-of-plane rotation, with inclination towards the central nave (Figure 8a).

The more the sinking of the basements, the greater the inclination of the columns. A first measurement has been made confirming that the columns with the main out of plumb (about 12 cm) are the columns near the altar, which have the lowest basements (Figures 8b, 8c).

Figure 8. Column inclination and sinking of basements a) Out-of-plumb of the column near the altar on the North side and b) plan and c) base of the column near the facade and d) near the presbytery

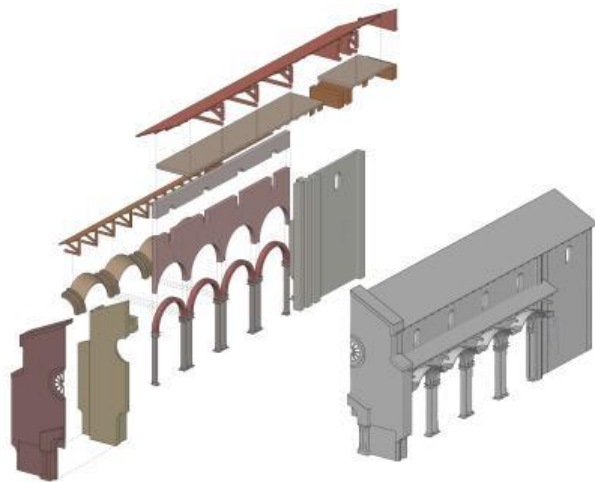
Figure 9. 3D exploded view of the analyzed system

- The method of Limit Analysis is used to determine the internal forces in a settlement states as it is shown in Como (2010);
- Thanks to the experimental monitoring of the outward deformation and soil settlements effects on the columns, we decided to use minimum thrust solutions, among the infinite possible equilibrium configurations;
- The analysis of the damage, characterized by an accurate observation of the current crack pattern and the behavior of the structure, allows to better define the data for the structural analysis.
- The division of the structure for studying each structural element, that compose it (Figure 9).

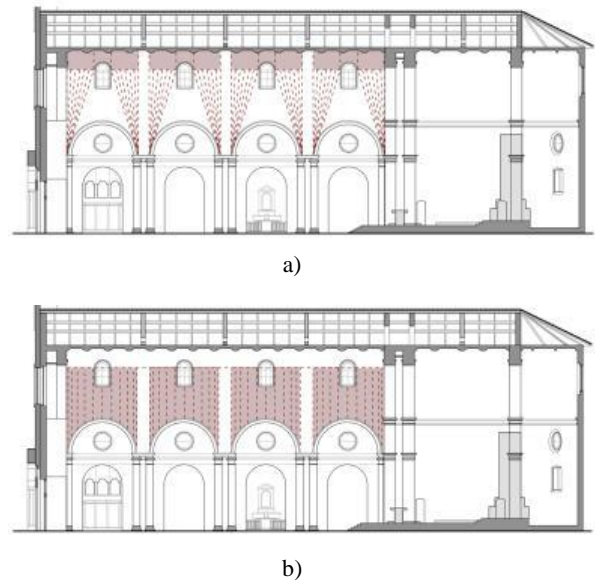
Figure 10. Subdivision of the main wall in two horizontal portions: a) Upper band of the wall and b) Lower part of the wall

The wall separating the nave from the aisles represents the most complex element, for this reason the analysis provided for the horizontal division of the wall into two parts: one at the top above the single windows, and a second lower portion (Figure 10).

**5.1.1 Top band of the wall:** Primarily the top part corresponds to the portion of wall included between the central covering skewback and the arches skewbacks of the single-windows (Figure 10a).

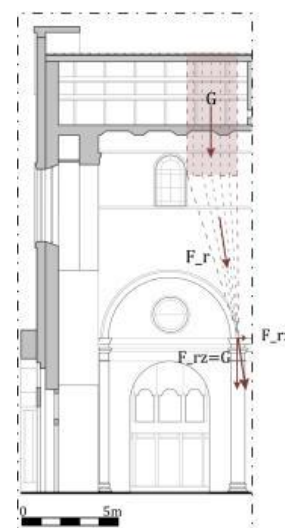
This part was considered as a free body, which in addition to its own weight, supports the load of the central roof. The total load is transferred through the “centered fans” up to the top of the columns (Figure 5). The load transfer scheme is based on the cracks arranged like a centered fan above the columns. The cracks observed, corresponding to the transferring of the weight of the upper band wall to the columns, are pronounced, due to the soil settlements.

Figure 11. Use of the centered fan for the upper band

the radial stress of the fan (Figure 11). It is important to note that the radial forces meet in a nodal support area with triaxial stress in which the longitudinal arches, the transverse arches, the filling of the vault and the column meet.

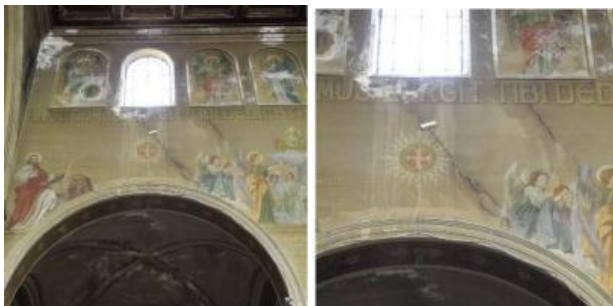
The observation of the diagonal cracks confirms the hypothesis of soil settlements, in particular, the cracks in figure 12 are caused by the settlement of the double façade.

Figure 12. Images of the cracks present on the central walls, North side caused by soil settlements

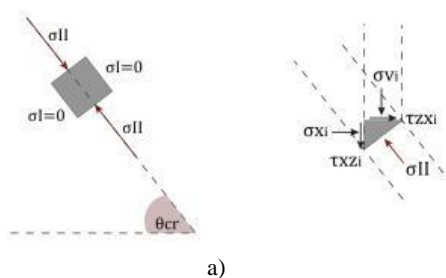
For the behavior of the material, a no tension solution was adopted for the stresses in the diagonally cracked masonry at the bottom interface of the arch and the wall (Figure 13a, 13b).

The diagonal force and the weight of the wall, for free body equilibrium, are balanced by a diagonal force  $E$  acting on the wall-façade interface (Figure 13c).

Figure 13. a) Diagonal stresses, according to the crack observed, obtained through the Mohr Circle, b) Diagonal stresses acting on the wall-arch interface and c) balancing force acting on the wall-façade interface

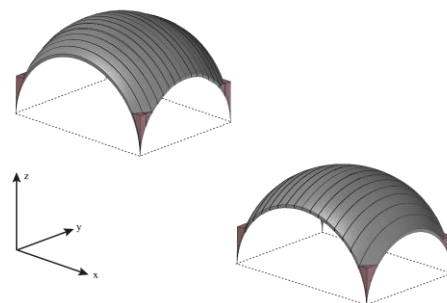
Figure 14. Subdivision of the vault in sections in the two directions X, Y

The dimensions of the sail vaults of the church are about 4.82 x 6.31 m. They have been divided into the two directions X, Y (Figure 14). Along each axis they have been divided into 16 slices. After calculating the reactions of each portion, the resulting forces are obtained, which the vault unloads on the

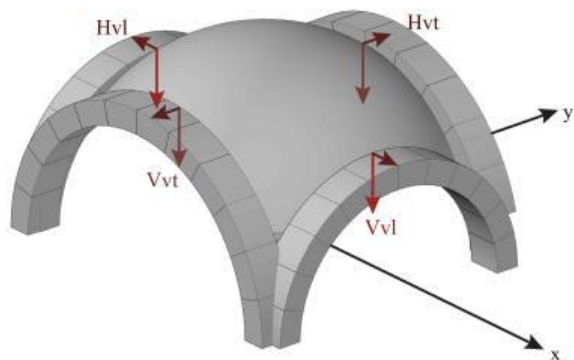
two transverse arches and on the two longitudinal arches (Figure 15).

Figure 15. Forces transferred by the vault on the four arches along the perimeter

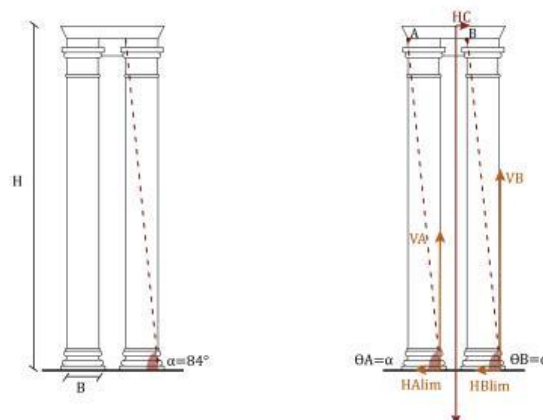
Figure 18. Columns analysis: a) Column limit inclination and b) Horizontal limit reactions at the base of the columns

The analysis involved not only the head walls, but also the columns. The study includes two checks (Figure 18):  
- the first check will look for the limit slope that the forces acting on the columns can have. By checking the forces acting on the North side columns, higher values above the minimum required value of 84 degrees are obtained (figure 18a);  
- the second check regards the horizontal limit reactions at the base of the columns.

Figure 18b shows the vertical forces  $V_A$  and  $V_B$  equilibrate  $H_C$  and  $V_C$ . The analysis seeks to verify that the sum of the limit reactions at the base is greater than the real value of the thrust  $H_C$  acting at the top of the column.
