AN INFORMATIVE CONTENT 3D MODEL FOR THE HALL HOLDING THE RESURRECTION OF CHRIST BY PIERO DELLA FRANCESCA MURAL PAINTING AT SANSEPOLCRO, ITALY

M. Coli¹, A. L. Ciuffreda¹, M. Micheloni^{1,*}

KEY WORDS: HBIM, Piero della Francesca, Sansepolcro, 3D model, cultural heritage, mural painting

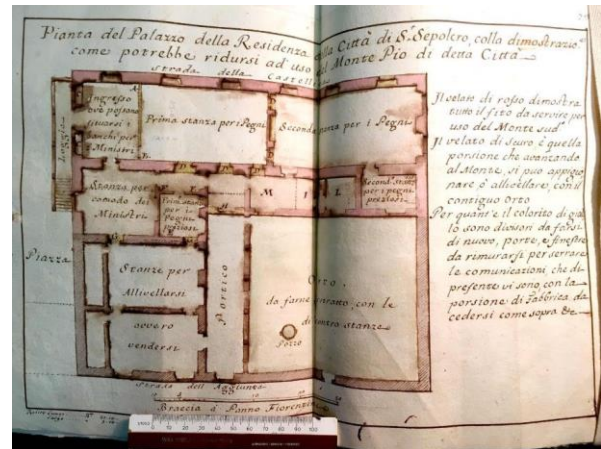
Figure 3. Map of the state of the places and works planned for the settlement of Monte dei Pegni, mid XVIII century (Paola Benigni, in print).

In the XVIII century, the Monte dei Pegni (Figure 3) uses the building. Between the XVIII and XIX centuries in the hall of Piero a false wall was built and three doors were closed in the right wall; two doors on the sides of the painting was opened and closed, while the fireplace was closed.

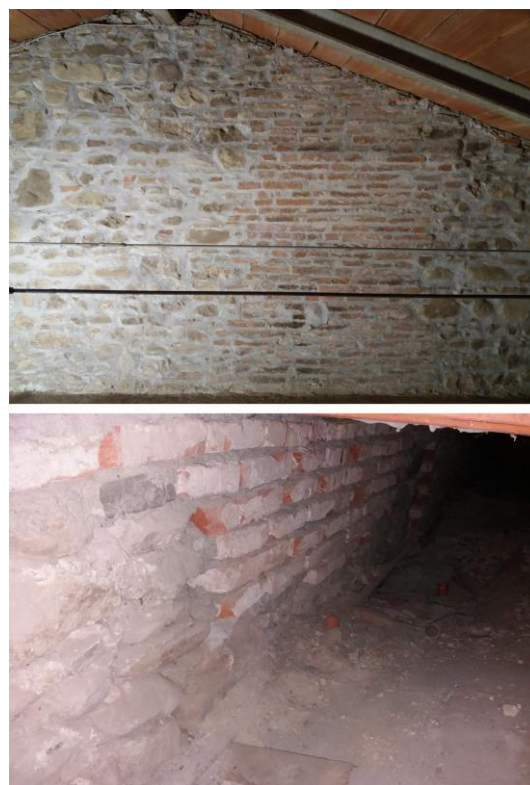
Figure 4. Up: the intermediate wall in the attic where the counter wall supporting the mural painting wall-panel is not present. Down: the counter wall supporting the mural painting wall-panel above the vault but below the attic floor.

Inside this wall, the fireplace and the chimney were made of bricks of 30x15x5 cm, placed by flat, and with mortar of about 1 cm. In the attic is visible the wall that encases the chimney (Figure 4).

The portion of the wall on which the painting stands is made up of a brick wall (thickness 15 cm), laid out flat, 5 cm high and with mortar levels of about 1 cm (Figure 4).

The counter-wall that supports and contains the wall of the painting is made of bricks, (thickness 15 cm) and rises up to the floor of the vaults (Figure 4).
