SHEAR CAPACITY PREDICTION FOR STIRRUP-CORRODED RC BEAMS STRENGTHENED WITH FRP

Ahmed K. EL-SAYED*

Centre of Excellence for Concrete Research and Testing, Department of Civil Engineering, King Saud University, P.O. Box 800, Riyadh 11421, Kingdom of Saudi Arabia

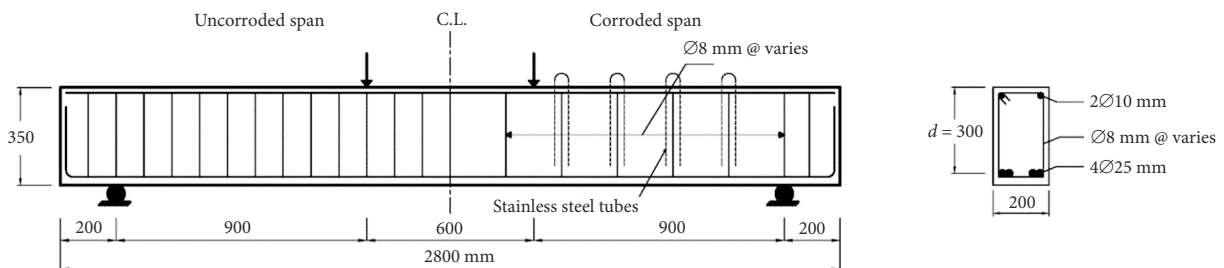
Figure 1. Reinforcement details and dimensions

The experimental program consisted of tests on 3 full-scale RC beams as given in Table 1. The test specimens were 200 mm wide, 350 mm deep, and 2800 mm long. The beams were reinforced with four 25 mm-diameter deformed steel bars as main tensile reinforcement and two 10 mm-diameter deformed steel bars as top reinforcement. The main tensile bars were anchored at the beam ends using standard hooks to prevent anchorage failure. The steel stirrups were deformed bars having a diameter of 8 mm. The side concrete cover of the stirrups was 25 mm. One of the shear spans of the beams was allowed to include corroded stirrups while the other shear span included uncorroded stirrups. The stirrup spacing in the test span was variable (100, 150, and 200 mm). The stirrups in the beams were corroded using an accelerated corrosion technique. The corroded beams were strengthened in shear using CFRP sheets. A section loss of 20% corrosion damage was targeted for this study. The designation of the beams uses the letter B stands for beam. The first number, 20, refers to the target mass loss of 20%. The second number (100, 150, or 200) stands for the stirrup spacing while the letter S stands for strengthened. The reinforcement details and dimensions of the beams are shown in Figure 1. The longitudinal steel bars were epoxy-coated to preclude corrosion of these elements. Additionally, electrical tape was used to cover and insulate the longitudinal bars at the intersections of the bars and the stirrups. After casting and curing the beams for 28 days, the accelerated

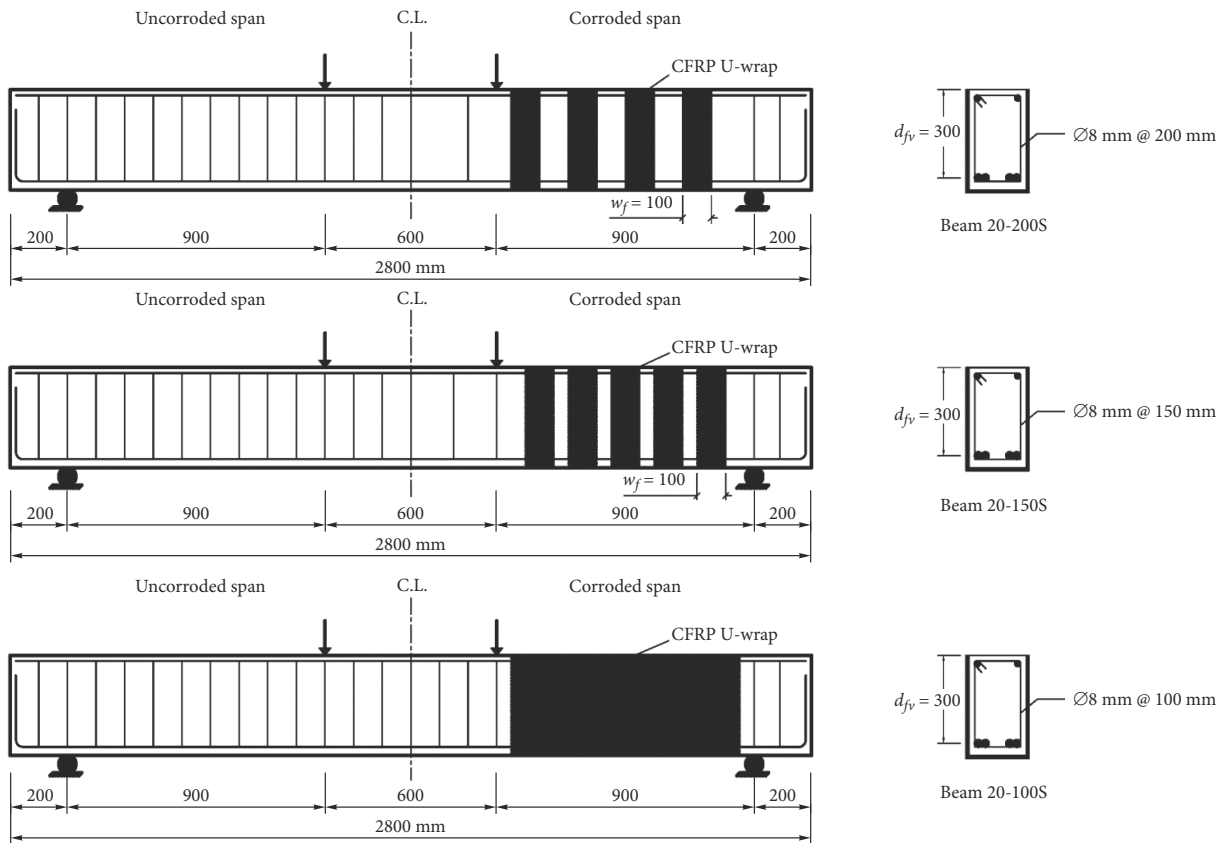
Figure 2. Schematic of CFRP repair of the beams

recorded. Before CFRP strengthening, structural epoxy adhesive was used to fill and repair the corrosion-induced cracks. The CFRP strengthening scheme used consisted of two layers of U-wraps. The CFRP repair procedure has two main steps: surface preparation and CFRP application. The surface was prepared by using a grinder with an abrasive attachment to round the bottom corners of the beam along the test span to avoid stress concentration in the CFRP sheets. The epoxy resin was mixed according to the manufacturer’s instructions. The first coat of the epoxy resin was applied to the concrete surface using a roller. The CFRP sheet was adhered to the surface with the fibers perpendicular to the longitudinal axis of the beam. A second coat of resin was impregnated into the fabric using a steel roller. Then a second layer of CFRP was adhered. Finally, a sealer coat of epoxy resin was applied to the outer CFRP layer. The repaired beams were left to cure for 7 days at room temperature before structural testing. The CFRP layers were U-shaped strips of 100 mm width and spaced at the same spacing of corroded stirrups to ensure having CFRP strip at the section of each corroded stirrup. Figure 2 shows schematic diagrams of CFRP repair of the beams, whereas Figure 3 illustrates repaired beams after CFRP strengthening.

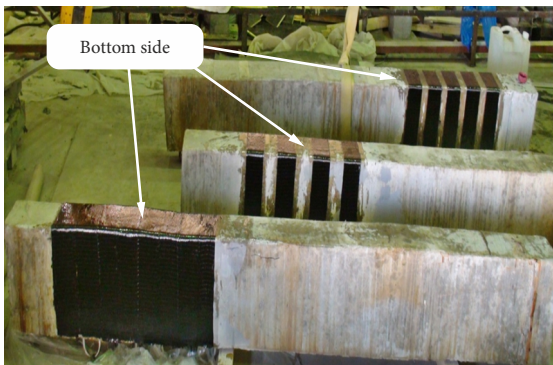
Figure 3. CFRP strengthened beams

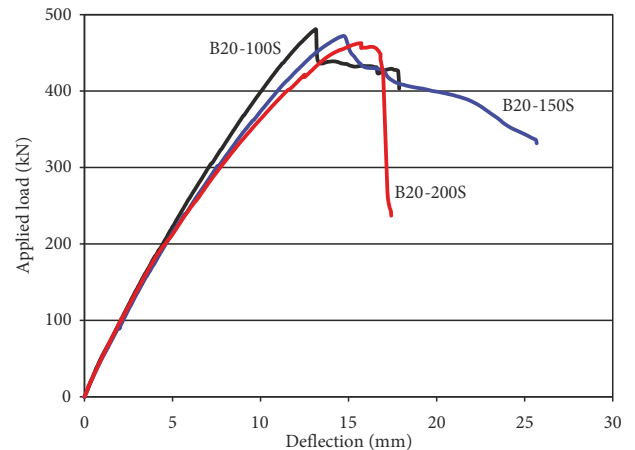
Figure 5. Load-deflection relationship for the test beams

The applied load versus midspan deflection plots for the tested beams are presented in Figure 5. The figure shows approximately linear relationship up to failure indicating the brittle nature of the shear failure. The three beams exhibited the same stiffness up to a load of 200 kN. Then, beam B20-200S started to exhibit lower stiffness followed by beam B20-150S and by beam B20-100S which showed the highest stiffness. This behavior may be at-

tributed to the difference in the spacing of steel stirrups and FRP U wraps in the beams. Figure 5 also shows that strengthened beam B20-200S exhibited a sudden drop in the load at the peak value unlike the two other strengthened beams B20-150S and B20-100S. This indicates the more brittle nature of the debonding failure mode of the CFRP sheets of beam B20-200S compared with the shear compression failure mode experienced by beams B20-150S and B20-100S.

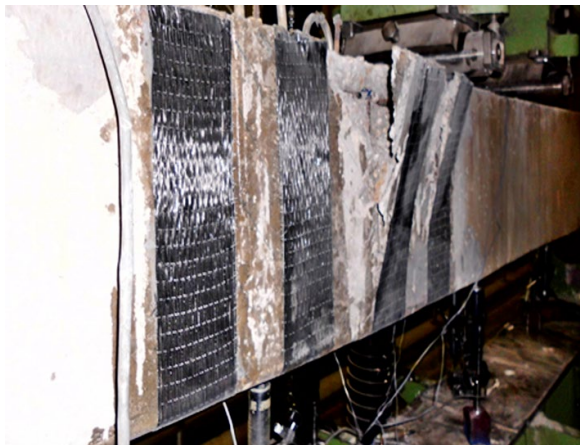
Figure 4. Delamination of concrete cover failure mode (B20-200S)

Table 2 gives a summary of the test results of the beams including the failure mode of the beams as in the last column of the table. Strengthened beam B20-200S failed by delamination of the concrete cover. This mode of failure occurred suddenly by separation of CFRP sheets with the concrete cover from the web of the beam after formation of diagonal crack. On the other hand, strengthened beams B20-150S and B20-100S failed in shear compression which is characterized by crushing of the concrete above the upper end of the inclined crack. Figure 4 illustrates by photograph the delamination of CFRP strips with the concrete cover of beam B20-200S.

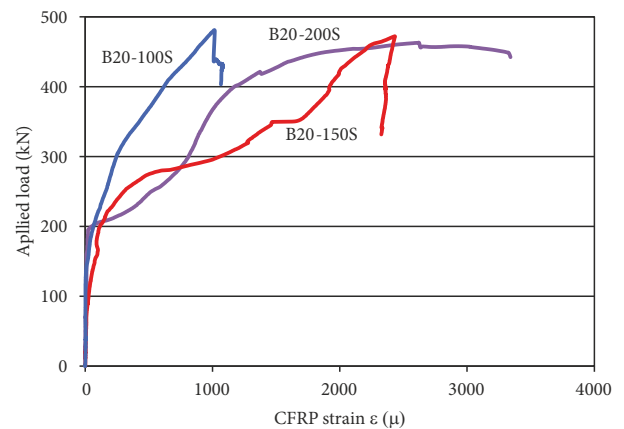
Figure 6. Load versus CFRP strain for strengthened beams

The applied load-strain plots for the CFRP sheets are shown in Figure 6. It can be seen from the figure that the CFRP sheets did not capture strain before diagonal cracking. After the formation of diagonal cracking at an average load of about 170 kN, CFRP sheets began to capture strain as they started to resist crack opening. At the beginning of this stage, beam B20-200S with wider spacing of CFRP

reinforcement showed highest rate of strain increase, followed by beam B20-150S, and then by beam B20-100S with continuous CFRP sheets. However, at a load level of 285 kN, the rate of CFRP strain increase for beam B20-200S reduced showing lower strain behavior than that of beam B20-150S. At a load level of 400 kN, the rate started to increase again and the beam experienced the highest CFRP strain at failure. As given in Table 2, the maximum strain developed in the CFRP sheets at failure was 3341 micro-strain for beam B20-200S, followed by 2432 micro-strain for beam B20-150S, and then by 1015 micro-strain for beam B20-100S. This result indicates that the strain increases with the increase of CFRP spacing. Also, the mode of failure affected the obtained strain values. Beam B20-200S experienced relatively higher value of CFRP strain compared to the other two beams because it failed by delamination of CFRP strips. On the other hand, the other two beams failed by shear compression before debonding of CFRP strips. The value of the debonding strain of CFRP strips of beam B20-200S represents about 19% of the ultimate strain of the CFRP materials.
