# LESSON LEARNED ON MONITORING CULTURAL HERITAGE AT RISK UNDER CLIMATE CHANGES: STRATEGY, TECHNIQUES AND RESULTS

**KEY WORDS:** Moisture, historic masonry, archaeological area, NDT diagnostics, monitoring, rising damp, drainage system, climate change

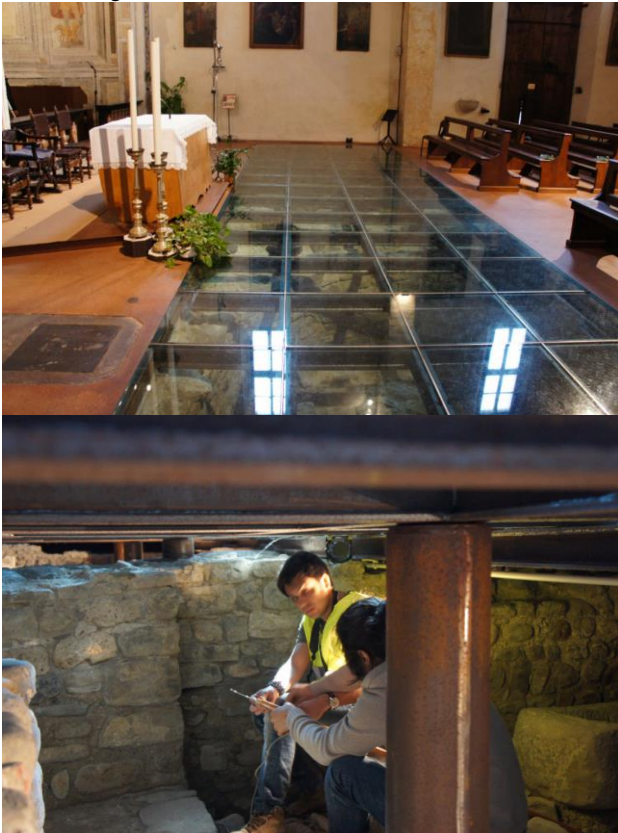
Figure 1. Lavello Convent. Archaeological area inside the Church covered with glass panels. Anemometric tests were performed to understand the ventilation under the covering and to design the correct plant.

The preliminary measurements in Lavello started before the yard of restoration in the church, in 1998, because the archaeological areas was discovered in its wholeness only with the remotion of the pavement of the church, dating back to the '50. Therefore only in 1999-2001 a complete archaeological survey, stratigraphy, laser scanning permitted to assess the presence of the remains of three previous churches in the same site, the firs dating back to the romanesque time. The microclimate went under monitoring at the end of the yard, after the restoration of the findings and the construction of the new glass floor that let visitors appreciate the remains underneath it (2006-2013). Condensation, rising damp, biological growth are the main risk of damages. A microclimate monitoring was set for planning the best management of the ruins area to prevent those damages.

The aim of the microclimate monitoring was to verify the effectiveness of the passive ventilation system that was realized in the new steel structure supporting the floor.

The results of the microclimatic monitoring highlighted the highly risky condition due to very high air humidity, the presence of light from the church across the glass slabs, the absence of natural ventilation (the passive ventilation system did not work), the fluctuation of water content in the remains and church masonry due to the variation of the water level outside. Gathering the experimental data of monitoring resulted very helpful for simulating by CFD the real air condition of the hypogeum and to design the most effective active ventilation system, that could adjust the air flux from outside in the way to keep air Humidity below 80% (Moioli et al., 2013). The threshold of 80% resulted the most suitable for slowly decrease the extreme high value (95-100%) resulted after the flood of march 2007 and next.

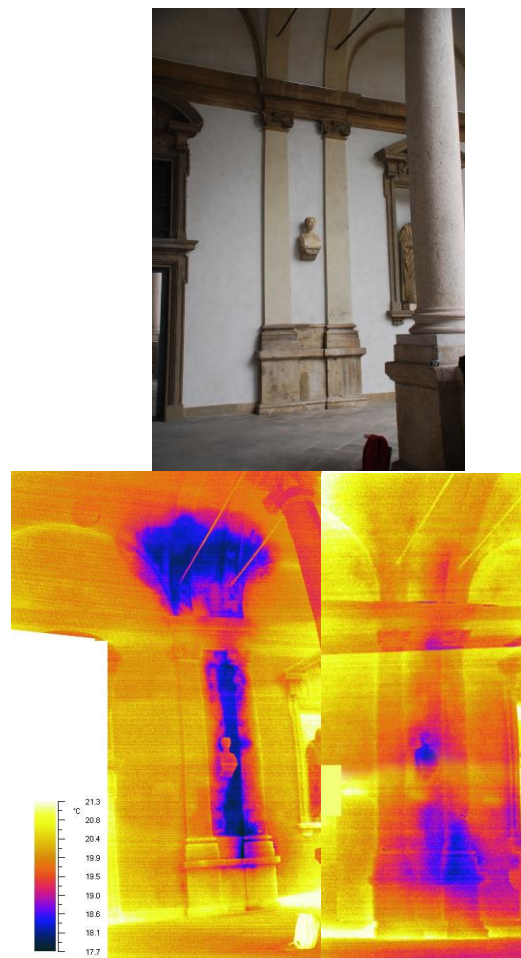
Figure 2. Brera Palace, Visible light and mosaic of thermograms of the wall in front of the broken downpipe. Left side 8 June 2011, right side 10 October 2011.

The palace of Brera Gallery (Milan) and the Duomo of Mantua had serious damages due to recent storms that in few minutes flooded the gutters and downspouts. In the first case the downspouts were set inside the masonry: the push of the water caused the breakage of the drainpipes and leakages inside the building itself.

In fact, despite their maintenance has been granting the regular flux of rain up to recent time, very abundant rainfalls in June 2011 provoked the break of a downspout: the immediate filling with water the space around the pipe caused the breakage of the

surrounding wall due to the fast increasing of water pressure. The major risk was that the water could break the wall towards the interior instead of the exterior. In such a case, also the precious paintings inside the room where the damage occurred could be seriously threatened.

In Brera Palace, the use of IRT and probes for monitoring the air T and RH was integrating with gravimetric test (in the internal side where the leakage occurred) and boroscopy/videoscopy of the interior of downspout, along the deadspace from the roof to the cellas, where the basin for gathering drained water is located. The test were performed in the few weeks following the breakage of the downspout, the air condition motoring was prolonged 1 year.

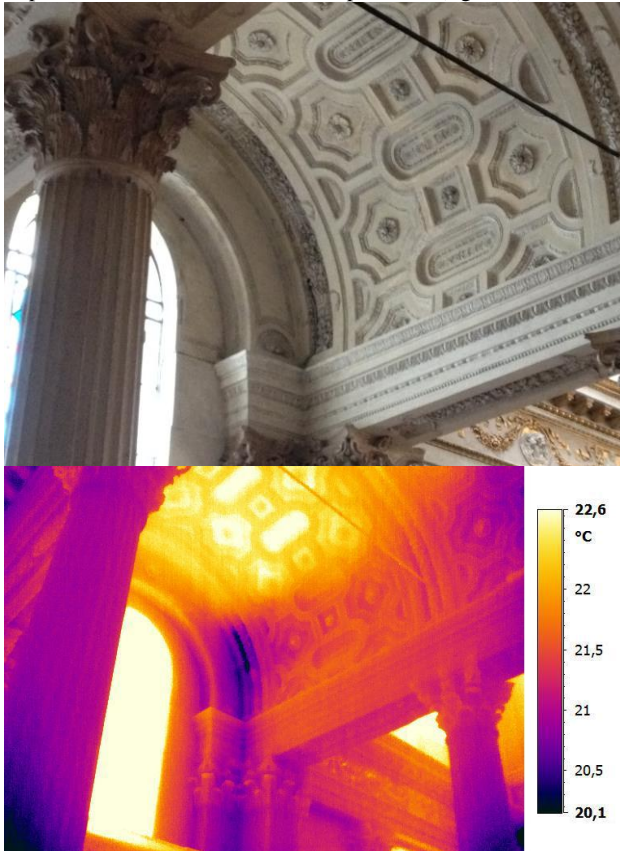
Figure 3. Mantua Duomo. Visible light and Thermogram (24 May 2017) of the vault of the first bay/span, southern nave towards the counter-façade.

In Mantua Duomo, a punctual monitoring has shown the high and the depth of the rising damp with thermography and drilling analysis in three different moments of the years (dry and after abundant rain, 24 May, 21 June, 25 October 2017). The location of the samples was near the possible causes and in few places where no accidental causes could increase the water content.

The results of monitoring at Mantua Duomo showed that the presence of consistent and high rising damp is due to three

causes: the groundwater in Mantua is very close to the surface of soil, the missing connection of the downspouts to the sewage system and the possible breakage of the sewage system set along the side of the church.

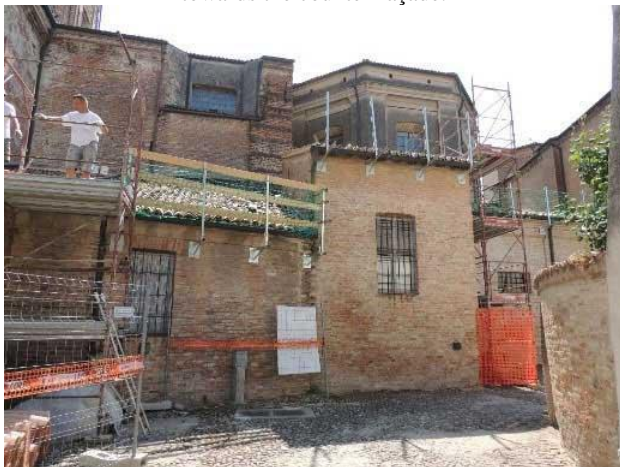
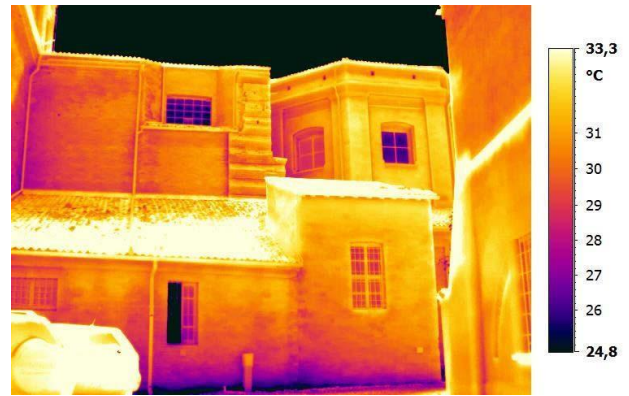
Figure 4. Mantua Duomo. Visible light and Thermogram (24 May 2017) of the North-East façade.

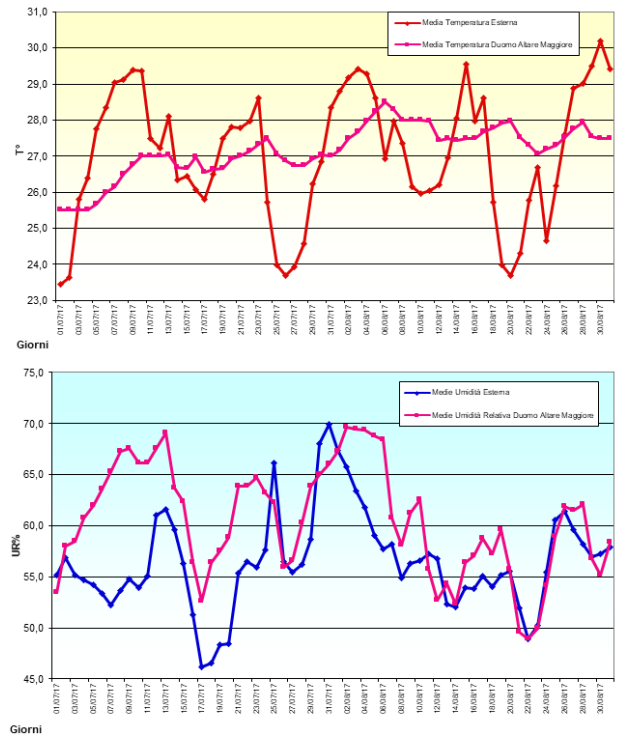
Figure 5. Mantua Duomo. Graphic of the values of the daily average Temperature (yellow) Relative Humidity (blue), July and August 2017.

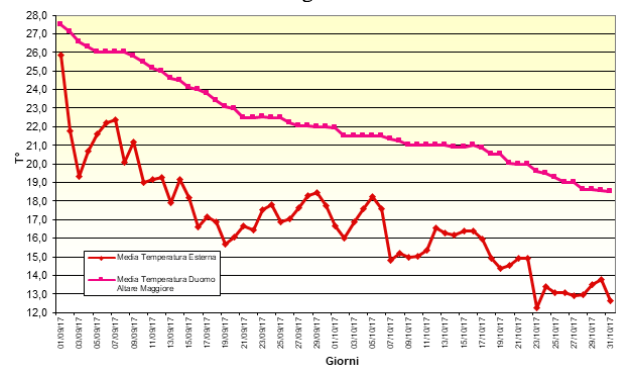
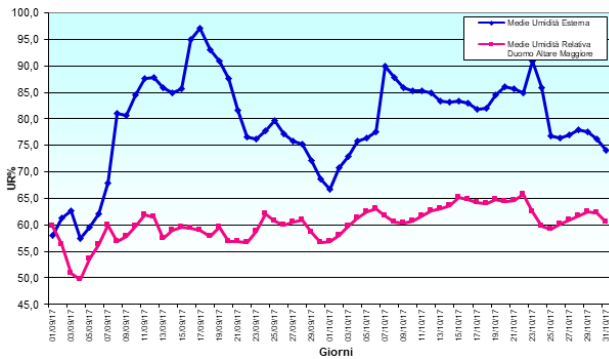
Figure 6. Mantua Duomo. Graphic of the values of the daily average Temperature (yellow) Relative Humidity (blue), September and October 2017.

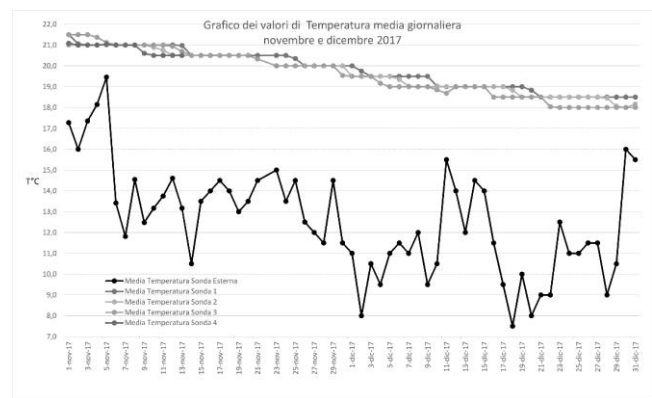
Figure 7. The Tomb in Cagliari, graphic of the values of the daily average Temperature, November and December 2017. During this period the tomb was closed.

Apart from the zone of the entrance, the microclimatic monitoring has allowed to establish that the daily mean values of RH and T are almost independent from the external variations. The temperature values recorded inside are subject to a variation of about 0.5°C every 10 days, and show a delay between the peaks and minimum of two months compared to the outside ones. Recently, archaeological excavations in the tomb and outside, in front of the main entrance, have led to wider variations in temperature and slight variations of Relative Humidity, if compared to the ones recorded in the previous year. The total amount of the variation is similar to the previous period, but larger fluctuations are more frequent. Figure 4 and 5 show the values of the daily average air Temperature in the same period of the year (November and December), however in the first picture (fig. 7) the Tomb was closed, while in the second (fig. 8) the presence of people influenced the Temperature values.

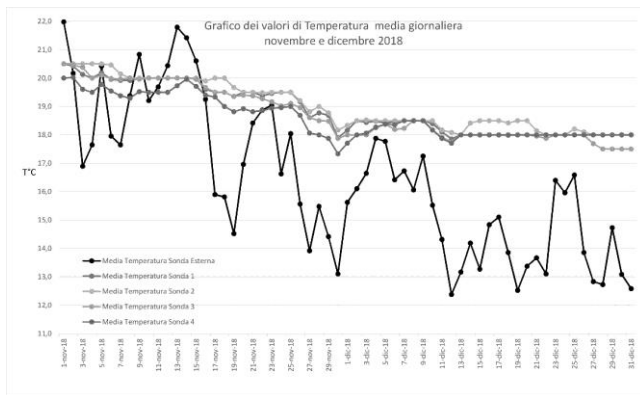
Figure 8. The Tomb in Cagliari, graphic of the values of the daily average Temperature, November and December 2018. During this period, the Tomb was kept partially open for the excavation work (3-5 archaeologists 8-10 hours a day)
