3D OBJECT RECONSTRUCTION IN A PRE-DIGITAL ERA: CASE STUDY IN THE HISTORY OF RESTORATION

Restoration of the ensemble of parks, palaces and fountains of Peterhof (Petrodvorets) near St. Petersburg (Leningrad), Russia, is one of world-renowned restoration projects of the post - World War II period. However, little has been analysed of this unique restoration experience. This paper presents a specific episode in the history of this restoration project.

This paper focuses on the approach, methodology and the selected technological aspects of the restoration of cupolas of the Grand Palace, with a view to their interpretation at the time of restoration of cupolas (1950-s) as well as to modern restoration principles. It shows the process and methods of non-digital reconstruction of the shape of 3D object aided by non-digital models, unique decisions and techniques.

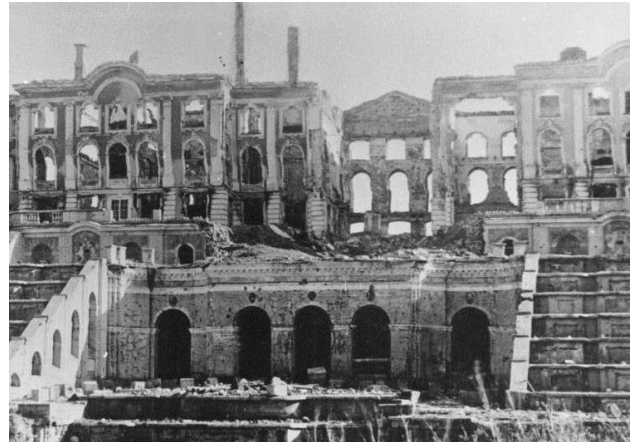
Figure 1. Central part of the Grand Palace and the Grand Cascade of Peterhof after the damages of WWII. © Boris Lobovikov archive

Parks, buildings and fountains were severely damaged. Some part of the works of art were evacuated before the occupation. Many sculptures from the Lower Park stayed hidden in the ground through the years of occupation, and some structures remained in a good condition. However, overall scope of damages was very extensive (Fig. 1).

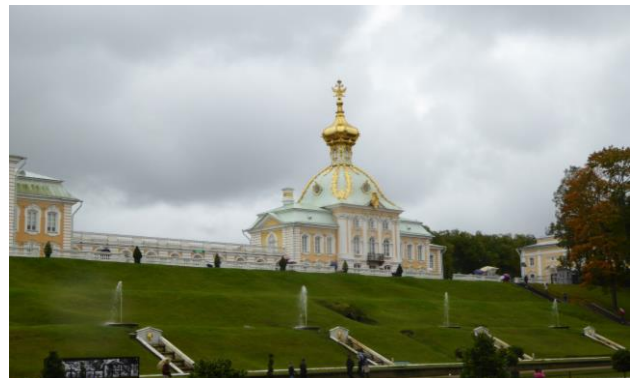
Figure 2. Present day state of cupola and the dome of the Western part of the Grand Palace (photo ©A. Segre, 2016)

Two cupolas flanked the architectural composition of a three hundred meters-long façade of the Grand Palace on both sides (Fig. 2). Each cupola consisted of a dome crowned with a smaller cupola on a lantern. The restoration of the Peterhof ensemble after the war started with general works, restoration of fountains of the central part of the ensemble, and structural works on the Grand Palace. By 1956 the structure and facades of the building of the Grand Palace had been practically fully restored, according to the restoration project by architect V. Savkov, but its two cupolas were still missing.

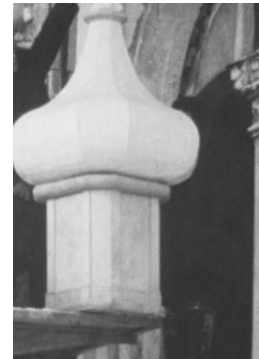
Figure 3. Basic model for a 3D shape reconstruction of a cupola on lantern. Scale 1:5, placed on scaffolding at a relative height © Boris Lobovikov archive

The geometry reconstruction of the cupolas can be sub-divided into “macro”-geometry of the overall shape of domes, lanterns and cupolas, and “micro”-geometry of their decorative elements. In order to reconstruct the 3D shape of the cupolas, several steps were undertaken. First, the original pieces of the cupolas which had fallen into the debris of the ruined palace were searched for, sorted and studied. These efforts lasted in Peterhof through almost two decades after the war. Besides that, all available visual material was analysed. On the basis of these two sources of information a series of models of general shape of domes, and of the cupolas on lanterns were made in diverse scales, subsequently progressing from general form (e.g. scale 1:5 - Fig. 3) to partial detailed models (scale 1:1 - Fig. 4). Models were lifted to a height which was in scale compatible with each model, and studied and photographed from an up-to-scale eye level. The photographs were then compared with the original photographs of cupolas before damages taken from the same points of view, which allowed for correcting the models, if needed. The first basic models were aimed at verifying the precise proportions of the general shape, and didn’t include

details (Fig.3). Larger scales models were based on the first models; they already included decoration elements, and often were focused on verifying a specific part of a cupola, or specific type of elements. The later models, unlikely the first monochromatic ones, included colour distinction as typical of the original colour scheme of the palace and its cupolas: greyish metal-covered roof (which included the domes) gilt details decoration elements, including garlands of the domes and elements of cupolas on lanterns.

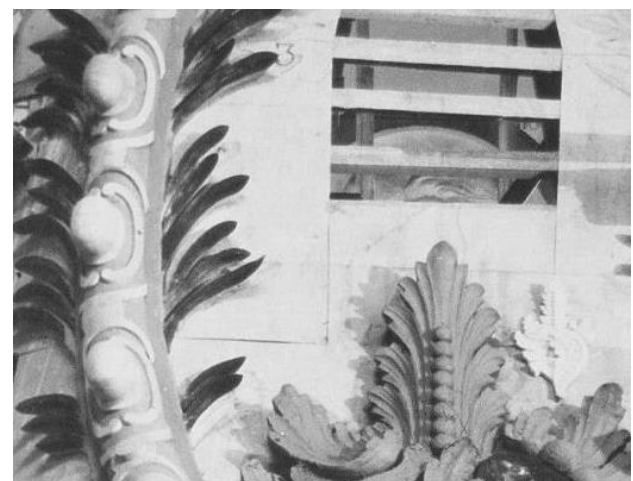
Figure 4. Fragment of a model combining the original and reconstructed decoration elements. Scale 1:1. © Boris Lobovikov archive

With regard to reconstruction of the original geometry of the decorative elements (“Micro”-geometry), the case was easier, because it could be based on the original parts and elements found on site. They were thoroughly studied and put on their original location on a model, e.g. a model of a corresponding part of a dome made to scale 1:1. 3D geometry of missing elements was reconstructed according to the same iterative image-model-image analysis process as of “Macro” geometry reconstruction. The missing elements were then modelled in clay, and incorporated in the same model of a 1:1 scale along with the original elements.

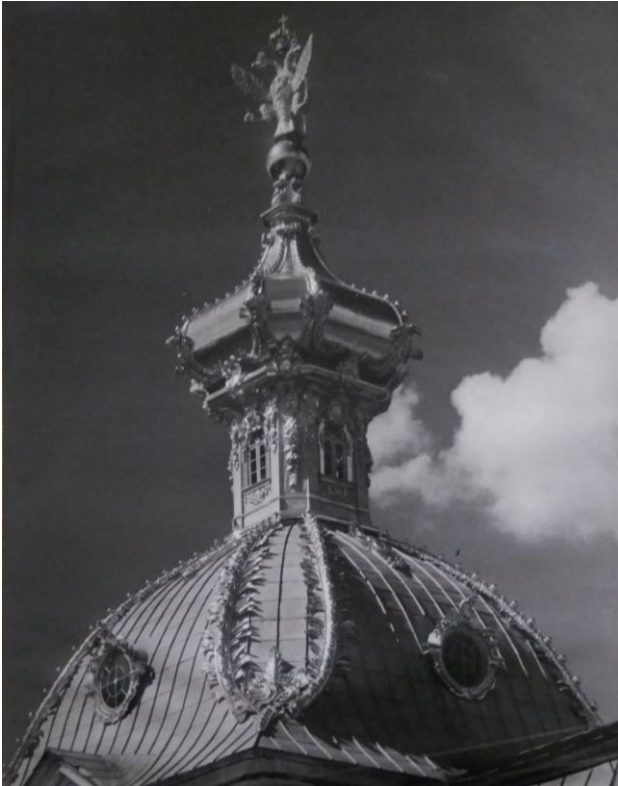
Figure 5. The cupola and the dome of the Western part of the Grand Palace after restoration © Boris Lobovikov archive

included the following stages: clay model, plaster cast, zinc form, final copper elements. Restoration/ reconstruction of cast sculptural elements was of a major importance and also involved clay models as one of the first steps of the process. Gilding work was undertaken in accordance with a scrupulous technological procedure of preparing targeted surfaces before gilding. This was based on the original technology and included a multi-step iterative process of applying layers of lacquer-based cover, drying, and a subsequent polishing of a lacquer-covered surface.
