DIAGNOSIS PROCESSES FOR DESERT ROSE DOMES OF THE SOUF REGION IN ALGERIA

KEY WORDS: Souf region, Desert Rose stone, dome, damage, diagnosis, FEM analysis

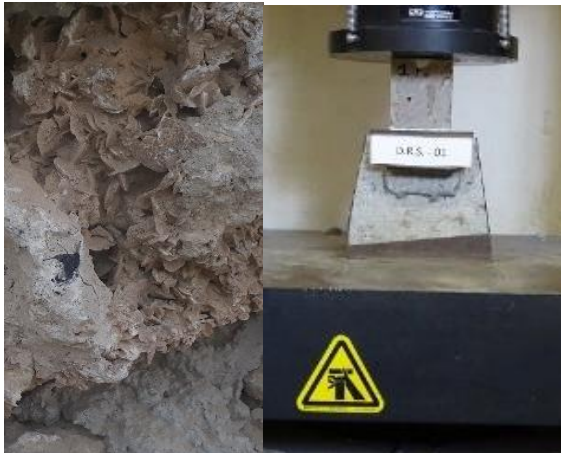
Figure 2.(a) The Desert Rose stone. (b) Compression test on Desert Rose stone sample.

Compression test on Desert Rose stone samples allowed to determine 10 MPa for the compressive strength and 1350 MPa for the Young modulus.

The experimental analysis highlights that the block material is characterized by rather low mechanical characteristics with very dispersed experimental values. These results depend on the very heterogeneous nature of the material which also has a high porosity. The texture of the masonry is very chaotic, being the employed desert rose blocks very irregular. In fact, the blocks are not squared and different sizes of the blocks are used. In figure 3, the really chaotic texture of the walls is represented. For these reasons it is easy to assume that the mechanical characteristics (compressive strength and elastic modulus) of the masonry (blocks and mortar) are much reduced compared to those of the blocks.

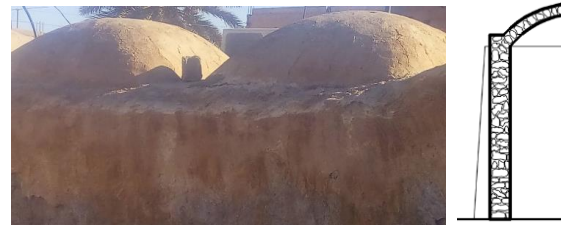
The walls are usually 0.30 m thick, and the domes are about 0.20 m thick (Figure 3). The dome is set at a height between 2 to 2.5 m.

Figure 3. (a) Domes of a building in Guemar. (b) Section of wall and dome.

The construction of the dome is done without formwork, thanks to the use of gypsum-based mortars that quickly set. The execution starts from the square base and grows progressively on the same level carrying out in the corners small mortar squinch. Using the Desert Rose stone blocks and gypsum based mortar, without the use of the formwork, the mason rises the successive courses, one above the other, until the center. The shape of these domes is close to a cloister dome, but the discontinuities in the edges along the diagonal arches is very

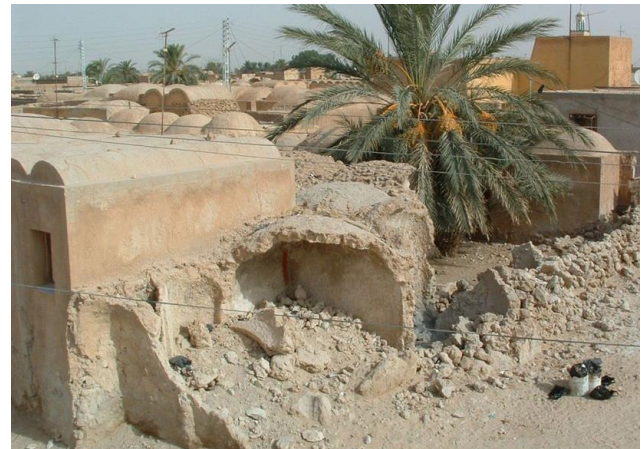
Figure 4. The degradation states of building in the Guemar.

Currently, the degradation state of the architectural heritage of Souf region are very remarkable. Such degradation states are widespread and is characterized by different levels of gravity.

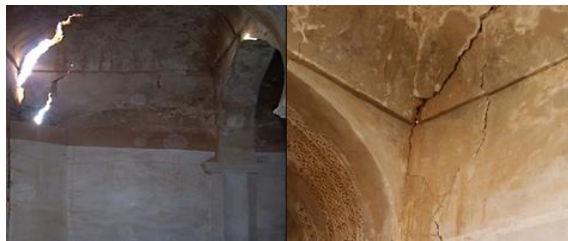
In many cases serious structural damages are evident. In particular, in many buildings partial or total collapse of the domes happened. In many other buildings, it is possible to detect serious cracks that involve the domes (Figures 6 and 7). In particular, there are large fractures at the corners of the domes (along the diagonal arches), determining fragmentation of the domes (Figure 6). These fractures allow the dangerous passage of water and the degrading action of atmospheric agents and can lead the domes to collapse if not repaired.

Figure 6. Fractures at the corners of the domes, along the diagonal arches.

At the diagonal arches, there is a geometric-constructive discontinuity which determines structural weaknesses. Further weakness is generated in the middle of the building unit sides where the horizontal thrust of the flying buttresses arches is maximum. Such thrusts can cause the overturning of the top part of the walls and the partial collapse of the dome (Figure 6).

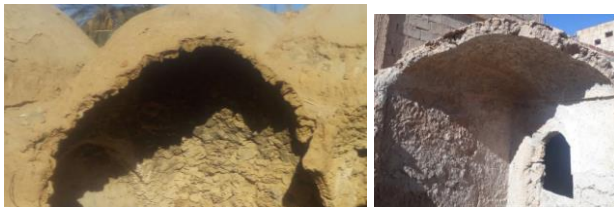
Figure 7. Partial collapse of the domes.
