# Changes in ground deformation prior to and following a large urban landslide in La Paz, Bolivia, revealed by advanced InSAR

**Abstract.** We characterize and compare creep preceding and following the complex 2011 Pampahasi landslide ( $\sim 40 \text{ Mm}^3 \pm 50\%$ ) in the city of La Paz, Bolivia, using spaceborne radar interferometry (InSAR) that combines displacement records from both distributed and point scatterers. The failure remobilized deposits of an ancient complex landslide in weakly cemented, predominantly fine-grained sediments and affected  $\sim 1.5 \text{ km}^2$  of suburban development. During the 30 months preceding failure, about half of the toe area was creeping at  $3\text{--}8 \text{ cm a}^{-1}$  and localized parts of the scarp area showed displacements of up to  $14 \text{ cm a}^{-1}$ . Changes in deformation in the 10 months following the landslide demonstrate an increase in slope activity and indicate that stress redistribution resulting from the discrete failure decreased stability of parts of the slope. During that period, most of the landslide toe and areas near the head scarp accelerated, respectively, to  $4\text{--}14$  and  $14 \text{ cm a}^{-1}

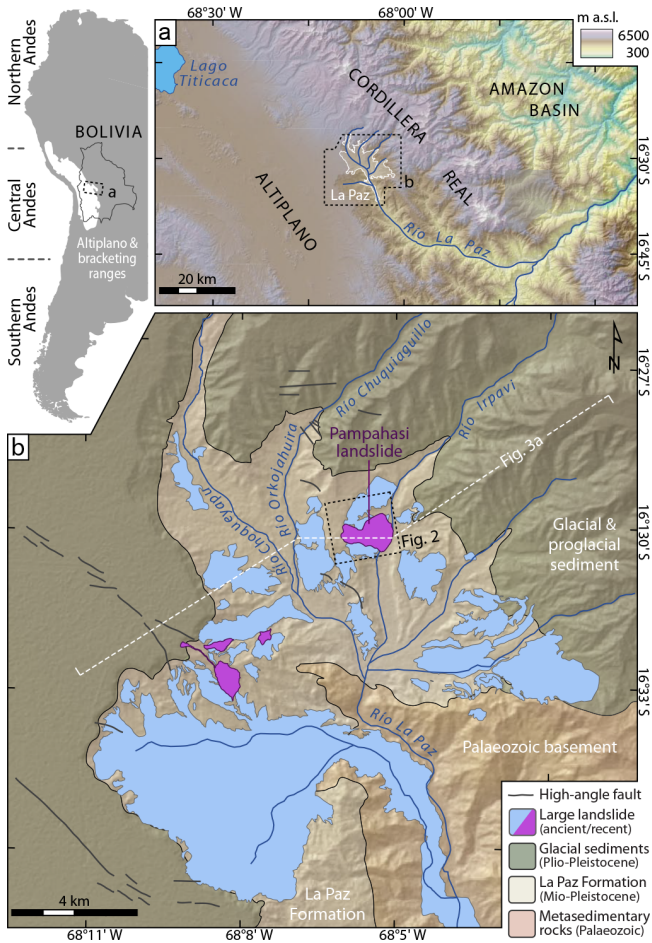
**Figure 1.** Setting of La Paz, Bolivia. (a) Location and physiographic context. (b) Generalized geology after Dobrovolny (1962) and Anzoleaga et al. (1977), with faults from Dobrovolny (1962) and Lavenu (1978). Terrain is from the ASTER GDEM v2 produced by METI and NASA.

Pampahasi Plateau is  $2.2 \text{ km}$  long,  $0.2\text{--}0.7 \text{ km}$  wide, and forms part of the interfluvium between ríos Orkojahuirra and Irpavi (Fig. 1b). Its margins are generally scalloped (Fig. 2) and in several places terminate in nearly vertical cliffs dropping  $20\text{--}80 \text{ m}$  to irregular, locally steep valley slopes below.

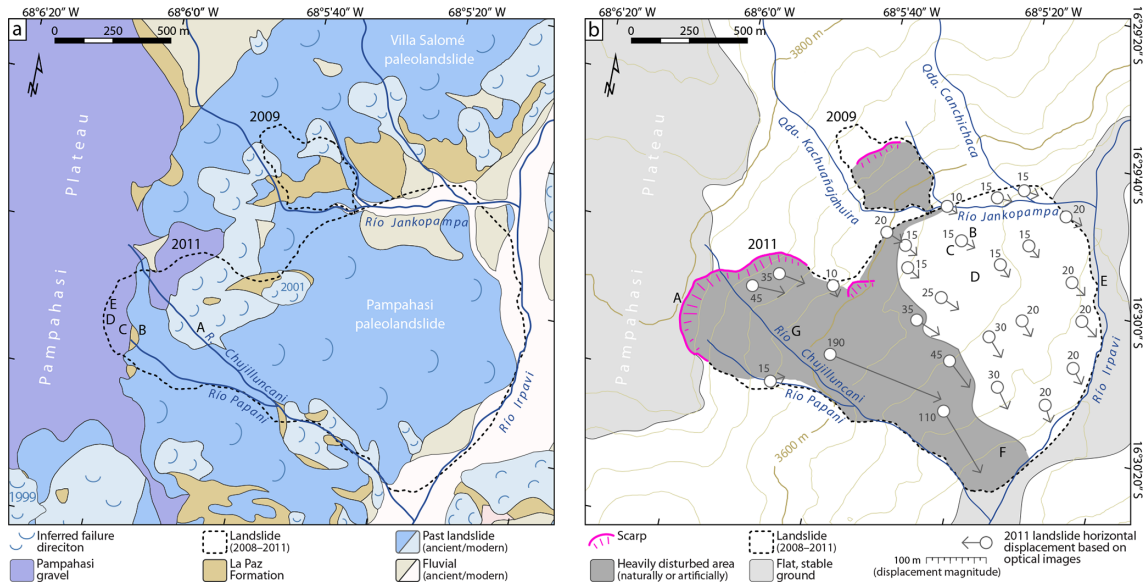
**Figure 2.** Ground surface conditions in the Pampahasi area. (a) Surficial geology prior to the start of the twenty-first century; adapted from Anzoleaga et al. (1977). (b) Slope morphology and ground disturbance showing the extent and morphologic features of landslides that occurred during the period of radar acquisition (September 2008 to December 2011). Horizontal displacements during the 2011 Pampahasi landslide are based on comparison of pre-failure and post-failure WorldView-2 scenes. Contours are from NASA’s Shuttle Radar Topographic Mission v3.0.

Many slopes descending from Pampahasi Plateau are mantled by ancient landslide deposits derived from the La Paz Formation (Dobrovolny, 1962; Anzoleaga et al., 1977). The deposits consist of largely intact brittle blocks of the La Paz Formation within a matrix of softer, ductile, and completely disaggregated La Paz Formation. Small (< 1 to 20 ha) failures evident in aerial photographs have occurred since at least the early twentieth century in many places within large (~ 20–200 ha) prehistoric failures. The slope descending ~ 380 m to Río Irpavi directly east of the southern half of Pampahasi Plateau comprises the undated Pampahasi paleolandslide (Fig. 2a).

Several locations in the upper part of the slope showed field evidence of slow ground deformation, largely visible as offset walls and road surfaces (Fig. 5, locations in Fig. 2a) in the years prior to catastrophic failure (Quenta and Calle, 2005; Hermanns et al., 2012). These features were recognized as evidence of an impending landslide (Quenta and Calle, 2005), although not of the magnitude of the 2011 failure. In response, the municipality of La Paz increased risk communication and installed concrete pillars to remediate what became the 2011 landslide head scarp (Hermanns et al., 2012). However, due to their localized and shallow nature, the stabilization efforts probably had little if any influence on the stability of the slope or behaviour of the subsequent failure.

The 2011 Pampahasi landslide occurred in several phases from the evening of 26 February to 1 March (Fig. 6, locations in Fig. 2b). Eyewitness accounts suggest that failure initiated in an area of earlier small slumps along Río Chujilluncani<sup>2</sup> (Hermanns et al., 2012; Fig. 5a)  $\sim 400$  m downslope of the east margin of Pampahasi Plateau. Motion was fastest (up to several metres per second) and largely vertical in the head region, which failed shortly after, lasting 1 to 2 h and forming a  $\sim 60^\circ$  and 80 m high head scarp (Fig. 6a). Movement in the central zone and at the toe, which began soon after the initial formation of the head scarp, was slower (metres per minute to metres per day) and largely horizontal. The degree of ground disturbance and the magnitude of displacement generally decreased to the east and north (Fig. 2b). The northern part of the landslide's toe experienced relatively limited, but economically costly, ground disturbance (e.g. Fig. 6b–d) and moved as a more or less coherent mass  $\sim 15$  m southeastward (Fig. 2b). Deformation of the lower part of the landslide continued for days. A bridge across Río Irpavi (Fig. 6e) was shifted 10 m and uplifted on the morning of 27 February; uplift of several metres at the east end of the bridge suggests a rotational failure zone passing, at least locally, under Río Irpavi. Buildings near the south toe of the landslide (Fig. 6f)

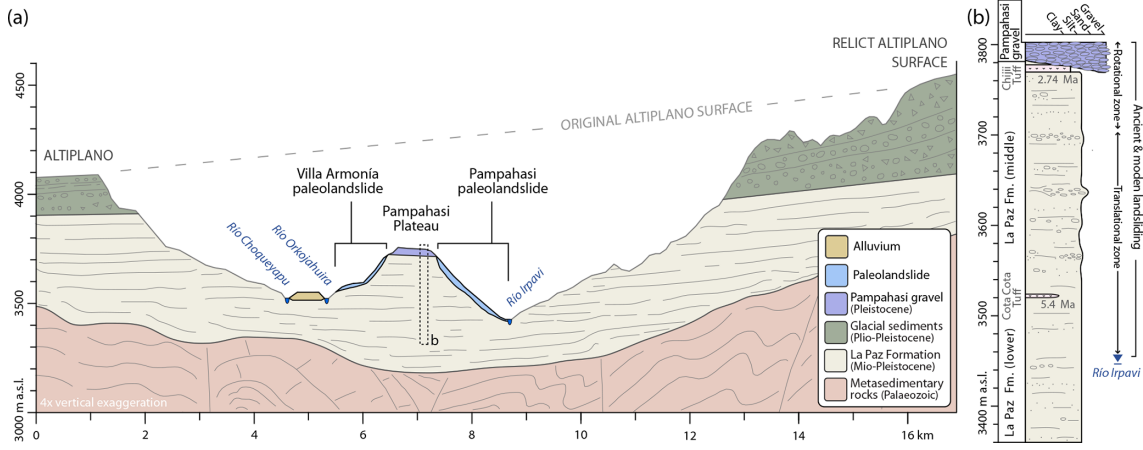
**Figure 3.** Stratigraphic sequence. (a) Cross-section oblique to the trend of the Cordillera Real through the fill underlying the Altiplano (location in Fig. 1b). (b) Lithostratigraphy beneath Pampahasi Plateau, including principle units involved in the Pampahasi paleolandslide and 2011 Pampahasi landslide. Modified from Anzoleaga et al. (1977) based on field mapping throughout the La Paz area.

The plateau surface dips slightly southward and lies at an elevation several hundred metres below the local southwest-dipping Altiplano and its erosional remnants (Fig. 3a).

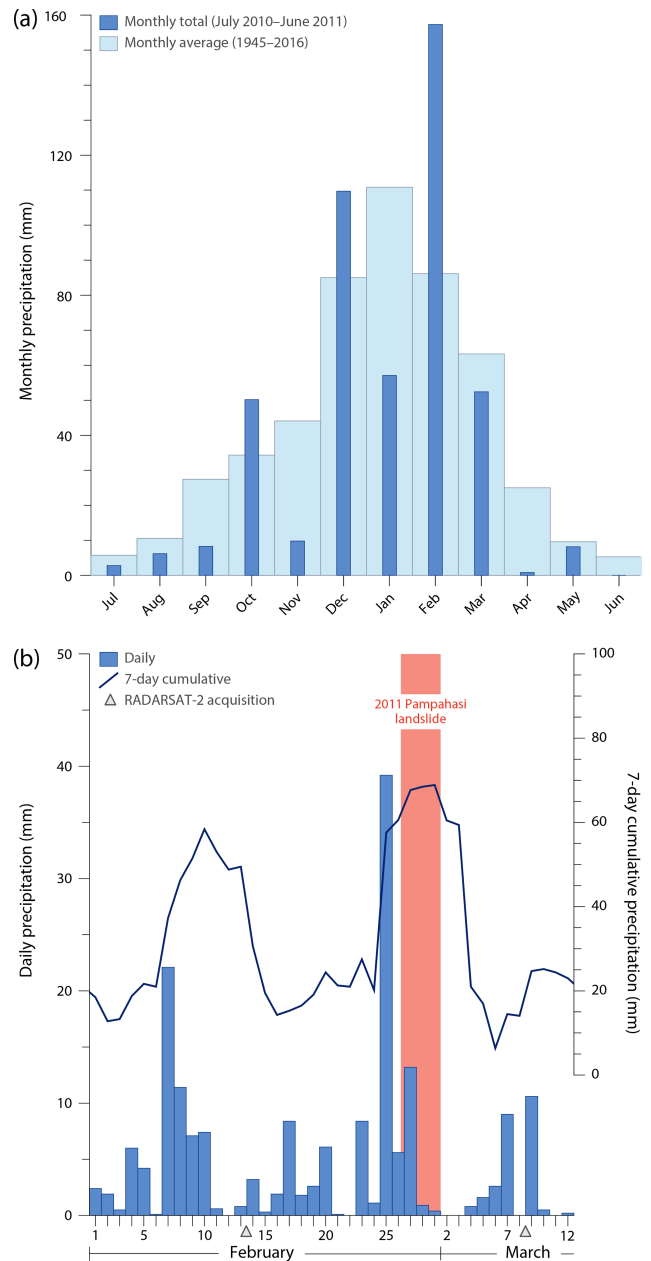
**Figure 4.** The precipitation record for the Laykacota meteorological station (see Fig. S1 for station location). (a) Comparison of monthly average precipitation (1945–2016) with monthly precipitation for the second half of 2010 and first half of 2011. (b) Daily precipitation and 7-day cumulative precipitation during February and early March 2011.

The Pampahasi landslide<sup>1</sup> occurred at the end of February 2011 following a week of variable precipitation (0–39.2 mm daily, Fig. 4), which included one of the wettest days on record (25 February, Table S3). The  $\sim 1.5$  km<sup>2</sup> failure remobilized a large part of the Pampahasi paleolandslide deposit between the east side of Pampahasi Plateau and Río Irpavi (Fig. 2). In addition to previously failed material, it included small volumes of in situ weakly cemented La Paz Formation and, in the head-scarp area, the overlying uncemented Pampahasi gravel (Fig. 2a). None of the sediments involved were substantially weathered.

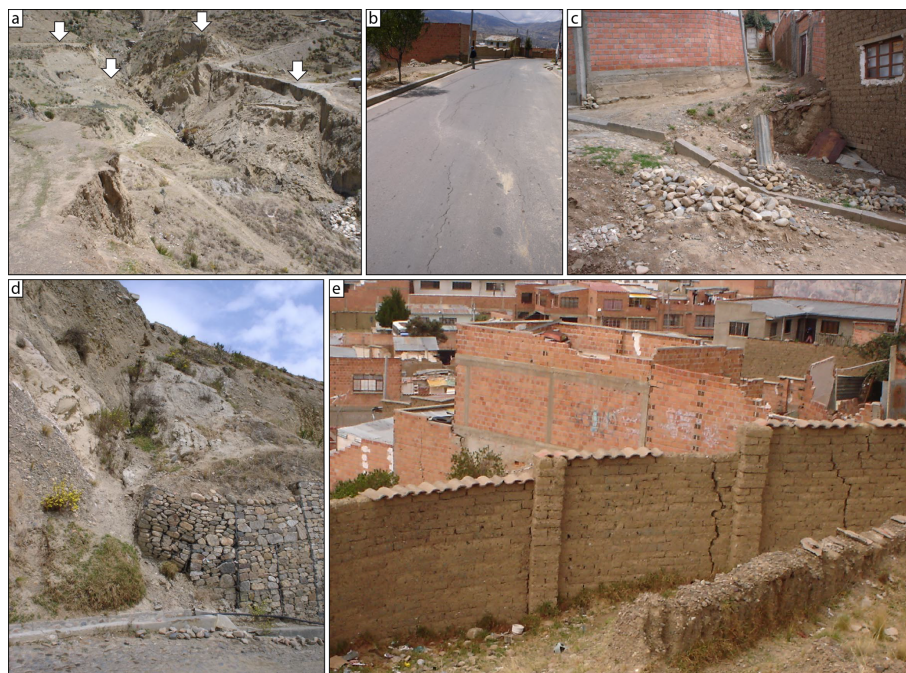
**Figure 5.** Field evidence of pre-failure creep in what would become the head region of the 2011 Pampahasi landslide. (a) Small recent slumps (arrows) along Río Chujilluncani,  $\sim 400$  m downslope from the east margin of Pampahasi Plateau. (b) Minor cracking and centimetre-scale vertical offset of a paved road about 200 m east of, and 75 m below, the east margin of the plateau. (c) Unpaved road with  $\sim 1$  m displacement near the 2011 head scarp. (d) Vertical offset along a gully  $\sim 75$  m from the future south lateral margin of the 2011 landslide. The side of the gully nearer the middle of the 2011 landslide (right of the photo) has dropped  $\sim 0.5$  m relative to the adjacent slope, causing deformation of the gabions and curb in the foreground. (e) Cracks in an adobe wall (right foreground) and brick house (left middle ground)  $\sim 50$  m downslope of the east margin of the plateau, corresponding to the middle of the 2011 landslide head scarp. See Figs. 2a and 8a, b for locations of photographs. Photos taken by Reginald L. Hermanns in October 2005.

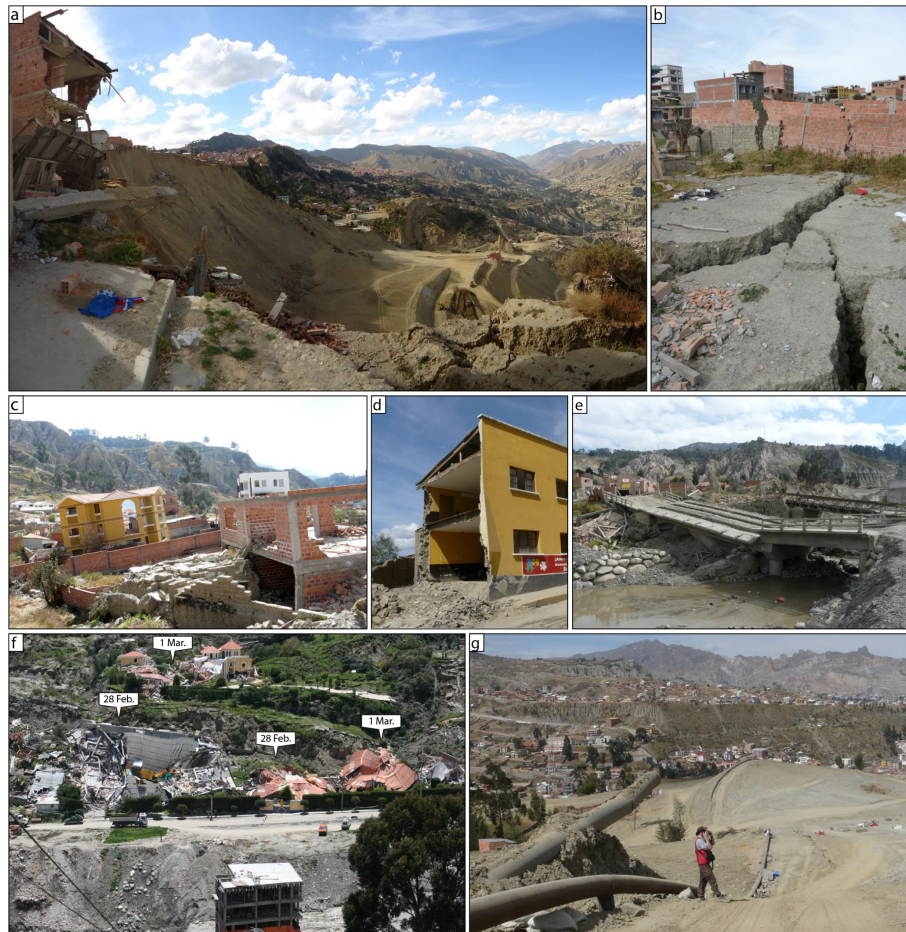
**Figure 6.** Impacts of the 2011 Pampahasi landslide. (a) Head scarp (80 m height) along the east margin of Pampahasi Plateau (note excavator and trucks in lower middle ground for scale). (b) Ground fissures in the northern part of the lower landslide mass. The wall in the background is  $\sim 2$  m high. (c) Back-tilted houses and apartment buildings on the northern part of the lower landslide mass (movement was from left to right). (d) Community building with collapsed wall on the northern part of the lower landslide mass. (e) Bridge across Río Irpavi that was deformed and shifted from its footings on 27 February near the centre of the landslide toe. (f) Buildings on the southern part of the toe of the landslide that collapsed on 28 February and 1 March (dates of collapse shown; photo by Marco-Antonio Guzmán, 2 March 2011). (g) Water service line ruptured by the landslide (upper pipe) and replacement water service line (lower pipe). See Figs. 2b and 8c, d for locations of photographs. Photos taken by Nicholas J. Roberts in May 2011 unless otherwise indicated.

The southern part of the toe of the paleo-landslide (iii in Fig. 8), which was stationary prior to the 2011 Pampahasi landslide (Fig. 8a), reactivated following the failure (Fig. 8c). Although the exact cause of the reactivation is uncertain, it is clearly a result of forces imposed on the toe of the paleo-landslide by the 2011 event and may be related to consequent adjustment of stream erosion along the east margin of the deposit. Creep in this area was greatest directly upslope of the place where several buildings collapsed (Fig. 6f) in the

The new displacements behind the head scarp and along the upper lateral margins of the 2011 landslide (Fig. 8c) gradually expanded over time into, respectively, the Pampahasi gravel (Fig. 9b) and paleolandslide deposits (iv and v in Fig. 9a). Movement in the latter suggests post-failure re-activation of paleolandslide material as a result of the 2011 landslide. Movements on the plateau are likely the result of dilation of the Pampahasi gravel in response to removal of material to a depth of up to 80 m along the 2011 head scarp (Fig. 6a).

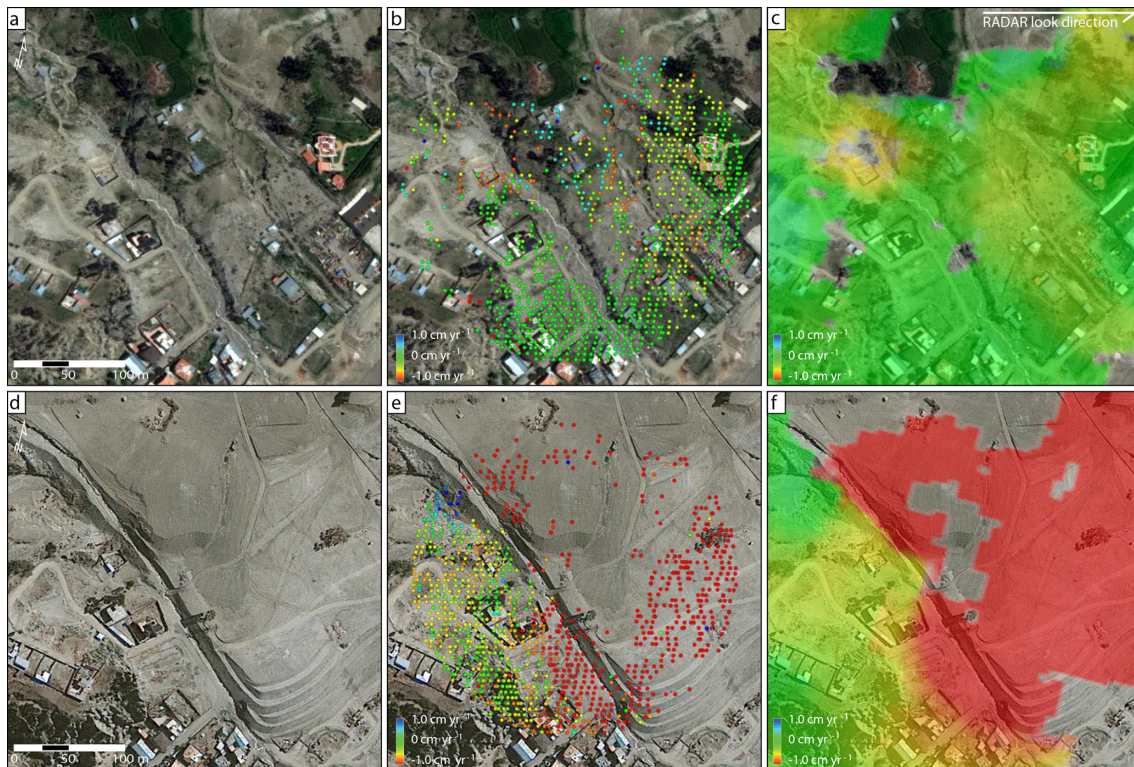
**Figure 7.** Typical density and spacing of HDS-InSAR results for an area of mixed suburban, agricultural, and commercial development. Both the pre-failure stack (a, b, c) and post-failure stack (d, e, f) are shown. Panels for each stack depict satellite images showing land cover without InSAR data (a, d); point data representing HDS neighbourhoods (pixel neighbourhoods) (b, e), each recording a displacement time history; and linear displacement map interpolated from HDS points (c, f). Localized variability in HDS results is suppressed by linear deformation interpolation. Displacement rates are in the satellite line of sight. The deforming area is the southern boundary of the active part of the landslide toe. Base image is a 4 January 2011 QuickBird image viewed in GoogleEarth™. Base images are from GoogleEarth (a, b, c 4 January 2011 and d, e, f 25 July 2011). See Fig. 8a, c for location.

interpreting the spatial variability of slope creep (see Fig. 7c, f). Furthermore, the interpolation weighting suppresses very localized HDS clusters that differ greatly from the average (Supplement, Sect. S4.7). Consequently, these small-scale variations, whether representing surficial movement or noise from uncorrected phase unwrapping errors, are insignificant to large-scale patterns described below. The displacement maps record deep, spatially regular slope movements as well as shallower, more variable movements, but their differentiation requires consideration of displacement patterns and may not always be clear.

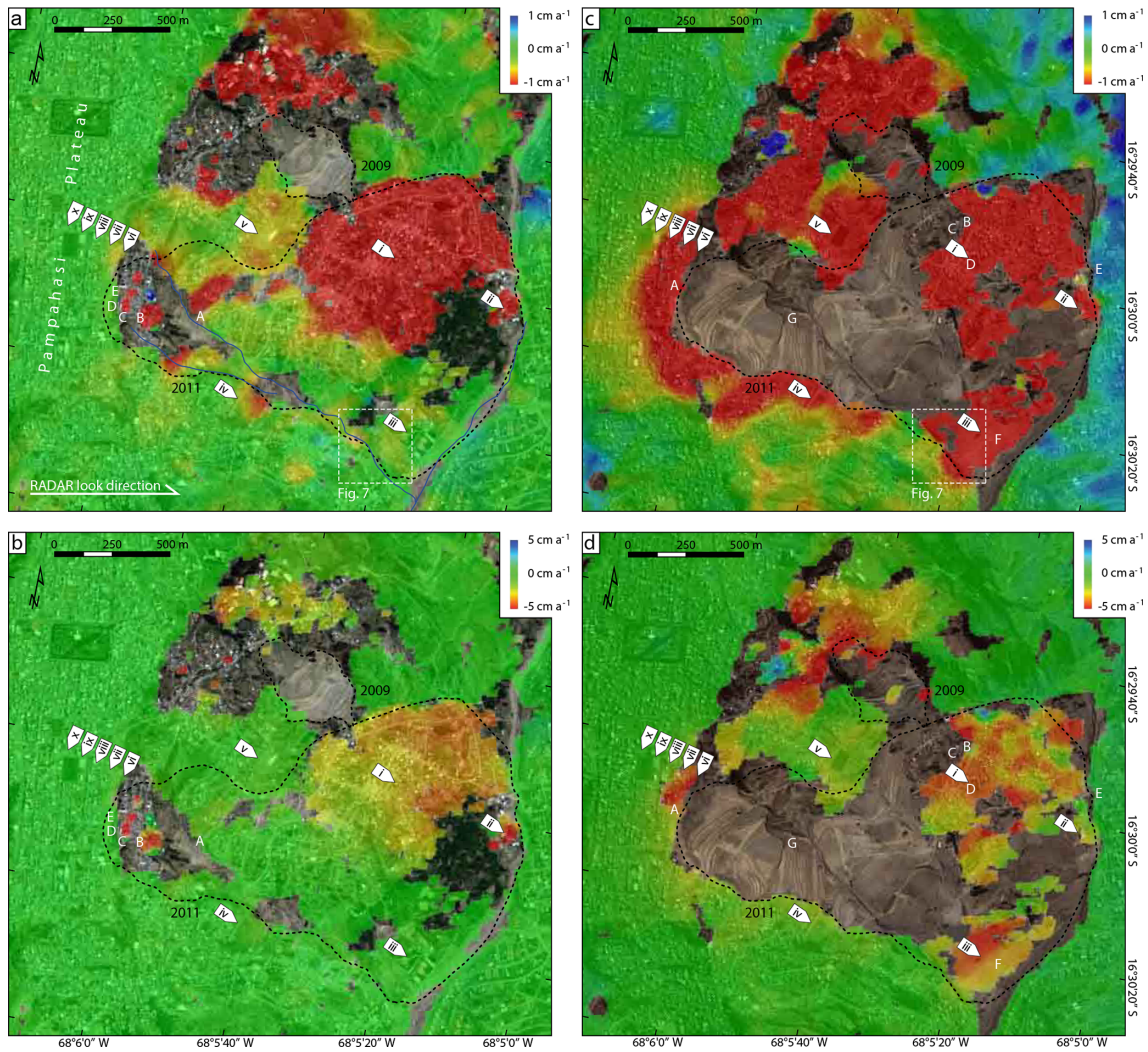
**Figure 8.** InSAR-measured line-of-sight ground displacements in the Pampahasi area. Average linear deformation rates during (a, b) the 30-month period before and (c, d) the 10-month period after the Pampahasi landslide. Compressed ( $-1$  to  $1 \text{ cm a}^{-1}$ ; a and c) and expanded ( $-5$  to  $5 \text{ cm a}^{-1}$ ; b and d) displacement scales emphasize, respectively, the spatial limits and spatial variability of slope activity. Dashed lines are the limits of landslides that occurred in 2009 and 2011 during the period of radar scene acquisition. Roman numerals show locations of displacement histories in Fig. 9. Letters show locations of photos taken, respectively, before (Fig. 5) and after (Fig. 6) the 2011 landslide. Base images are from GoogleEarth (a, b 4 January 2011 and c, d 25 July 2011).

the toe of the Pampahasi paleolandslide ( $2\text{--}5 \text{ cm a}^{-1}$  LOS, i in Fig. 8), where it extended into Río Jankopampa alluvium mantling the paleolandslide deposit. There it terminated abruptly  $\sim 50$  m north of the river (Fig. 8a) at a locally stable slope comprising undisturbed La Paz Formation (Fig. 2a). A 1 ha zone directly west of Río Irpavi and halfway along the toe of the paleolandslide (ii in Fig. 8) crept even faster ( $5\text{--}8 \text{ cm a}^{-1}$  LOS, Fig. 8b). In contrast, activity on the southern part of the paleolandslide toe (iii in Fig. 8) was limited to a few small areas creeping at less than  $0.5 \text{ cm a}^{-1}$  LOS.

of the landslide (north and south of B in Fig. 8a, b), creep may have been localized to a few smaller areas there. Minor isolated movement ( $< 1 \text{ cm a}^{-1}$  LOS) is apparent along what became the 2011 landslide's upper lateral margins (e.g. iv in Fig. 8). Creep within the Pampahasi paleolandslide deposit beyond the limits of the 2011 failure was also localized and generally slower than  $1 \text{ cm a}^{-1}$  LOS (Fig. 8a). The largest of these areas involved 12 ha of paleolandslide material between the 2009 and 2011 landslides (v in Fig. 8) directly upslope (northwest) of the most active part of the slope toe and crept at  $0.5 \text{ cm a}^{-1}$  LOS. The most rapid pre-failure motion ( $9 \text{ cm a}^{-1}$  LOS) was restricted to the upper portion of the future landslide where infrastructure damage had been documented in prior years (Fig. 5b, c). Aside from a small, slow-moving ( $0.5 \text{ cm a}^{-1}$  LOS; vi in Fig. 8) area, no motion is evident along the future landslide head scarp, including sites of localized deformation observed in 2005 (Fig. 5d, e), or on the plateau behind it (vii–x in Fig. 8).

During the 10 months following the landslide, the area of movement on Pampahasi Plateau and the valley slope between it and Río Irpavi increased by about two-thirds to nearly 300 ha and included the entire area of the 2011 landslide where coherence was maintained (Fig. 8c). The maximum inferred downslope displacement rates following the landslide ( $14, 9 \text{ cm a}^{-1}$  LOS; Fig. 8d) were similar to those before it but occurred in a region of the toe that was previously stable (iii in Fig. 8) and along the new head scarp (vi in Fig. 8) where creep had previously been slow ( $0.5 \text{ cm a}^{-1}$  LOS). Displacement rates also increased in the northern part of the toe (ii in Fig. 8, from 2–5 to 3–6  $\text{cm a}^{-1}$  LOS) and were more spatially variable than in the pre-failure period (Fig. 8).

The most striking change in ground motion following the 2011 failure is the development of a new area of creep several hundred metres wide fringing the head region of the landslide (Fig. 8c). This zone extends up to nearly 400 m beyond the head scarp on Pampahasi Plateau, in one place reaching

the opposite margin of the plateau surface. The magnitude of creep decreases steadily away from the head scarp (vi–x in Figs. 8c, d, and 9b). This zone of new deformation extends hundreds of metres down both lateral margins.

The height and steepness of the 2011 landslide head scarp indicate a deep-seated basal failure zone in the upper slope (Fig. 11b). Neither the paleo-landslide nor the 2011 failure aligns with documented faults (Dobrovlny, 1962; Lavenu, 1978; Fig. 1b) that might indicate a structural control. A lack of displacement records for the head region following the 2011 landslide limits inferences about post-failure behaviour. However, pre-failure records, although incomplete, provide some insight into localized activity. Displacements within the head region prior to the landslide and the lack of movement in adjacent steep paleo-landslide scarps suggest that pre-failure creep was part of the ongoing slope failure rather than localized instability resulting only from steep slopes. Localized small-scale slumping occurred lower in the head region along Río Chujilluncani (A in Fig. 8a, b) adja-

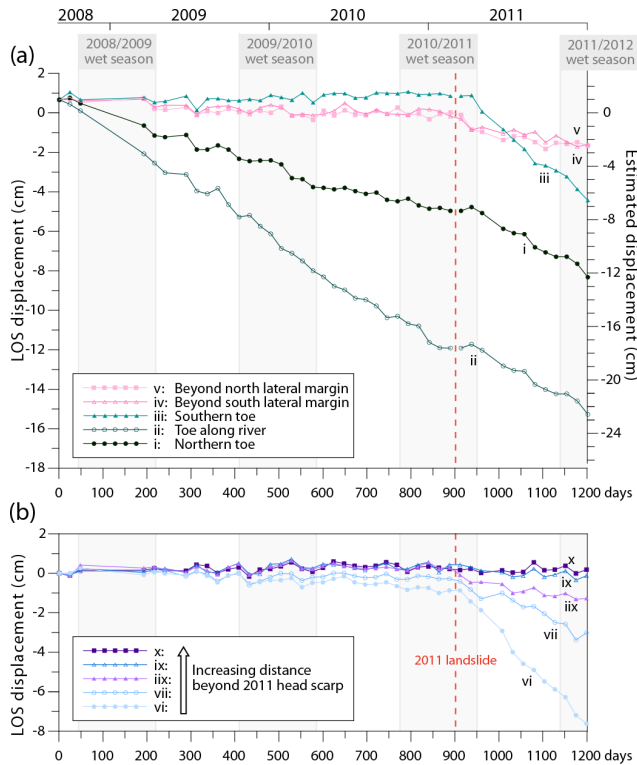
**Figure 9.** Displacement time series from the Pampahasi area (locations i to x in Fig. 8). **(a)** Movement of the west slope of the Río Irpavi valley within the area affected by the 2011 landslide (i–iii) and adjacent paleolandslide deposits (iv–v). The right axis is approximate, given that additional error is introduced from conversion from LOS to true motion. **(b)** Movement on Pampahasi Plateau behind the head scarp of the 2011 landslide (vi–x). Variability in the data, which is most pronounced in parts of the time series with low displacement rates, indicates phase noise resulting from factors unrelated to ground motion. Displacements between the end of the pre-failure stack and the start of the post-failure stack are not precisely constrained within the limits of the 2011 landslide (i–iii). For the Pampahasi slope adjacent to the 2011 failure and for the Pampahasi Plateau, displacements between the stacks are based on results of full-stack processing (see Sect. S4.8).

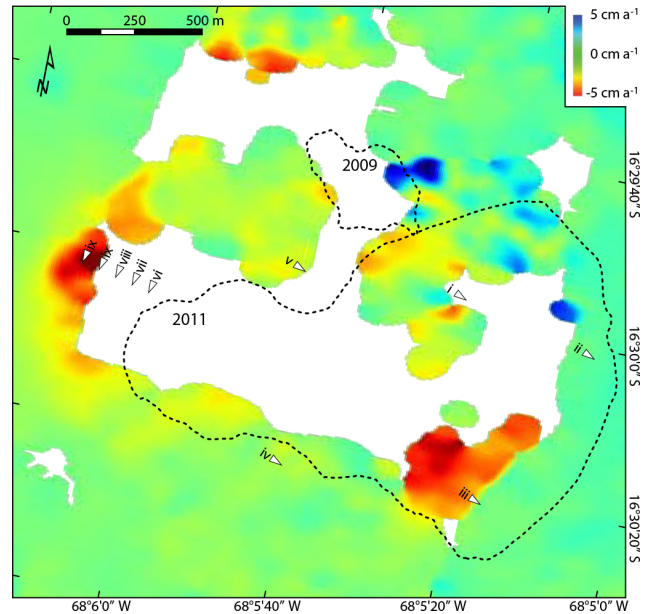
**Figure 10.** Change in line-of-sight slope creep of the Pampahasi area following the 2011 failure relative to pre-failure creep. Positive and negative values indicate, respectively, decreased and increased post-failure displacement rates away from the satellite. Green areas experienced no change in displacement and were largely stable both before and after the 2011 landslide. White areas lacked coherence phase in pre-failure scenes, post-failure scenes, or both. Roman numerals show locations of displacement histories in Fig. 9. Pre-failure and post-failure imagery spans, respectively, 8 September 2008 to 13 February 2011 and 9 March to 22 December 2011.

A 1 ha zone near the midline of the landslide toe (ii) is one of the few locations of decreased post-failure activity (Fig. 10). Its high, localized activity prior to the 2011 landslide (5–8 cm a<sup>-1</sup> LOS, Fig. 8b) suggests a shallow failure driven by incision at a location where Río Irpavi impinges on the toe of the slope (Fig. 2). This localized activity is probably similar to the east-bank landslide mapped by An-

zoleaga et al. (1977)  $\sim 400$  m farther upstream, opposite the Río Jankopampa confluence (Fig. 2a), which was creeping throughout the entire period of radar monitoring (Fig. 8). Decreased post-failure activity of the small west-bank instability may reflect local modification of the Río Irpavi channel by the 2011 landslide and subsequent channel remediation efforts, or it may result from post-failure stress reorganization. Several similar linear areas of decreased post-failure creep along the toe of the 2011 landslide as far north as Río Jankopampa (Fig. 10) may represent similar conditions.

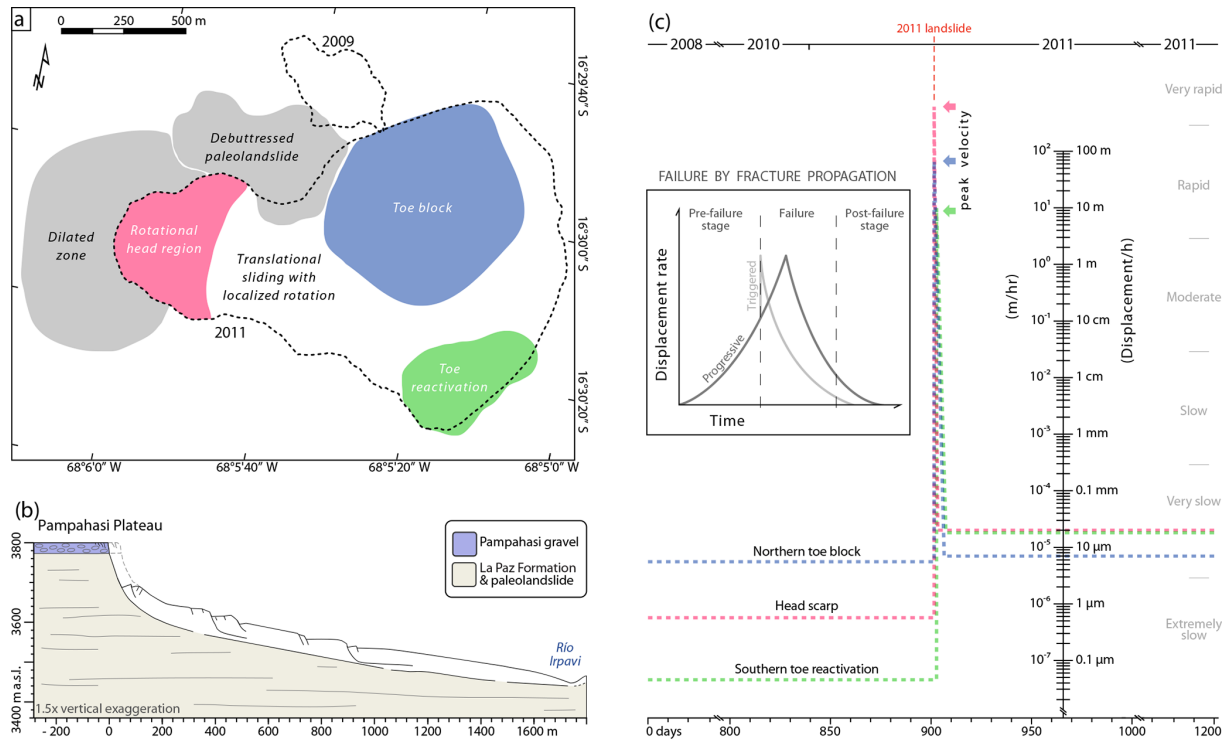
**Figure 11.** Proposed geomechanical model for the Pampahasi landslide and adjacent terrain. **(a)** Components of failure, which differ in kinematics and activity history. **(b)** Generalized section through the failing slope illustrating the approximate depth and attitude of the failure zone. The topographic surface is based on NASA’s Shuttle Radar Topographic Mission v3.0, which depicts the generalized pre-failure terrain. Dashed and solid lines in the source area (0 to  $\sim 150$  m  $x$ -axis distance) represent, respectively, pre-failure topography and post-failure topography based on terrain changes measured in the field using a handheld laser rangefinder. Terrain lower on the failed slope changed comparatively little during the landslide; the solid line beyond  $\sim 150$  m  $x$ -axis distance is thus generally representative of both the pre-failure and post-failure topography. **(c)** Schematic temporal displacement history generalized from InSAR measurements bracketing the 2011 Pampahasi landslide and eyewitness accounts. Due to the revisit frequency of RADARSAT-2 (24 days), the lack of acceleration leading up to the 2011 Pampahasi landslide is based on the lack of such effects reported by local residents. Velocity classes are from Cruden and Varnes (1996), spanning all classes except for “extremely rapid” ( $> 5 \text{ m s}^{-1}$ ). The inset shows schematic stages of slope movement during first-time failure by fracture propagation (after Hermanns and Longva, 2012).

The failing slope has many interconnected components that are largely within, but also extend locally beyond, the Pampahasi paleolandslide (Fig. 11a). Slope morphology before and after the 2011 landslide shows that long-term failure occurs predominantly by complex rotational–translational sliding (Fig. 11b). Differing displacement behaviour of several

In contrast, over the 40-month period we monitored the Pampahasi slope (Fig. 11c), long-term steady-state creep was punctuated by temporary acceleration. Pre-2011 displacement rates are for the most part extremely slow (after Cruden and Varnes, 1996) but constant. No progressive acceleration was evident at the temporal resolution of RADARSAT-2 or from eyewitness accounts during the days leading up to failure. Displacement rates during the 4-day landslide event ranged from moderate to very rapid but did not reach the extremely rapid range ( $> 5 \text{ m s}^{-1}$ ; Cruden and Varnes, 1996) typical of catastrophic failures. Creep rates following the 2011 landslide were also constant but were greater than those prior to failure, indicating a new state of instability following the landslide, which may reflect temporary post-failure

proves terrain representation. Topographic correction of the post-failure stack thus accounts for landslide-induced terrain changes, which were greatest in the source area (Fig. 11b). Temporal soil moisture variability is unlikely to affect phase by more than 100° (Rabus et al., 2010), which equates to approximately one-third of an interferometric fringe or 0.9 cm for the sensor used here. Comparison of precipitation records in the 30 months before and 10 months after the 2011 Pampahasi landslide indicates that long-term precipitation amounts during the pre-failure and post-failure stacks were comparable (Fig. S2; Table S4). Spatial moisture gradients are a more substantial error source (Rabus et al., 2010), but major differences present in a single scene are removed during stack processing.
