IABSE Symposium 2019 Guimarães
Towards a Resilient Built Environment - Risk and Asset Management
March 27-29, 2019, Guimarães, Portugal

Structural Health Monitoring of a masonry viaduct with Fibre Bragg Grating sensors

The Marsh Lane viaduct is a masonry railway bridge constructed during the 19th century nearby Leeds Central Railway Station. The bridge appears significantly damaged due to the increase of the operational train loads over the last decades and due to environmental effects. Due to this degradation, extensive repair was conducted in 2015. After this repair work, an extensive fibre optic sensor network was installed below three spans of the bridge to monitor surface strains at 68 locations on the underside of the arch spans. The paper compares data collected from two monitoring periods, 16 months apart. Combining statistical analysis and signal processing techniques, the results show that local damage, as well as change in the global dynamic behaviour of the structure over time, can be effectively detected with the use of Fibre Bragg Grating sensors.

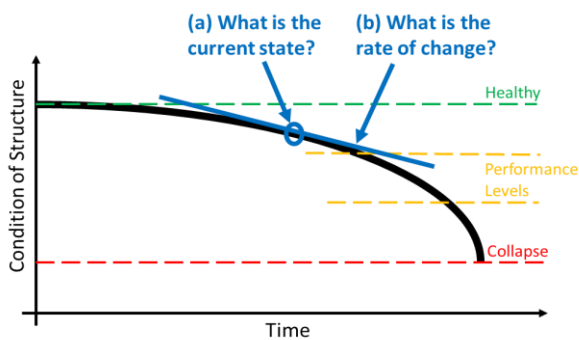
Figure 1. Typical deterioration curve of an ageing structure

As the population grows, an increasing number of people rely on established transport and utilities networks. In particular, ageing masonry bridges comprise 50-60% of the European rail stock [1, 2]. The majority of these structures were built more than a century ago, before the enforcement of building codes, and their condition deteriorates with time due to the combined action of increased train loads, support movements, and environmental effects. Today, engineers are facing the challenge of maintaining these vital assets, while at the same time there is a limited capability to answer two important questions: (a) what is the current state, or performance, of the structure, and (b) how quickly is deterioration happening (Figure 1).

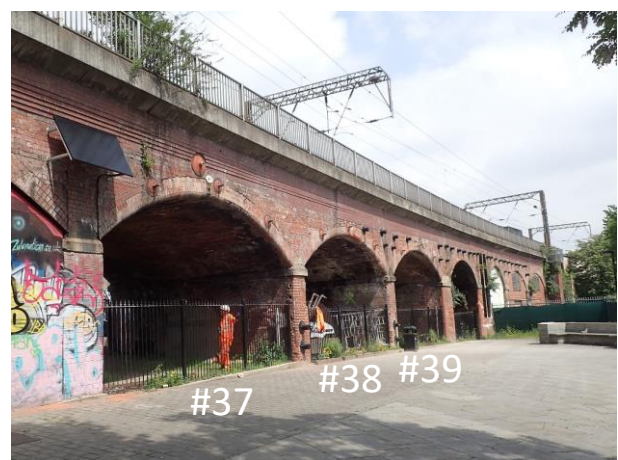
Figure 2. The southern side view of the Marsh Lane Viaduct in Leeds, UK

The Marsh Lane Viaduct is located next to the Eastern entrance of Leeds Railway Station, in the centre of the city. The bridge was constructed between 1865 and 1869 [6]. Today it carries two electrified tracks with a traffic load that exceeds 200 trains per day, ranging from typical passenger trains to multi-wagon freight trains. Figure 2 shows the southern side of the investigated section of the bridge, which comprises the Arches 37, 38 and 39.

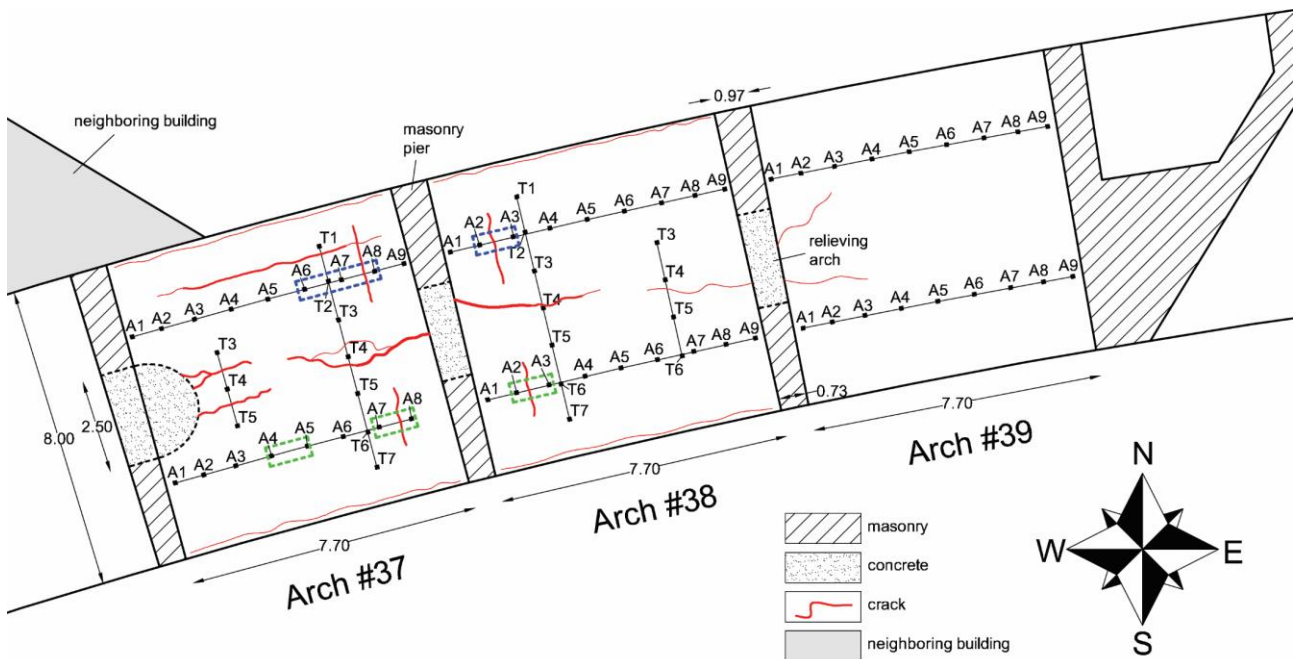
Figure 3. Plan view of the investigated section of the Marsh Lane Viaduct, showing the main damages observed under the arches (in red) and the installed fibre optic sensors network

Bridge dimensions and damages are discussed in detail in Acikgoz et al. [7]. Figure 3 shows the plan view of the bridge that summarizes the main damages in the arches. Arch 37 is the most damaged arch, followed by 38 and 39. The most severe damages are concentrated over the relieving arches at the centre of the piers due to a spreading mechanism that forces the relieving arch keystone to descend and the walls to bow outwards [7]. For this reason, Network Rail, the owner of the bridge, conducted in 2015 an extensive repair by filling in the relieving arches with concrete and installing steel ties to arrest transverse movements of the piers and the spandrel walls, as shown in Figure 4. This mechanism is observed in both piers between Arches 37-38 and Arches 38-39, although in the first case masonry degradation is more intense. Furthermore, over the 37/38 pier, there are symmetric transverse cracks in the arches at the level of the top of the backing, where the backfill level starts (see Figure 4). According to [7], these separation cracks are related to the out-of-plane rocking response mechanism of the pier. In addition, a longitudinal crack along the Arch 37 develops below the northern trail of the bridge.

The long-term monitoring system shown in Figure 3 comprises:

- 47 FBG strain sensors in the longitudinal direction, at the North and South sides of Arches 37, 38 and 39

- 17 FBG strain sensors in the transverse direction, at the East and West sides of Arches 37 and 38

- 4 FBG sensors attached to steel wires that connect the springings of Arch 37 and Arch 39, measuring relative horizontal displacement of the top of the piers

- 5 FBG sensors calibrated to measure temperature, distributed over different locations in the bridge.

For these 73 sensors, four custom designed arrays of FBGs were used. Each one of the four cable arrays has a Germanium doped single mode silica fibre with 20 FBG sensors distributed every one meter. The cables are fixed on the bricks using precision machined aluminium clamps, which appear as small squares in Figure 3. The clamps along the longitudinal direction are denoted with the letter A, numbered from West to East (A1-A9), and in the transverse direction with the letter T, numbered from North to South (T1-T7). The FBGs are located between the clamps, measuring relative strain between two fix points.

While the response is similar in most locations, the analysis reveals that there is a significant amplification of the dynamic deformation of the bridge at the sensor locations inside the boxes with dashed blue line, shown in Figures 3 and 7, between the first and the second installation, which are more than 16 months apart. In particular there is a 100% increase in 37NA6A7, and a 50% in 37NA7A8 and 38NA2A3. These sensors are located next to the most damaged pier between Arches 37 and 38, at the location of the transverse separation cracks. In addition, this significant increase happened in the locations that present the biggest anomaly; meaning that they deform much more compared to symmetric locations in the same or neighbouring arch.

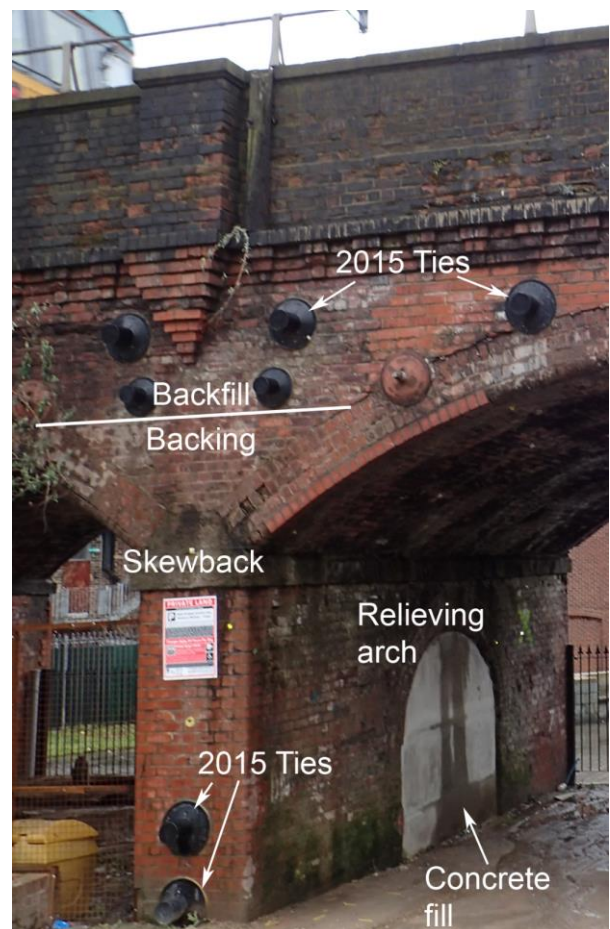
Figure 4. Northern view of the pier between Arches 38 and 39.

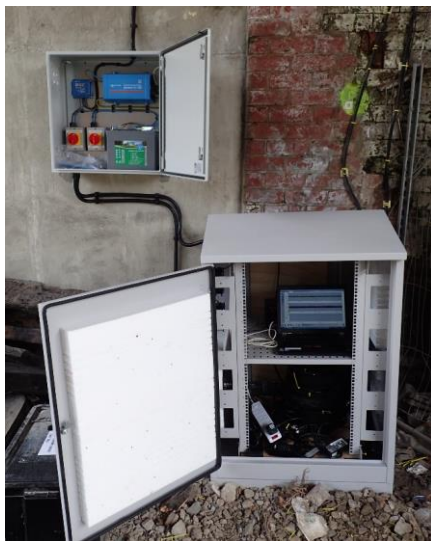
Figure 5. Current view of the data acquisition system

The 4-channel sm130 Optical Sensing Interrogator of Micron Optics, Inc. that is used in this study offers up to 1 kHz sampling rate per sensor and 2-3 micro-strain ($\varepsilon\mu$) resolution. The interrogator is continuously acquiring data, but is triggered to log only strains from train passage. The interrogator is permanently installed under Arch 37, inside the outdoor cabinet shown in Figure 5. The cabinet is equipped with 110 Watt heater and two fans controlled by thermostats, to protect the

equipment from humidity and extreme temperatures. The interrogator is connected to a laptop with a router, which transmits remotely daily data to the CSIC server at the Department of Engineering, University of Cambridge, through a 4G internet connection. The data are shared with the Alan Turing Institute through an SFTP (Secure File Transfer Protocol) connection between CSIC and Department of Mathematics, Imperial College servers.

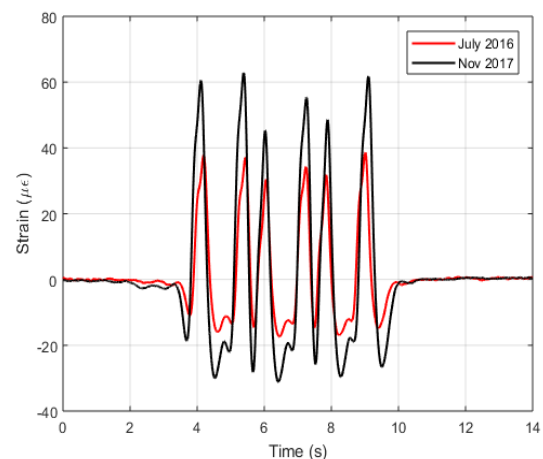
Figure 6. Change in the dynamic deformation of a damaged area of the bridge between July 2016 and November 2017

Figure 6 presents a typical dynamic response of the sensor “37NA6A7” under train loading, meaning the longitudinal sensor between clamps A6 and A7 at the North side of Arch 37 (see Figure 3). The signal corresponds to the most common passenger train type, the British Rail Class 185, with three carriages and typical bogie weight 33.4 tons. Positive values correspond to relative tensile strain, and negative to relative compressive strain. The Class 185 3-carriage train represents approximately 50% of the data. Another 20% corresponds to Class 155 with 2 carriages and typical bogie weight 19.2 tons. The rest 30% represents other passenger trains with four or more carriages (e.g. Classes 222, 144) or multi-wagon freight trains.

A code in MATLAB was developed to post-process the signals and automatically group the loading events based on train type and direction. This permits direct comparison of the dynamic response of the bridge at 68 locations for the exact same train loading over time. For instance, in Figure 6 the typical response of the 37NA6A7 sensor for the 3-carriage Class 185 train in July 2016 (red line) is compared with the response at the same location, same train, speed and direction in November 2017 (black line). Although the majority of the sensors presented identical signals, few locations, like the 37NA6A7, presented a significant amplification of the dynamic deformation.

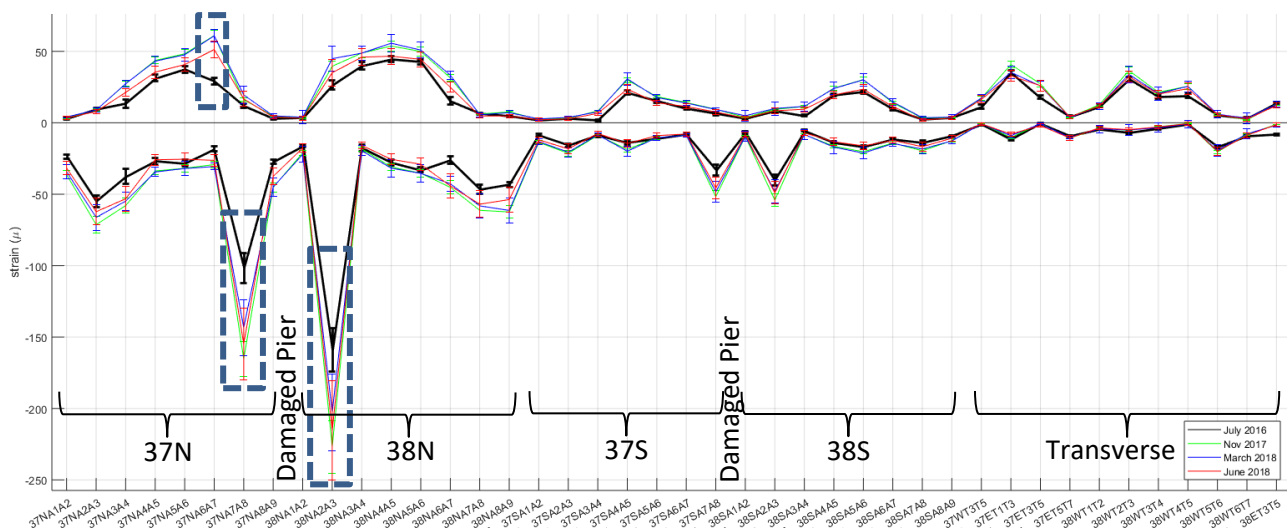
Figure 7. Mean value and standard deviation of the maximum and minimum peaks of FBG signals (see Figure 6) for 42 sensors underneath Arches 37 and 38, for the Class 185 3-carriage train that is heading East, exiting Leeds Station

Figure 7 presents mean value and standard deviation of the maximum (positive/tensile) and minimum (negative/compressive) relative strains for 42 sensor locations that the 2016 and 2017-18 deployments had in common. The statistical analysis is performed for the Class 185 3-carriage train, heading East, which is the reason why 37N and 38N longitudinal sensors under the North trail recorded bigger strains compared to 37S and 38S longitudinal sensors under the South trail. The bold black line represents the dynamic deformation of the bridge in July 2016, whereas the green, blue and red lines corresponds to November 2017, March and June 2018.

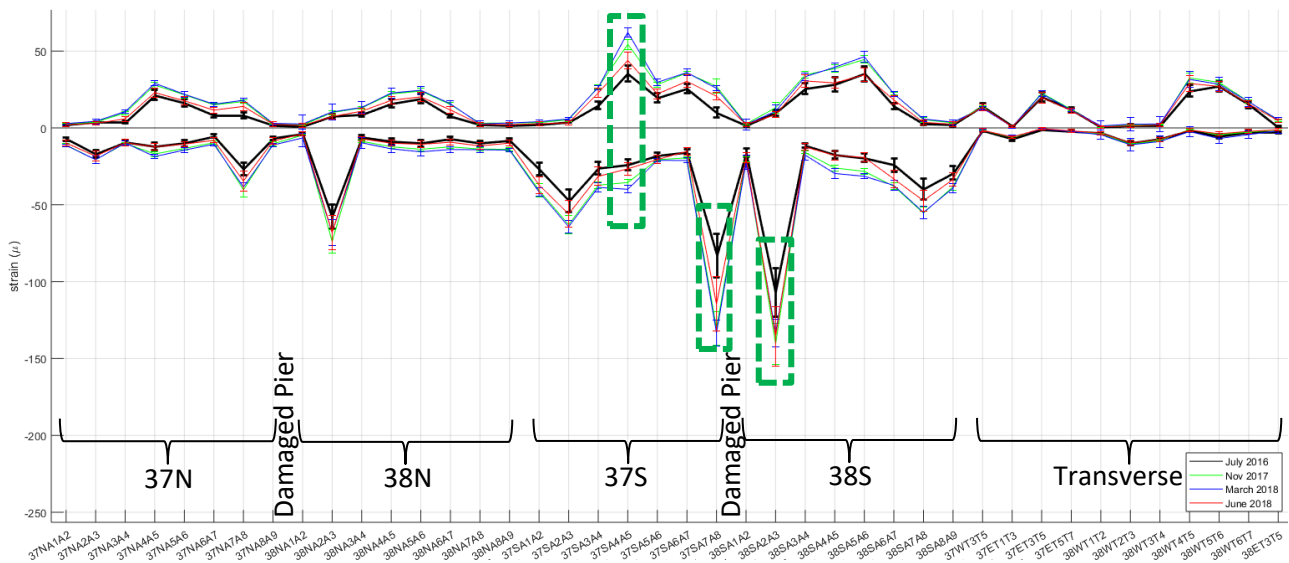
Figure 8. Mean value and standard deviation of the maximum and minimum peaks of FBG signals (see Figure 6) for 42 sensors underneath Arches 37 and 38, for the Class 185 3-carriage train that is heading West, entering Leeds Station.

Figure 8 presents the same results for the Class 185 train, this time heading West, which explains why the south longitudinal sensors, 37S and 38S recorded bigger strains compared to the north longitudinal sensors, 37N and 38N. Again, similar anomalies are observed for the sensors 37SA7A8 and 38SA2A3 next to the damaged pier shown inside the green dashed boxes in Figures 3 and 8. At these locations, the increase of the dynamic deformation is again 50%. Furthermore, both the tensile and compressive relative strain in the south keystone sensor 37SA4A5 at the most damaged arch (Arch 37) appears significantly increased.

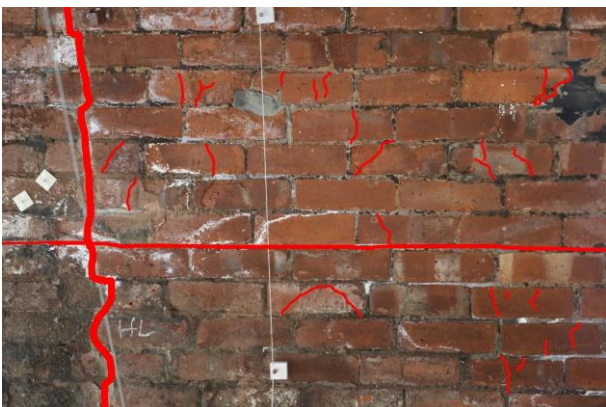
Figure 9. Cracks observed near sensor 37NA7A8

These results are matching with the formation of new micro-cracking in bricks, as shown in Figure 9. Although micro-cracking in bricks is observed in various locations in the bridge, the intensity is much larger near the sensors that presented the biggest increase of the compressive relative strain, such as the sensor 37NA7A8 presented in Figure 9.
