Exposure of tourism development to salt karst hazards along the Jordanian Dead Sea shore

Najib Abou Karaki^{1,a}, Simone Fiaschi², Killian Paenen³, Mohammad Al-Awabdeh⁴, and Damien Closson⁵

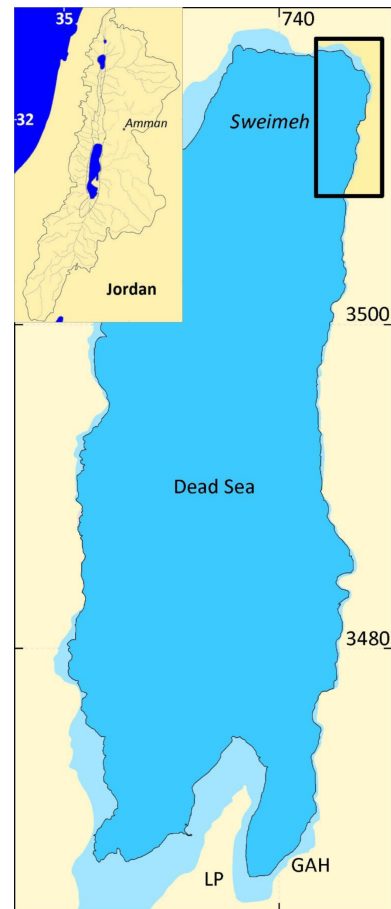
Figure 1. Inset: the Dead Sea watershed (coordinates in degrees). Main map: location and extent of the Dead Sea. The study area (Sweimeh) is located in the north-east (black box). The extent of the lake in the 1960s appears in light blue colour. The black line indicates the shoreline in 2018. In the south are located two main sinkhole sites: the Lisan Peninsula (LP) and Ghor Al-Haditha (GAH) (coordinates in UTM 36 (km), WGS 84).

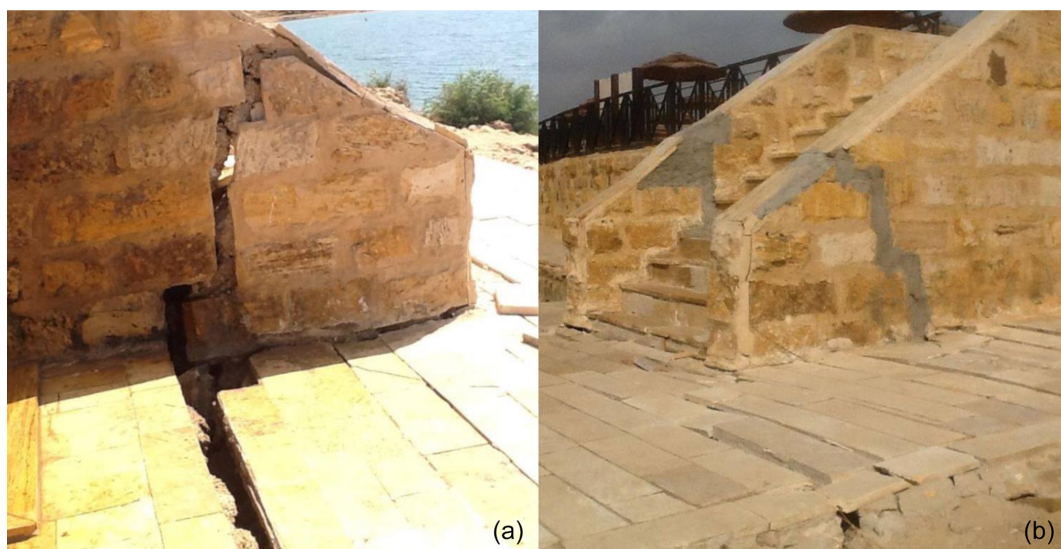
Figure 8. Examples of damage (a) and of quick repair (b) that are common at the beachfront of the hotels along the DS coastline.

During the last decade, regular field inspections were carried out approximately biannually to follow and monitor the deteriorations of the DS shore in Sweimeh. All areas show surface deformations reflecting the ongoing subsurface dissolution processes. Cracks occur very frequently on land, on walls, in swimming pools and in other man-made structures (Fig. 8). No effort was generally made by investors to investigate the causes of the damage or define a reasonable strategy to deal with the quite visible deteriorations. Instead, these were “repaired” hastily, inefficiently and superficially on a nearly daily basis. Land cracks are still being systematically filled with sand, while cracks affecting structures are being filled with concrete. Most of these cracks are likely

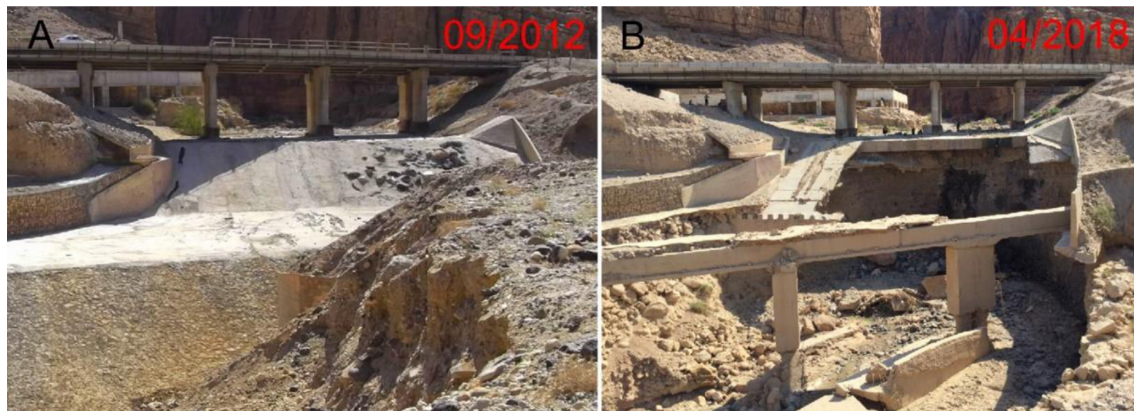
Figure 10. Example of a bridge along the Dead Sea motorway damaged by progressive erosion of the sediments. All bridges along the Dead Sea coast are affected by the rapid incision of the river bed.

There are several major bridges on the DS highway, all suffering the effects of the DS water level decline, especially vertical erosion processes. In October 2017, one of these bridges located 3 km south of parcel E, was heavily damaged and lost one of its supporting pillars. Another bridge that suffered significant damage as a consequence of vertical soil erosion is the Zara–Ma’in Bridge, situated just a few kilometres south of the study area. Figure 10 shows the extent of the evolution of the damage affecting the western side of

the Zara–Ma’in Bridge on the highway between 2012 (renovated bridge) and 2018. Most of the other bridges on the eastern DS highway also show advanced signs of deteriorations.
