## INVESTIGATION OF EXPLOSION SAFETY OF DC POLYMER SURGE ARRESTERS 3.3 KV FOR TRACTION NETWORK OF RAILWAY TRANSPORT

**The goal of the work** is the determination of the explosion safety of SAp-3.3 kV samples with a polymer case on the equipment of an operating DC traction substation under conditions as close as possible to operation.

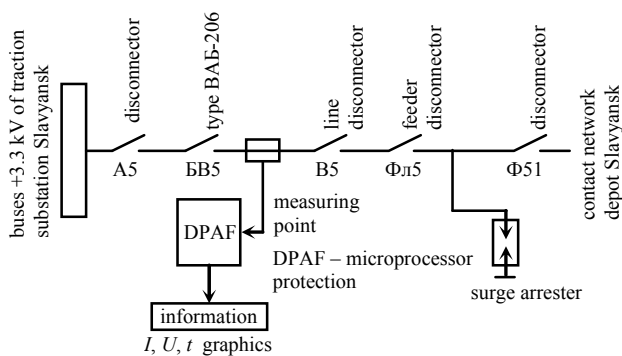
**A technique of testing for explosion safety.** Tests for explosion safety of surge suppressors were carried out on the basis of the Slavyansk traction substation according to the program agreed with the JSC «Ukrainian Railways». The electrical circuit of tests is shown in Fig. 2.

Fig. 2. Electrical circuit of testing sections of the SAP on the traction substation of Slavyansk city

The sample of the surge arrester was mounted on one of the metal poles at height of 5.5 m located on the territory of the substation and connected to the traction substation buses of 3.3 kV via disconnectors A5, B5, ФЛ5 and high-speed circuit breaker BAB-206 (Fig. 3).

The test circuit was separated from the contact network by a Ф51 disconnector. After the BAB-206 circuit breaker was closed, a short circuit current flowed through a column with a experienced preliminary breakdown or shunted by a copper wire varistor with the formation of an electric arc inside the SAP section.
