Management of erosion of inflatable penile prosthesis reservoir into bladder. A different approach

Summary We report a rare case of erosion of an inflatable penile prosthesis reservoir into the bladder that was managed with a different approach from the literature by preserving the existing reservoir. Inflatable penile implant was applied to a 54-year-old male patient who had undergone with a robot-assisted radical prostatectomy operation due to localized prostate cancer 2 years before. Two months after the operation, the patient referred to our clinic with predominant symptoms of lower urinary tract system associated with scrotal pain and swelling. The urinary system ultrasonography (USG) and the lower abdomen magnetic resonance imaging (MRI) demonstrated that the reservoir of the penile prosthesis was in the bladder. Cystoscopy confirmed that the reservoir was surgically removed from bladder. After bladder repair, the rectus muscles were repaired creating a space between the rectus muscle and the skin, where the reservoir was placed. After postoperative observation, the patient was discharged without any infection and regression of the lower urinary tract symptoms. No problem wa

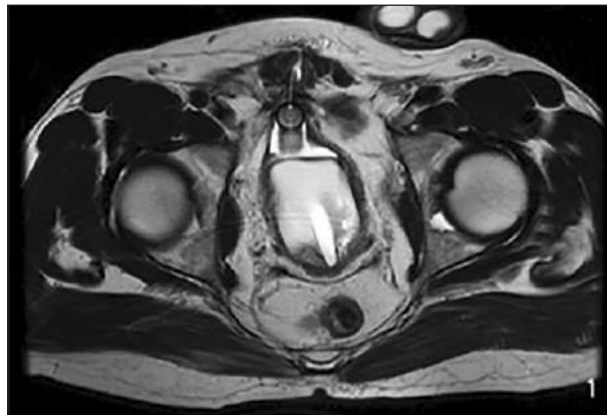
Figure 1.
MR scan showing erosion of the reservoir into bladder.

A 54-year-old male patient underwent a robot-assisted radical prostatectomy operation due to localized prostate cancer two years before our observation. Because of erectile dysfunction after operation, the patient received sildenafil therapy without benefit from the treatment, so inflatable penile implant was placed in another center. Two months after the operation, the patient referred to our clinic with predominant symptoms of lower urinary tract system associated with scrotal pain and swelling. On physical examination, the right testicle was normal at palpation with minimal hydrocele and penile prosthesis was detected. Left testicle was normal and minimal hydrocele was observed. Scrotal ultrasonography reported a bilateral complicated chronic hydrocele. Laboratory findings showed at urinalysis the presence of 1605 leukocytes, with positive leukocyte esterase (++) and nitrite (+); blood count showed WBC 6900/mm³; serum procalcitonin level was 0.09 n/ml and erythrocytes sedimentation rate (ESR) 59 mm/h; urine culture was negative. Meropenem 500 mg ter in die treatment was started after consultation with *Infectious Diseases and Clinical Microbiology* clinic. In addition to antibiotic therapy, diclofenac sodium, scrotal elevation and cold application were also provided. Despite the treatment, due to the persistence of the patient's complaints, urinary system ultrasonography (USG) and lower abdomen magnetic resonance imaging (MRI) were performed and it was demonstrated that the reservoir of the penile prosthesis was in the bladder (Figure 1). Cystoscopy confirmed the presence of the reservoir in the bladder.

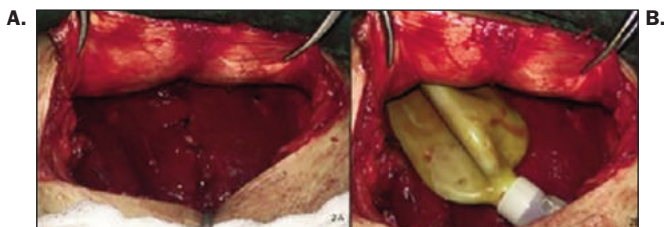
Figure 2.
A. Space was created between the rectus muscle and the skin.
B: The reservoir was placed in the space formed.

A Pfannenstiel incision was made to expose the bladder and perivesical space and the bladder anterior wall was released, to reach where the reservoir entered in the bladder. The bladder wall was opened to remove the reservoir and after that bladder repair was performed. After bladder repair, the rectus muscles were repaired and a space was created between the rectus muscle and the skin (Figure 2A). The reservoir was kept in saline

with diluted 180 mg of gentamicin for 10 minutes. Then the reservoir was placed in the space formed (Figures 2B-3). After the operation, the patient was treated with vancomycin and meropenem for 2 weeks. After postoperative observation, the patient was discharged without any infection and regression of symptoms of lower urinary tract. No problem in using the penile prosthesis was reported by the patient at 1-month and 3-month follow up. The patient was not uncomfortable in this regard because the patient's reservoir was not visible under the skin and *computed tomography* (CT) at 3 months did not show any infection status or abscess around the reservoir (Figure 4).

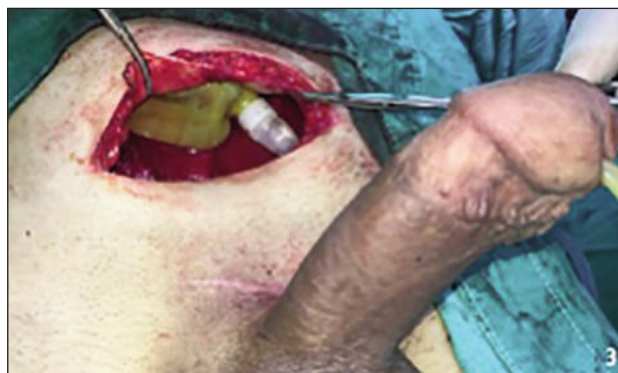
Figure 3.
The reservoir was placed in the space formed and semirigid penile erection was obtained.

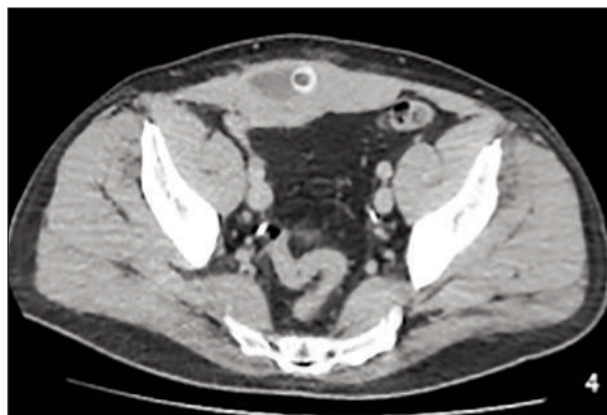
Figure 4.
CT scan at 3 months after operation showing the reservoir in the area formed without problem.
