The failure of the floating cover of a vertical cylindrical tank

Abstract. The location of oil tanks for the storage of volatile hydrocarbons could be done in geographical areas where the standard unit weight of the snow layer on the horizontal surface of the land reached 1500 ... 2000 N / m². The snow layer deposited on the floating cover under heavy weather conditions can cause a compressive force between 4500 and 6000 N / m². This creates problems in the operation of the tank and consequently the constructive structure of the floating cover can not bear this unitary load from the snow load, inevitably causing the damage. The capacities of the floating cover should be considered not only in terms of limitations on load-bearing considerations in general, but also in terms of the distribution of loads on the surface of the floating cover. The paper presents the aspect of the failure of a floating cover of a vertical cylindrical tank used to store liquid hydrocarbons under heavy climatic conditions.

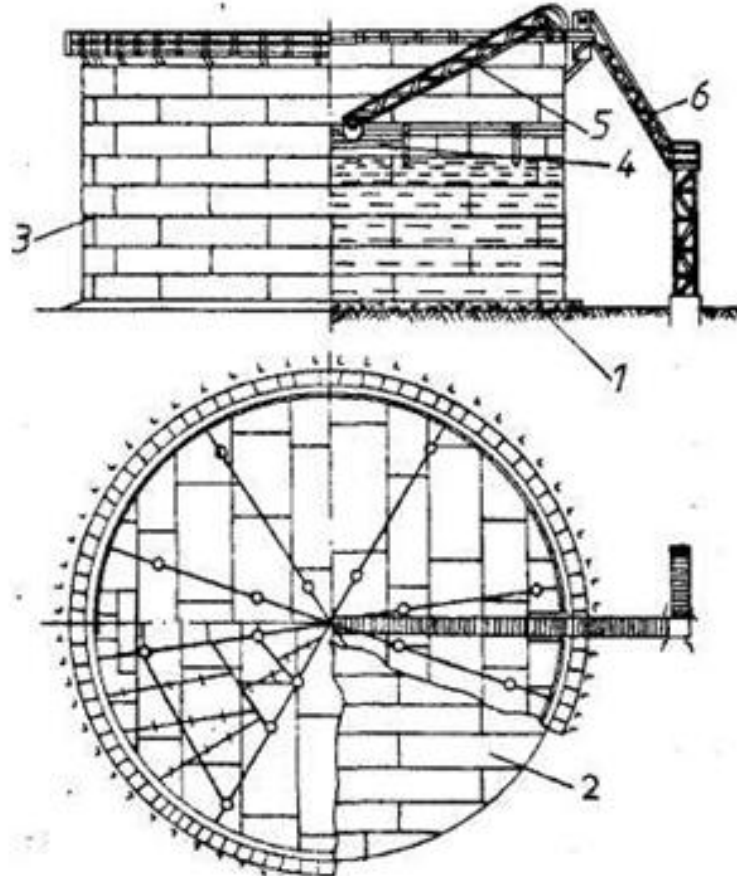
Figure 1. Overview of the vertical cylindrical tank with floating cover-funding the tank; 2- the bottom of the tank; 3-shell of the tank; 4 floating cover; 5-sliding access staircase; 6-outer access staircase.

Figure 1 shows the components of a vertical cylindrical tank with a floating lid.

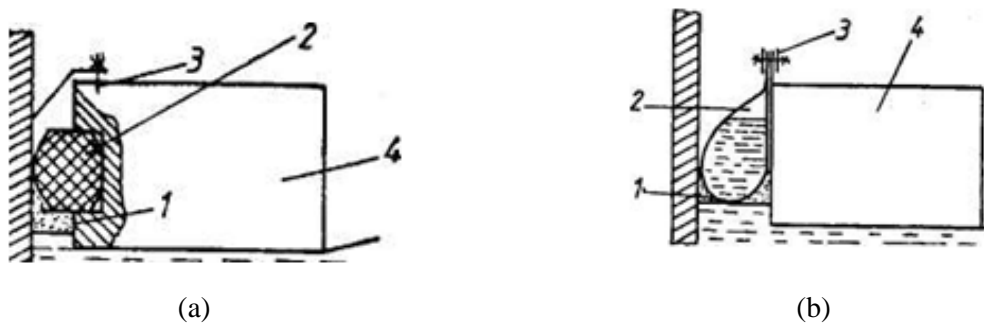
Figure 2. Sealing with ring seal and toroidal gasket
(a)-seal with-ring seal; (b)-with toroidal gasket filled with air or water

sealing systems with ring seal are used as shown in Figure 2(a) or with toroidal gasket filled with air or water, as seen in Figure 2(b).

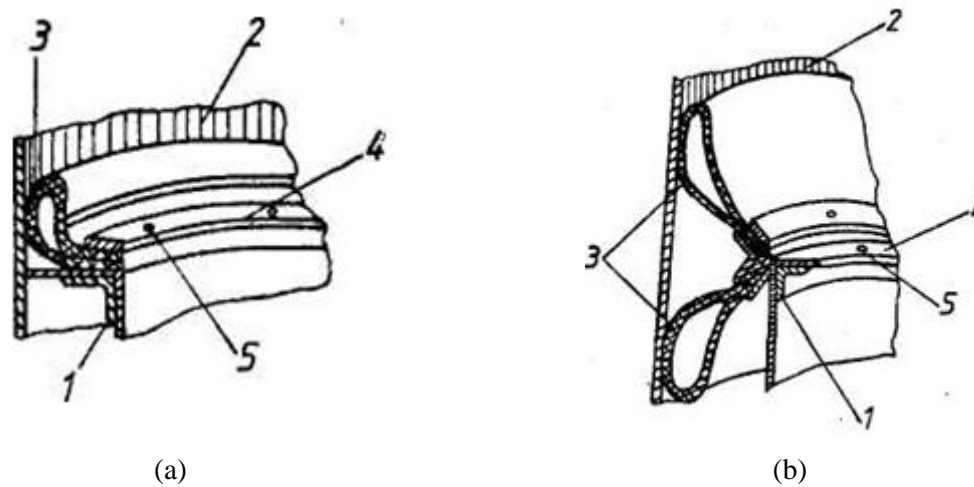
Figure 3. Sealing system with loop seal
(a)-with a simple loop; (b)-double loop

Sealing systems with loop-shaped gaskets can also be adopted for better sealing. These can provide the simple loop seal as shown in Figure 3(a) and the double loop as shown in Figure 3(b).

The simple loop seal is shown in Figure 3(a) and the double loop is shown in Figure 3(b).

The sealing system with the deburring gasket is more efficient.

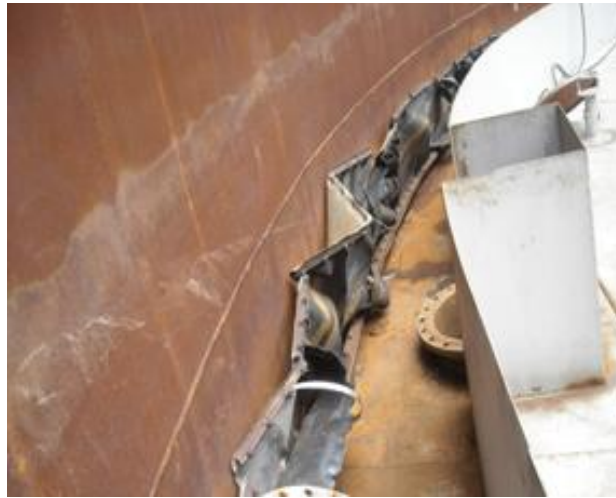
Figure 4. Failure of the sealing system

The natural fall of precipitation (snow) and wind direction favored the accumulation of a large amount of snow over that considered in the design calculation, with uneven settlement on the surface of the floating cover. This has been felt, as seen in Figures 4 and 5, in the degradation of the float cover displacement, has led to the tilting float cap tilting about an almost diametrical axis, reaching the shell, having an arrow of approximately 200 mm shifted by the broken prop.

The sealing system of the floating cover deteriorated approximately 50%, the rubber membrane broke and the gripping accessories deteriorated.

The failure of the sealing system can be seen in Figure 4.

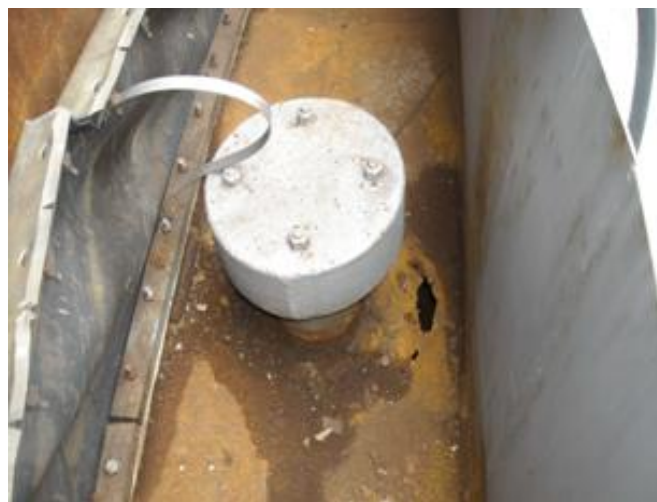
Figure 5. Failure of the ponton

The failure of the ponton can be seen in Figure 5.

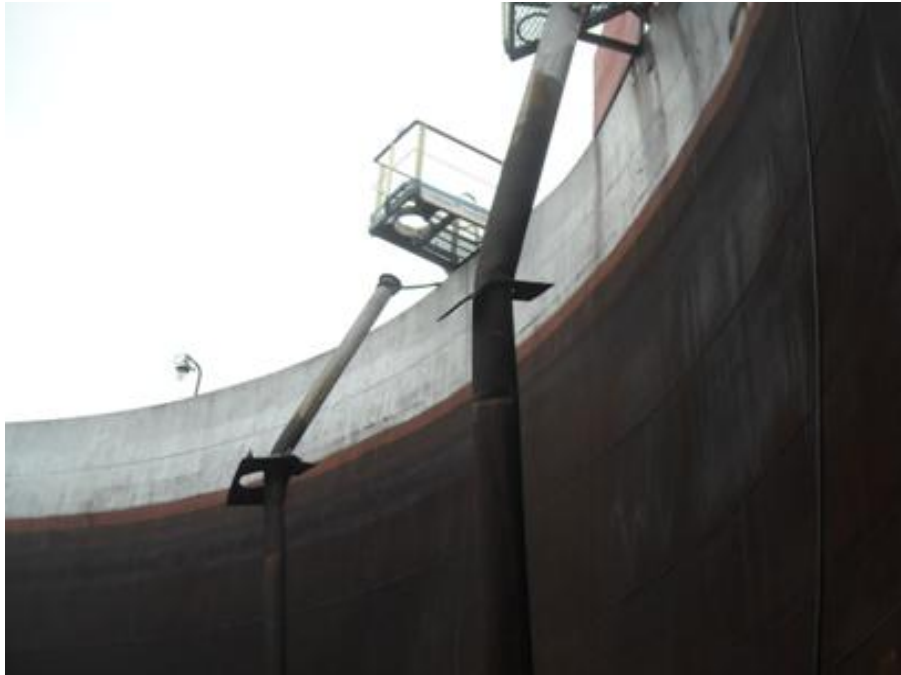
Figure 6. Failure of anti-rotation devices DN 200 and DN 300

The anti-rotation DN300 and DN200 anti-drift devices have been deformed as seen in Figure 6.

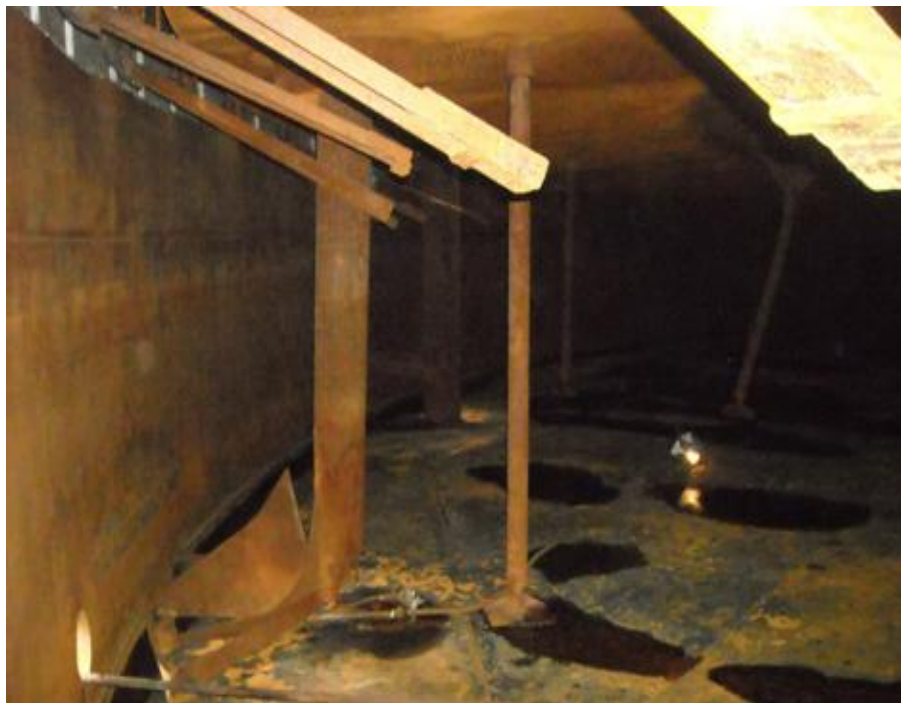
Figure 7. Failure of the bottom plate of anti-rotation devices

The guide plate has been detached from the pontoons, the inner clamping welded yoke on the tank has been damaged and the bottom plate of the device antirotative was damaged, as seen in Figure 7.

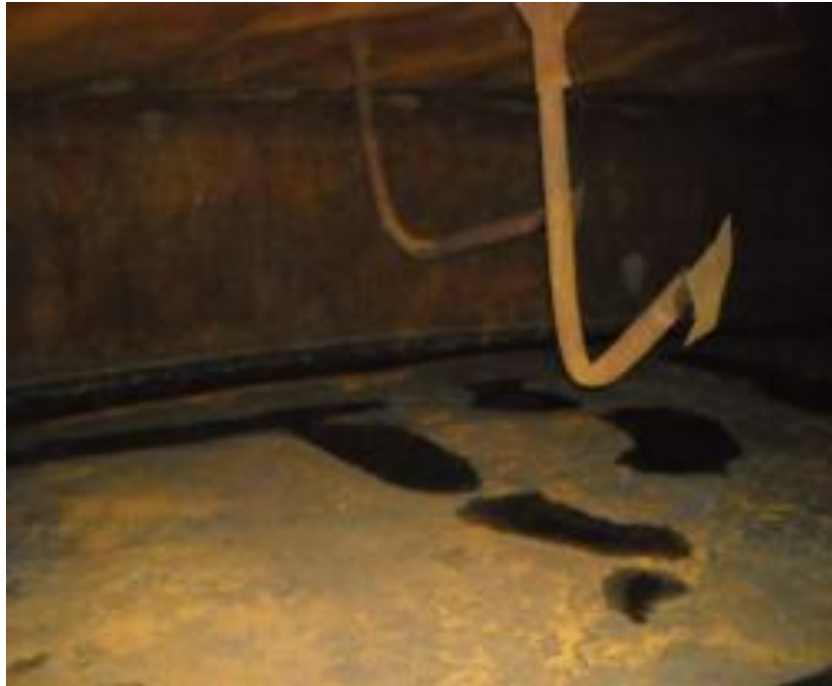
Figure 8. Failure of the floating cover pillar damaged inside

The support caps of the floating cover have been deformed, the pontoons and the membrane having the removed buffers, as can be seen in Figures 8 and 9.

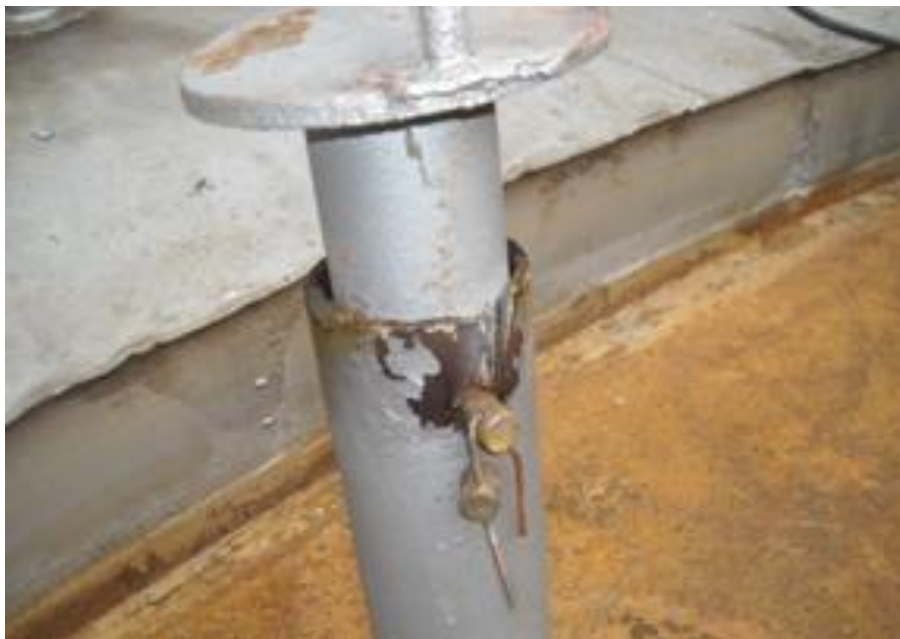
Figure 9. Failure of the floating cover pillar damaged on the outside

The failure of the floating cover pillar damaged on the outside can be seen in Figure 9.

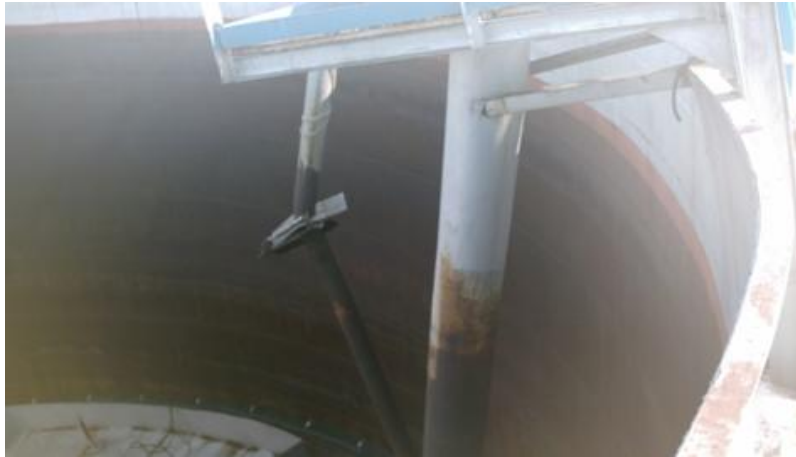
Figure 10. Deformation of the cover in the anti-rotation area

The cloak of the last and penultimate violin was deformed to the inside about 200 mm in length about 4 m in the area of the antirotative device, as can be seen in Figure 10.

The deformation of the cover in the area of the anti-rotation device is shown also in Figure 10.

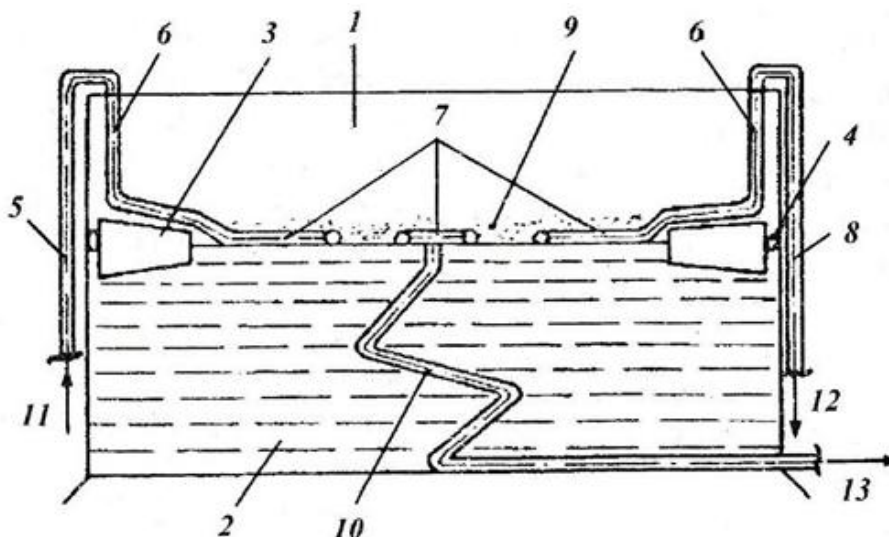
Figure 11. The principal scheme of a technological water removal system resulted from the defrosting of snow

Figure 11 illustrates [4] and schematised in principle a technological water removal system resulting from the defrosting of snow on the CP. The water is evacuated through the hose 10 to the sewer 13 and the heating agent (steam) has a course 5 → 6 → 7 → 8 → 12.

1-RCV-CP; Stored 2-benzene; 3-floating cover (with peripheral pontoon); 4-peripheral and sealing device; 5-metallic pipe for the introduction of steam into the coil of the CP; 6-hose reinforced; 7-tube heating coil on CP; 8-metallic duct for condensate drainage; 9 snow; 10-articulated drainage pipe; 11, 12-steam input and condensate outlet; 13 - sewage water

- It completely eliminates the manual actions of defrosting the CP;
- Snow removal and ice is certain in any position in RCV-CP;
- The feasibility of technological processing of gasoline storage in HPV-CP under winter conditions is considerably improved;
- The articulated pipe for the removal of water from the snow melting on the CP is permanently and completely stored in gasoline which a priori does not exclude gasoline leaks through the joints and other own components reaching the sewer (environmental pollution risk).
