Simulation and modelling of microclimate in a building with high thermal mass during the winter season

Abstract. This paper presents the simulation method for evaluating the heating system from a church. The inside climate has been evaluated by measures of temperature and humidity taken in the winter season. The aim of the paper is to model and validate the indoor climate measures through numerical analysis and to evaluate the heating system performance. The paper includes a case study over a representative category of buildings, used as a worship place that can contain heritage values. Nowadays, to conserve the historical heritage is a fact studied in many countries of Europe.

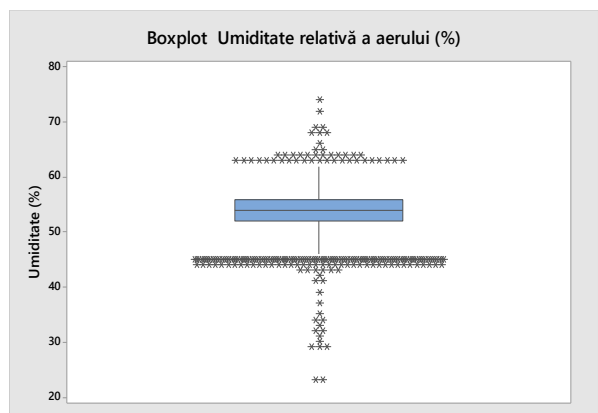
Fig. 11. Relative humidity of air boxplot in St. Sava Church.

Also, it can be seen a good variation of humidity without peak loads in a quick time. The mean value of humidity is around $54,17\% rH$ with a standard deviation of $3,407$ (Fig. 11, Fig.12).

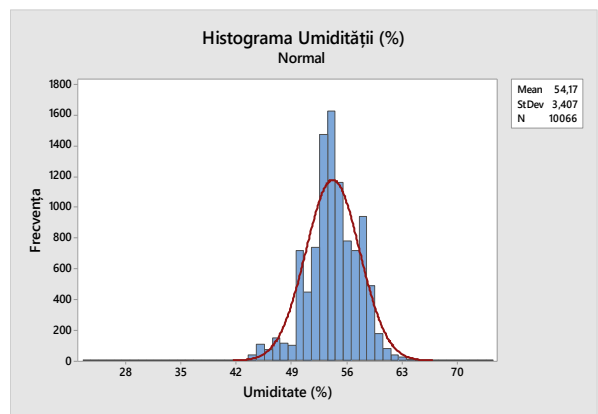
Fig. 12. Relative humidity of air histogram in St. Sava Church.

The minim value of relative humidity measured is 42 % and the maxim is 63 % rH (Fig. 12).

From the figure 12 and 14 it can be observed that the level of comfort is high with a height degree of satisfaction, approximately of 90 %, this showing that the heating system is succeeding to maintain a comfortable environment for the churchgoers.

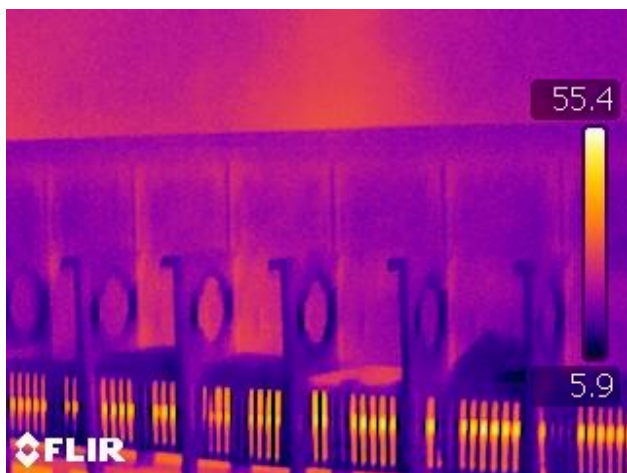
Fig. 15. Convection current caused by static heaters in St. Sava Church.

With the help of thermography it was able to evaluate and to see the convection currents created by the static heaters placed on the exterior walls under the windows (Fig. 15). Also it could be analysed the thermal bridges for the exterior walls and heat loss thought the windows (Fig. 16).

Thermo-vision analysis show that the static heaters that operate as natural convectors make the air at the bottom to heat and to rise because of buoyancy to the

top. This system cause the deterioration due to suspended particle deposit. Also cause blackening above the heated areas and on cold surface, especially the ceiling, frescos and paintings in general, organs stuccoes, tapestry.
