# Numerical analysis of the thermal comfort in a church building

**Abstract.** Based on the monitoring campaigns, we have evaluated the indoor microclimate in a church. Most church buildings are characterised by low thermal comfort due primarily to their architecture, heating huge volume of air. The CFD tools was used for thermal comfort evaluation in case of the existing heating system during the winter season. The simulation model was validated with experimental data and it was used for thermal and air velocity profiles in the occupancy zone of churchgoers. The aim of the paper is the study the feasibility of maintaining the heritage values of the churches while achieving the significant improvement of the thermal comfort.

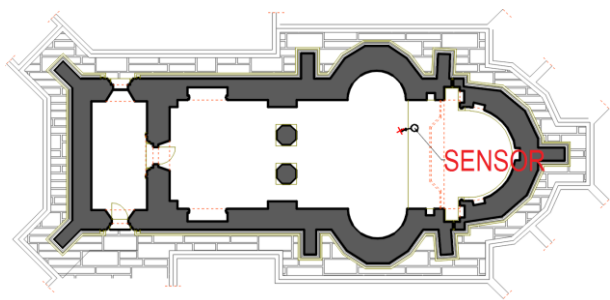
The interior of the church is divided into the main part of an orthodox church as follows: a closed porch, narthex, nave and sanctuary (Fig. 2).

**Fig. 2.** Plan view at ±0.00 m of Cetățuia Monastery.

For evaluating the microclimate in the church of Cetățuia Monastery there have been utilized equipment as thermal imaging camera from Flir, USB Data Logger DS 100 for temperature ( $T - ^{\circ}C$ ) and relative humidity (rH - %). The sensor have been placed at the top of Mother of God icon, in a determinant and important position seen in figure 9, figure 4 and as is drawn in architectural plan from figure 2, 3.

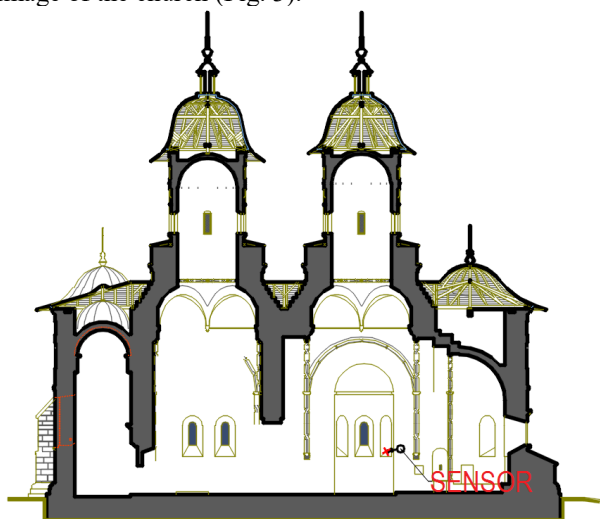
Also the church surprise the eye through the windows made in gothic style, having 0.5 m in width and 1.5 in height with the wall dimension of 1.35 m, made from brick and limestones. In plane, the church has the width of 9,80 m, the length of 30 m, the height to the ceiling of 10,60 m and the total height in the towers of 21,70 m. The fact the church is built in triconch plan together with the two orthogonal towers gives a unique image of the church (Fig. 3).

**Fig. 3.** Plan view at ±0.00 m of Cetățuia Monastery.

The existing heating system is composed from static heaters (Fig.5) placed in the pews (Fig. 3). The main purpose of this research being is to evaluate the microclimate created in the church and also the heritage conservation condition. There has been done an analysis in CFD environment to evaluate the physical

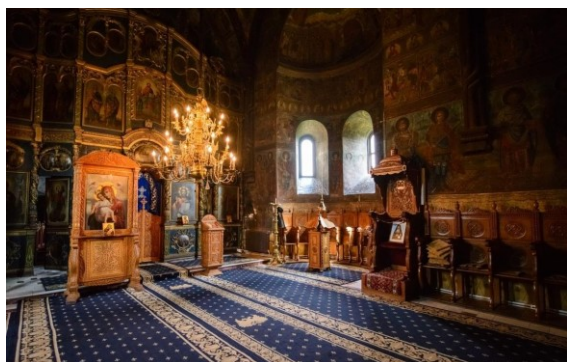
**Fig. 4.** Old iconostasis and pew in Cetățuia Monastery.

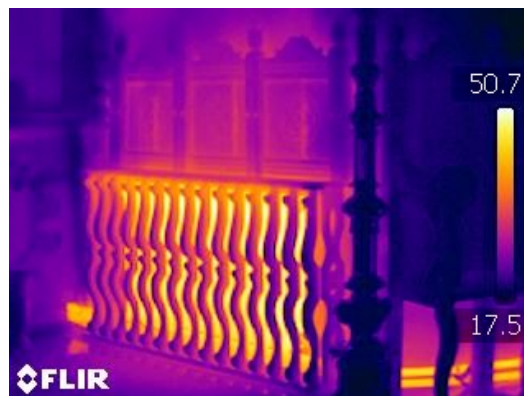
Static heaters operate as natural convectors, air enters at the bottom of the static heaters and rises due to buoyancy at the top (Fig.6).

Hot water heating systems generate gentle air motions that are sufficient to blackening walls, especially above the support brackets. Above the brackets the uprising warm air becomes turbulent increasing the blackening rate (Fig. 6). The main deposit mechanism is the inertial impaction, which acts in synergism with thermophoresis and Brownian motions. So that the static heaters should be positioned below frescos to avoid damage for T-rH cycles and blackening. (Fig. 7) [4]

**Fig. 6.** Static heaters placed in pew from Cetățuia Monastery view with thermal imaging camera.

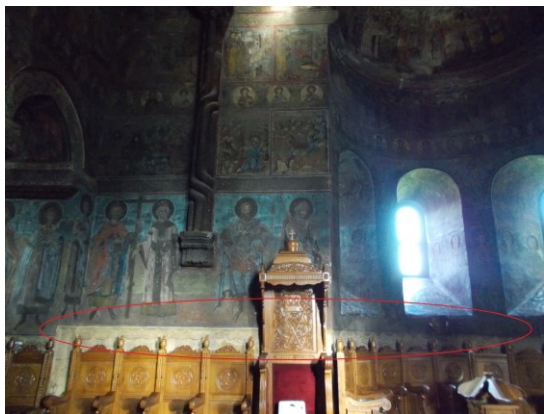
**Fig. 7.** Blackening due to static heaters placed in pew from Cetățuia Monastery.

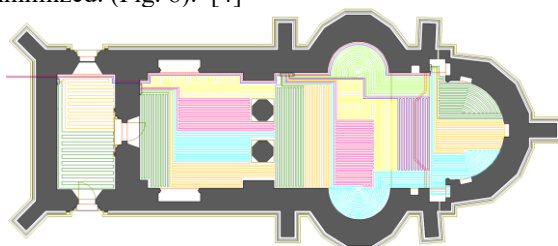
To improve to thermal comfort condition and to reduce the damage to the artwork in the church is proposed to use a complementary heating system. By choosing an underfloor heating system the thermo-convective fluid temperature is reduced in the static heaters placed in the pews and so the air movement that cause blackening and damage to the frescos on the wall is gradually minimized. (Fig. 8). [4]

**Fig. 8.** The proposed underfloor heating system to be placed in Cetățuia Monastery.

As is known, underfloor heating system uses pipes embedded in the flooring. The pipes carry hot water ( $T_{supply} = 40^{\circ}C$ ,  $T_{return} = 20^{\circ}C$ ) that can be provided by any source. Instead of hot water pipes, electrically heated cables or mats can be used. The floor is gradually heated and provides a comfortable feeling of radiating warmth from below. About one is required to reach equilibrium. A makeshift, less invasive solution is to install a footboard with embedded water pipes or electrical heating cables on the floor, as a basement for pews. This solutions leaves the floor untouched, but less efficient. [5]

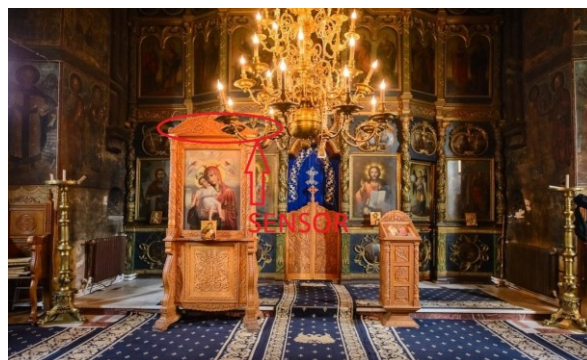
**Fig. 9.** Senzor placement in Cetățuia Monastery.

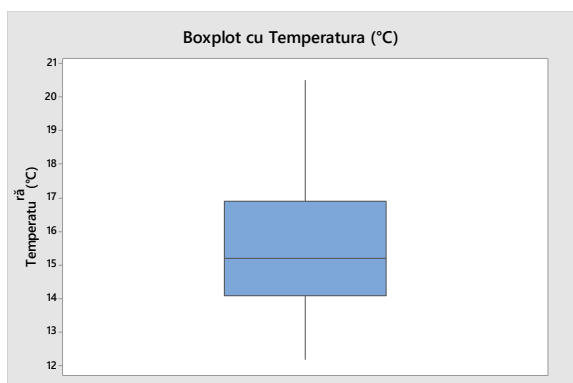
The microclimate from Cetățuia Monastery church shows (fig. 11,12) that the temperature are in a large scale between 12-20 °C, with a mean value of temperature around 15,45 °C, with a standard deviation of 1,575, given by the histogram plot in figure 11, 12.

**Fig. 11.** Temperature boxplot in Cetățuia Monastery Church.

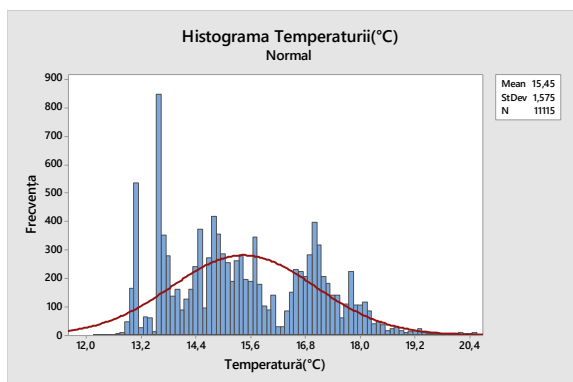
**Fig. 12.** Temperature histogram in Cetățuia Monastery Church.

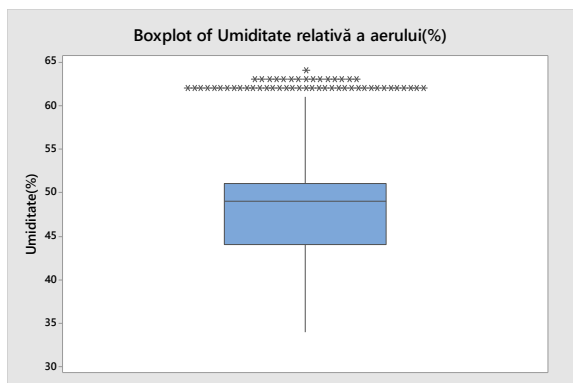
Also it can be seen a variation of humidity with peak loads in a quick time. The mean value of humidity is around 48,20 % rH in a scale between minimum of 35% and maximum of 64%, with a standard deviation of 4,745 (Fig. 13, Fig.14).

**Fig. 13.** Relative humidity of air boxplot in St. Sava Church.

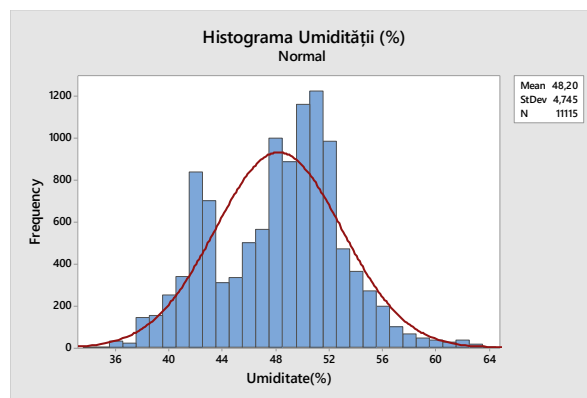
**Fig. 14.** Relative Humidity of air histogram in St. Sava Church.

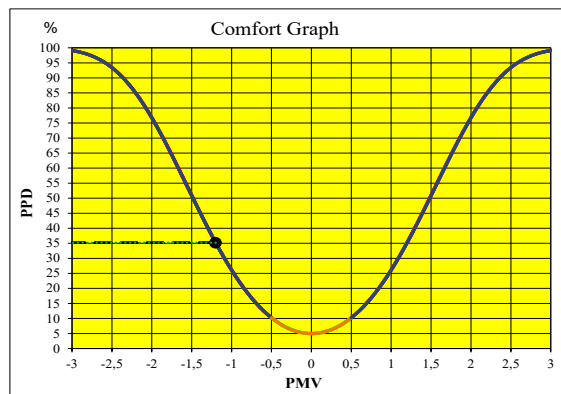
**Fig. 16.** Comfort graph of PMV and PPD index in Cetățuia Monastery Church.

From the Figure 15 and 16 it can be observed that the level of comfort is medium to high with a degree of satisfaction, approximately of 65 %, this showing that the heating system is assuring a comfortable environment for the churchgoers.

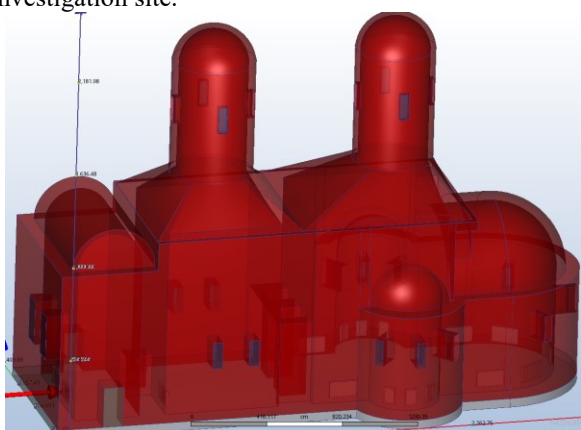
Within the research, the CFD package of Autodesk CFD, version 2019 was used. Software used is Autodesk 2019 – capable of solving heat, air and water vapour simulation, the analysis was run in steady state. The 3d model was made in Autodesk Inventor 2019 (Fig. 17), in order to have a model at real scale closed to the investigation site.

**Fig. 17.** Cetățuia Monastery Church 3d modelling.

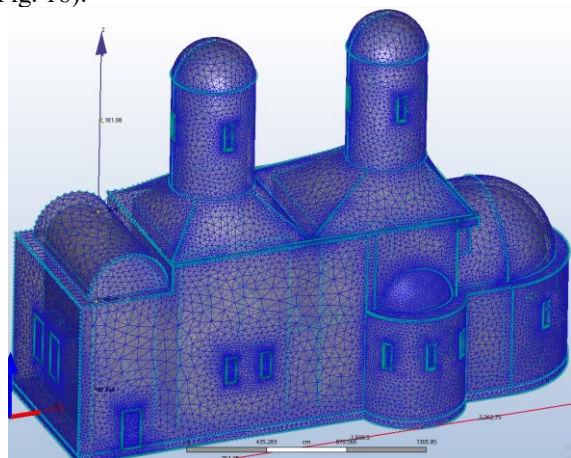
The model was build using Cartesian coordinates, in which a non-structural grid was applied. The idea behind the non-structural grid was to properly model the indoor climate. Within the CFD model, the equation for Flow, Turbulence, and Energy were solved. The discretization schemes for these equations are: Standard, Simple and the First Order scheme for Momentum, Turbulence Kinetic Energy, Turbulence Dissipation rate and Energy (Fig. 18).

**Fig. 18.** Mesh discretization of the Cetățuia Monastery Church at 8.6 M elements.

For the next three simulation we increased the refinement resulting a number of 8.6 M elements (Fig. 18).

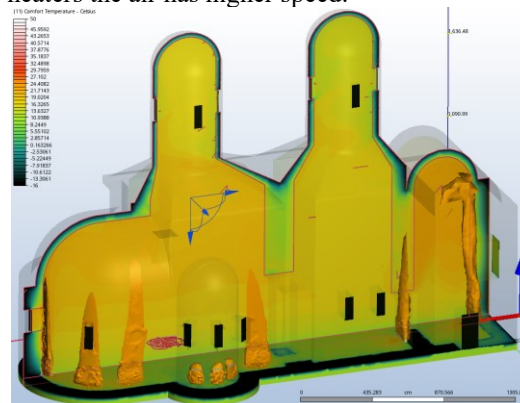
In Fig. 19 it can be seen that the temperature have a stratifying distribution and that in the influence zone of the heaters the air has higher speed.

**Fig. 19.** Temperature in the section plans of Cetățuia Monastery Church.

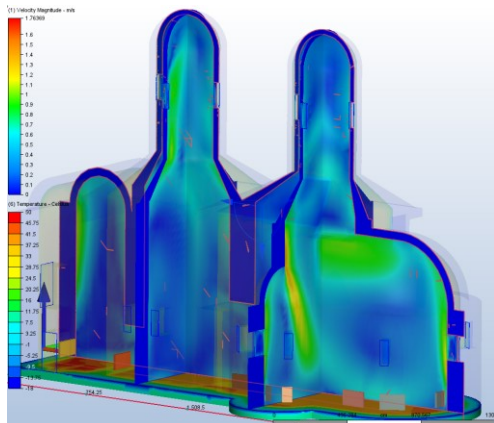
From the Fig. 20, in the cross section plans of the church it can be seen that the air velocity has higher speed, mainly due to the underfloor heating system compare with the cross section from figure 21, where the heating system is only with static heaters that creates air current in the influence zone, especially on the support wall.

**Fig. 20.** Air speed velocity in the section plans taken in Cetățuia Monastery Church due to underfloor heating system.

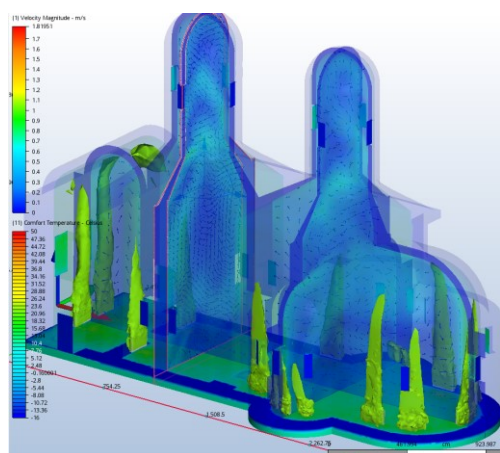
**Fig. 21.** Air speed velocity in the section plans taken in Cetățuia Monastery Church due to static heaters.

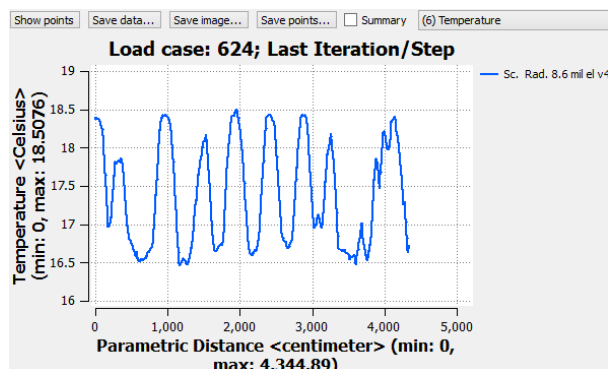
The variation of the temperature is represented in Fig. 22, with a mean temperature of approximately 17.5 °C, which is appropriate to the temperature from the underfloor heating system Fig. 23 of 17.80°C.

**Fig. 22.** Temperature graph in Cetățuia Monastery Church generated by static heaters.

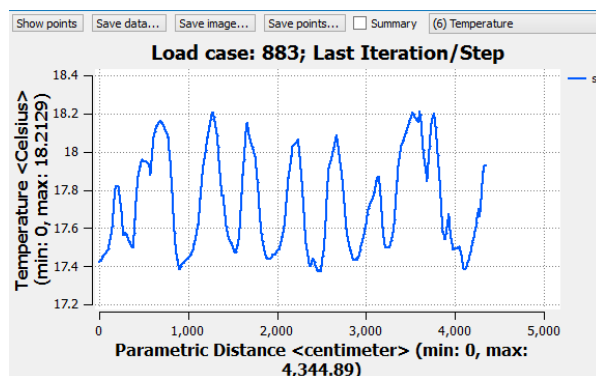
**Fig. 23.** Temperature graph in Cetățuia Monastery Church generated by underfloor heating system.
