STUDY ON A NEW DESIGN OF GROUTING PUMP FOR MANAGING WATER INRUSH IN KARST TUNNELS

ABSTRACT

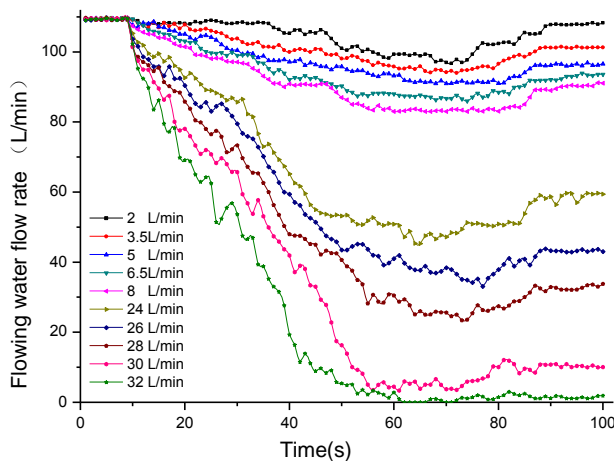
Fig. 5 – The curve of the flowing water flow rate over time

Considering the grouting test in Pipe 2 as an example, different water flow velocities were analysed (at 0.1 m/s, 0.3 m/s and 0.5 m/s). Different grouting flow rates are shown against time in Figure 5.

- (1) In case of an identical pipe and an identical initial water velocity, as the grouting flow rate increases, the water flow rate reduces.
- (2) In case of an identical pipe and an identical grouting flow rate, the larger the initial motive water flow, the smaller the amount of reduction. The slower the dynamic water flow changes, the greater the difficulty in sealing.

- (3) During the grouting process, as the flow rate of the grouting increases, the flow rate of the water decreases gradually. When the grouting is stopped, the water flow rate rebounds. When the grouting flow rate is too small compared with the initial water flow rate, the water flow rate is restored to the initial flow rate.

- (4) As shown in Figure 5(a), with an initial water flow velocity of 0.1 m/s and a grouting flow rate higher than 24 L/min (i.e., grouting using CN-0.5S), the flowing water could be sealed effectively. Figure 5(b) shows a case with an initial water flow velocity of 0.3 m/s and a grouting flow rate of 32 L/min, providing effective water sealing. Figure 5(c) shows a case where an initial water flow velocity of 0.5 m/s and a grouting flow rate of 32 L/min caused a reduced water flow rate, but could not seal it effectively. The grouting flow rate needed to be increased in this case.

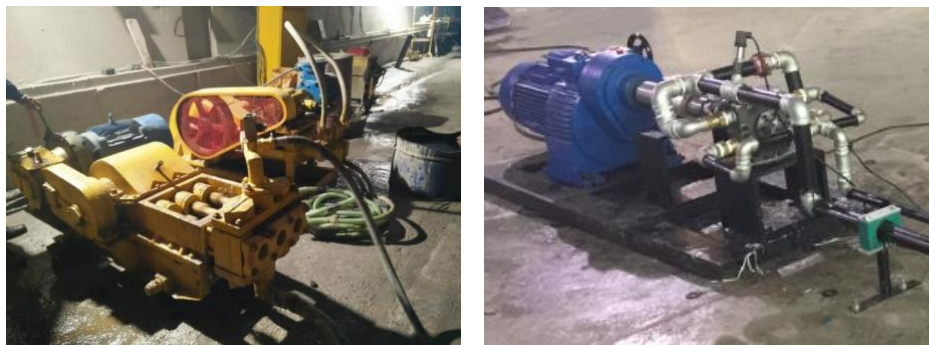
(a) Piston pump

(b) Rotary piston pump

Fig. 8 – Two types of grouting pumps

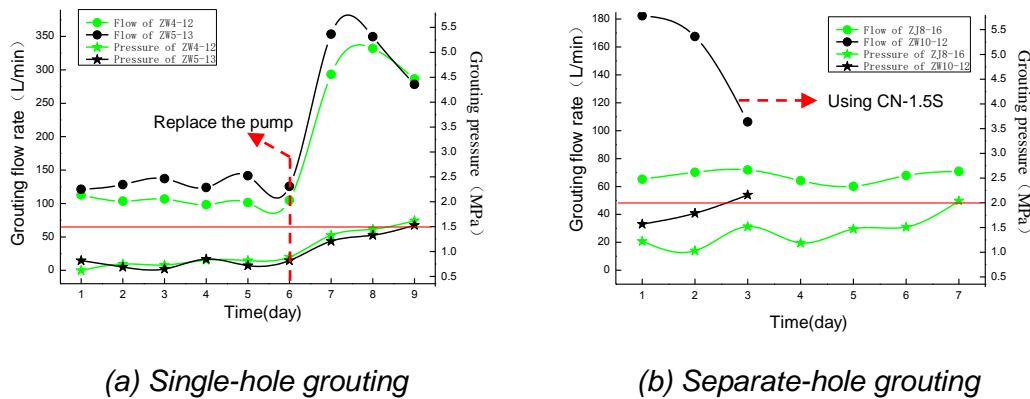
(a) Single-hole grouting (b) Separate-hole grouting
 Fig. 9 – The changes of grouting flow rate and grouting pressure

A single liquid cement slurry was used to fill the cavity in the exposed single drilling hole ZW4-12 and ZW5-13, and the final pressure was 1.5 MPa. In the process of grouting, 3SNSA was used for grouting initially. After grouting for days, the amount of grouting did not decrease, and the grouting pressure did not increase. In this case, CN-1.5S was used for grouting and filling. The sealing of the cavity was completed in a short period of time. The total amount of grouting and grouting pressure is shown in Figure 13. For the ZW4-12 hole, 3SNSA was used for grouting during the first 6 days. The daily grouting volume did not change significantly, and the grouting pressure was consistently low. After using CN-1.5S, the daily grouting surged, and the grouting pressure reached the final designed pressure on the 3rd day.

The drilling hole ZJ8-16 and ZJ8-16 were exposed revealing the karst fissure pipeline and the water inflow was large. GT-1 double liquid cement slurry was used to seal the gushing water, and the final design pressure was 2 MPa. 3SNSA and CN-1.5S were used in ZJ10-12 and ZJ8-16, respectively, and grouting treatment was started at the same time. The daily grouting amount and

grouting pressure changes are shown in Figure 14. The daily grouting amount was significantly higher in the ZJ10-12 grouted by CN-1.5S than that of the ZJ8-16 grouted by 3SNSA. ZJ10-12 reached the designed final pressure in 3 days with CN-1.5S. The cumulative amount of grouting was 453 m³. The drilling of ZJ8-16 continued to reach the designed final pressure in 7 days, with a cumulative grouting volume of 470 m³.

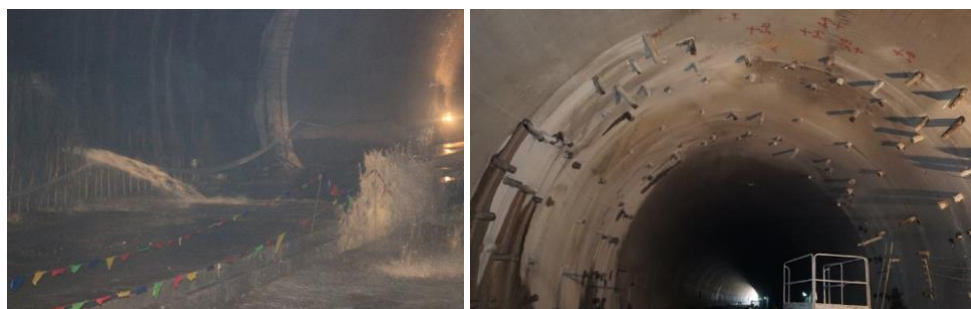
(a) Before the grouting (b) After the grouting
 Fig. 10 – The comparison before and after the grouting engineering

It can be observed from the grouting tests that the grouting flow rate of the new rotary piston pump is significantly higher than that of the existing grouting equipment, such as grouting filling in karst water storage structures or grouting sealing with low-pressure flowing water. The grouting efficiency is also considerably improved. After further adaptation of the newly developed grouting equipment in the overall test sites, the right hole of the tunnel reached the management requirement on October 15, 2015. The surrounding rock and lining were found to be intact. The entire right hole grouting project was 28 days ahead of the schedule, saving approximately 30% of the resources. A visual comparison of the test site before and after the grouting work can be seen in Figure 10.
