EVALUATION OF THE POSSIBILITIES FOR STREAM RESTORATION: PREASSESSMENT OF THE VÁLI-STREAM (HUNGARY)

ZSOMBOR BOROMISZA^{1*} - ZSUZSANNA ILLYÉS¹ – ATTILA GERGELY¹ – SZILVIA MÉSZÁROS¹ – ZSÓFIA MONSPART-MOLNÁR²

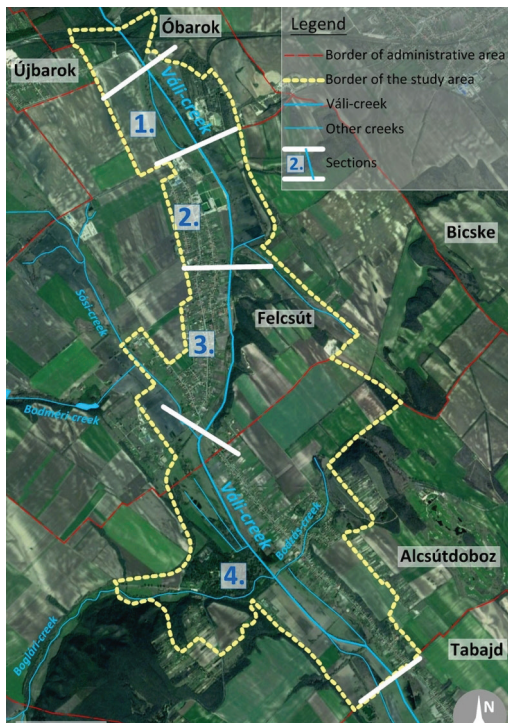
Fig.1. The location of the study area

Trans-Danubian-mountains, between the valleys of the river Danube and Sió-channel. The stream valley is surrounded by 700-900 metres wide alluvial plain from both sides, dominantly sedimented by riverine sand, deposited during the Pleistocene (Dövényi 2010). The Váli-stream originated from several spring-heads at the toes of the Vértes and Gerecse mountains, flowing into the river Danube at Adony. The length of the Váli-stream is 56 km (Boda 2002). The water level of the stream is considerably fluctuating (KöDVG 2010), seriously affected by seasonality of the karstic water level and mining activity. The study area is a 10 km long section of the floodplain along Váli-stream (see Figure 1.).

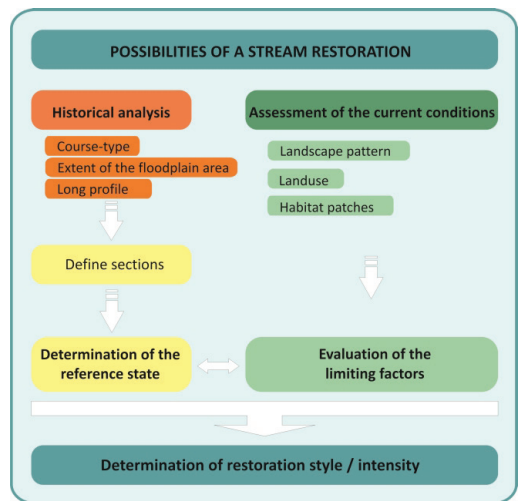
Fig. 2. Scheme of multi-step evaluation method

The potential of stream restoration was analysed in multiple steps (see Figure 2.). The starting point was a historical analysis, which resulted in the definition of different sections within the study area, providing a base for the further restoration goals. The assessment of the current conditions elaborated particularly to determine the factors which could limit restoration. These assessments cover the land use pattern, furthermore the analysis of vegetation and habitat patches. In the view of the historical reference state of the stream and the current limiting factors, restoration goals were determined for every section. The methodological details of the subtopics are described in the following.

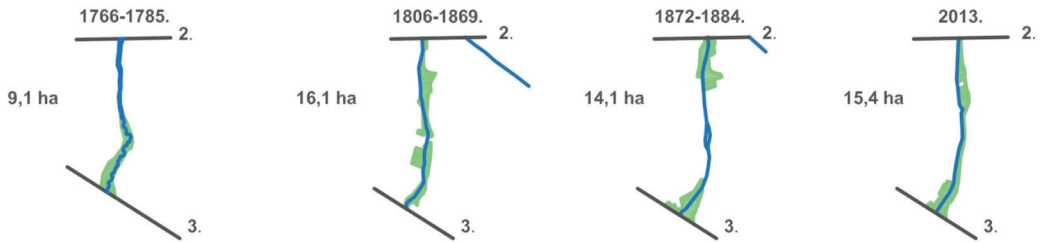
Fig. 5. Historical changes of Section 3. based on historical military mapping (range of alluvial wetland area marked with green)

As against the previous ones, the third section had a limited extent of alluvial wetland areas coupled with high permanency at the same time. Because of the fixed morphology of the valley, there is only a slight change in the long section, as well. The high permanency, however, does not mean that the water bed has not undergone any transformations, since the cross embankments and levees affecting the vertical track have influenced the water runoff as early as from the first half of the 19th Century. In the narrow valley, the closeness of the railway line to the stream-bed is an important factor, especially if the railway will be used again in the future (see Figure 5.).

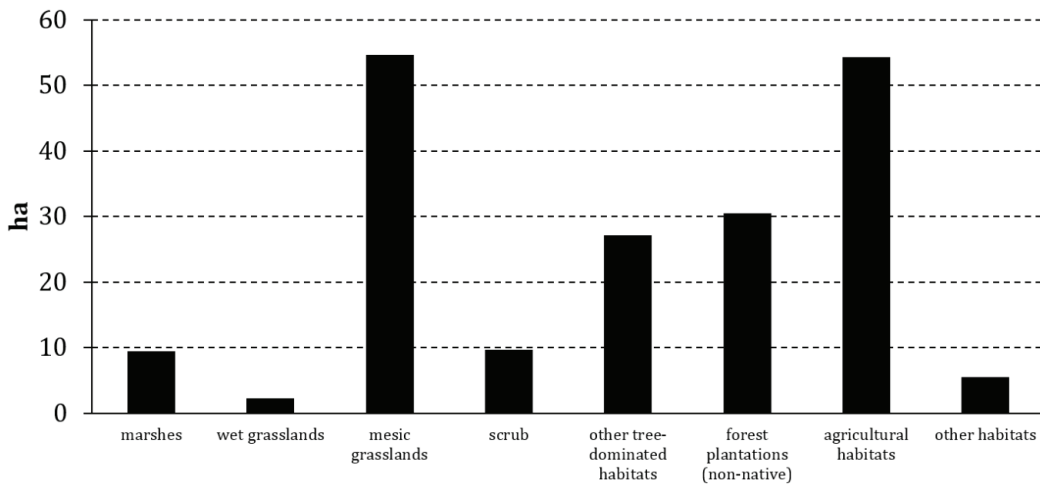
Fig. 7. Main habitat types of Váli-stream

The ratio of the main habitat types is the following (see Figure 7., Table 1.):

1. wet and mesic meadows (29,4%)
2. agricultural habitats (28,1%)
3. non-native afforestation (15,7%)
4. native tree-dominated habitats (14,0%)
5. scrub (5,0%)
6. marshes (4,9%)
7. other habitats (2,8%)

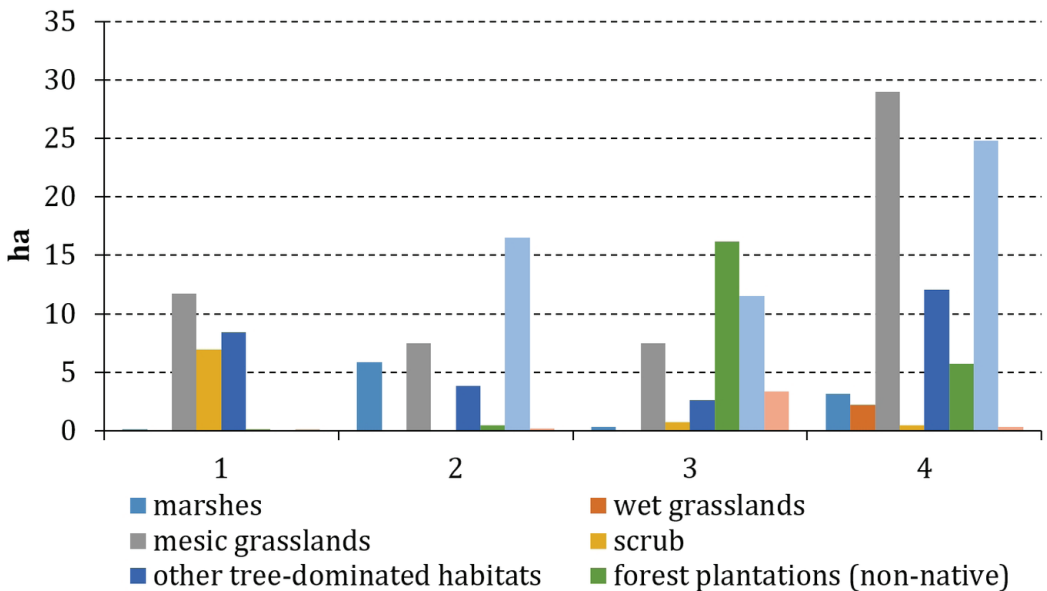
Fig. 8. Main habitat types of the 4 sections along Váli-stream

The typical vegetation of 4 sections taken in the historical analysis are characterized as follows (see Figure 8.):

- Section 1 (Felcsút: „Felső-malom”): mesic meadows (11.7 ha), scrub (6.9 ha), native tree-dominated habitats (8.4 ha).
- Section 2 (Felcsút: „Fenék” és „Kenderföldek”): agricultural habitats (16.5 ha), mesic meadows (7.4 ha), marshes (5.8 ha).
- Section 3 (Felcsút: inner area of vil-lage): non-native afforestation (16.2 ha), agricultural habitats (11.5 ha), mesic grasslands (7.4 ha).
- Section 4 (Alcsútdoboz: „Felső- és Alsó-rétek”): wet and mesic meadows (31.2 ha), agricultural habitats (24.8 ha), native tree-dominated habitats (12 ha), non-native forest plantations (5.7 ha).

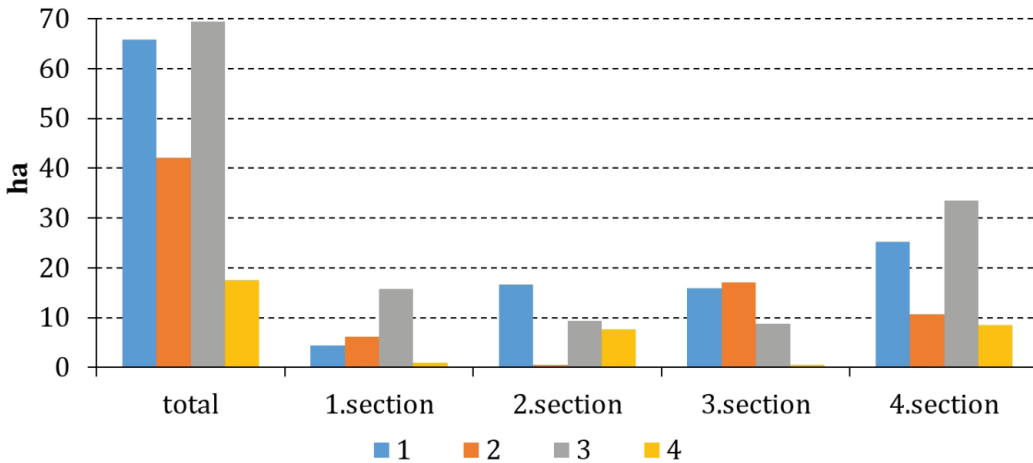
Fig. 9. Vegetation naturalness of 4 sections along Váli-stream (legend: 1= totally degraded state, 2= heavily degraded state, 3= moderately degraded state, 4= semi-natural state)

The habitat quality of the 4 sections taken in the historical analysis are characterized as follows (see Figure 9. and 10.):

- Section 1 (Felcsút: “Felső-malom”): mainly moderately degraded/regenerated (58%).
- Section 2 (Felcsút: „Fenek” és „Kenderföldek”): mainly totally degraded (49%), but 22% semi-natural (reed beds and scattered native trees).
- Section 3 (Felcsút: inner area of the village): totally or heavily degraded (78%).
- Section 4 (Alcsútdoboz: „Felső- és Alsó-rétek”): mainly moderately degraded (43%), but 11% semi-natural (mesic meadows).

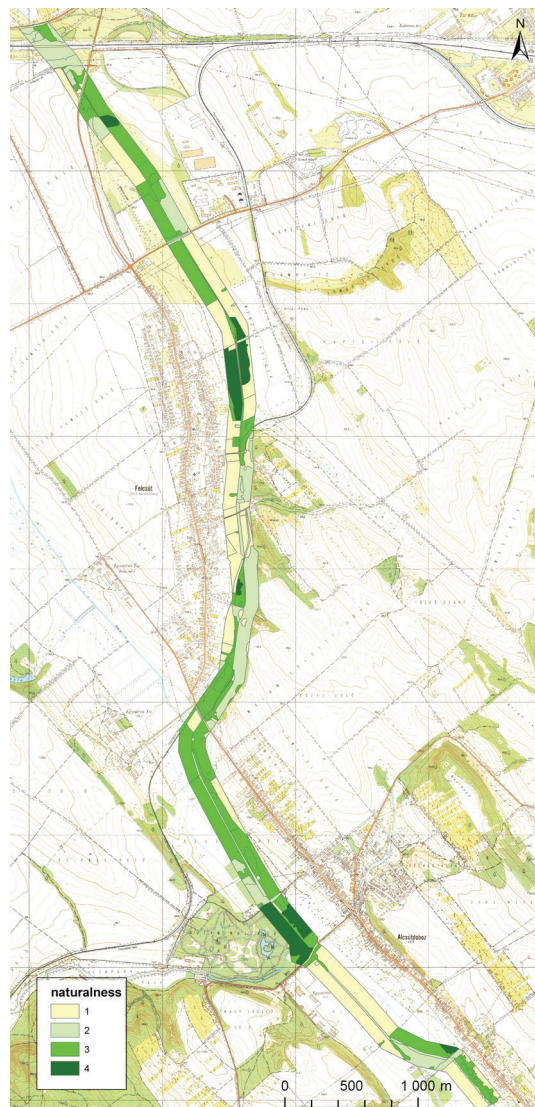
Fig. 10. Vegetation naturalness of Váli-stream (legend: 1= totally degraded state, 2= heavily degraded state, 3= moderately degraded state, 4= semi-natural state)
