ANALYSIS OF CAUSES WHICH DETERMINE THE DEGRADATION OF CONVEYORS WITH METAL INSERTS

Sabin DIMULESCU, Lucian Blaga University of Sibiu, Sibiu, Romania
Dan DOBROTĂ, Lucian Blaga University of Sibiu, Sibiu, Romania

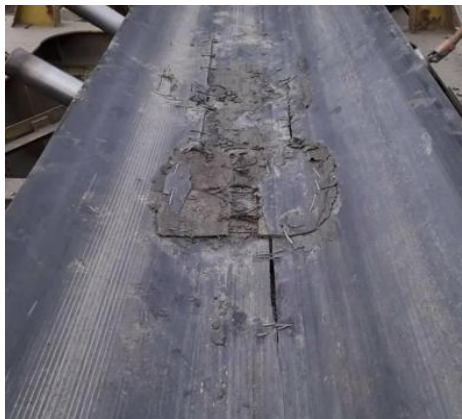
Figure 3. The longitudinal splicing of the conveyor belt

Longitudinal splicing of conveyor belts with metal inserts is one of the causes that lead to the rapid removal of conveyor belts. This phenomenon occurs due to inappropriate operation and high wear of the conveyor belt cover faces (Fig.3).

If working conditions are excessive they lead to the premature aging of running faces causing their thinning and implicitly the phenomenon of longitudinal splintering. A very important factor is also the quality of the rubber in the casing covers and, if it does not have the specific features of the band's working environment, the degradation of the cover faces is inevitable. Improved wear on the conveyor belt faces after commissioning may also occur due to the aging of the rubber due to its long storage under improper atmospheric conditions.

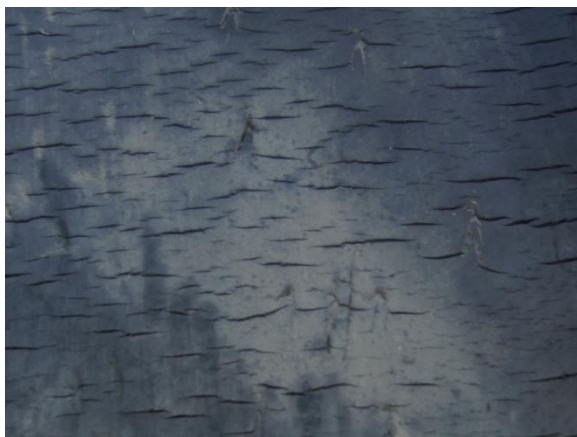
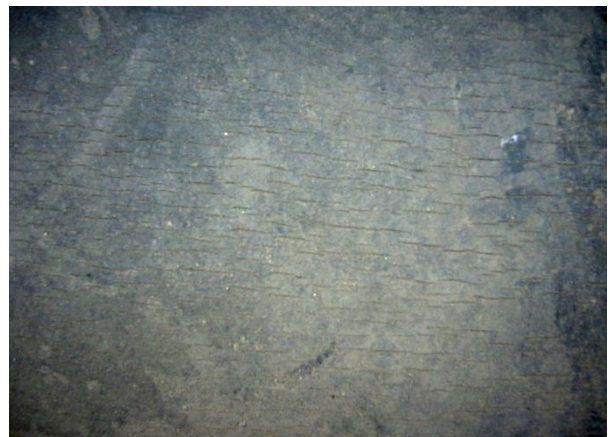
Figure 4. Transverse cracks on conveyor belt

The appearance of micro cracks on the cover faces is one of the causes that lead to the removal of conveyor belts. Conveyor belts with steel cord capacity due to too high loads can

cause a drum friction phenomenon, a phenomenon that can lead to a higher surface temperature. The high surface temperature over time can destroy the chemical bonds in the rubber layer resulting in an advanced degradation of the conveyor belt.

Also, the exposure of the conveyor belts to humidity, gaseous pollutants, UV radiation, reduces their life span. UV radiation also leads to breakage of surface polymeric bonding of the rubber layer causing the appearance of transverse microchip networks Fig.4.a.b.

A cause that can lead to the degradation of the coating faces of the conveyor belts can also be determined by the high temperature that exists in the strip after vulcanization. The temperature accumulated in the rolled strip on the drum immediately after vulcanization is maintained, and the cooling is done over time by heat loss. This prolonged time in which the drum roll is kept at a temperature close to the vulcanization temperature can lead to the destruction of chemical bonds in the rubber layer.

a) network of cracks on the carrier face

b) network of cracks on the rolling face

When the rubber coatings (Figure 4a, b) have reached a degree of wear which endangers the constraining structure of the conveyor belts, one of the main measures intended to extend the length of use of the belts is their reconditioning.

The reconditioning of the conveyor belts consists in the repair of the rubber layers and of the damaged inserts, as well as their adjustment to the initial manufacturing sizes. Such an operation is preceded by a series of activities, which mainly aim at preparing the strip structure. The re-conditioning of the bands leads to a prolongation of their lifetime, as well as
