Journal of Applied and Computational Mechanics

Research Article

Clogged Impeller Diagnosis in the Centrifugal Pump Using the Vibration and Motor Current Analysis

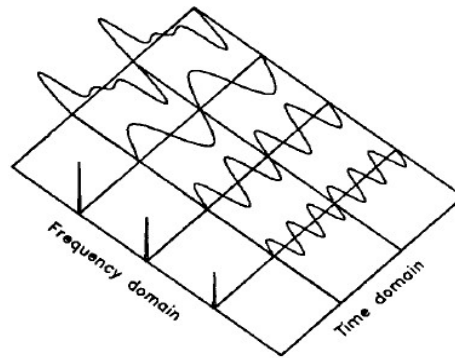
Fig. 1. Relationship between time domain and frequency domain [18]

For example, in Fig. 1, an original signal is decomposed into its constituent signals.

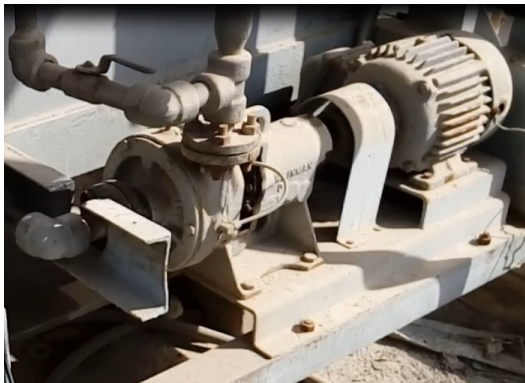
Fig. 2. WEINMANN centrifugal pump

The pump which is used in the present research is a Weinmann centrifugal pump with a closed impeller coupled with a three-phase squirrel-cage induction electromotor (manufactured by Westinghouse Electric Corporation) operating at 2940 rpm, maximum power of 3 hp, and nominal current of 5 A. This equipment is used for calibration purposes in the measurement calibration unit at Bandar-e-Imam Petrochemical Complex (Iran). An overview of the examined pumping system is shown in Fig. 2. The studied impeller is a bronze-made closed one with 6 vanes of 180 mm in outer diameter (Fig. 3).

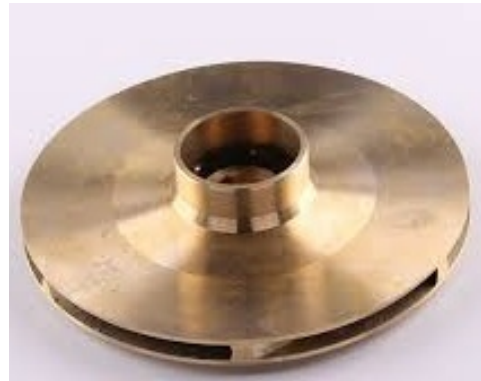
Fig. 3. Bronze impeller with six vanes

Given that the impeller is six-vane, vane pass frequency is 294 Hz (obtained by multiplying the number of vanes by the rotation frequency (49 Hz)). In the present research, a vibration measurement device designated as VIBER-X5 is used with a VMI-192 accelerometer sensor (serial number: 1868). The sensor is manufactured by a Swedish company, VMI. Moreover, in order to measure the vibration signal, a special clamp is used which is capable of measuring the electrical field around a current-carrying wire. Data collection is performed at two points. One point on the electromotor close to the coupling, and another one on the bearing chamber close to the impeller. Data collection on the pump along the axial direction is demonstrated in Fig. 4.

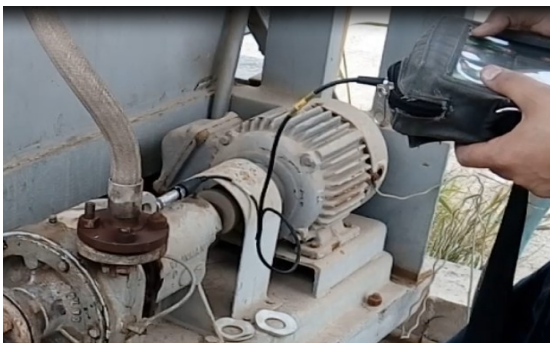
Fig. 4. Vibration measurement

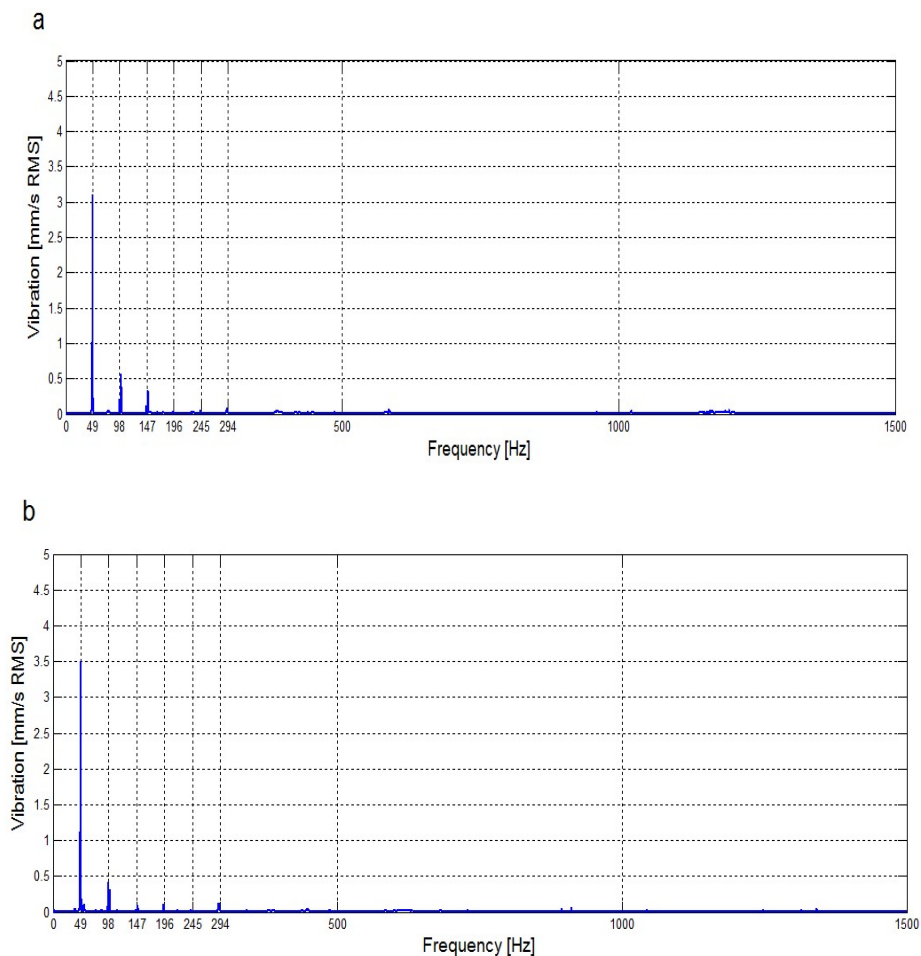
Fig. 7. Normal impeller vibration's FFT in the main directions (a). Horizontal. (b). Vertical. (c). Axial.

As shown, Fig. 7 indicates the frequency response of pump vibrations along the three primary directions when the impeller is operating normally (without any clogging).

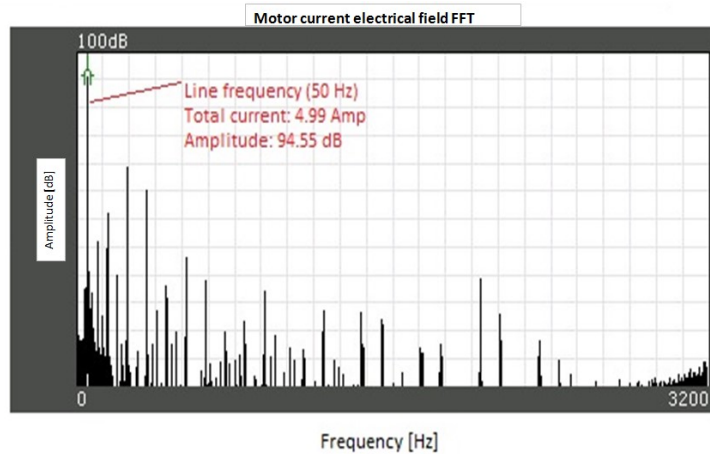
Fig. 8. Motor current FFT (pump with normal impeller).

Table 1 reports the values of pump vibrations obtained when the impeller is operating with no clogging, for the six principle harmonics. As can be seen, Fig. 8 demonstrates Fourier transform of the signal obtained from the electromotor current. Amplitude of the waves at power grid frequency (50 Hz) is 94.55 dB. In this stage, the electromotor consumes power at 4.99 Amp.

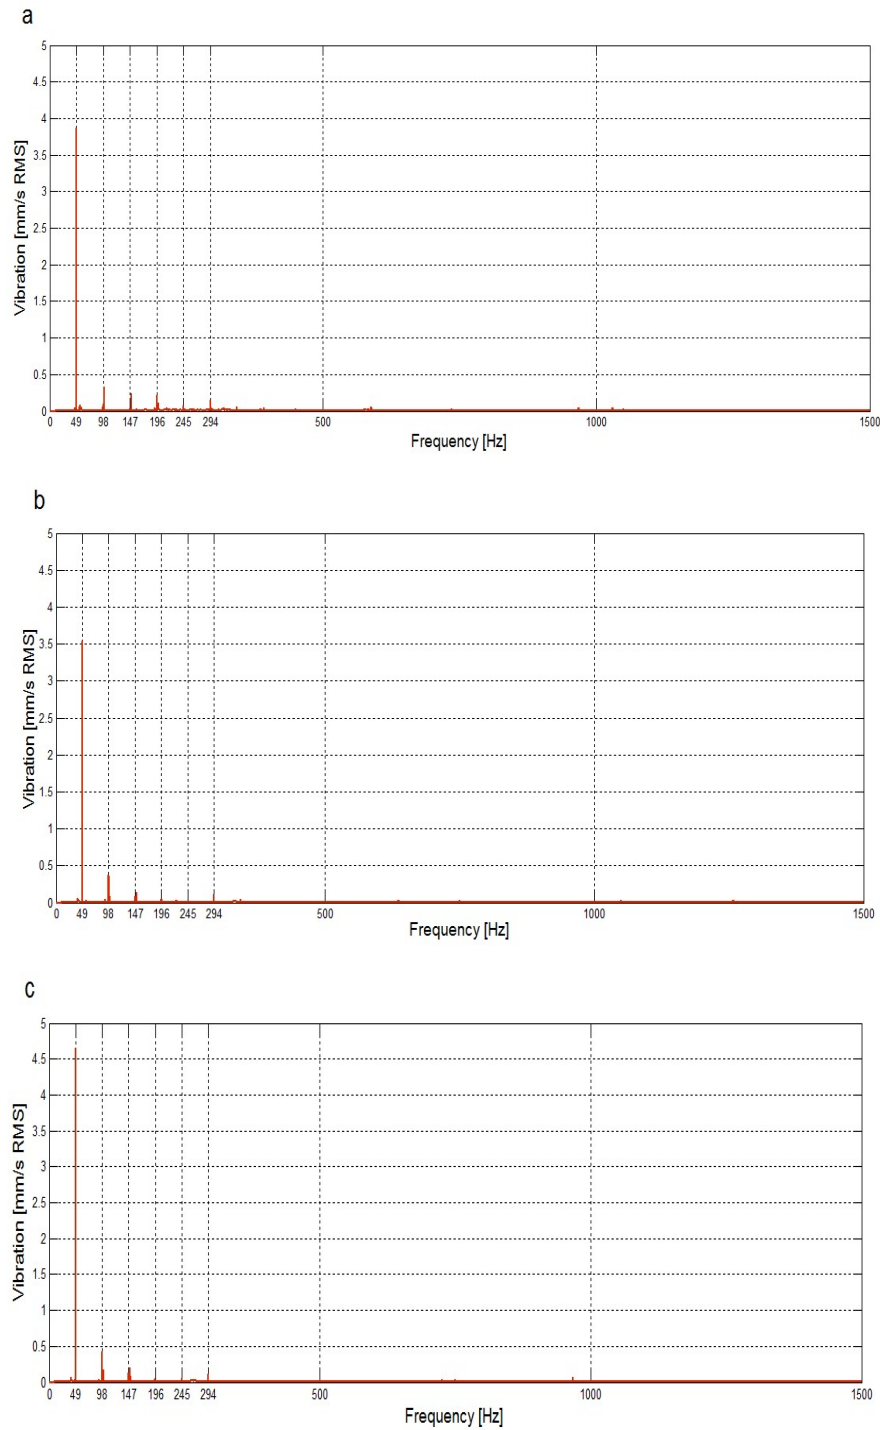
Fig. 10. Clogged impeller vibration’s FFT in the main directions (a). Horizontal. (b). Vertical. (c). Axial.

The following figure (see fig. 9) shows the impeller with clogging in one passageway. As shown, Fig. 10 demonstrates the pump vibration signal and its Fourier transform in the second case, i.e. the impeller within one passageway clogging.

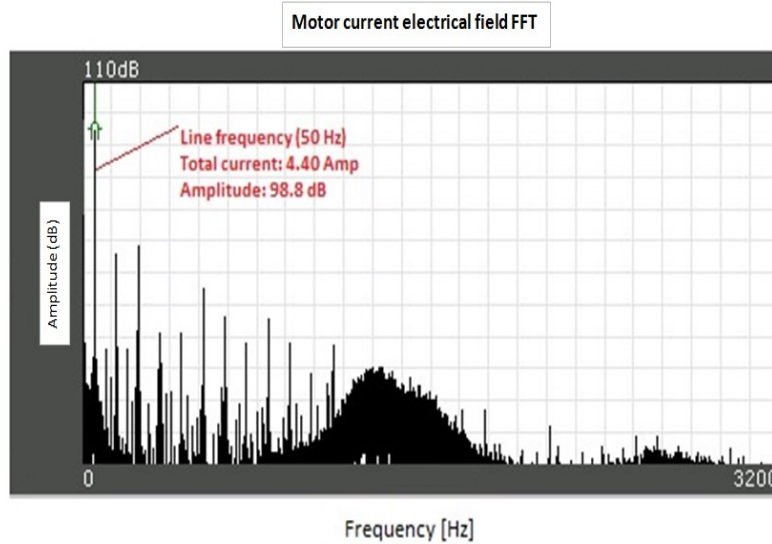
Fig. 11. Motor current FFT (pump with clogged impeller in one passageway).

Table 2 reports the values of pump vibrations in the second case, i.e. the impeller with one passageway clogged for the six principle harmonics. Fourier transform of the signal obtained from the electromotor current when the impeller is clogged in one passageway is demonstrated in Fig. 11. The amplitude of the waves at power grid frequency (50 Hz) is 98.80 dB. In this stage, the electromotor consumes power at 4.40 A. Table 3 details changes in vibration following the blockage. Maximum values reported in this table are those of the frequency equal to the pump rotation frequency. This frequency indicates faults, which in general, induce some imbalance in rotor.

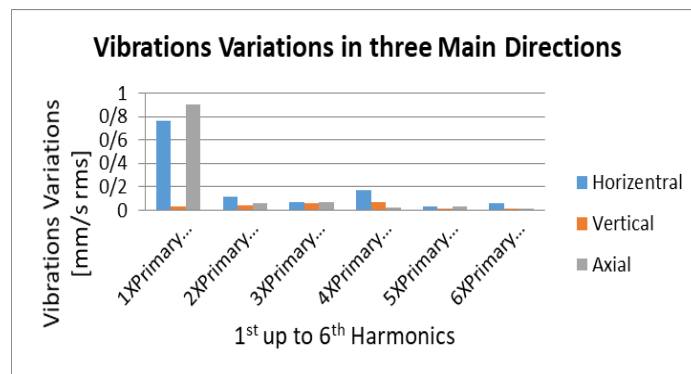
Fig. 12. Vibrations variations in three main directions

Changes in vibrations in the first six harmonics are demonstrated in Fig. 12. In this Figure, it is observed that, due to the blockage phenomenon in the impeller, maximum fluctuations in vibrations are seen in the first harmonic ($1 \times \text{RPM}$). Table 4 presents the consumed current by the electromotor in the first and second cases. It is seen in this table that, the impeller clogging has reduced the required current for pumping.
