EXPERIMENTAL INVESTIGATIONS AND COMPUTER SIMULATIONS TO SOLVE ACOUSTIC PROBLEMS IN THE MODERN CHURCH

Anna SYGULSKA*, Tomasz CZERNIAK, Adrian CZARNY-KROPIWNICKI

Faculty of Architecture, Poznan University of Technology, Poznan, Poland

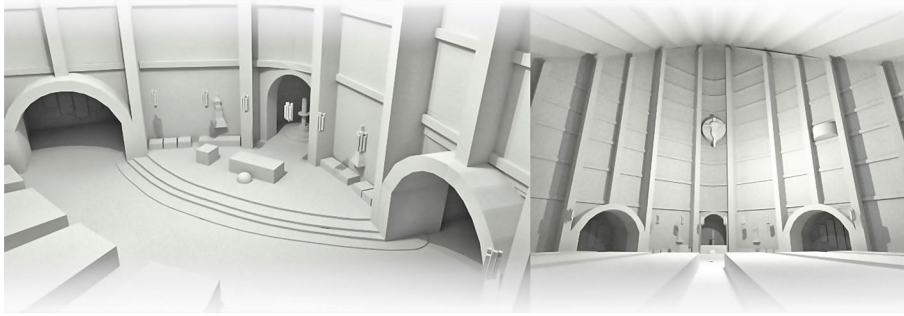
Figure 5. Bird-eye view onto the presbytery area and a view one side of the church towards the altar

The whole of a 3D model of the interior of the upper church, consisting of almost 5,000 polygons, was made in an open-source programme Blender 2.76. Figures 5 and 6 show rendering generated by the programme.

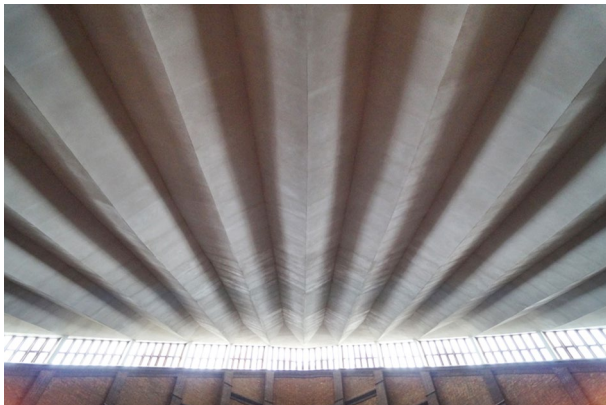
Figure 9. View of the accordion-like structure of the ceiling
