Violent explosion after inadvertent mixing of nitric acid and isopropanol – Review 15 years later finds basic accident data corrupted, no evidence of broad learning

Published in:
Safety Science

Publication date:
2014

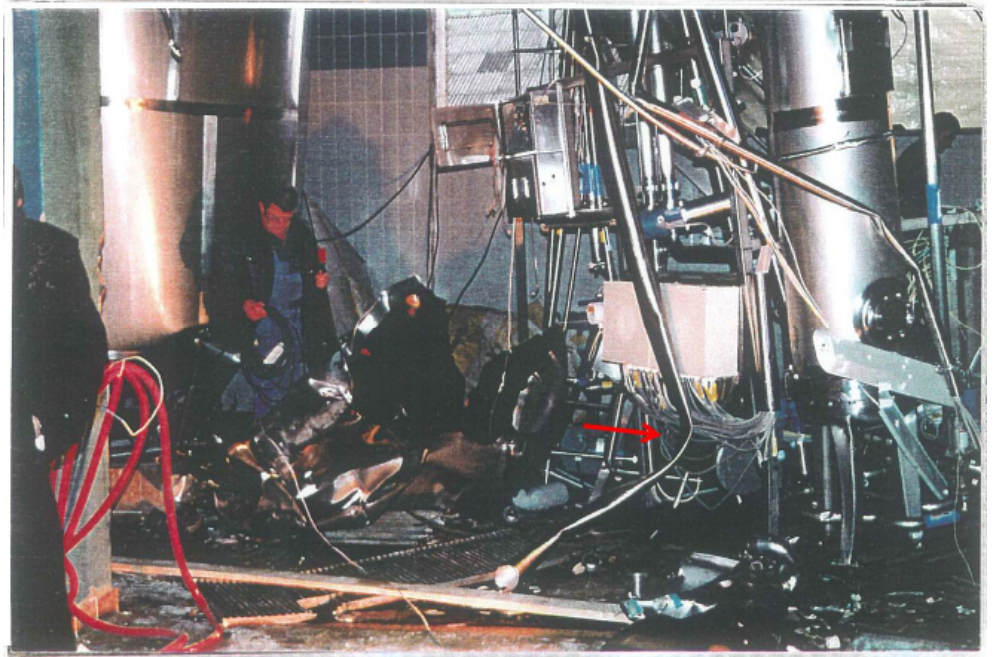
Figure 2 Right: damaged filter unit, left: caustic tank. Note flattened steel piping (arrow). Photo courtesy of company.

The force of the explosion flattened stainless steel piping. The upper part of the caustic tank was deformed and the tank leg facing the P3 tank was bent 45 degrees upwards. The adjacent filter unit was destroyed (Figure 2).

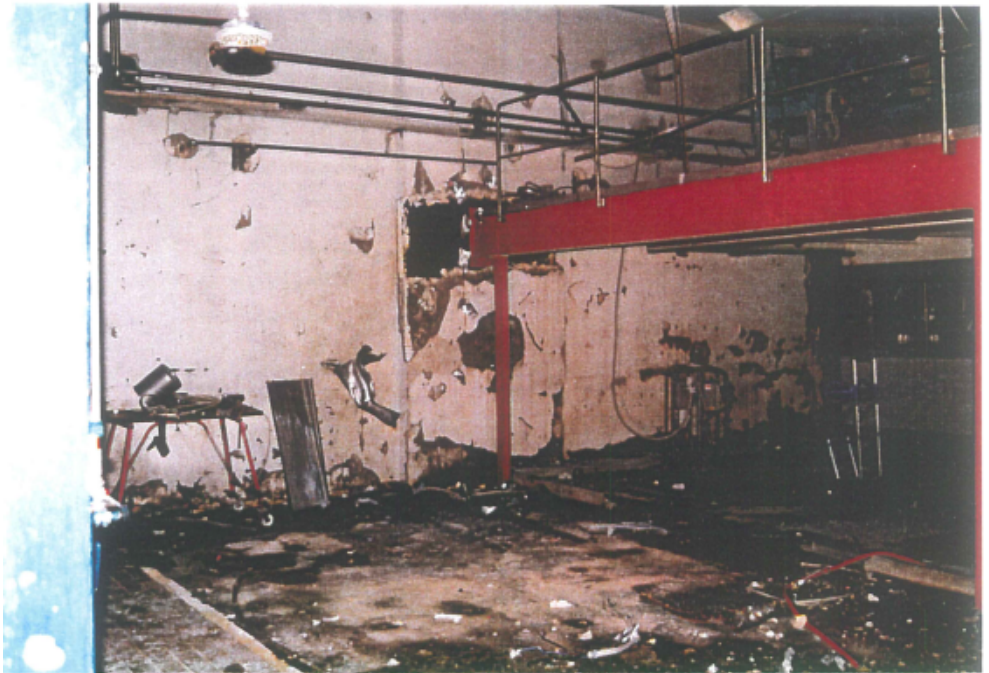
Figure 3 Tank fragments lodged in heavy concrete wall (marked as location b in Figure 1). Photo courtesy of company.

The severity of the explosion is perhaps best revealed by fragmentation damage. The P3 tank disintegrated and tore the adjacent nitric acid tank apart. Tank steel fragments lodged into the solid concrete wall (Figure 3). A stainless steel flange with an estimated weight of 8-10 kg originating from the bottom of the P3 tank traversed the hall, penetrated an electrical cabinet and caused a black-out (Figure 4). The nearby water tank was pockmarked by fragment impact, mostly at the lower part of the tank. Scattered crumbled tank fragments, damaged machinery and a deformed metal handrail is evidence of other forceful impacts. The concrete pillars had corners knocked off.
