The use of transverse connectors as reinforcement of multi-leaf walls

Marco Corradi · Antonio Borri · Elena Poverello · Giulio Castori

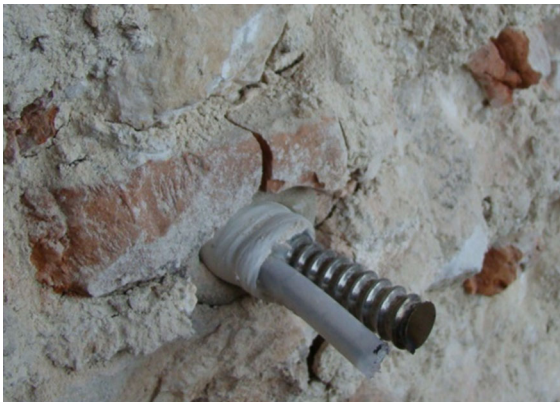
**Fig. 6** Typical masonry failure mode during pull-out tests

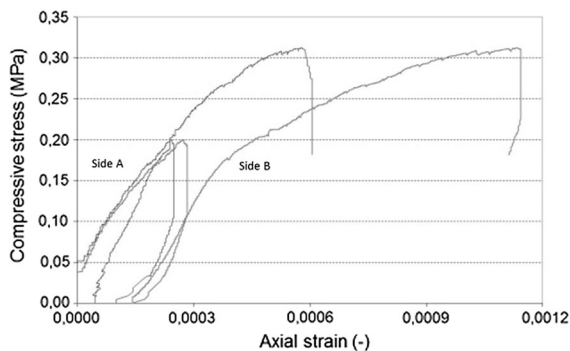
Fig. 9 Stress versus axial strain of masonry leaves for unreinforced panel 3Un

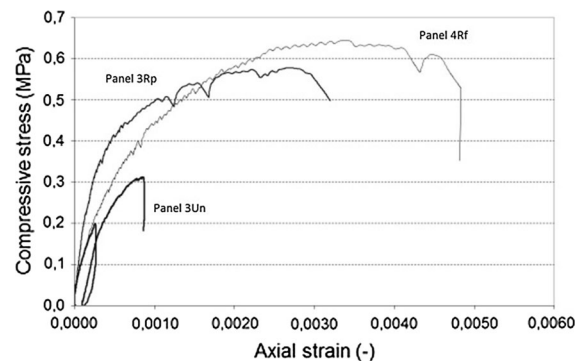
Fig. 10 Stress versus axial strain: comparison between the three compression tests

calculated (Fig. 10). For this second test, vertical cracks mainly appeared on the leaf's surface highlighting a more-likely compressive failure. Scattering of vertical strains between wall leaves highly reduced indicating a monolithic behavior of the wall.

in terms of compressive stress) was reached (Fig. 10). This was more than 108% greater compared to the control unreinforced wall panel. Again the failure occurred for the formation of vertical cracks on the leaf's surface. The analysis of the vertical deformations clearly showed the similar behavior between the two masonry leaves. For test on Panel 3Rp the magnitudes of the vertical strain at maximum load were 0.0030 and 0.0023, for side A and B, respectively (with a ratio between the strain values of 1.3). For test on Panel 4Rf this ratio was only 1.03.
