Landslides (2013) 10:219–230
 DOI 10.1007/s10346-012-0362-4
 Received: 11 April 2012
 Accepted: 2 October 2012
 Published online: 17 October 2012
 © The Author(s) 2012. This article is published with open access at Springerlink.com

Do Minh Duc

Rainfall-triggered large landslides on 15 December 2005 in Van Canh District, Binh Dinh Province, Vietnam

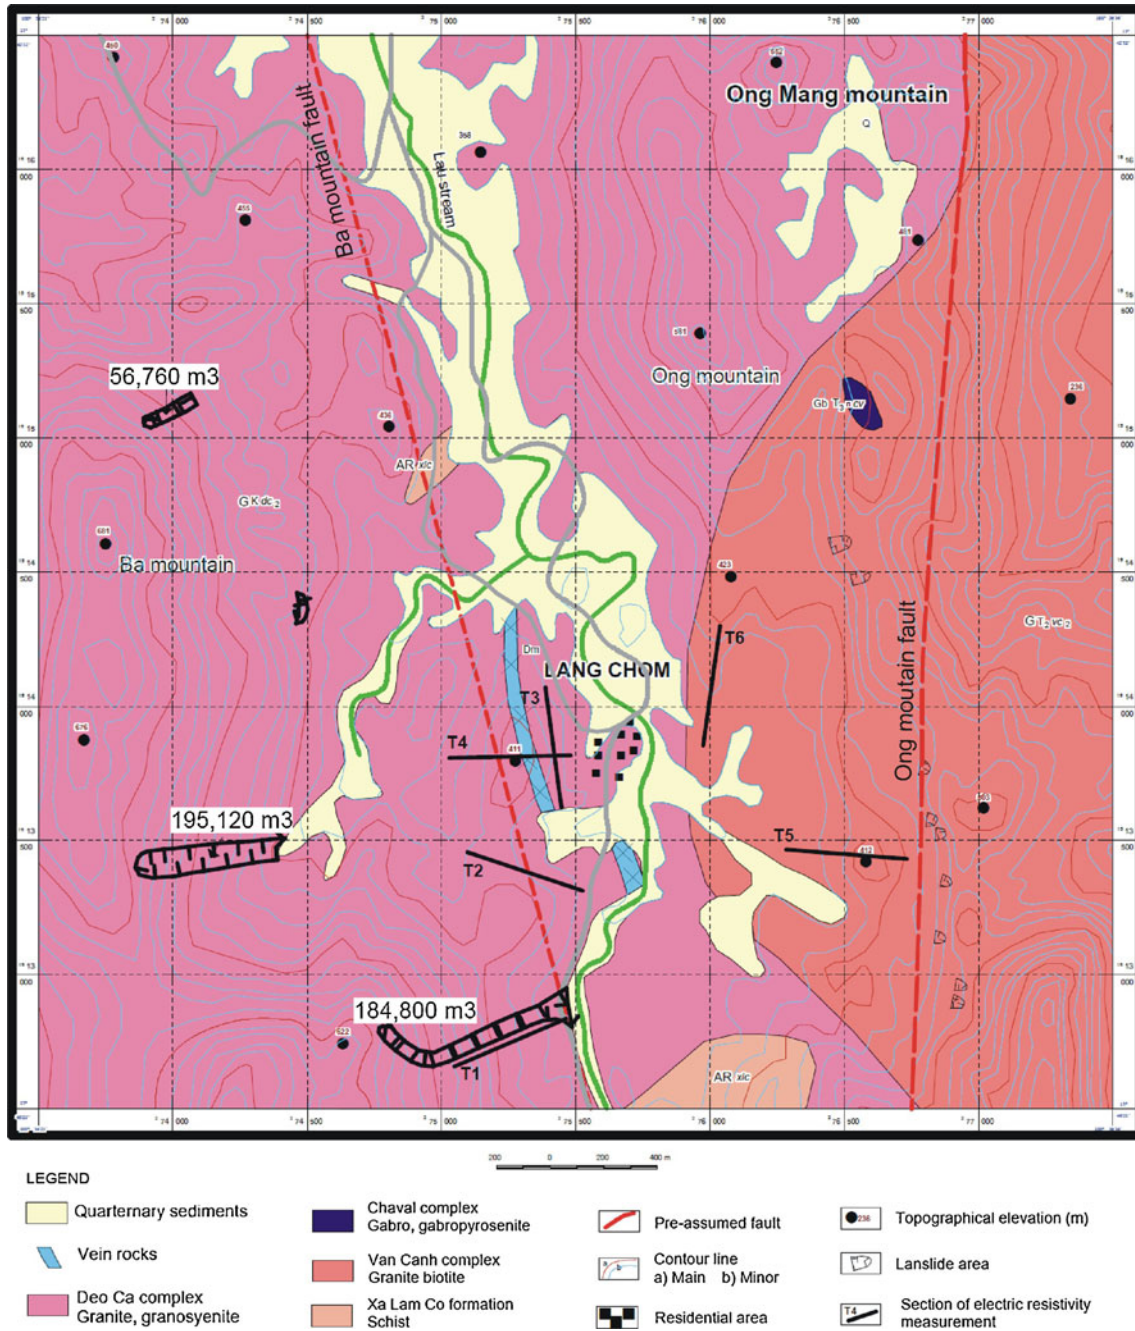
Fig. 2 Geological map of Lang Chom commune (detail investigation)

distance of electrodes (ABmax) is 140 m, which allowed us to investigate materials up to a depth of about 50 m. Six sections were measured, which are abbreviated as T.1, T.2, T.3, T.4, T.5, and T.6, respectively (Fig. 2). Each section is 450 m long. A total of 60 measuring points were included. Sections T1, T2, and T3 are designed to cut through the Ba mountain fault. Section T2, together with T3 and T4, are also for assessing landslide hazard at the hillside close to the main residential area of Lang Chom commune. T5 and T6 are for landslide hazard assessment in the tentative resettlement areas.

is much more effective. Detailed investigation in Lang Chom commune showed that the east side of Lang Chom commune was less vulnerable to landslides than the west side, especially downslope of geophysical sections T5 and T6. In this place, residual soils are which weathered from rocks of the Van Canh complex and can be classified as SW. The thicknesses of residual soils is 1–5 m. Slopes are gentle, with angles of 5–10° at the T6 section and 5–15° at the T5 section. A part of Lang Chom commune was resettled in a location downslope of the T6 section.

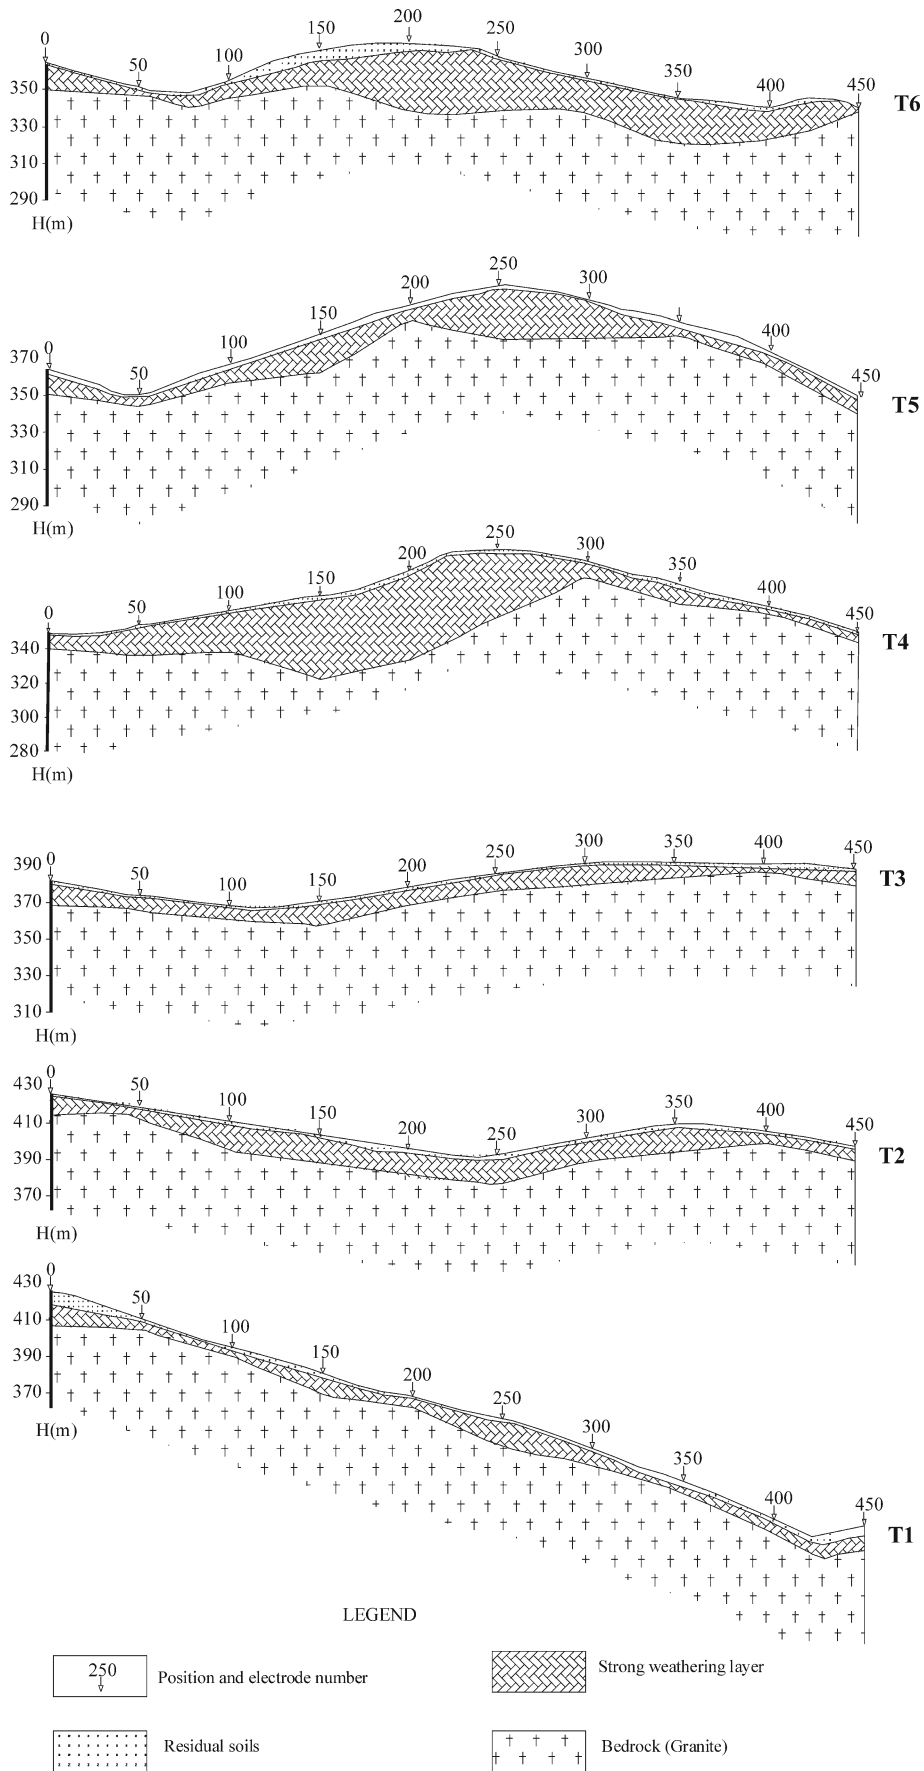
Fig. 4 Weathering crust (defined by electric resistivity measurement)

Deo Ca complex. The crust has three layers of soils and rocks (Fig. 4).

- The upper layer is residual soils which are classified as silt (ML), clayey sand (SC), and well-graded sand (SW). The thickness varies from 0.5 to 6.2 m. The layer has resistivity ranging from 174 to 4,136 Ω m. This layer is covered by trees, *Acacia mangium*, at a medium density. The trees are cut and re-planted every 3 years for the paper industry.

- The second layer is fractured and strongly weathered bedrock with a resistivity of 62–6,318 Ω m. The thickness varies over a large range: from 1.2 to 50.6 m (Fig. 4), greater thicknesses occur at fault zones and above vein rocks.
- The lower layer is intact bedrock with a resistivity of 1,168–50,175 Ω m.

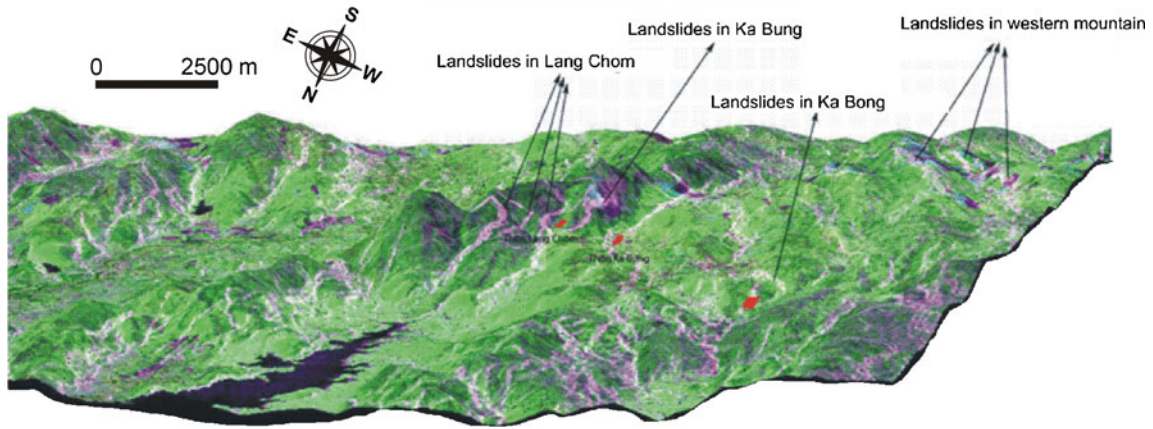
Fig. 5 Landslides in Van Canh district in December 2005 (interpretation of PALSAR satellite image on the third of November 2009) (revised from Ha 2011)

The three largest landslides took place in Lang Chom commune and had volumes of 56,760, 184,800, and 195,120 m³, respectively (Figs. 5 and 6). The landslides were accompanied by remarkable loud noises. The landslide slip surface has two parts. The upper surface is in residual soils and has an arc shape. The height of this part is 3–6 m. The main part of slip surface is the fault plane of the Ba mountain fault (Fig. 6). The figure shows that fault plane is the interface between intact rocks and weathering soils, sheared rocks in the landslide body. Residual soils are weathered from rocks of the Deo Ca complex and have a thickness of 4–6 m. The slope angles are 27–32°. Numerous granite boulders of about 10 m³ were transported downslope along a distance of hundreds of meters (Fig. 6). Sliding debris from the landslides destroyed a local road segment and filled up the Lau stream, causing an increase of

At the same time, in Ka Bung commune (the opposite site of the mountain), there was a series of large landslides (Figs. 5 and 7). The thickness of residual soils in these landslides is 6–9 m and slope angles are 28–32°. The average volume of these landslides is 20,500 m³. The landslides took place far from residential areas and did not cause any fatalities. Many other landslides and rockfalls were also triggered by rainfall along local routes and on rocky mountains with steep slopes on 15 December 2005.

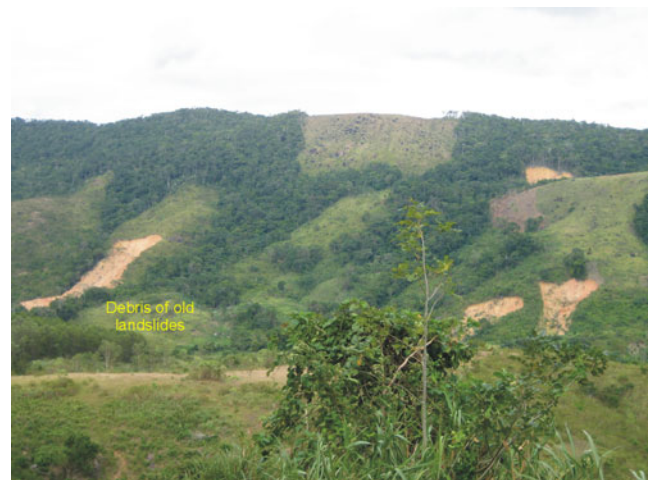
Fig. 7 Landslides in Ka Bung commune

At the slip surfaces of landslides, some fractures were recognized in the intact bedrock (Fig. 7d). Although the initial loud noises emanated from the sliding areas, they were not followed by rolling rocks or dust clouds. These sounds may have been the result of intact brittle rock fracturing in the slope. A similar event was recorded in the Afternoon Creek rockslide in the state of Washington, USA (Strouth et al. 2006) and in a catastrophic rockslide–debris avalanche at St. Bernard, Southern Leyte, the Philippines (Catane et al. 2007). The noises that followed may be due to the falling and rolling of rock boulders.

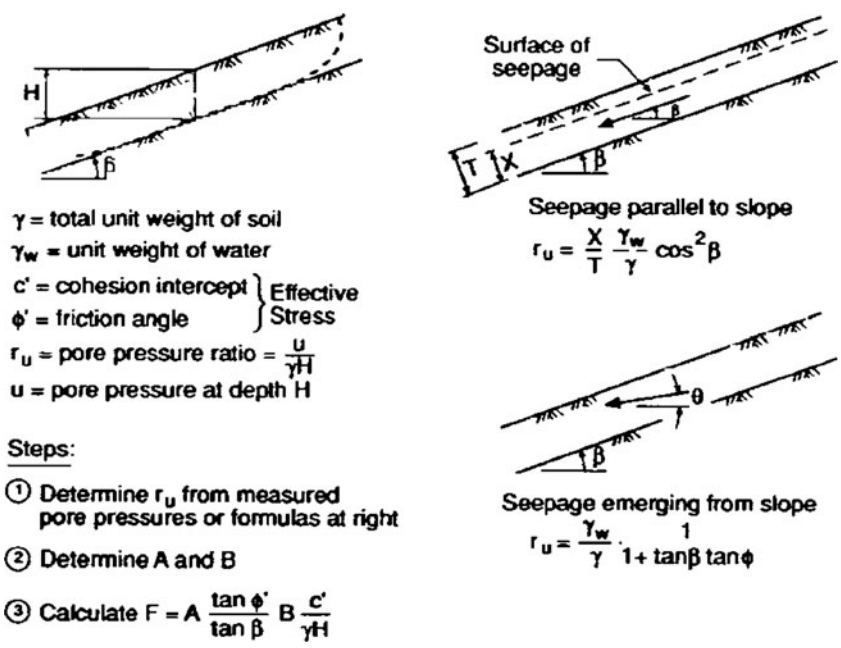
Fig. 8 Illustration of infinite-slope-analysis method (taken from Duncan 1996)

The infinite-slope-analysis method was employed for the stability analysis. It quantitatively analyzes the effect of soil saturation on the stability of those slopes where potential for translational slides exists (Duncan 1996). The analysis assumes the slip surfaces are long compared to their depth, and it ignores the driving force at the upper end of the sliding mass and the resisting force at the lower end (Fig. 8). The method requires a procedure with three steps:

1. Determination of the factor of safety (Fs) using the following equation:

$$Fs = A(\tan \phi' / \tan \alpha) + B(c' / \gamma H)$$

where H is the depth of soil measured vertically from the slope surface to the surface of sliding; ϕ' and c' are the effective strength parameters; α is the slope angle; and γ is soil density.

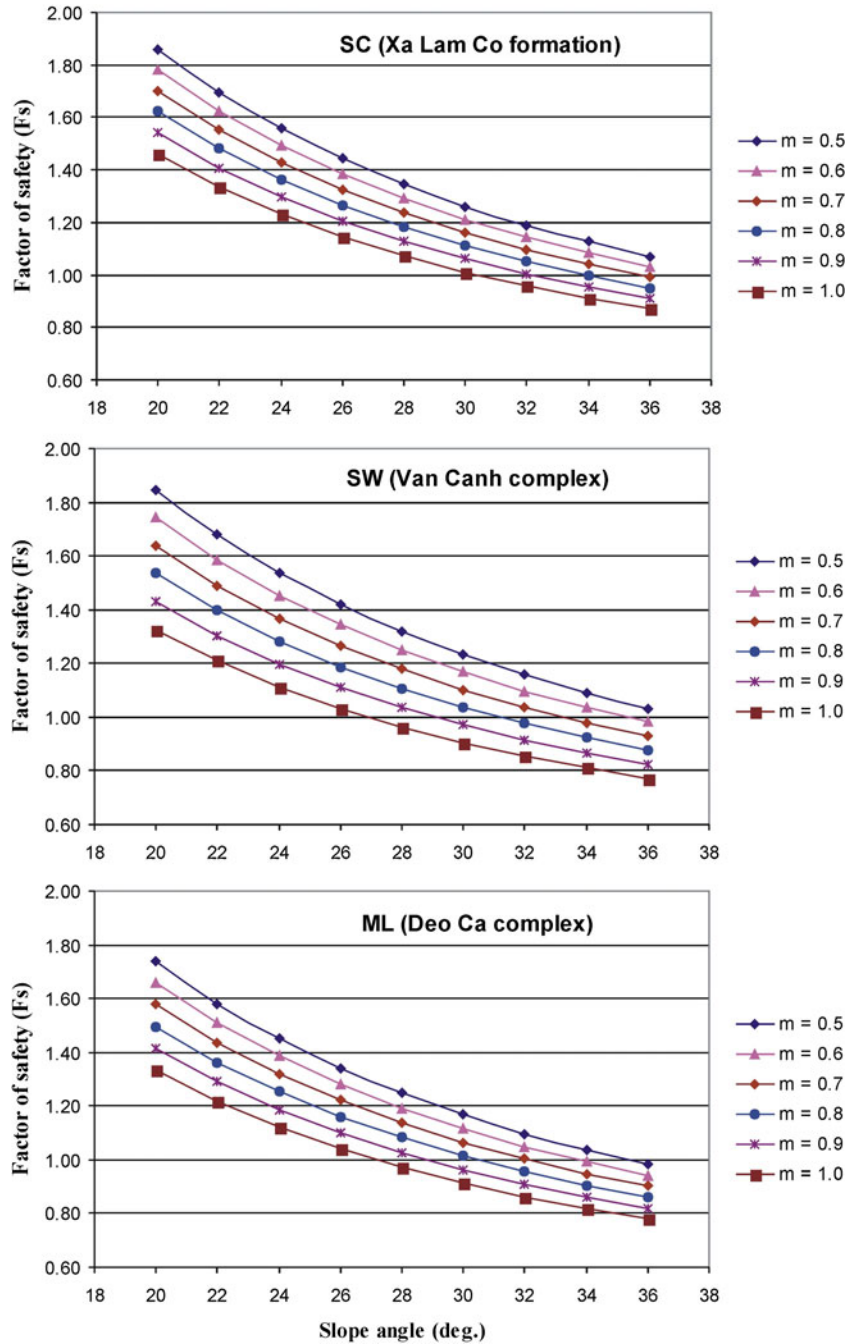
Fig. 9 Relationships between slope angle, saturated fraction, and factor of safety for various residual soils

The results are shown in Fig. 9 and display the relationships between F_s and slope angle at various values of saturated fraction (m). As can be seen in Fig. 9, a slope of well-graded sand and silt at an angle of more than 28° is unstable when fully saturated, meanwhile a 36° slope can fail if half of the soil mantle is saturated. Meanwhile, a saturated slope of

clayey sand is unstable at an angle of more than 30°. The results match well with actual observations, where failures occurred at slope angles of 28–31°. However, the phenomenon of rainfall-induced slope failure depends not only on soil properties but also on topographical and geological characteristics which contribute to the existence of a potential sliding surface.

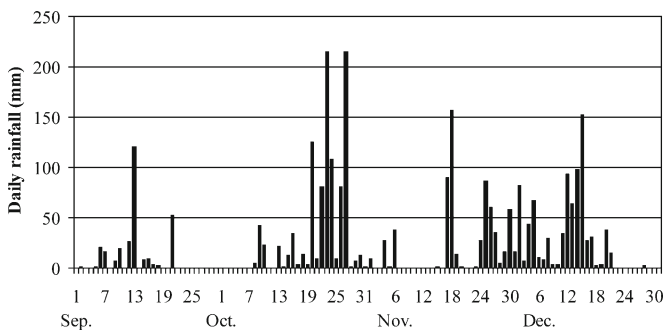
Fig. 10 Rainfall from 01 September 2005 to 31 December 2005

To determine an empirical relationship between rainfall and landslides, the daily rainfall data from September to December 2005 was taken into account. Total rainfall in September 2005 was 287.3 mm, a normal figure in comparison to other years. In October 2005, the figure was 1,016.8 mm which is larger than the normalized rainfall with a frequency of 5 % (1,015 mm, Table 3). Therefore the rainfall in October 2005 was above the value for a 20-year return period. The number of rainy days in this month was 20 days continuously. In particular, the rainfall in 3 days (23–25 October) reached to a total of 566.5 mm (Fig. 10). However, no large landslides occurred during that month. The rainfall in November and December 2005 was 627.6 and 829.0 mm, respectively (Fig. 11). The rainfall in November 2005 is also a normal event. But the rainfall for December 2005 is very remarkable, and has a return period of 50 years. Therefore, all of the large landslides occurred in a month with an extraordinary high amount of rainfall. The unusual high amounts of rainfall in October and December make a total rainfall of 2,766 mm in the fourth quarter of 2005 which is likely to have a return period of 100 years.

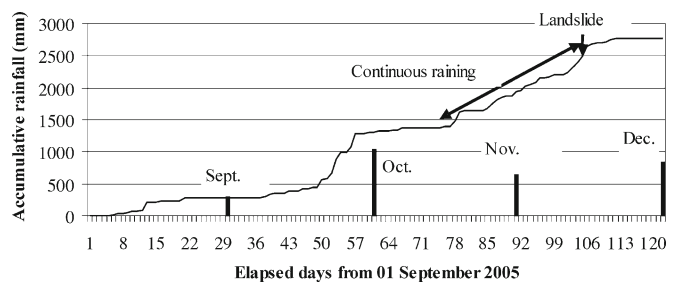
Fig. 11 Monthly and accumulative rainfall

The above results show that the landslides occurred after 3 months of heavy rain from September to December 2005. Heavy rainfall at the beginning of wet season (September and October) increased the water content of the soils but could not trigger landslides. In fact, the rainfall in October 2005 was even larger than in December 2005. As the results of slope stability analysis, we can predict that landslides were triggered when the slopes were almost saturated. The antecedent rainfall in October and November made soils and rock joint surfaces wetter, conditions that are more favorable for later showers to induce landslides. The total rainfall that triggered landslides was 1,260 mm, which occurred after about 1 month (17 November–15 December 2005) of heavy rains.

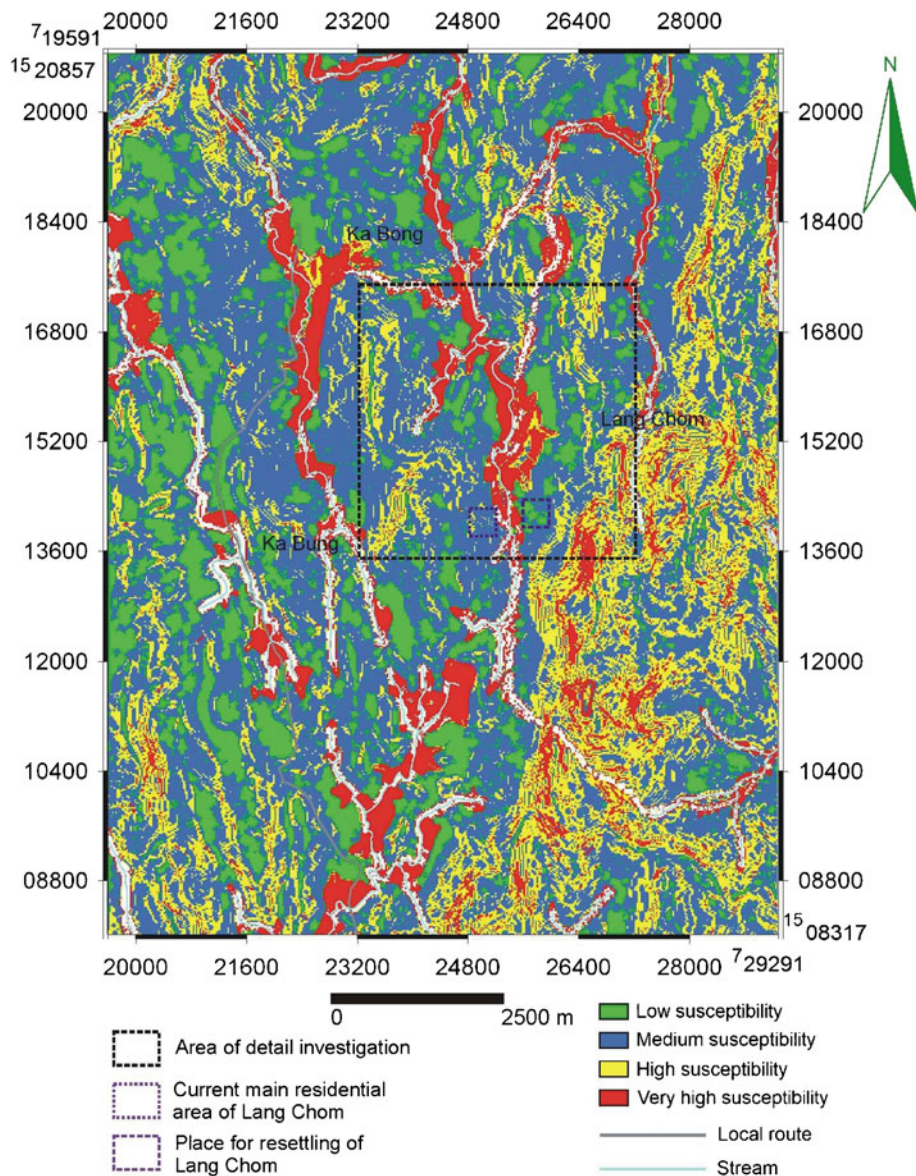
Fig. 12 Landslide susceptibility

Thematic maps of slope angle, aspect, and geology were overlaid by using ILWIS software. Pixels with size of 10×10 m were used. Based on the total score of these three factors, landslide susceptibility was divided into four levels with scores of 0–2, 3–4, 5–6, and 7–8 (Table 4). The results are shown in Fig. 12. It showed that areas of very high and high landslide susceptibility occupied only small portions of the area. However, a major proportion was distributed along streams and some routes because of steep excavated slopes. The map also provided an orientation and initial information for selection of resettlement sites.

To define suitable places for resettlement in the whole study area, a score-based method was applied to assess landslide susceptibility. It included four levels of low, medium, high, and very high susceptibility. The study results showed that main factors affecting landslide susceptibility include slope angle and faults. Based on the results of stability analysis (a fully saturated slope can fail at an angle of 28–30°), slope angles are classified into four categories with angles of less than 20°, 20–30°, 30–40°, and more than 40°, respectively (Table 4). The influence of faults includes two aspects. Firstly, the actual distance from the investigated point to a fault, which is categorized into four levels (Table 4). The second aspect was the difference between the strikes of the slope face and the fault plane. Plane failures were considered to occur if the slope face strikes parallel or nearly parallel to the fault plane ($\pm 20^\circ$) (Wyllie and Mah 2004). It has been called here “slope aspect” and was categorized into three levels, with the absolute value of difference of more than 20°, 10–20°, and less than 10°, respectively.

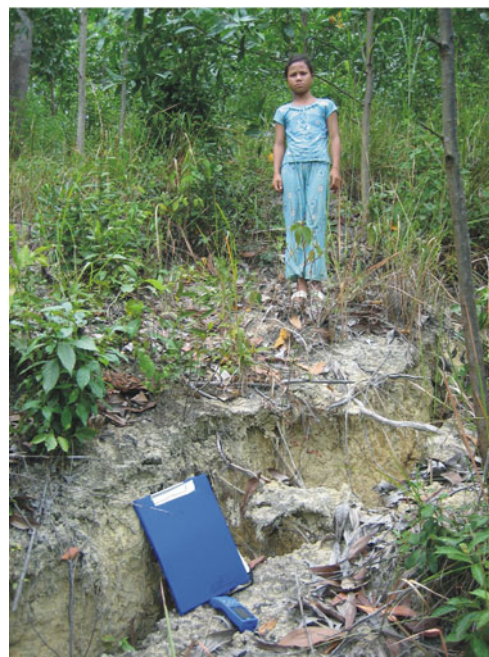
Fig. 13 Signs of potential landslides in Van Canh district (tension crack and scarp at the top)

Natural slope failure is normally a long-time process. The first sign of instability is a tension crack or scarp at the top of the potential slip surface. It is easy to recognize these signs (Fig. 13) because the local people usually carry out many activities on the slopes such as planting trees and feeding cattle. The signs can help to give an early warning of potential landslides and dangerous areas.
