BMC Musculoskeletal Disorders

Recurrent episodes of micturition with expulsion of symphyseal plate screws following pelvic ring fixation: case report

Keywords: Symphyseal plate screws, Traumatic symphyseal disruption, Urinary expulsion

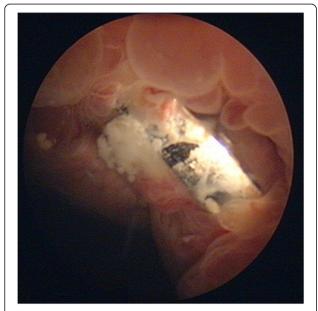
Fig. 3 Cystoscopy image with bladder perforation. Cystoscopy performed prior to plate removal and bladder repair showing perforation of the anterior bladder and intrusion of the posterior 4.5 mm DCPlate

Following eradication of the bladder infection, the patient had elective surgery for removal of the symphyseal plates and repair of the bladder ulceration. The previous Pfannsetiel incision was used for exploration. A pressure ulceration of the anterior bladder wall was contiguous with the posterior-superior plate which was protruding into the bladder and associated with multiple adhesions between the outer bladder wall, the pubic bones and the Retzius space. The plates were removed and the bladder was repaired primarily in a double layer, protecting the repair again with both suprapubic and urethral catheters. Bone cultures taken during the procedure showed growth of no organisms. A cystogram two weeks later was normal without leak and the catheters were removed (Fig. 4). Two months post removal, follow-up was normal and the patient denied any additional urinary symptoms and had sterile urinary cultures.

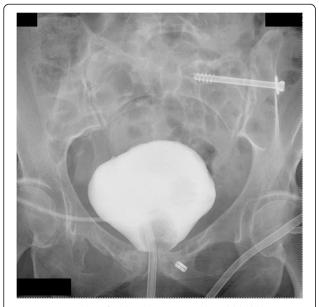
Fig. 4 Cystography after hardware removal and bladder repair. AP pelvic x-ray taken during cystography after symphyseal hardware removal and bladder repair shows no bladder leak. The cystoscopy shows the two urinary catheters used during the operative repair
