SEEKING CLARITY IN POSTHOLES:
AN EXAMINATION OF COLES CREEK EARTHFAST ARCHITECTURE

Honors Thesis
Curriculum in Archaeology
University of North Carolina at Chapel Hill

2015

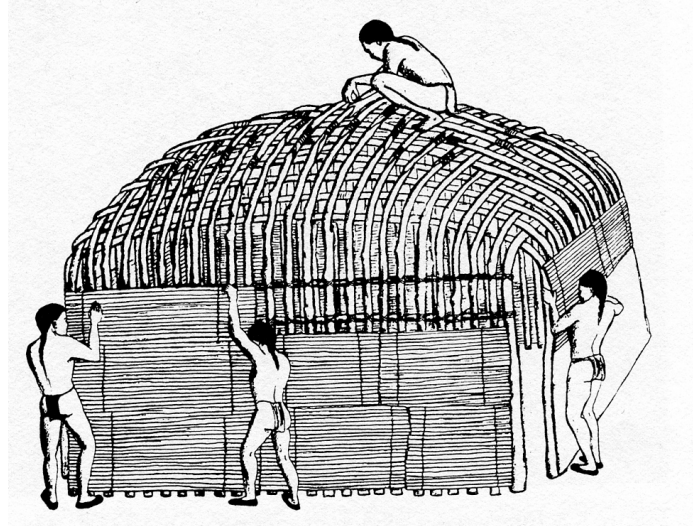
Figure 1. "Pole Construction" as illustrated by Lewis and Kneberg (1995: Figure 4.2).

(1995:55, 67). The former, called “pole construction,” was interpreted as having “unified wall and roof construction.” Termed “bent-post construction” in this study, this meant that long, flexible poles were placed in the wall trenches and bent over to form the roof, likely resulting in a dome-like shape (Figure 1). Lewis and Kneberg noted wedges within trenches that could have resisted the outward forces generated by the bent poles. They also cited examples of postmolds that were clearly bent inward within the wall trench. At the Hixon site, the charred poles were up to 25 feet long and were interwoven, clear evidence that these posts were bent over to form the roof (Lewis and Kneberg 1995: 56-60). The latter type of construction, termed “log construction” (“rigid-post construction” will be used elsewhere here) was interpreted as having rigid walls with roof beams attached above (Figure 2). Charred evidence suggested that wattle and daub was placed between wall posts. Many of the dwellings of log construction were built in shallow pits. Lewis and Kneberg noted that the pole buildings were common in earlier stratigraphic levels than the log buildings, suggesting temporal changes in construction methods within the Mississippi period (1995:67-68).

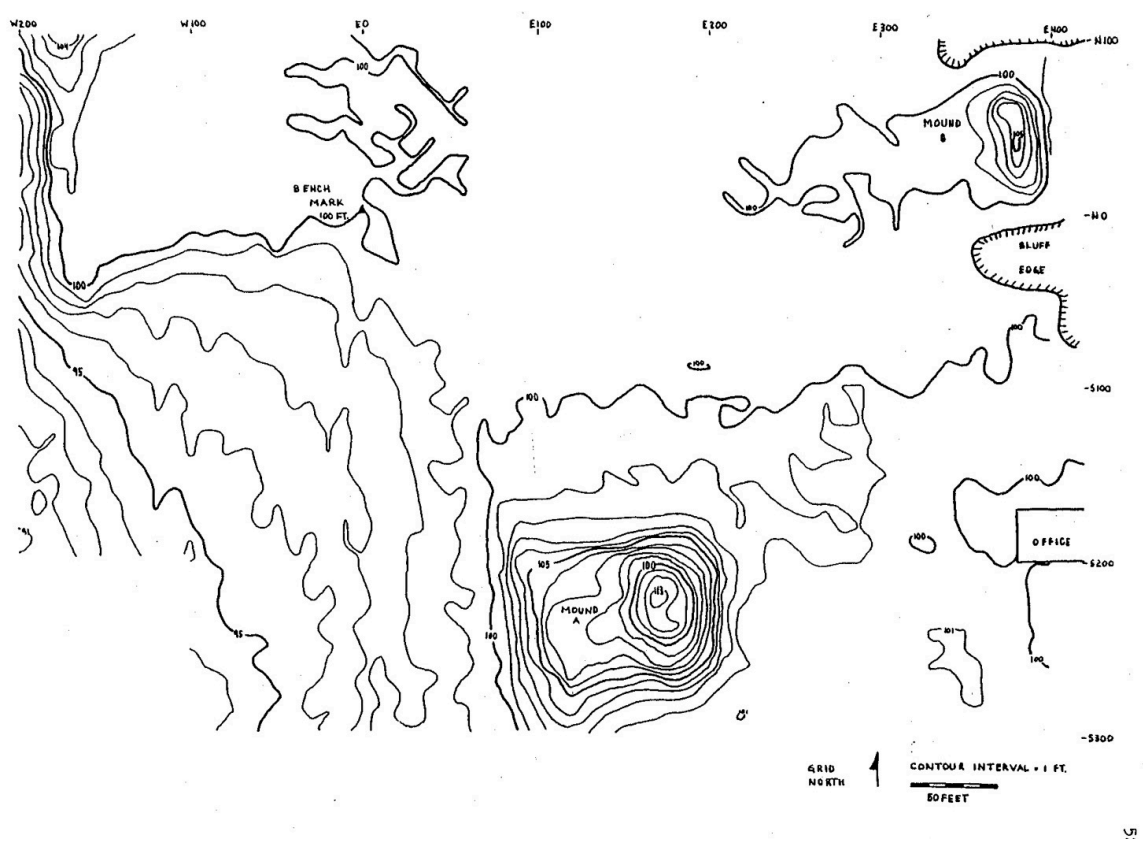
Figure 4. Baptiste site. Mound A is at center; Mound B is in the upper right. The area designated the "Village" is located between the two mounds. Excerpted from Whitmer (1987: Figure 25).

Baptiste site (Figure 4), located five miles south of the Marksville site in Avoyelles Parish, Louisiana, includes two small mounds. The site was under cultivation when excavated, so the mounds were not well preserved (Whitmer 1987:3). Despite cultivation, a total of 22 structures were identified at Baptiste, primarily found in a large excavated area between the two mounds (Whitmer 1987:122). All of these features were found at the bottom of the cultural deposits on the site, underneath or between the mounds, with the exception of two structures in Mound A (Whitmer 1987:124). On Mound A, the bottom portions of postholes were discovered

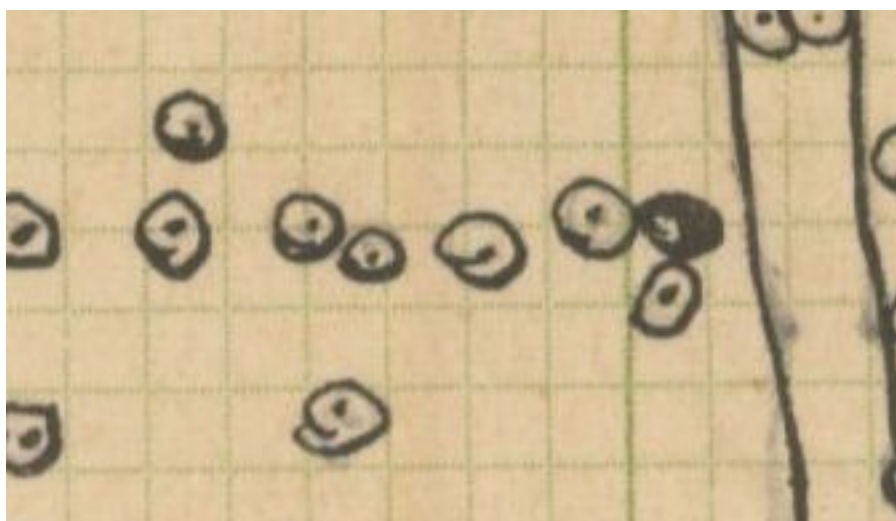
Figure 8. Detail from a feature map of Mound B at the Baptiste site (see also Figure 10). Excerpted from Map 388, Flat Map Collection, Louisiana State University Museum of Natural Science.

When high-resolution scans of structure maps from Baptiste site and Nick Farm site were obtained from Louisiana State University, it became clearly apparent how swiftly the posthole maps must have been drawn at WPA sites. It appears that the excavator, who drew the map, marked out the location of the center of the posthole on graph paper and quickly circled that point, leaving a general impression of posthole's size (Figure 8).

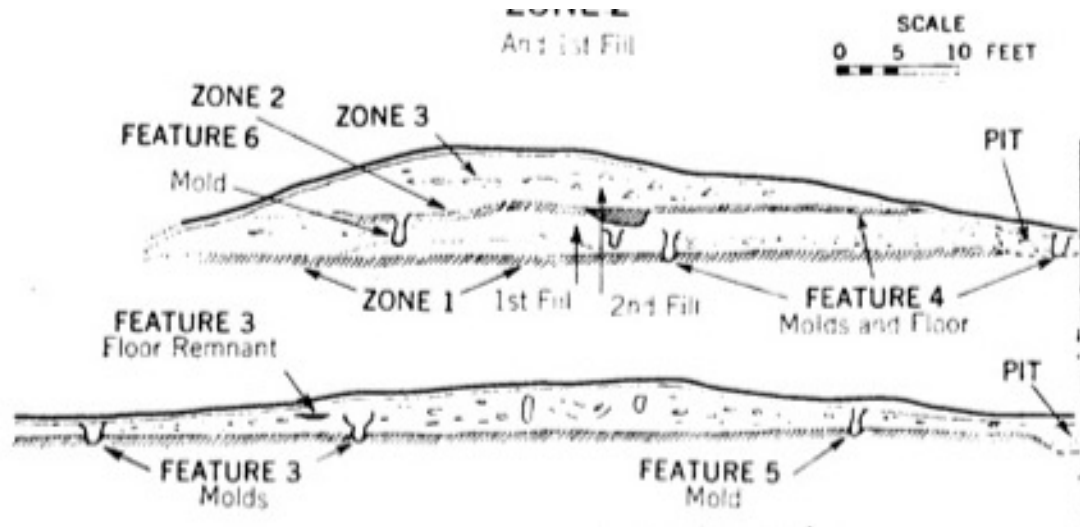
Figure 9. Profile of Mound B, Gordon site, showing slanted postholes (termed molds) with widened bases. Excerpted from Cotter (1952:Figure 53).

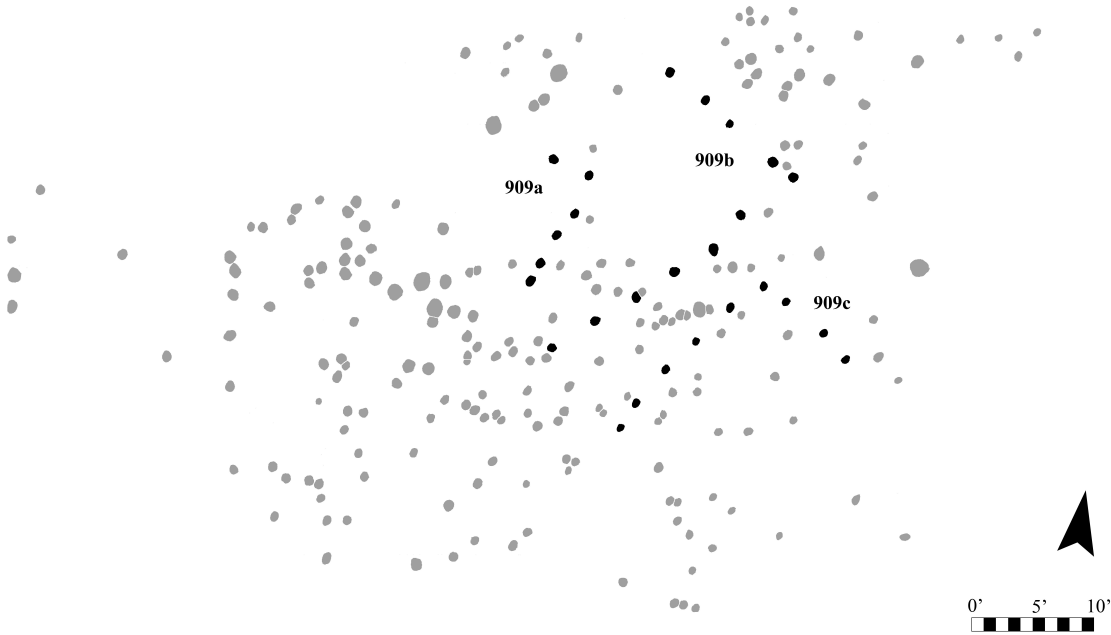
Figure 10. Feature 909, Mound A, Baptiste site. Discovered alignments are in black. Adapted from Map 533, Flat Map Collection, Louisiana State University Museum of Natural Science

alignments, although they fail to indicate clear buildings, support the idea that rectangular buildings once stood on this stage of Mound A. All three alignments suggest rigid-post construction, given the wide space between postholes. Postholes are in an intermediate zone between those of rigid-post and bent-post construction, based on parameters mentioned in the previous section. They feature widely spaced posts, but those posts are relatively narrow in dimension.

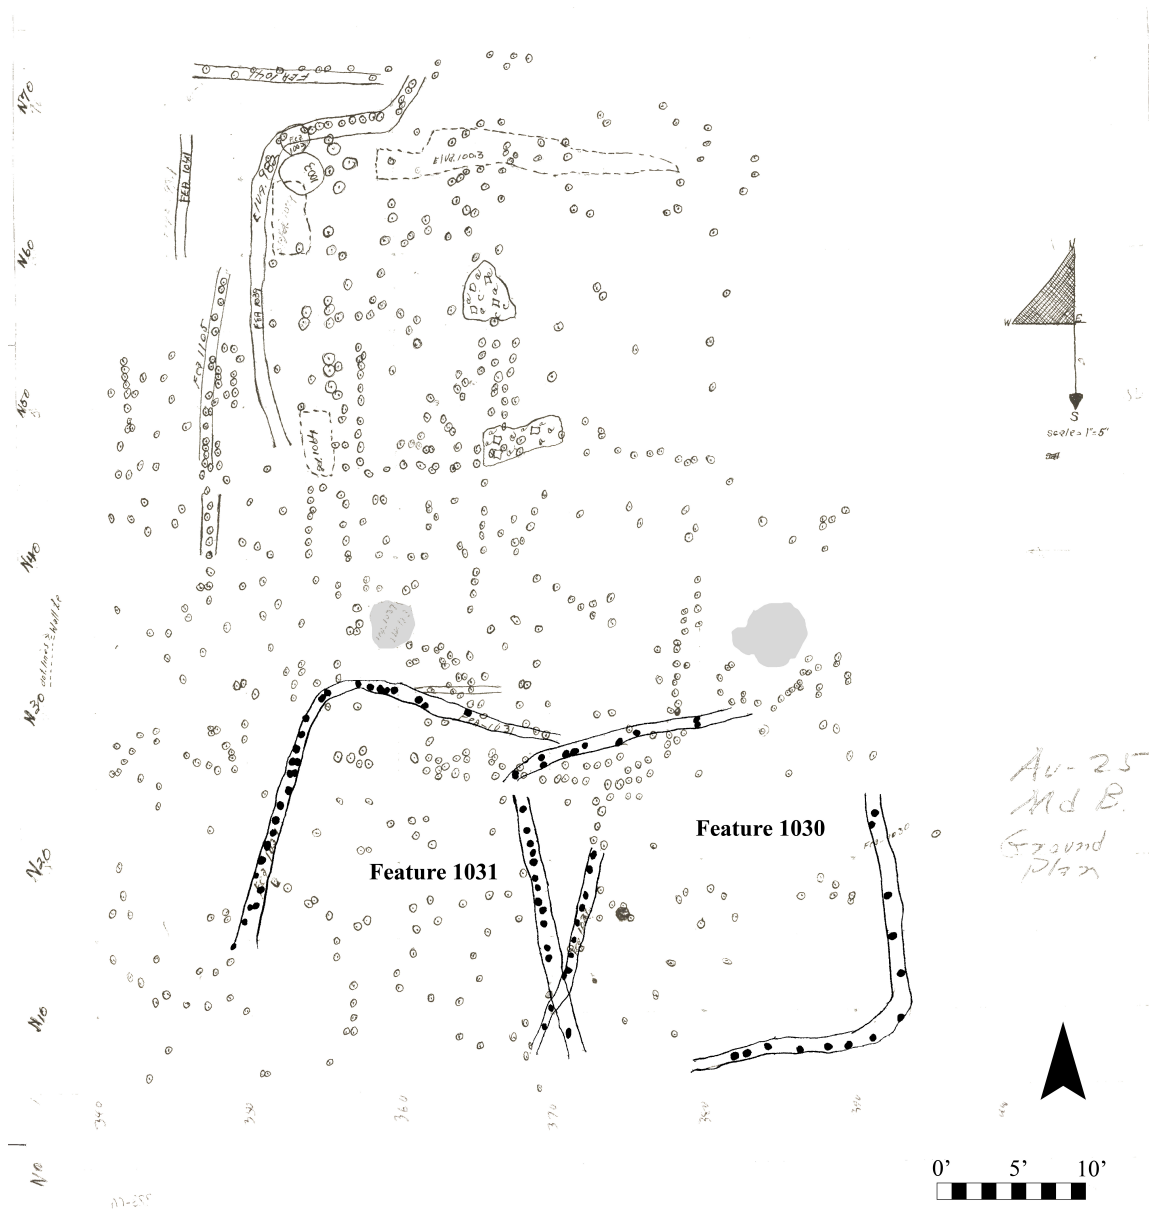
Figure 11. Features under Mound B, Baptiste site. Pit features associated with structures are colored gray. Adapted from Map 388, Flat Map Collection, Louisiana State University Museum of Natural Science.

Mound B featured extensive posthole evidence (Figure 11), including some post features found within wall trenches. These features revealed two clearly differentiated structures toward the south end of the mound (Features 1030 and 1031). Evidence for further structures was unclear but featured posts of similar diameter and spacing to those to the south of the mound. Given the clarity the two southern structures, these were taken as representative of other structural evidence on the mound, and further analysis of the post features found on Mound B was left to future study. Associated with some of the other possible structures were two patches of wattle (Whitmer 1987:Table 16).

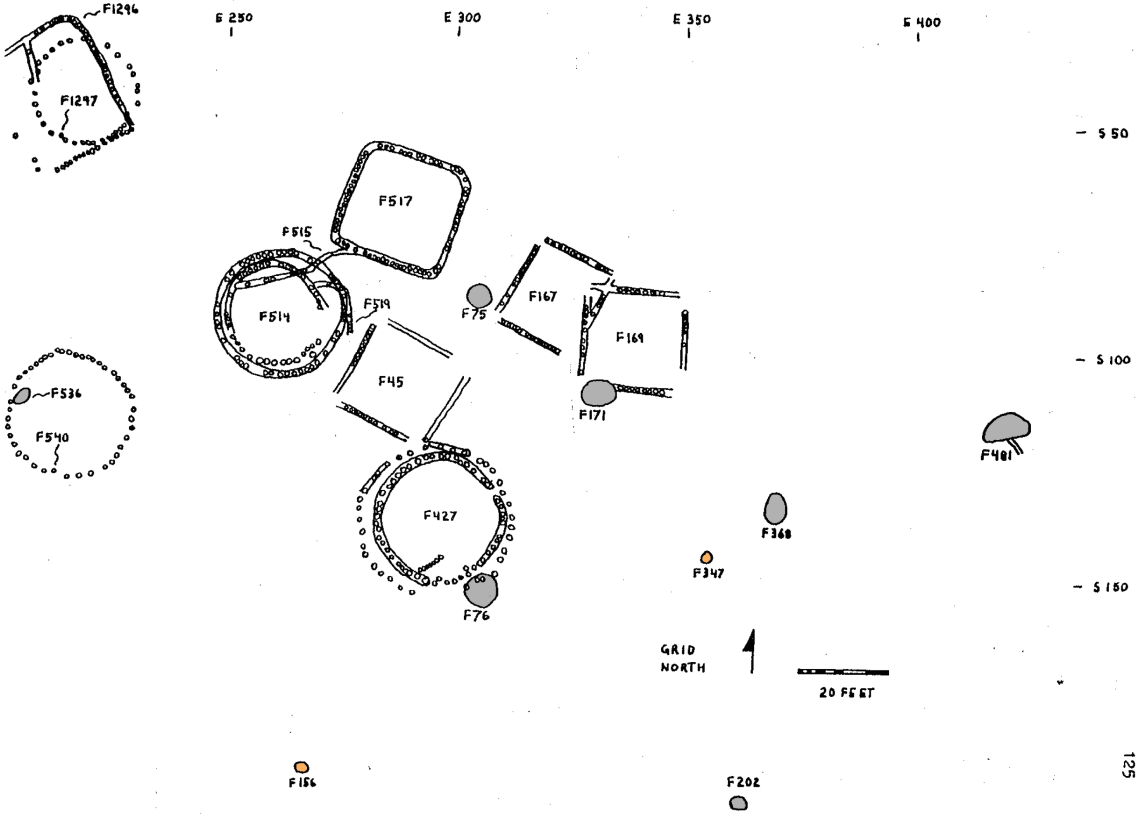
Figure 12. Baptiste Village. Hearths are colored orange; pit features are colored gray. Adapted from Whitmer (1987:Figure 39).

A well-made fire basin, four feet deep and two feet wide, was found on the floor of Level 7 (Ford 1951:36). If such a hearth was generally only found indoors, this would be strong evidence of the existence of a roofed structure. However, these sorts of fire basins are occasionally in outdoor settings, as indicated in the Village at Baptiste site (Figure 12).

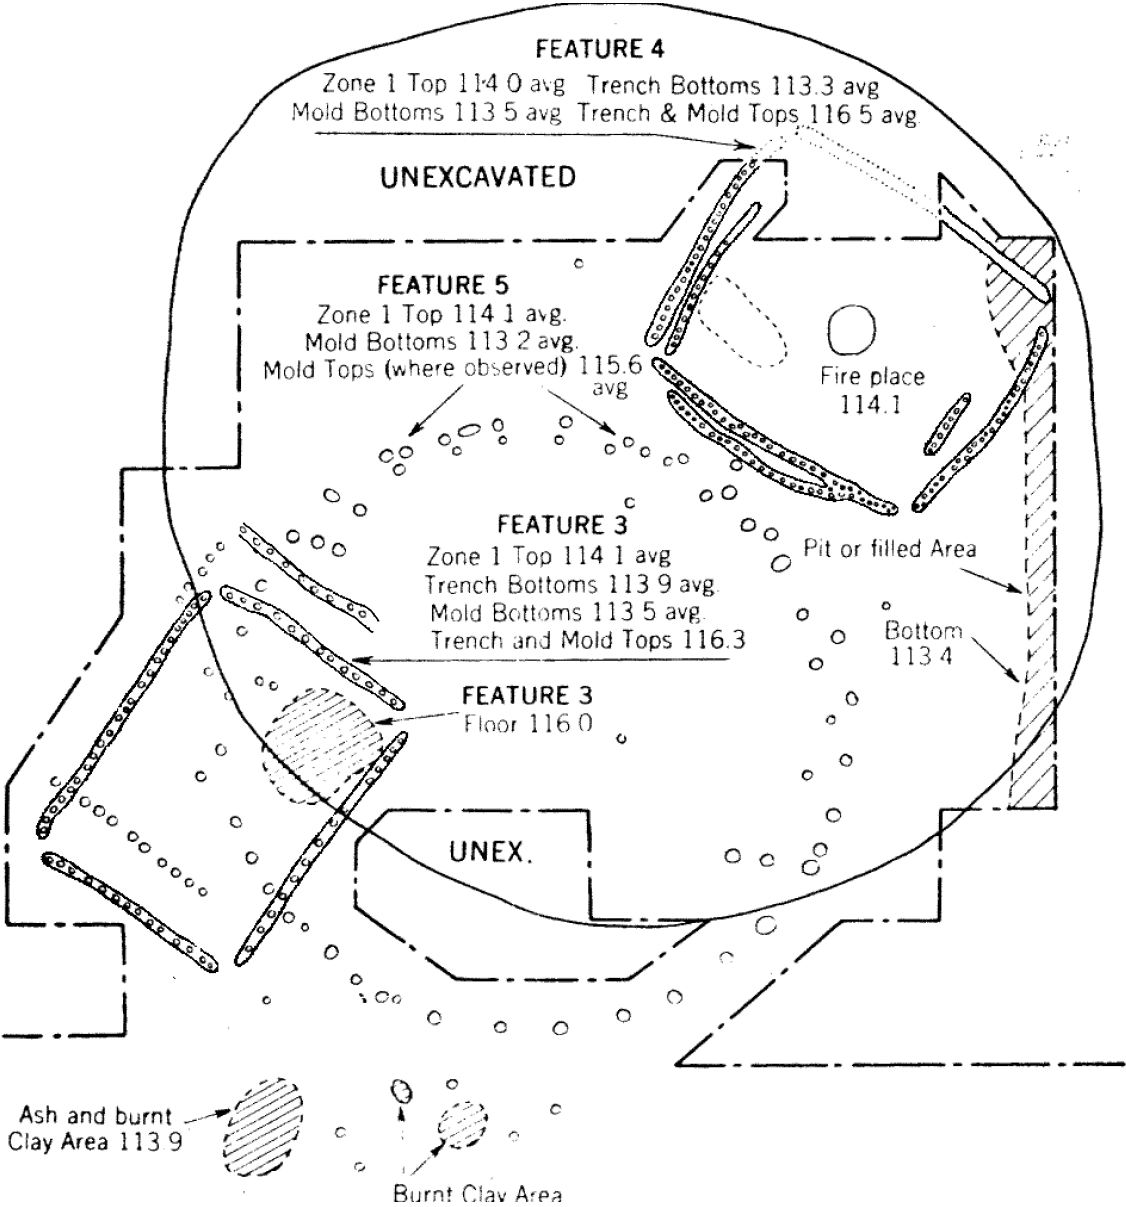
Figure 13. Architectural Evidence from Mound B, Zone 1, Gordon site. Excerpted from Cotter (1952:Figure 53).

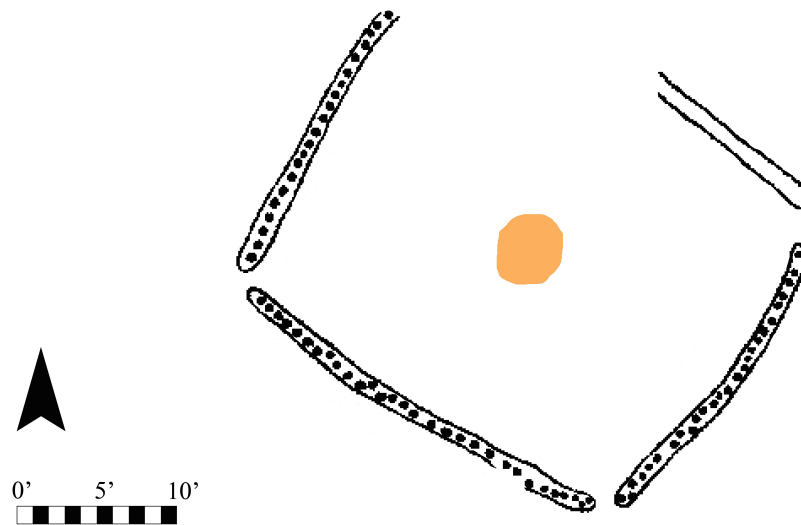
Figure 15. Feature 4a, Mound B, Zone 1, Gordon site. A hearth, possibly associated, is colored orange. Adapted from Cotter (1952:Figure 53).

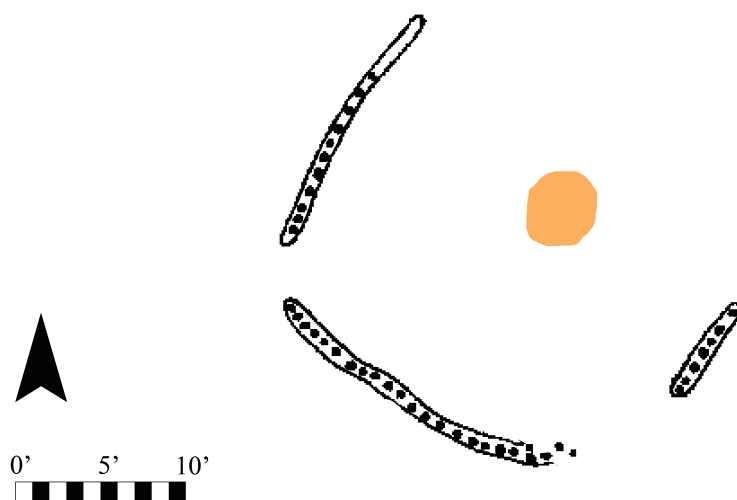
Figure 16. Feature 4b, Mound B, Zone 1, Gordon site. A hearth, possibly associated, is colored orange. Adapted from Cotter (1952:Figure 53).

free of postholes, which indicates that no roof was present, especially given the size of the structure. All evidence points to this structure being a circular enclosure of large posts. The precise geometry of the enclosure is remarkable.

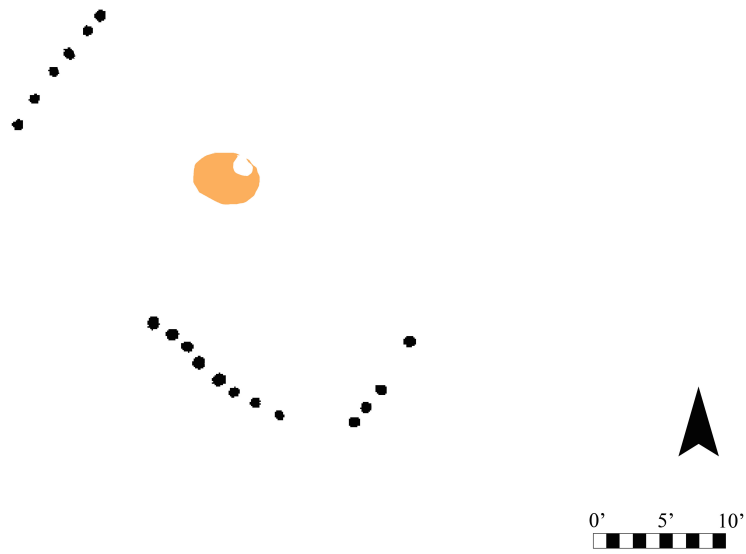
Figure 19. Feature 6, Mound B, Zone 2, Gordon site. A hearth, possibly associated, is colored orange. Adapted from Cotter (1952:Figure 53).

discovered during excavation. The basin may still be associated, as the postholes were probably discovered below the original mound surface. Based on the post size (accounting for some overestimation due to map processing) and spacing obtained from the published map, Feature 6 lies in the middle between bent-post and rigid-post construction. Given no evidence of support posts and the open-corner arrangement of posts, which would have aided in bent-pole construction, it seems more likely that Feature 6 had a bent-post form.

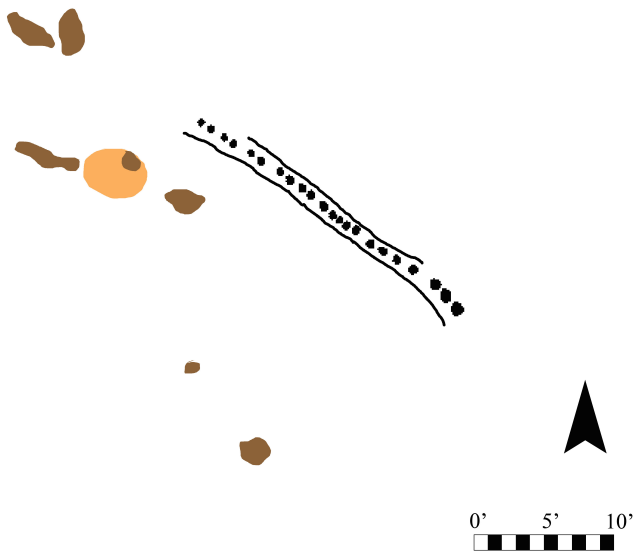
Figure 20. Feature 7, Mound B, Zone 2, Gordon site. A hearth and burials, possibly associated, are colored orange and brown, respectively. Adapted from Cotter (1952:Figure 53).

Feature 7. This feature (Figure 20) is a row of postmolds within a wall trench. The postmolds are an average of 7.6 inches wide, spaced by an average distance of 5.8 inches. This means that the postmolds are positioned in a manner that would describe bent-post architecture but are too large to hold flexible posts. This is a problem that seems universal at Gordon site and is probably the result of imprecision in map analysis, rather than the actual characteristics of the prehistoric structures. These postmolds were found beginning 2.8 feet above those of Feature 6 in the mound fill. This structure may have been associated with a hearth, as well as a number of burials found in the fill below.

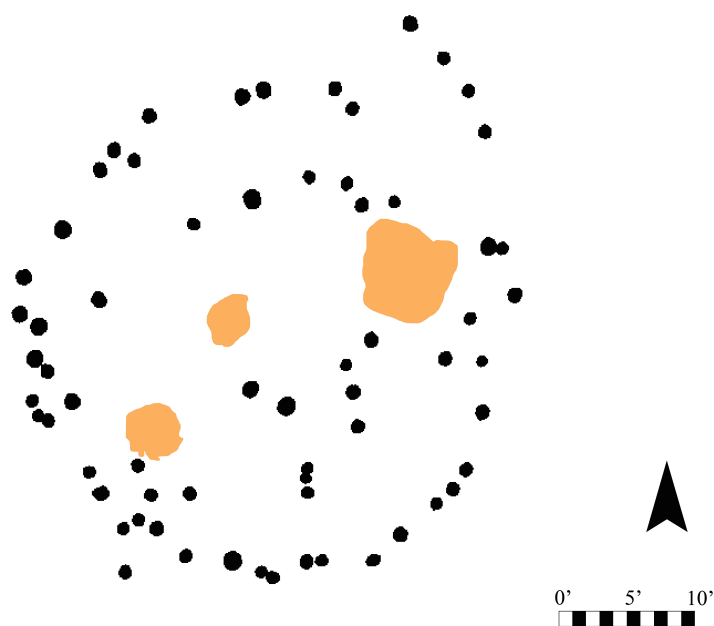
Figure 22. Greenhouse Mound A, Building Level 6. Areas of burned are clay colored orange. Adapted from Ford (1951:Figure 6).

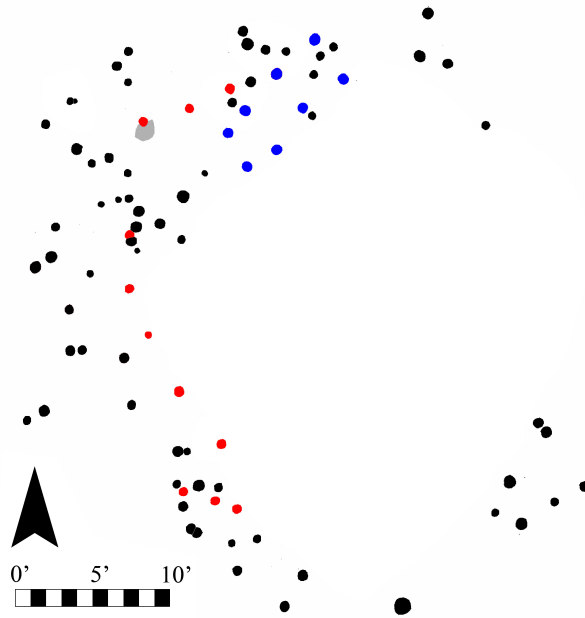
Figure 25. Greenhouse Mound F, Building Level 1, with all sub-floor posts removed, showing discovered alignments. Alignments of posts between 6 and 8 inches in diameter are colored red. Alignments of larger posts are colored blue. A small pit is indicated in gray. Adapted from Ford (1951:Figure 9).

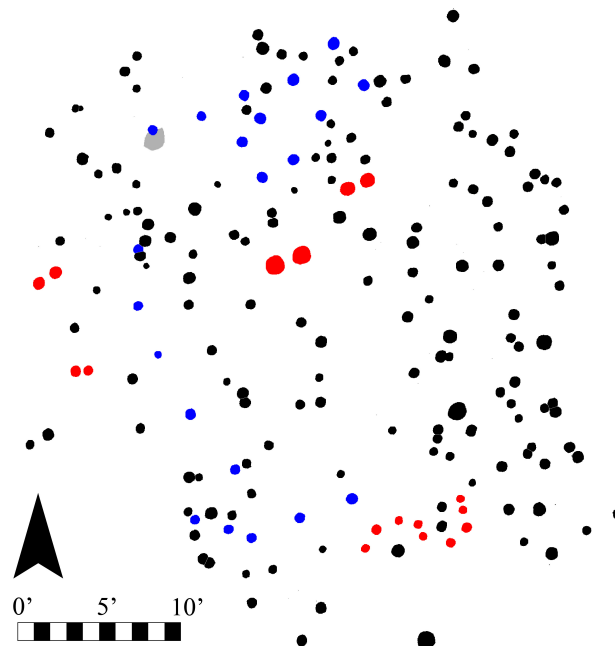
Figure 26. Greenhouse Mound F. Building Level 1. This image shows paired posts and an S-shaped alignment in red. Alignments from Figure 25, extended with additional posts, are colored in blue. Adapted from Ford (1951:Figure 9).

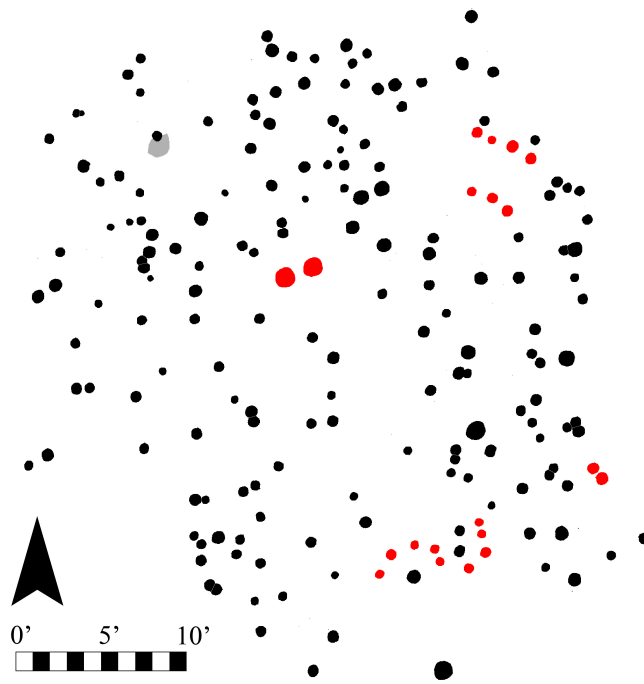
Figure 27. Greenhouse Mound F, Building Level 1. Alignments and possible paired posts resulting from Prezzano analysis are colored red. Adapted from Ford (1951:Figure 9).

Prezzano's methods were also applied to the postholes on this level (Figure 27). Linkages of certain lengths, between postholes within defined diameter ranges, again linked some of the identified pairs of postholes. Links between posts less than nine inches in diameter spaced less than 1.5 feet apart revealed a few parallel alignments in the northwest part of the map. The links also verified the S-shaped alignment to the south of the map. This analysis was unsuccessful at finding any longer alignments that clearly delineated a structure. Perhaps some of the small alignments, such as those in the northwest and the "S" shaped pattern to the south, represent light constructions, such as screens and racks, rather than buildings. The parallel alignments to the northwest could represent successive screen construction. Some of the largest posts, sometimes arranged in pairs, could be evidence of ritual post-setting.

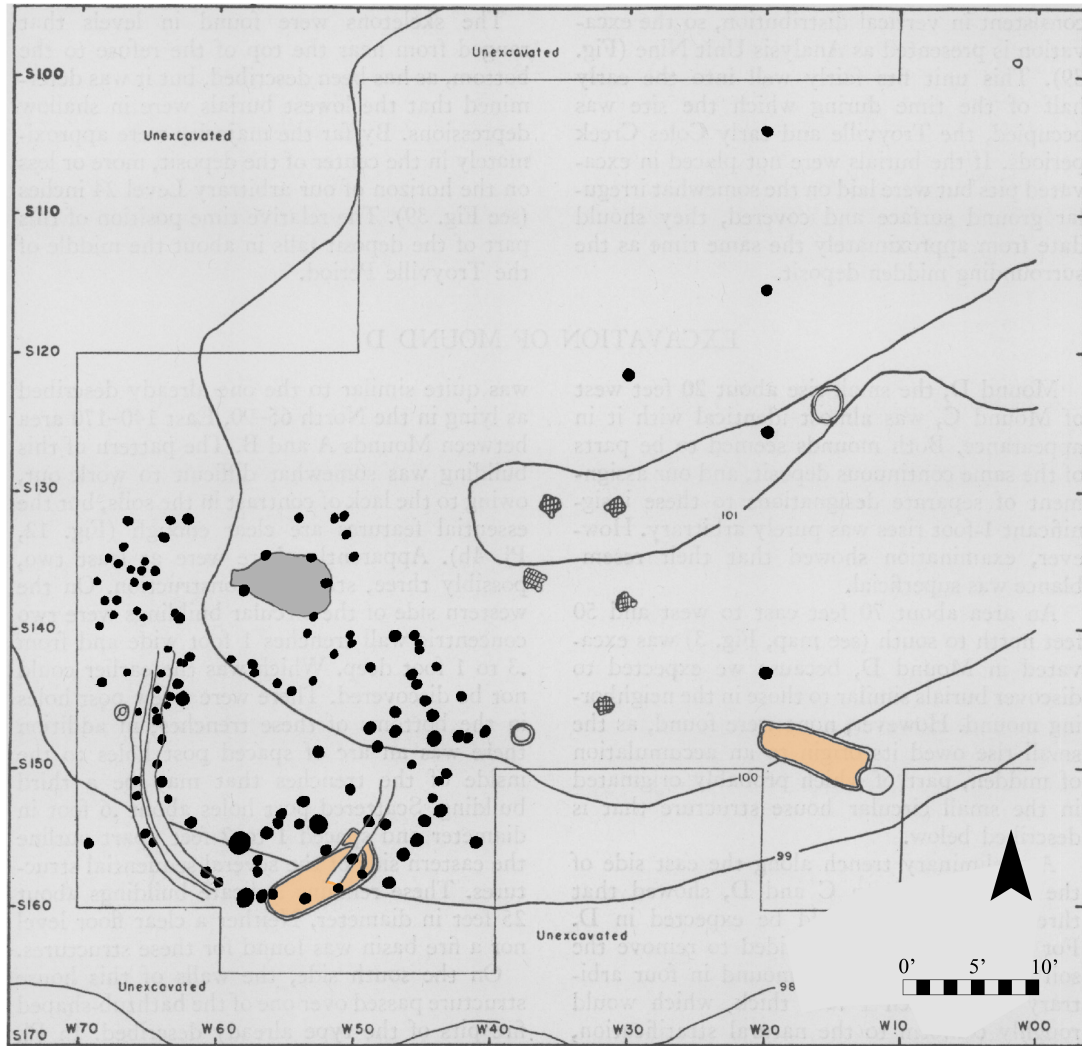
Figure 29. Features under Greenhouse Mound D. Pit features are colored gray. Bathtub-shaped pits are colored orange. Adapted from Ford (1951:Figure 12).

Mound D Submound. A circular structure (Figure 29) was evident underneath Mound D that featured posts with an average eight inches in diameter and spaced an estimated median of 8.5 inches apart. The structure had an approximate diameter of 30 feet. These posts were at least partially placed in wall trenches, and the presence of multiple wall trenches to the west and south of the structure likely indicates rebuilding. Posts overlay a bathtub-shaped pit to the south, and a pit to the north, part of evidence of frequent cultural activity underneath Mound D (Ford 1951: 45). Large posts with a diameter of over 15 inches lie within the southern portion of the structure. They may precede or supersede the structure, given their incongruous diameter, and not be contemporaneous with the other postholes.

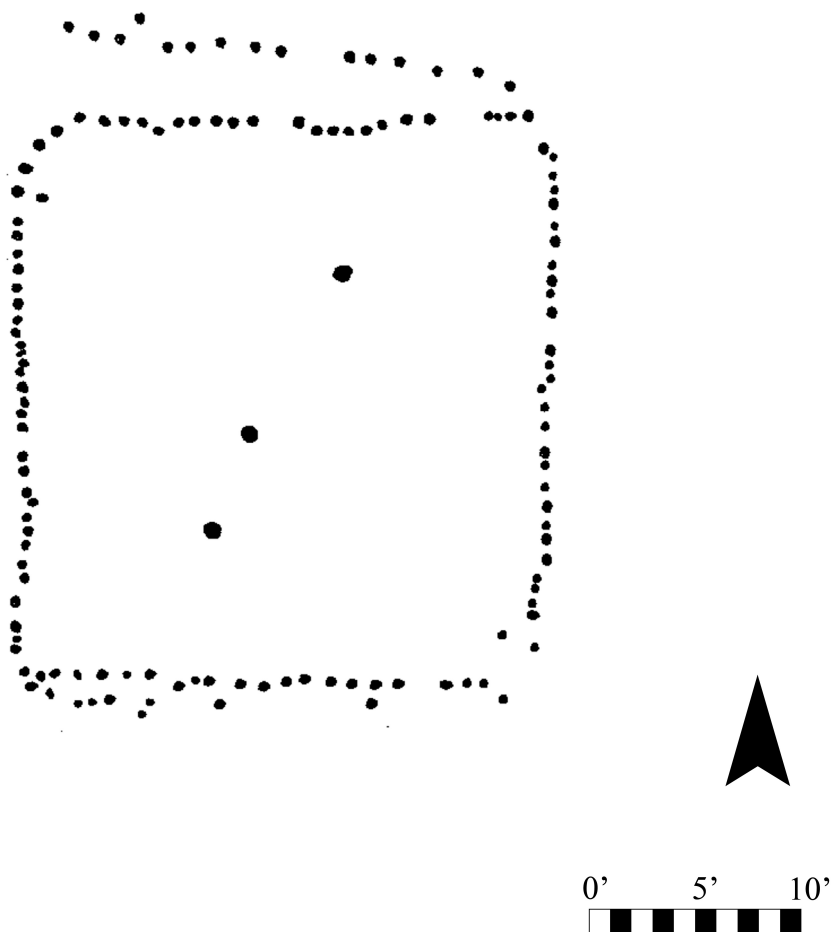
Figure 30. Feature 274, Mound A, Nick Farm site. Adapted from Schwab (1998:Figure 2).

Feature 274. This structure (Figure 30) has a rectangular form with postholes of a median 6.6 (6) inches in diameter, with a median spacing of 3.9 inches (2-6 inches). The structure has dimensions of about 26 feet by 24 feet, with closed corners. Three postholes in the middle of the structure were greater than 10 inches in diameter. These may have held supports of some kind, but they were asymmetrically placed within the structure. A line of postholes spaced wider than the postholes of the wall itself—at a median 11 (6-12) inches apart—ran west from the northeast corner of the structure. Schwab interprets this as a possible windscreen or privacy wall for an entrance (Schwab 1998:22).

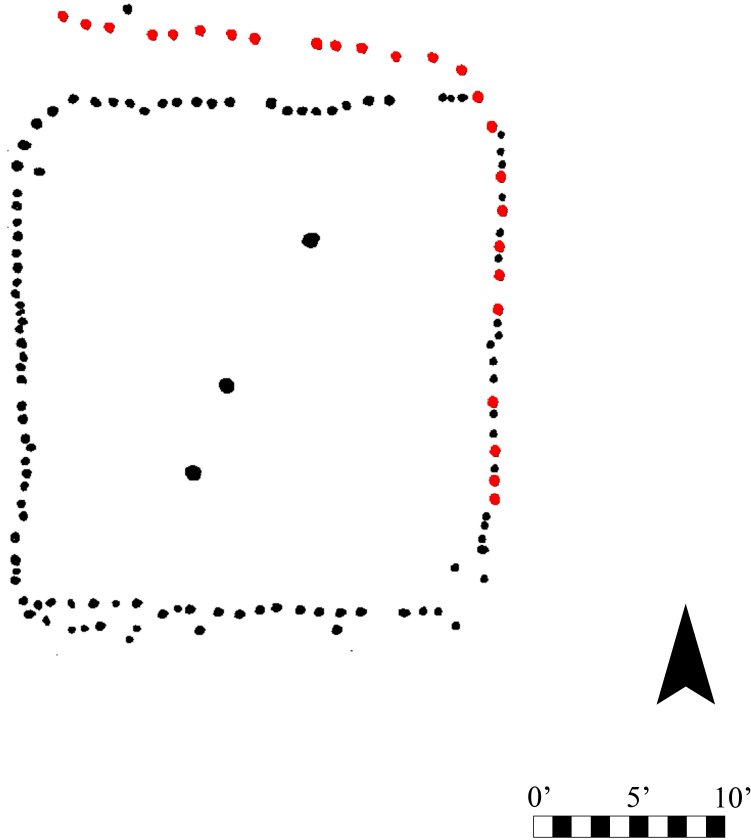
Figure 31. Posts (in red) with diameters greater than six inches extend into the eastern wall of Feature 274 from the extraneous wall. Adapted from Schwab (1998:Figure 2).

between the extraneous and eastern walls may lend some insight into the construction of the dwelling. Perhaps, rather than a windscreen, the extraneous line of postholes represented an aborted wall, for which posts were pulled when the line of posts was adjusted to a more appropriate angle.

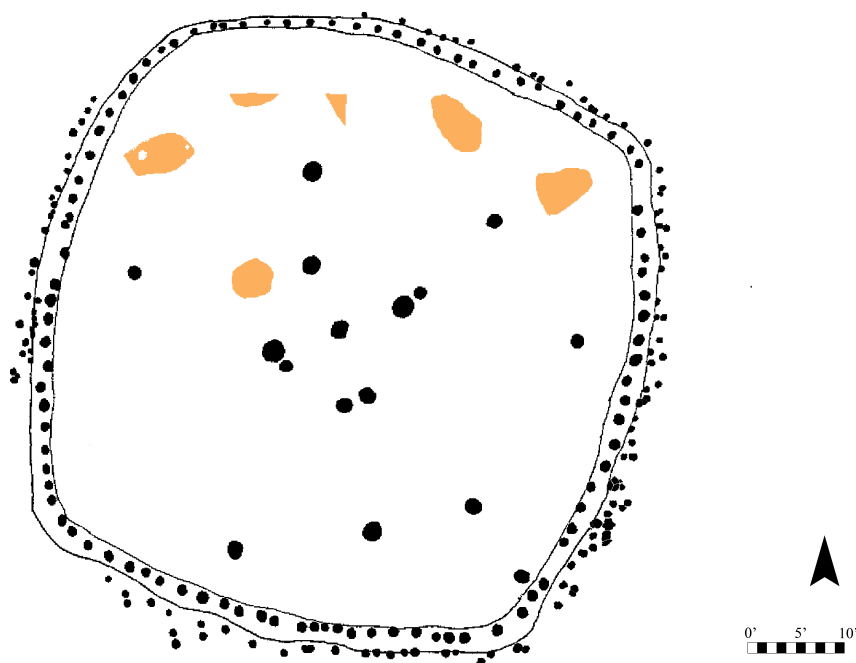
Figure 33. Feature 10, under Mound B, Nick Farm site. Hearths, possibly associated, are colored orange. Adapted from Schwab (1998:Figure 4).

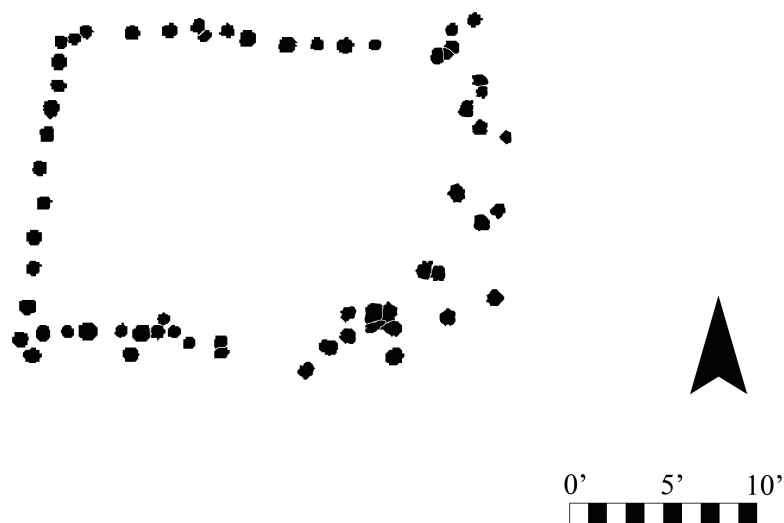
Figure 35. Feature 168, under Mound B, Nick Farm site. East wall obscured due to intrusion from Feature 10. Adapted from Schwab (1998:Figure 4).

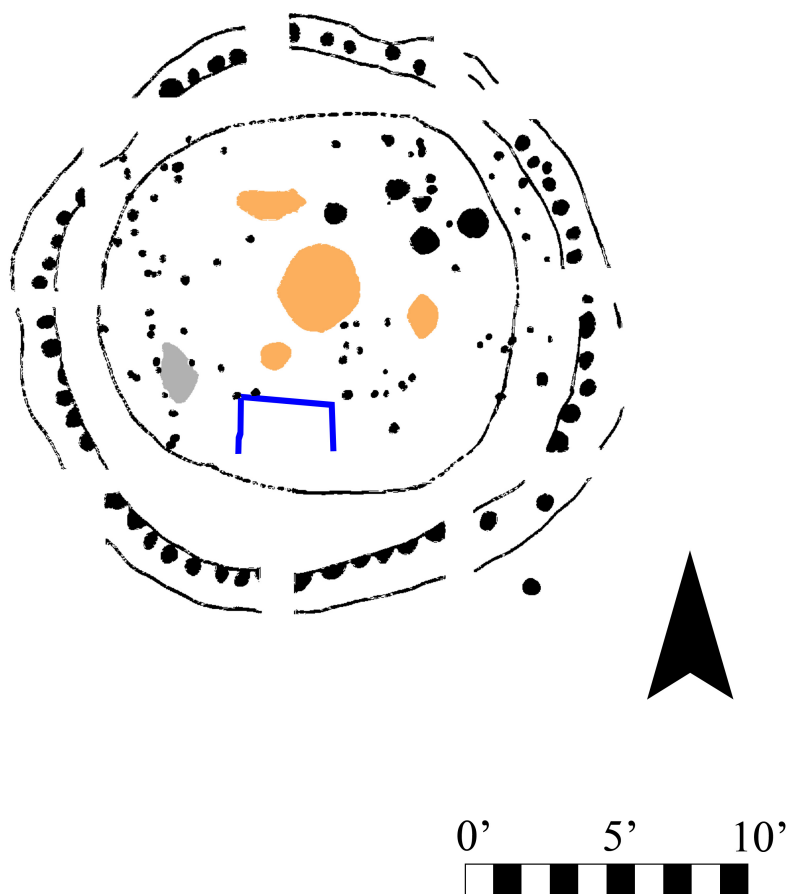
Figure 36. Feature 3 under the mound at St. Gabriel site. The clay embankment is outlined to the inside of the wall trench. The hearth and burned areas are colored orange. The ramp is outlined in blue. Gaps in the map are areas within balks. Adapted from Woodiel (1993:Figure 13).

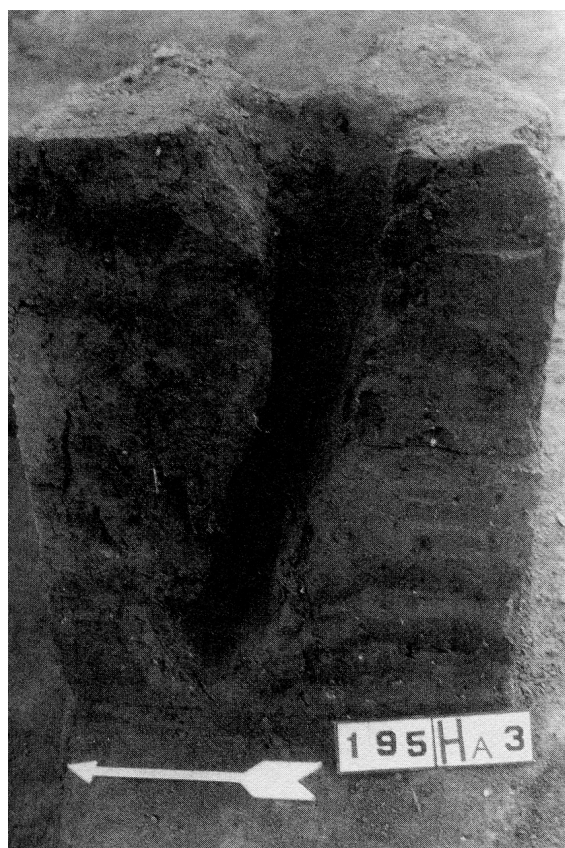
Figure 37. Outward-leaning postmold from house 65 at the Hixon site, Tennessee. The associated structure featured bent-post wall trench construction. Horizontal wedges on the inside of the post left the post in this position, once tension was applied. Excerpted from Lewis and Kneberg (1995:Figure 4.1).

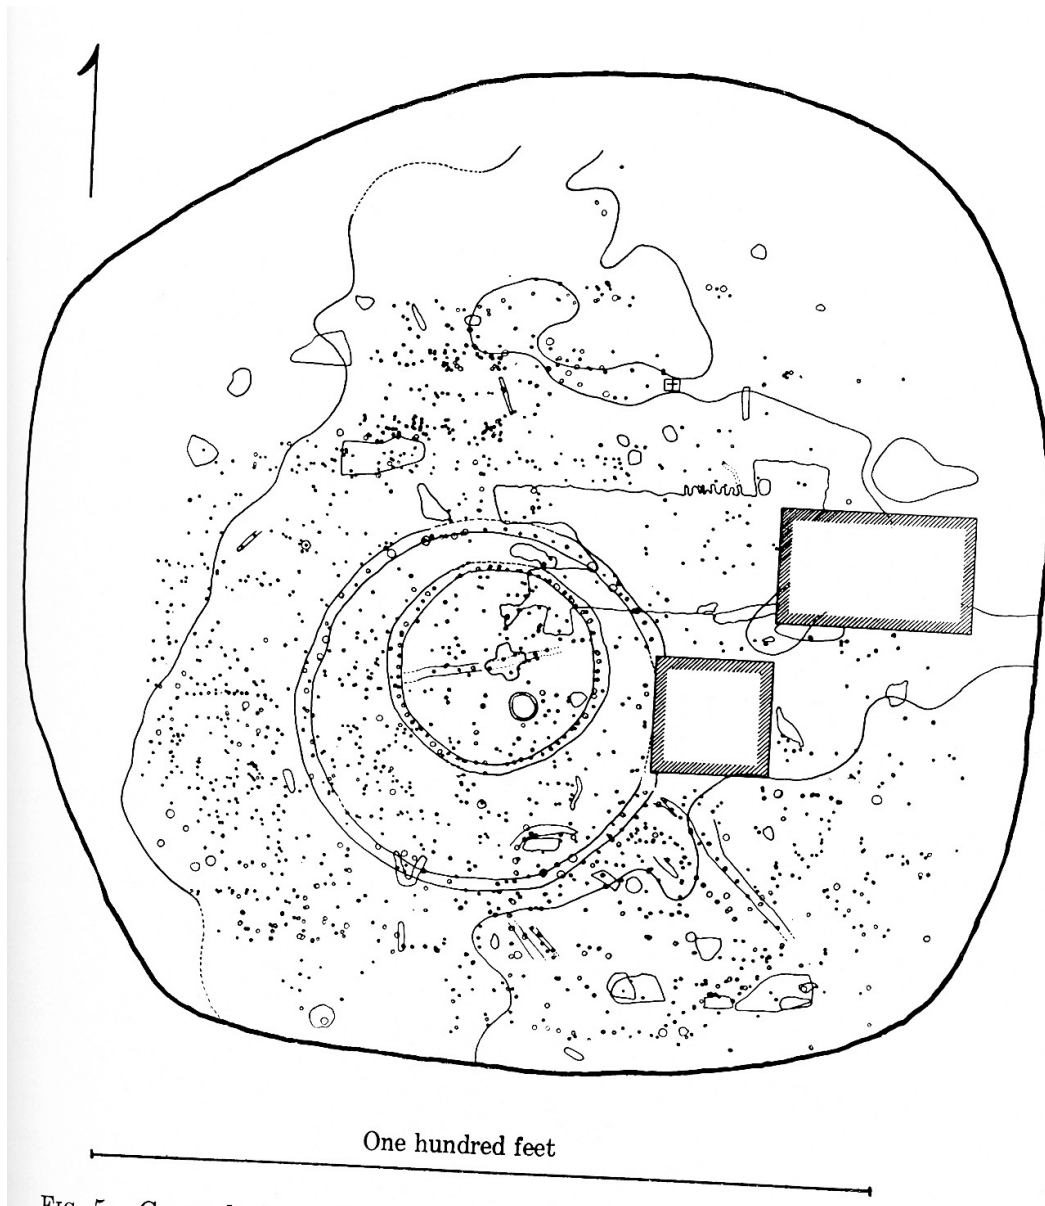
Figure 38. Features found at Level 1, Mound A, Medora site. The interior wall trench includes a cruciform hearth and a circular platform to the south. Adapted from Quimby (1951:Figure 5).

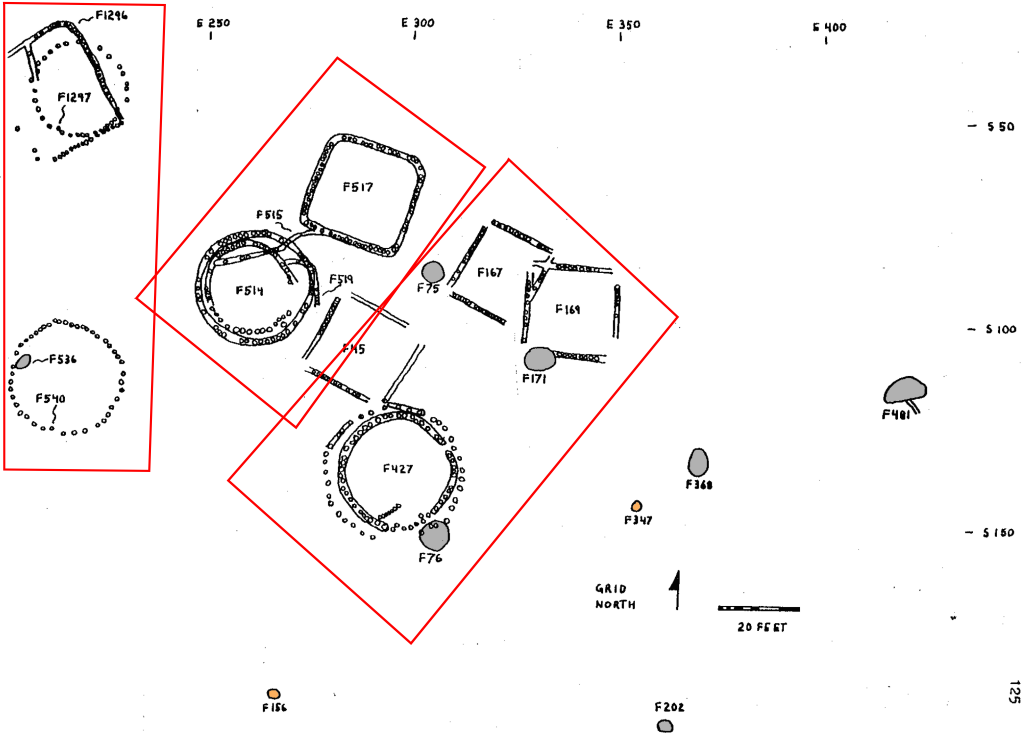
Figure 39. Baptiste Village, with structures divided into possible households. Adapted from Whitmer (1987:Figure 39).
