# Hydro-sedimentological Monitoring and Analysis for Material Sites on the Sagavanirktok River

2015–2016 Data Report

**Prepared for the  
Alaska Department of Transportation and Public Facilities**

Report INE/WERC 16.02

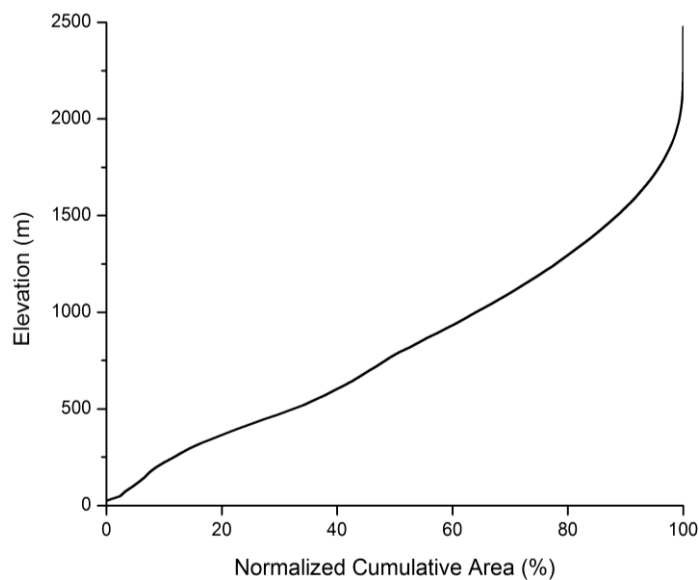
Figure 2. Hypsometric curve for the Sagavanirktok River basin.

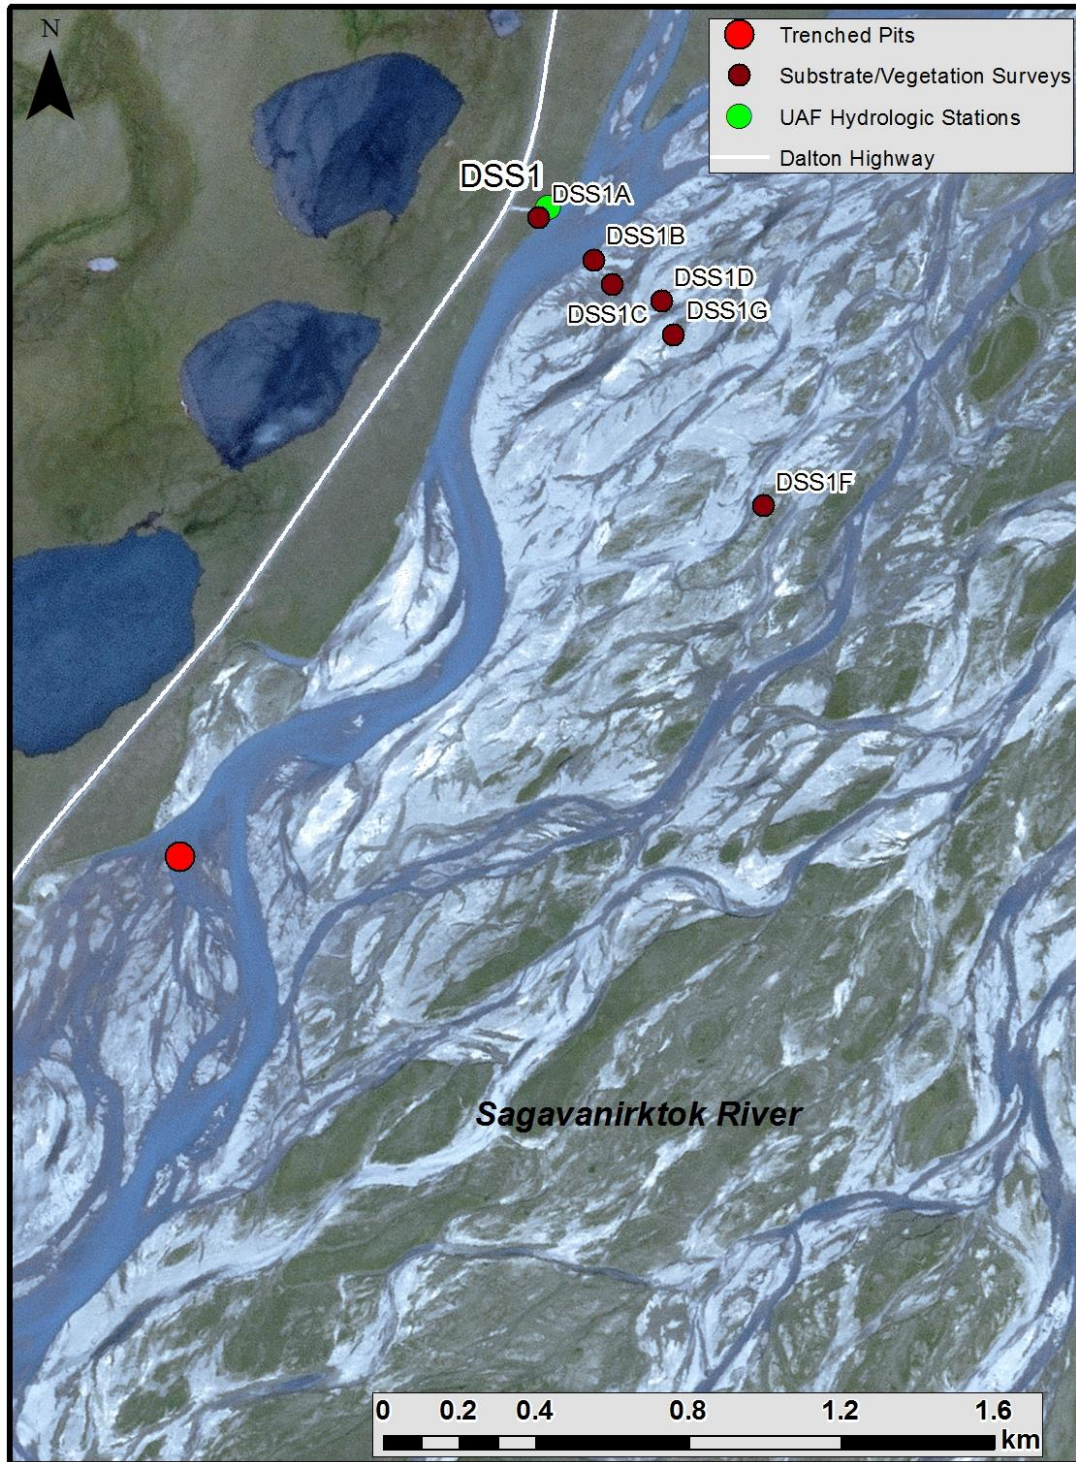
Figure 3. Study area DSS1, Sagavanirktok River Site 042, near Deadhorse and Dalton Highway MP 405. Flow direction is from bottom to top.

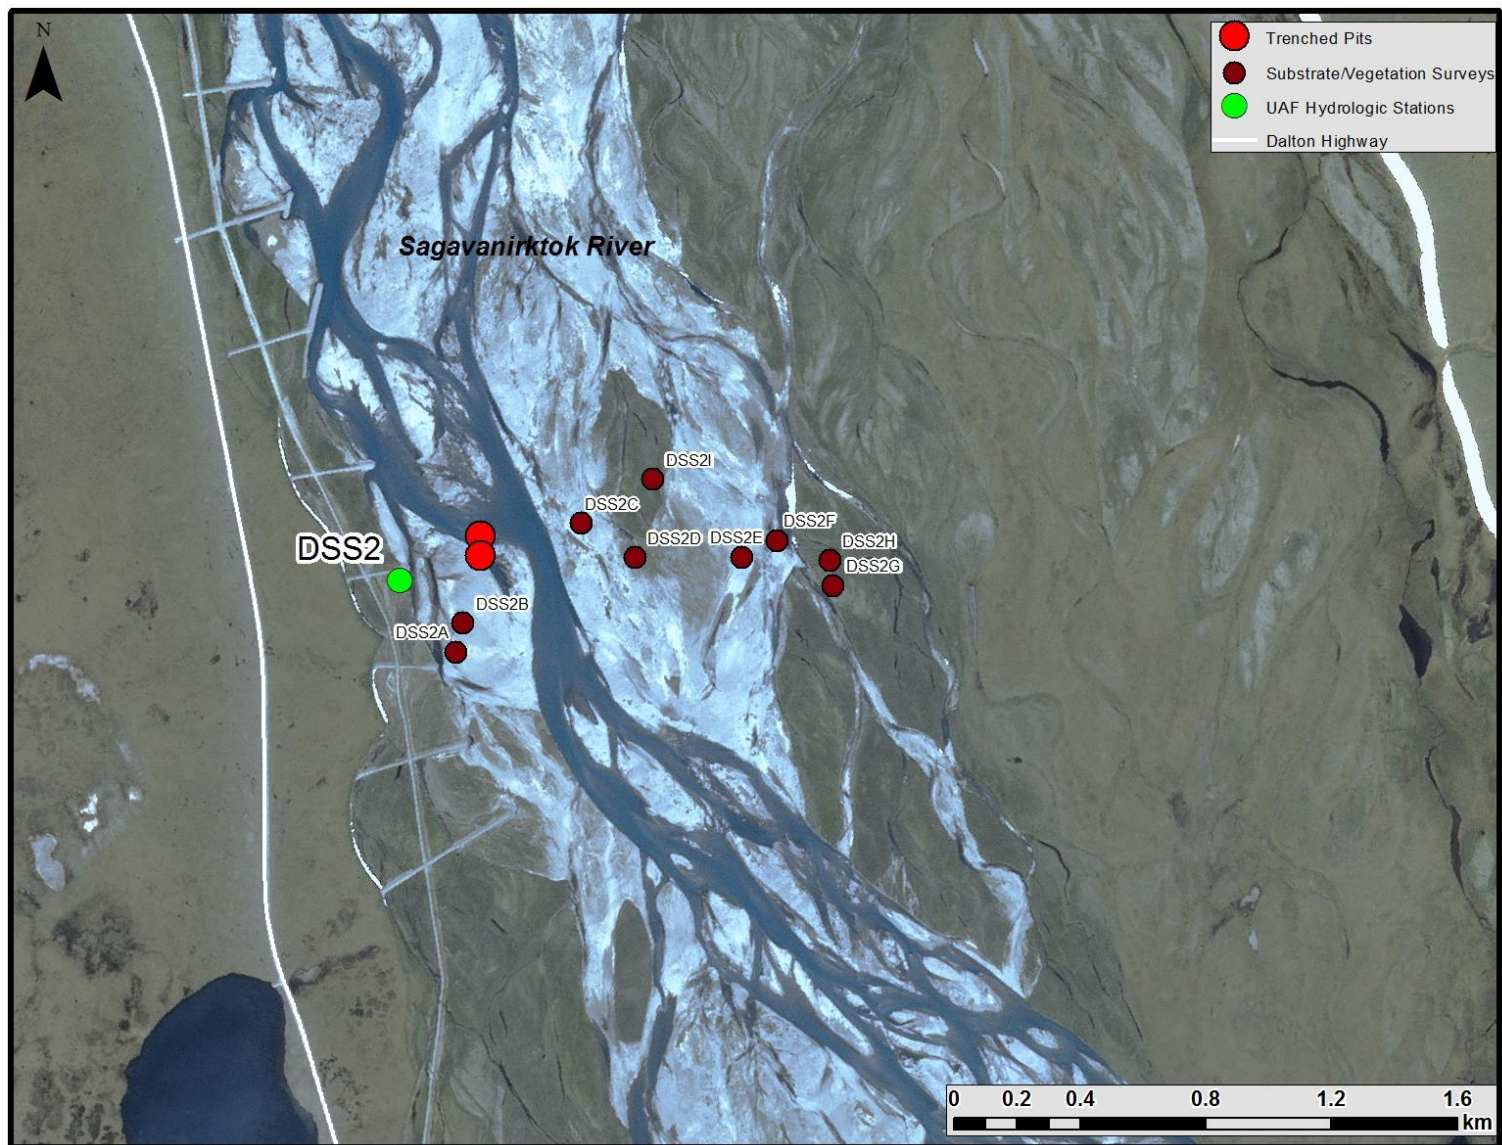
Figure 4. Study area DSS2, Sagavanirktok River below the Ivishak confluence. Flow direction is from bottom to top.

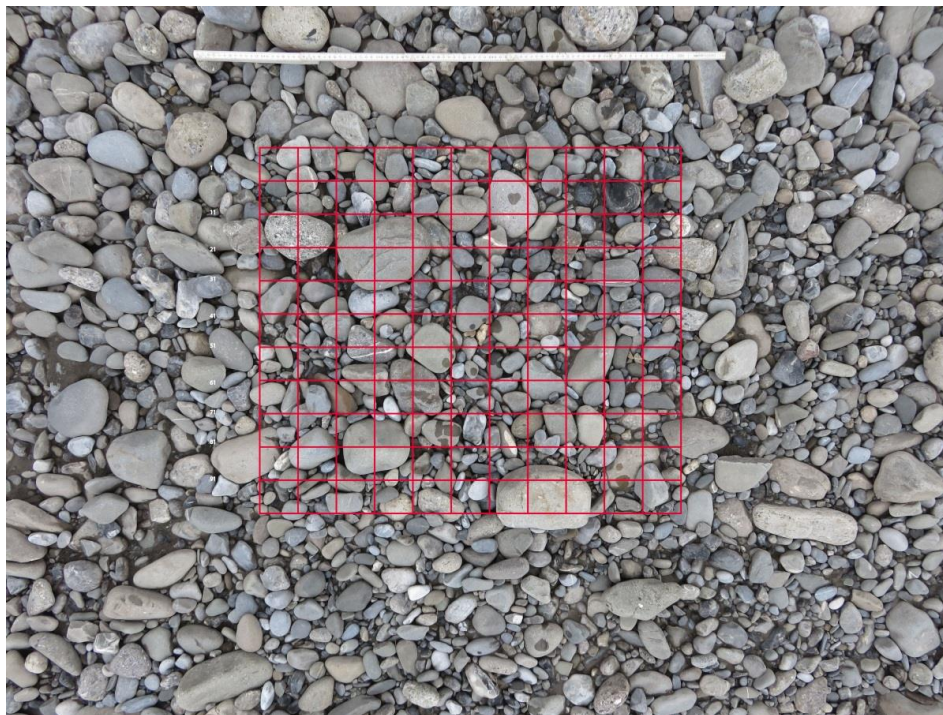
Figure 7. Example grid and 1-meter ruler used to measure grain size.

Additional photographs were analyzed with the automated software to compare with results from a manual technique described as follows: One hundred grains from each photograph were selected by overlaying a 10 by 10 grid and using the grid intersections to select particles (Figure 7). Large grains located under more than one grid intersect were measured only once, and then labeled as repeats for subsequent intersects. The outer gridline intersects were used to select the number of grains needed to reach the target of 100 measurements per photograph. The *b*-axis of all the particles was measured in pixels and then converted to millimeters based on the scaling of each photograph, calculated using the 1-meter ruler reference. Grain-size measurements were converted into phi values and used to plot a cumulative frequency curve for each sampled site. Values for standard diameter particles ( $D_{16}$ ,  $D_{50}$ , and  $D_{84}$ ) were drawn from these curves. These manually measured values were compared with those derived using the automated grain-size detection software. Resulting correction equations will allow the use of the automated software in future work.

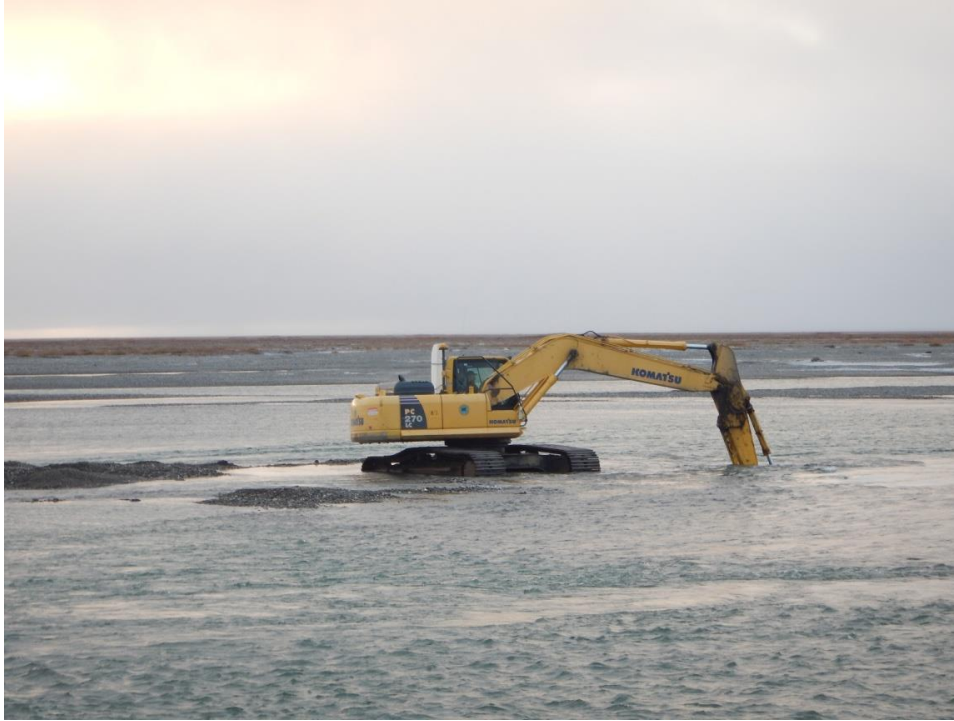
Figure 12. Digging the wet trench at DSS1 on September 9, 2015.

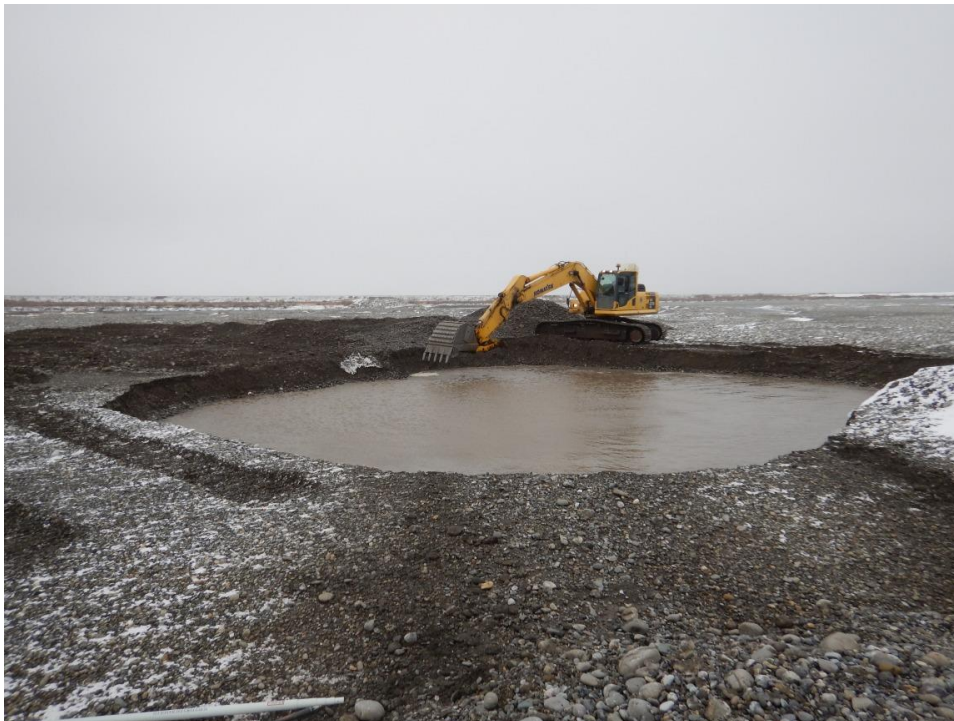
Figure 13. Digging the dry trench at DSS2 on September 10, 2015.

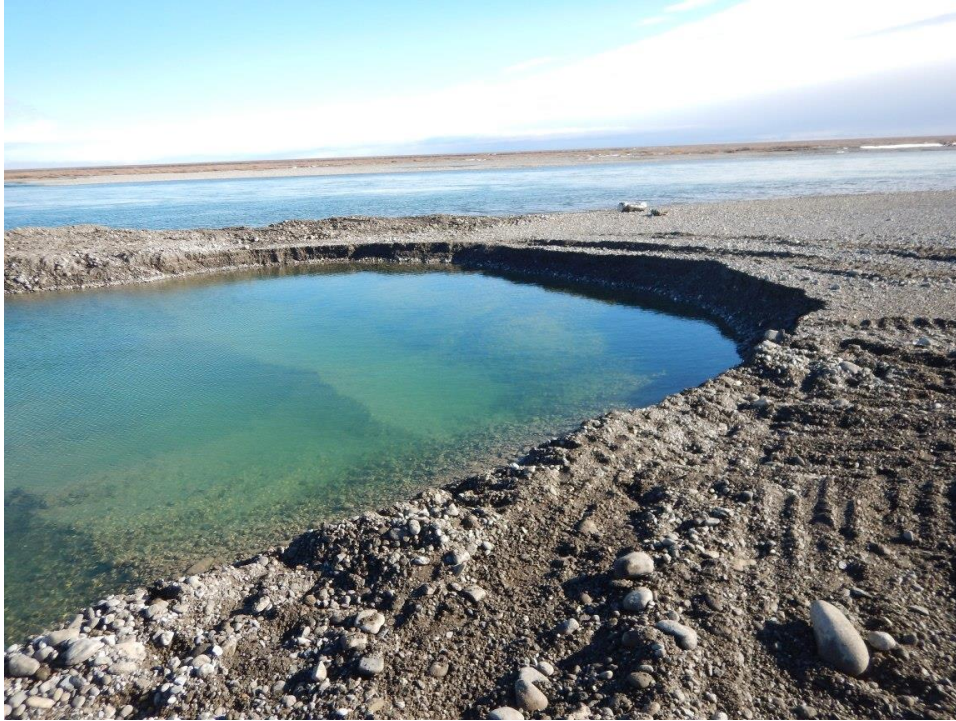
Figure 14. Dry trench at DSS2 on September 13, 2015, a few days after excavation.

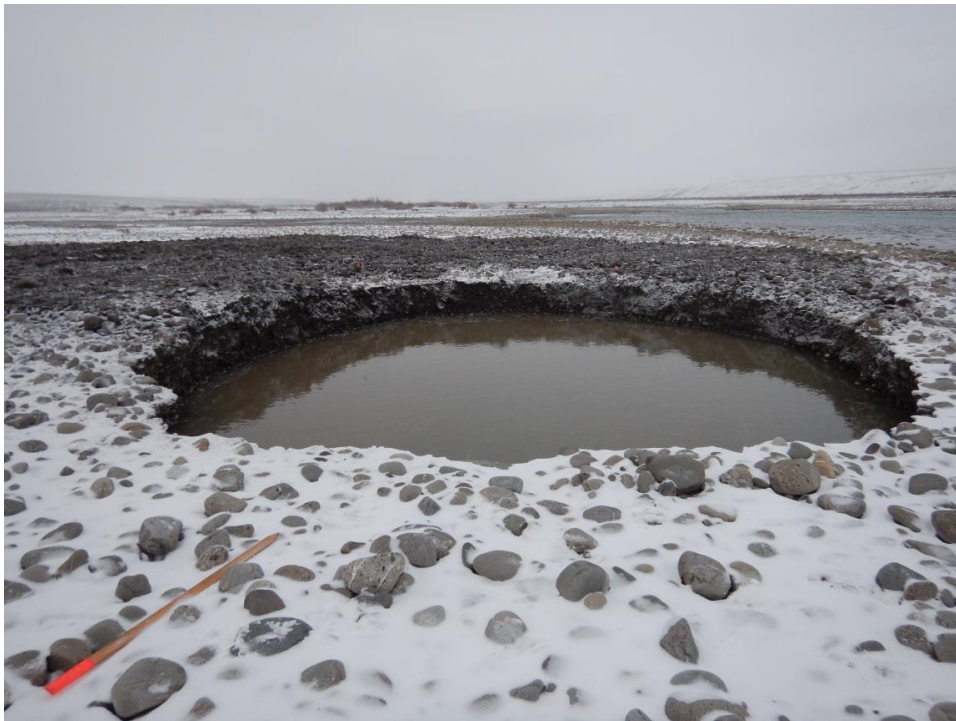
Figure 15. Dry trench at DSS3 on September 18, 2015.

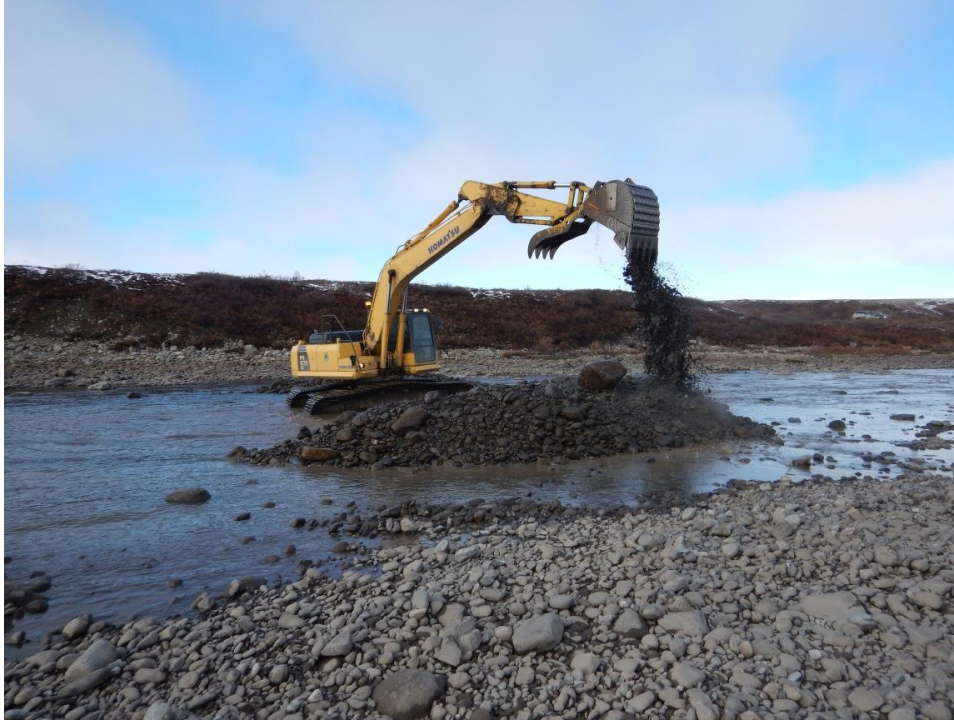
Figure 16. Digging the wet trench at DSS4 on September 15, 2015.

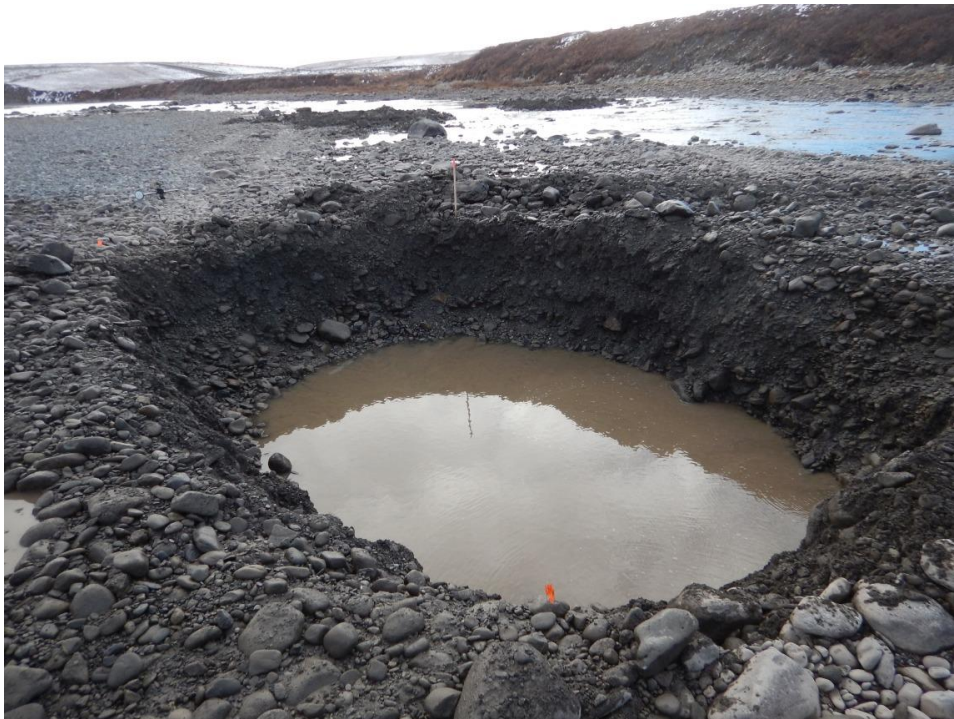
Figure 17. Dry trench at DSS4 on September 15, 2015.

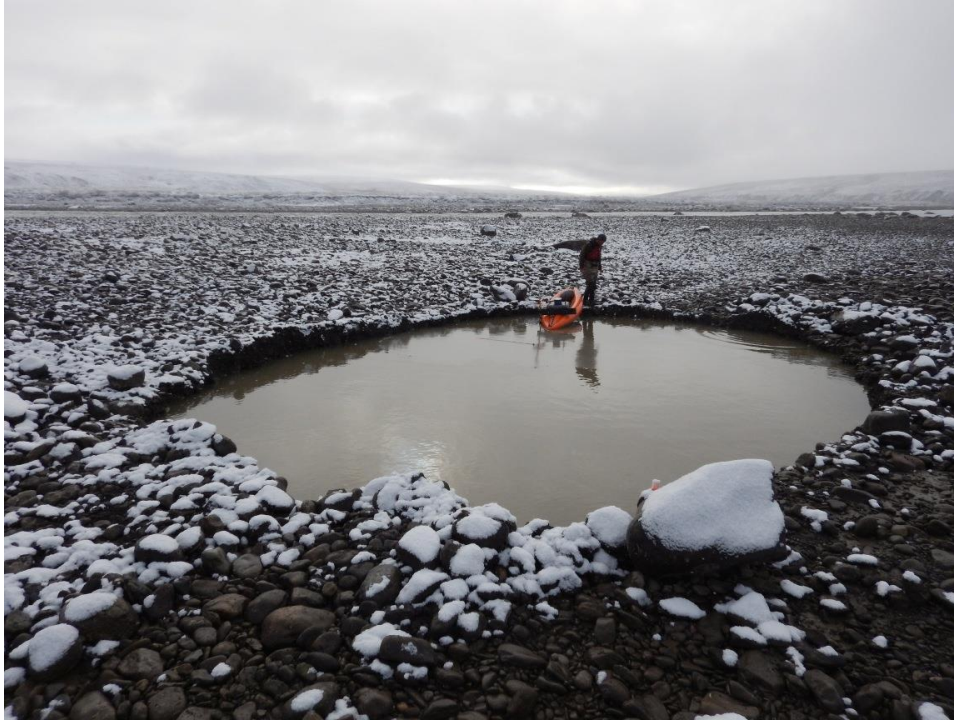
Figure 18. Dry trench at DSS4 on September 18, 2015.

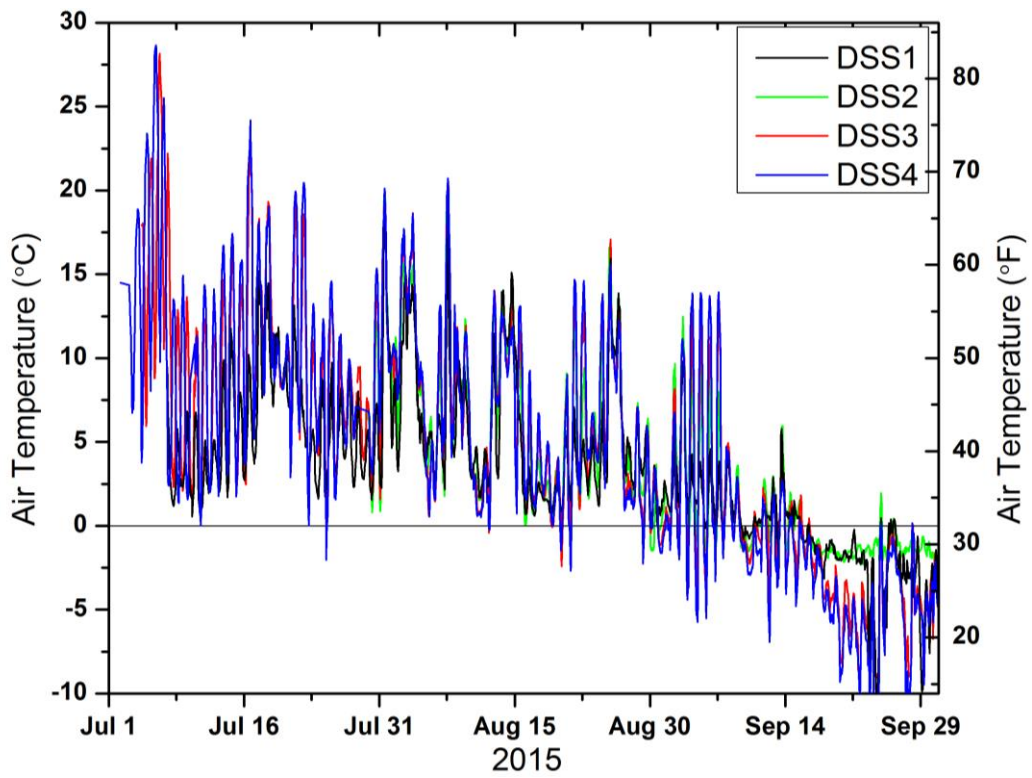
Figure 19. Air temperature at the four trench locations along the Sagavanirktok River in summer/fall 2015.

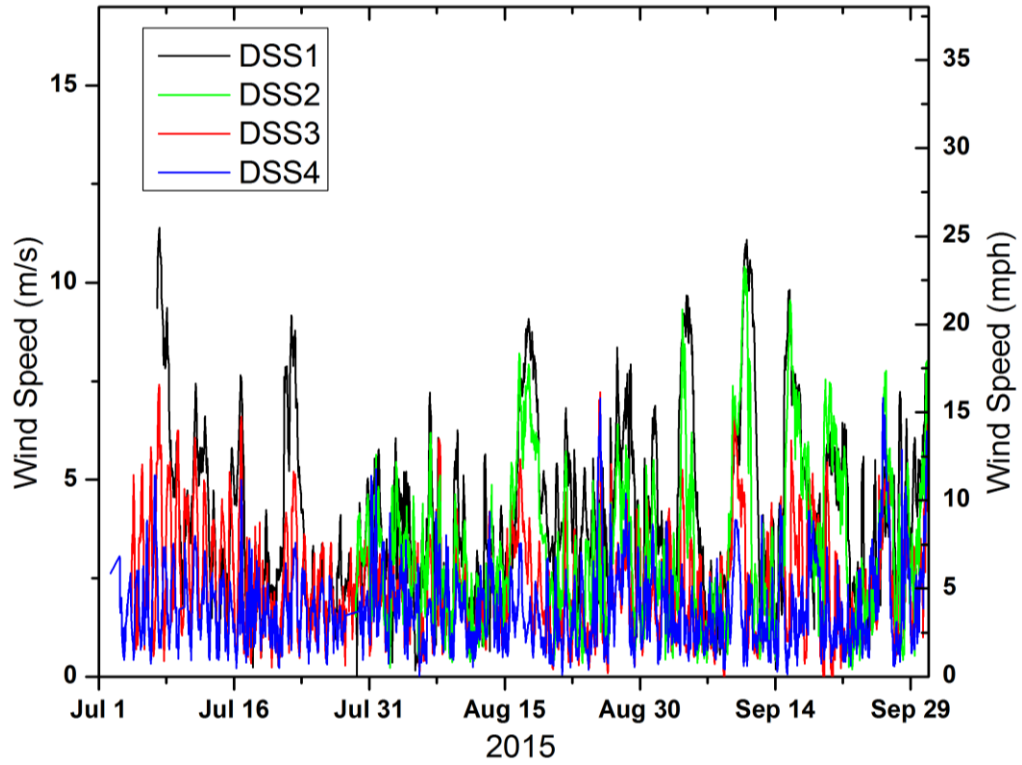
Figure 20. Wind speed at the four trench locations along the Sagavanirktok River in summer/fall 2015.

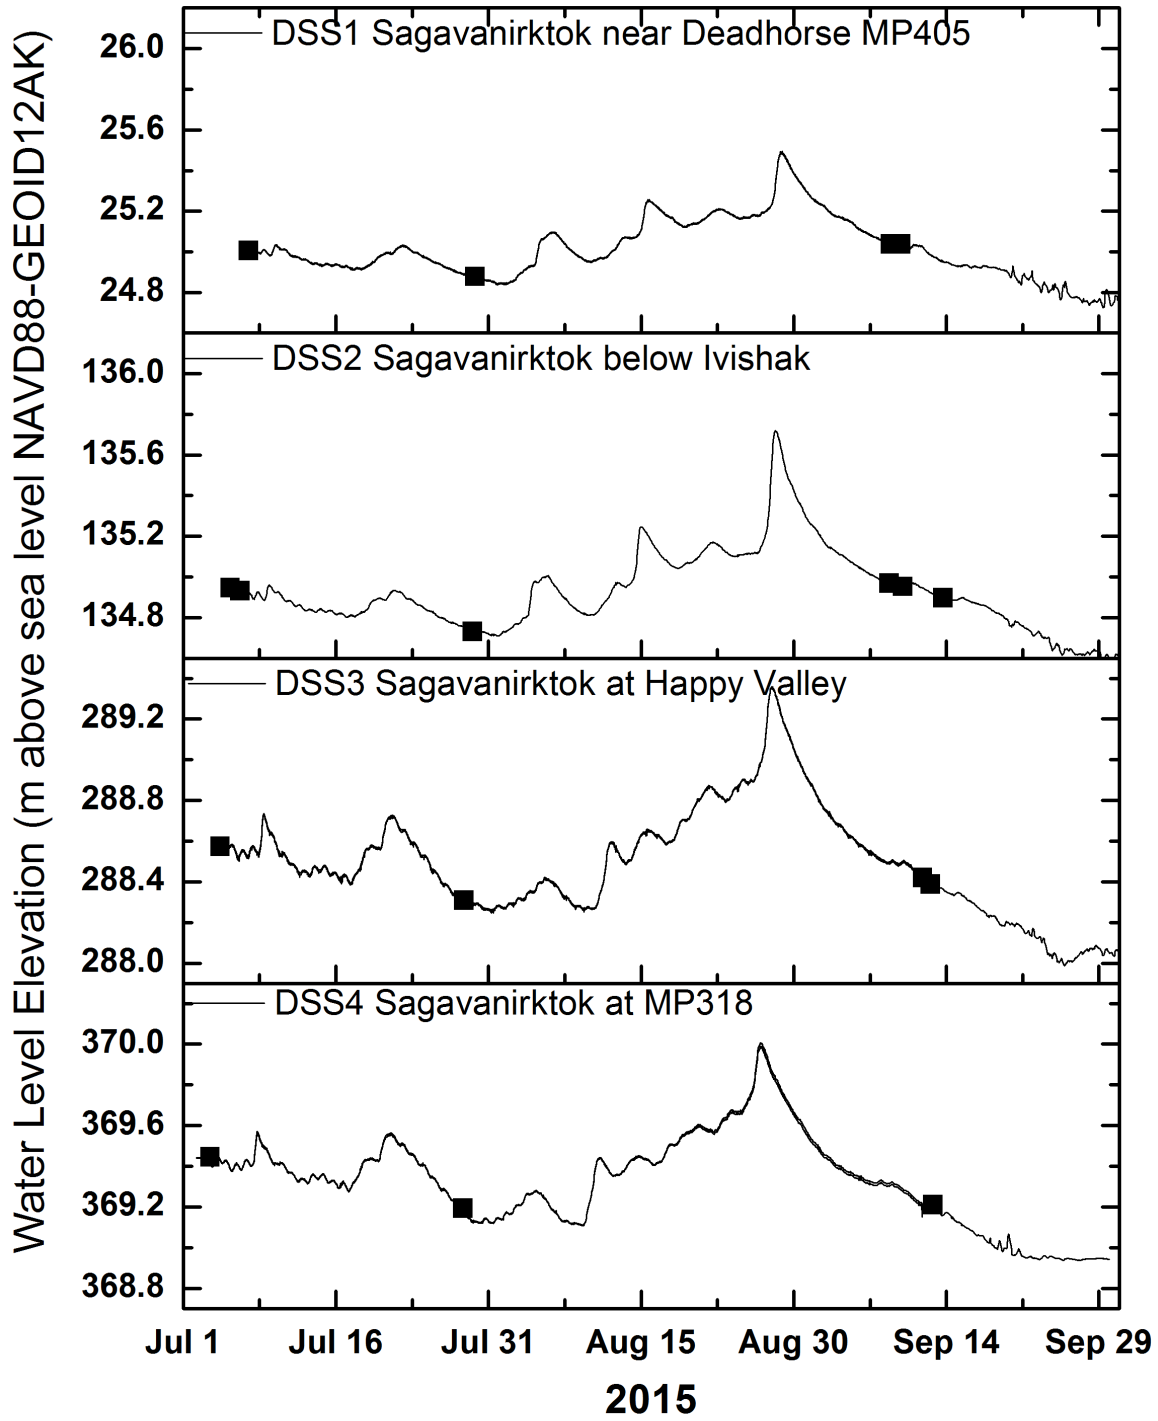
Figure 21. Continuous (solid line) and discrete (black square) water level elevations at the four Sagavanirktok River trenching locations.

Continuous water levels (or river stage) are presented in Figure 21. Pressure transducers were installed at each station (DSS1–DSS4) in summer 2015. Water levels were relatively low in the early part of summer. In mid-August, rainfall caused water levels to increase. Water levels declined through September going into winter. The annual peak stage for the year likely occurred during spring breakup; however, stations were not installed until after breakup. The peak summer stage for 2015 occurred on August 26 (DSS4), August 27 (DSS3), August 28 (DSS2), and August 28 (DSS1).

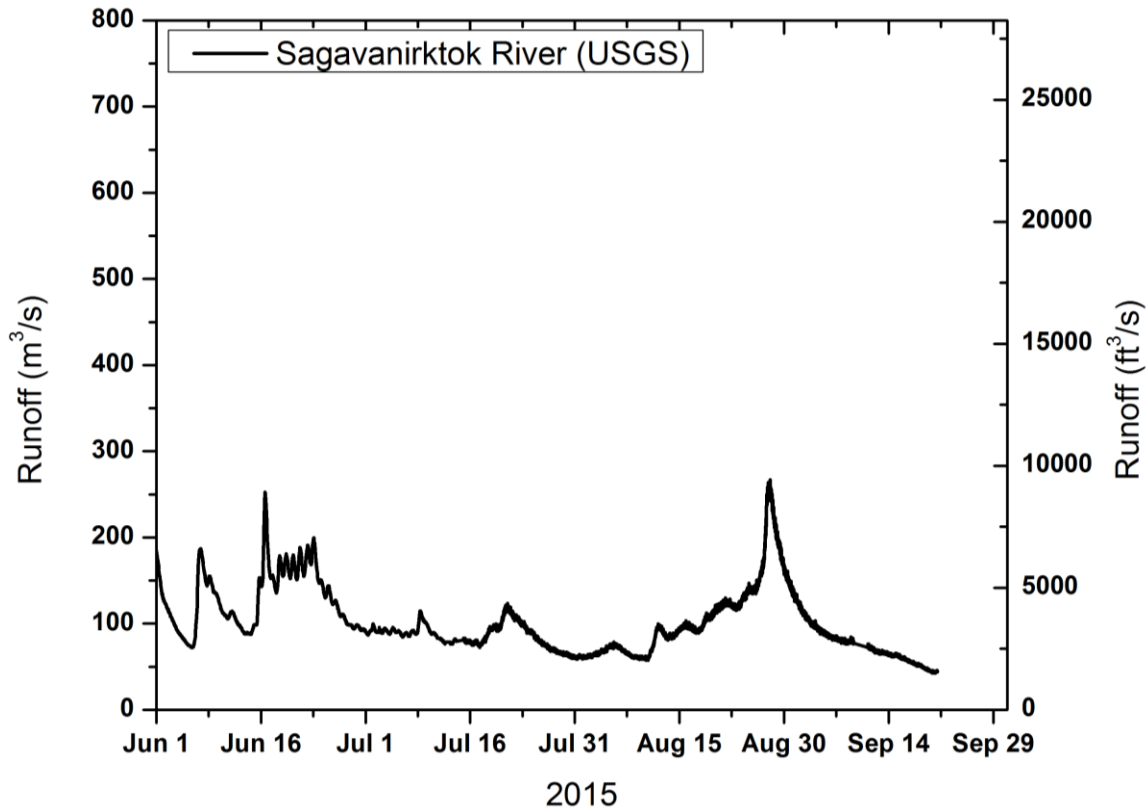
Figure 22. Upper Sagavanirktok River runoff for summer2015 (USGS, 2016).

Figure 22 presents runoff on the Upper Sagavanirktok River for summer 2015 (USGS, 2016). Above the gauge site, most of the basin lies in the Mountain region; a smaller percentage of the basin area is within the Foothills region. Similar to the river stage recorded at UAF stations DSS1–DSS4, the months of July and early August were relatively dry with lower flows. Late August produced some slightly higher flows due to rainfall events. The summer peak flow occurred on August 27.

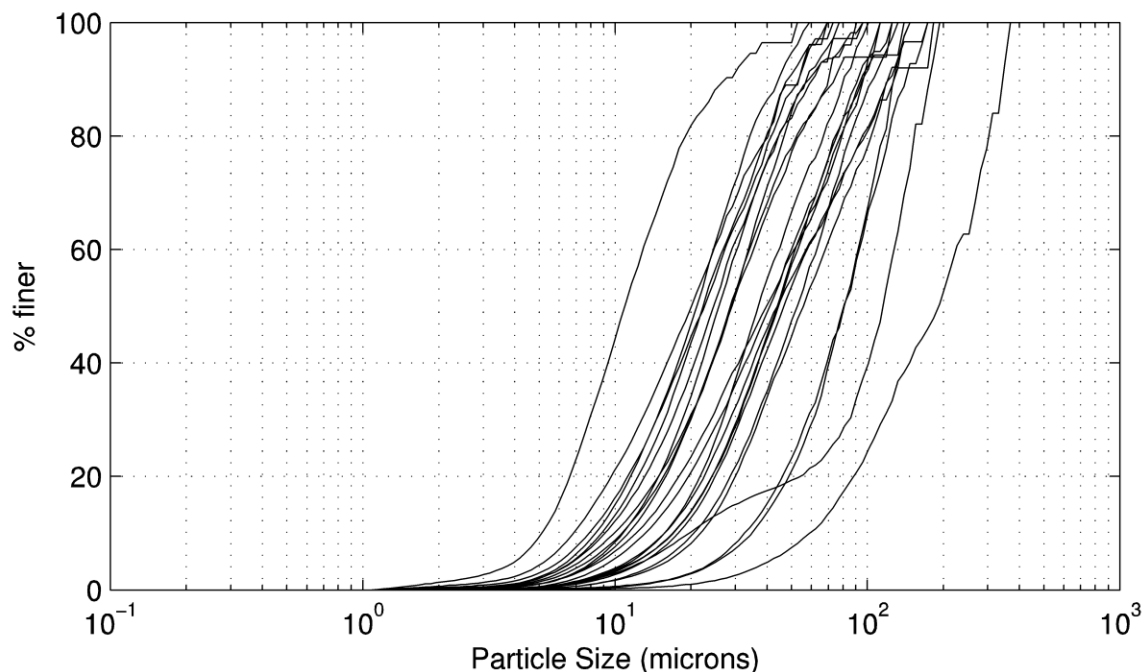
Figure 24. Grain-size distributions of 24 samples collected during summer 2015 on the Sagavanirktok River.

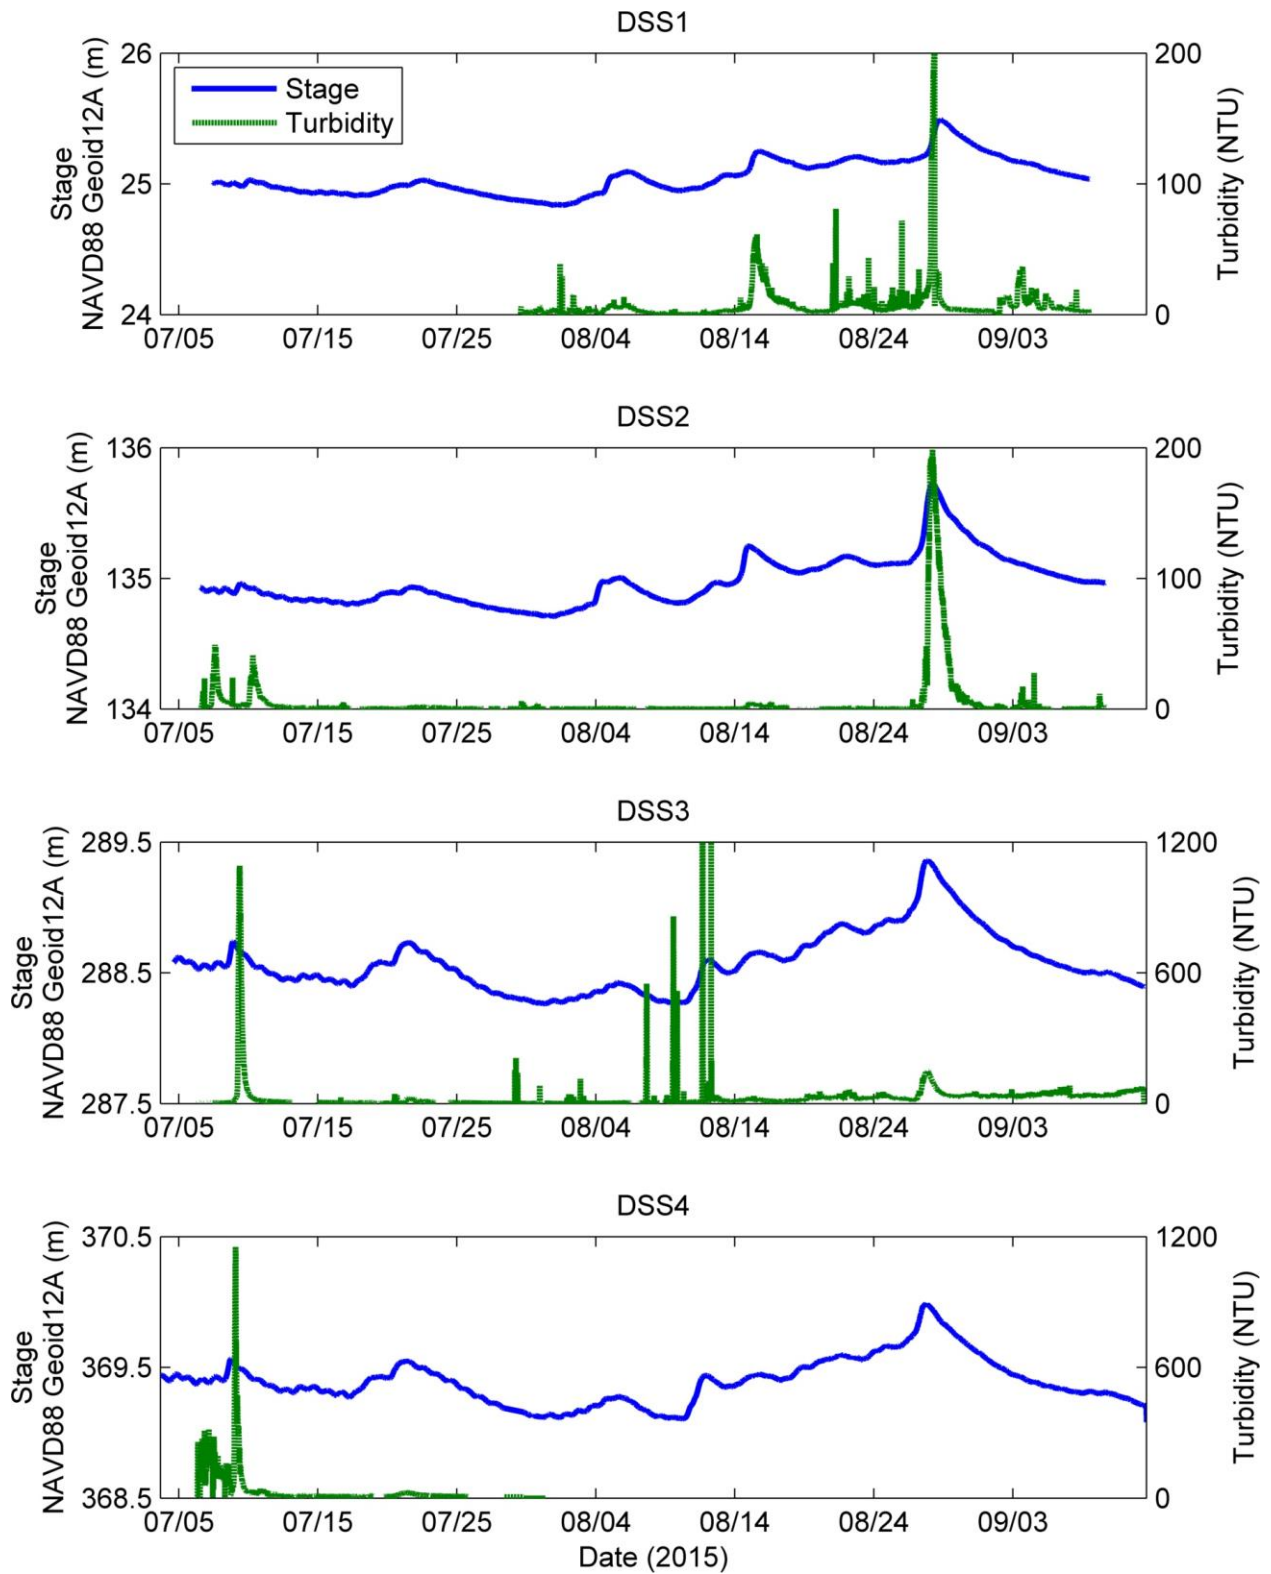
Figure 25. Turbidity and river stage at stations DSS1–DSS4 on the Sagavanirktok River.

Turbidimeters were deployed at all four stations on the Sagavanirktok River from early July 2015 to early September 2015. The turbidimeter at DSS1 failed shortly after installation; it was replaced on July 25, 2015. The new turbidimeter recorded data until it was retrieved on September 8, 2015. The turbidimeters at DSS2 and DSS3 recorded during the entire deployment from early July to early September. The turbidimeter at DSS4 malfunctioned on July 29, 2015; it was retrieved on September 10, 2015. Anomalous peaks appear in the data in late August at DSS1 and in early August at DSS3. These peaks may result from fouling of the optical sensor, which is a known problem with turbidimeters. The measured turbidity peaked during the same higher discharge events that resulted in elevated SSC (Figure 25).

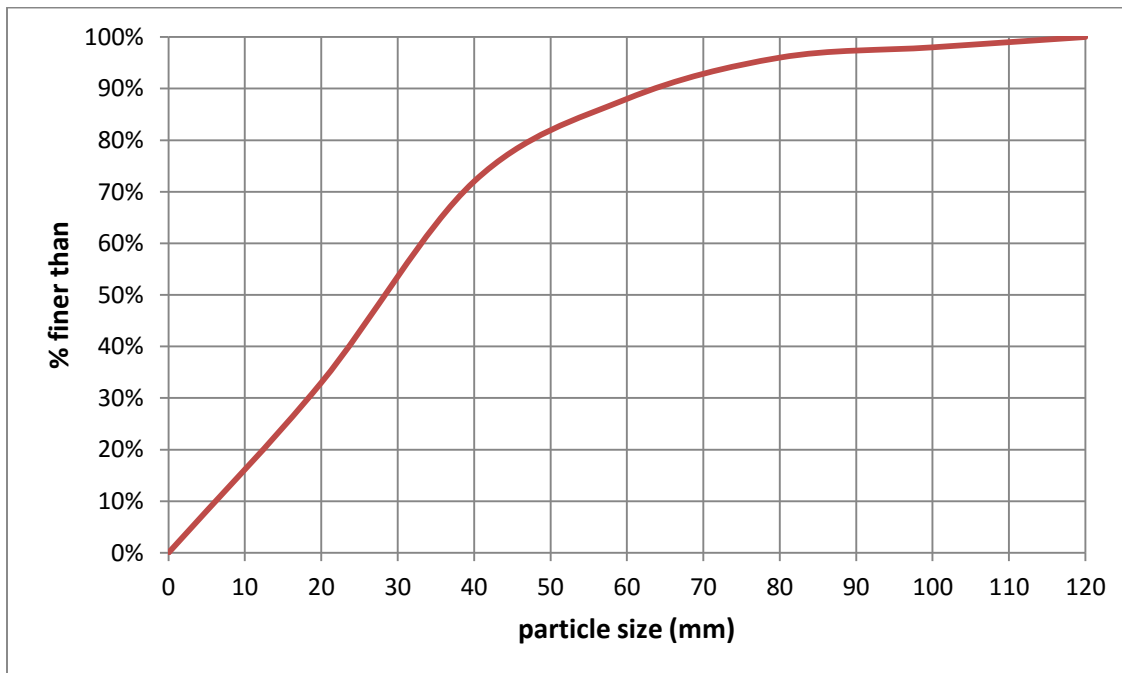
Figure 26. Example particle-size distribution plotted from grain size measurements of one substrate photos ( $n = 53$  photos).

The automated technique (described in Section 2.7.2) was used to estimate particle-size distribution in 142 images. Both manual and automated techniques were used to analyze an additional 53 images for particle size (Figure 26).

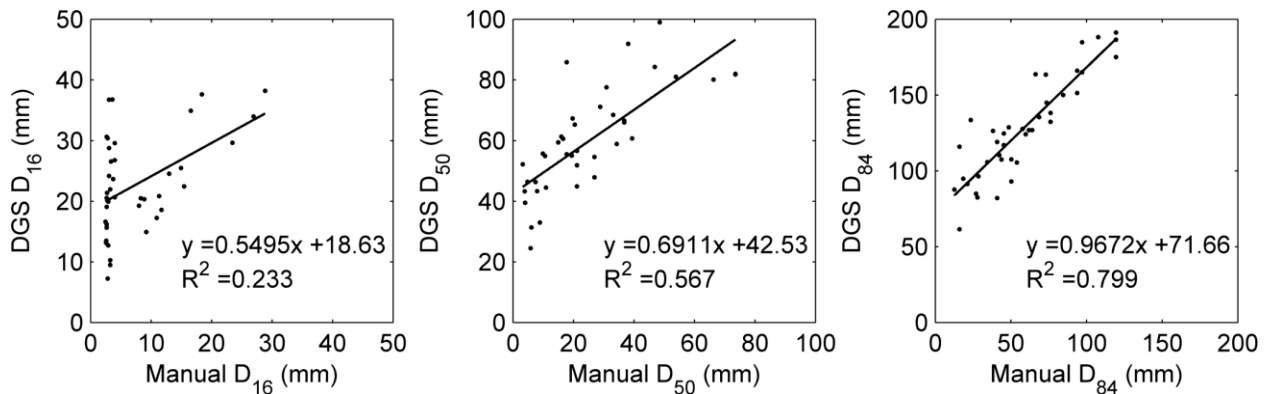
Figure 27. Correlation between automated (DGS, digital grain size) and manual particle size measurements.

The automated and manual measurements were compared to determine the relationship between the automated measurements and the actual particle size. We found the strongest relationship for larger particle sizes, with decreasing correlation coefficients at smaller grain sizes. These correlations could be used as correction equations to permit the confident use of the automated technique in future work (Figure 27).

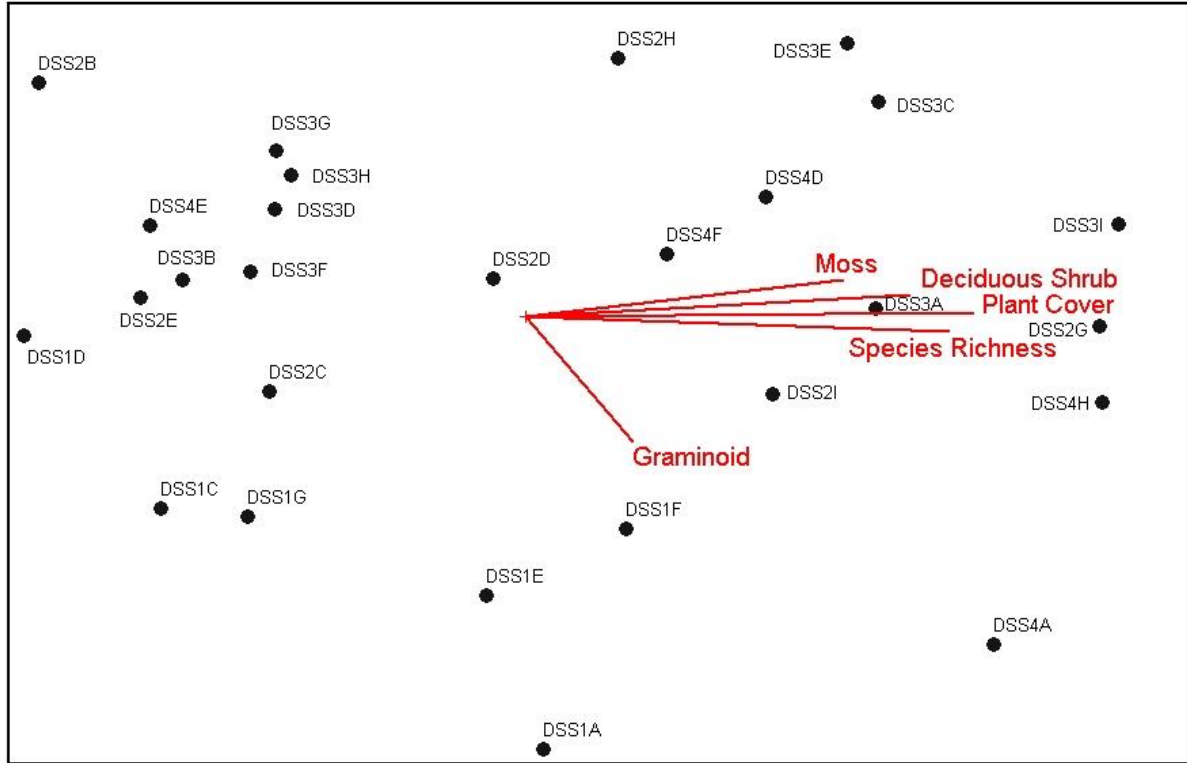
Figure 28. Non-metric multidimensional scaling plot ordination, where dots denote floristics at individual sites, and distance is proportional to floristic difference. Red lines are axes that describe the ordination space and thus explain vegetation differences among sites, where the length and direction of the axis indicates correlation. Vegetation differences are apparent between sites with high vegetation cover and low flood frequency (right two-thirds), and sites with low vegetation cover and high flood frequency (left one-third).

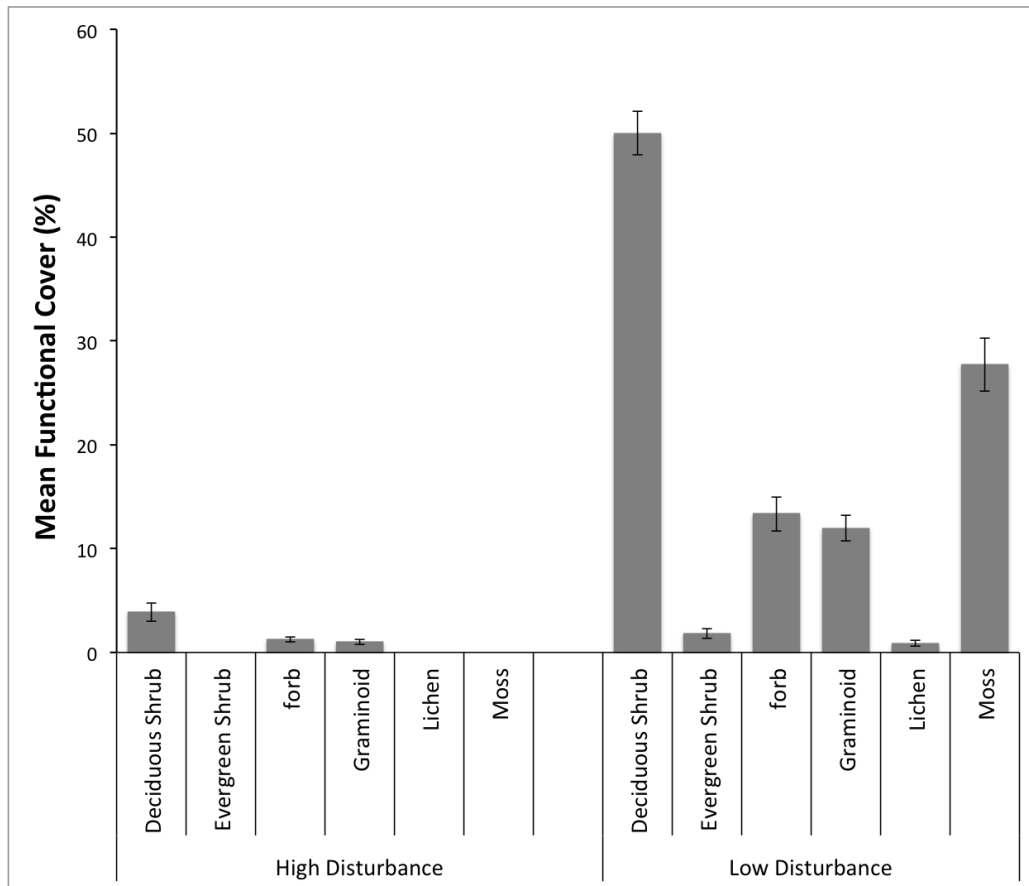
Figure 29. Mean cover of plant functional type as related to disturbance (flooding) regime. There are 15 plots in the low disturbance category and 19 plots in the high disturbance category. Low disturbance sites (infrequent flooding) had higher plant cover; this was true across all floodplain transects (DSS1–DSS4).
