# Hydro-sedimentological Monitoring and Analysis for Material Sites on the Sagavanirktok River

2015–2016 Data Report

**Prepared for the  
Alaska Department of Transportation and Public Facilities**

Report INE/WERC 16.02

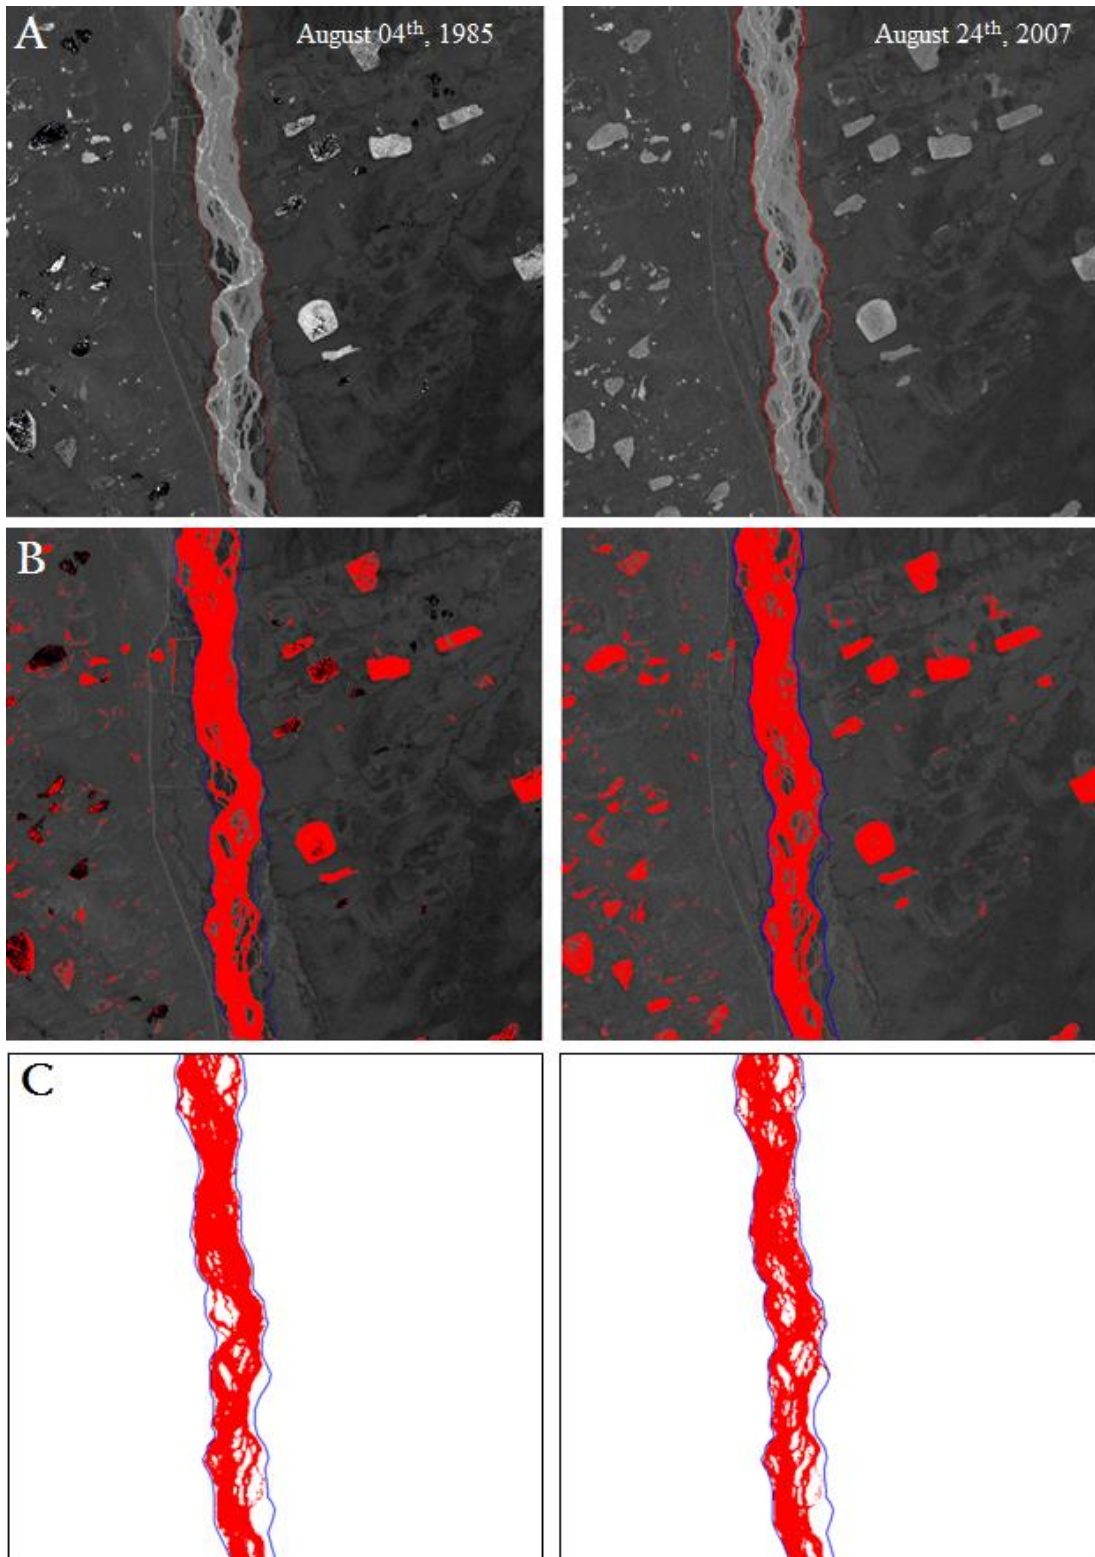
Figure 30. Active river channel detection flow chart. (A): NDWI computation. (B): NDWI threshold selection, pixels with a value greater than 0 in red. (C): active river channel extraction.

To detect the active river channel, we used several water indices proposed by Rokni et al. (2014). This methodology was originally designed to detect water; in this work, it was used to detect the active river channel. Six water indices were computed following this methodology (Table 9). To select those pixels belonging to the active river channel, we implemented a set of threshold values for each index. These threshold values were then iteratively modified to fit the Sagavanirktok River conditions. This process was accomplished by visually inspecting each index in each Landsat scene, determining that the Normalized Difference Water Index (NDWI) was best at identifying areas that appeared to be water (an example can be found in Figure 30A). Pixels with a value greater than 0 in the NDWI were selected as an active river category for each one of the Landsat scenes (see Figure 30B).

Once the pixels were selected, a coarse river channel morphology layer was used to mask the final image (see Figure 30C). This layer was previously photo-interpreted and digitized using the same Landsat scenes (an example can be found in Figure 31). Finally, to analyze the change in the active river channel, we combined the different layers by means of map algebra, allowing us to quantify the rate of change of the riverbed at various intervals from 1985 to 2007 (see Figure 32 through Figure 37 and Table 10). Figure 32 is a description of the study area showing the changes in the active river channel from 1985 to 2007. Figure 33 to Figure 37 are inset maps of the five rectangles in Figure 32 showing the temporal dynamics of the changes in the active river channel in the three periods: 1985–1999, 1999–2007, and 1985–2007. Figure 38 through Figure 40 show these changes at each trench site. The information provided in the figures seems to indicate that the active river channel was relatively stable during the three study periods for the entire area of interest.

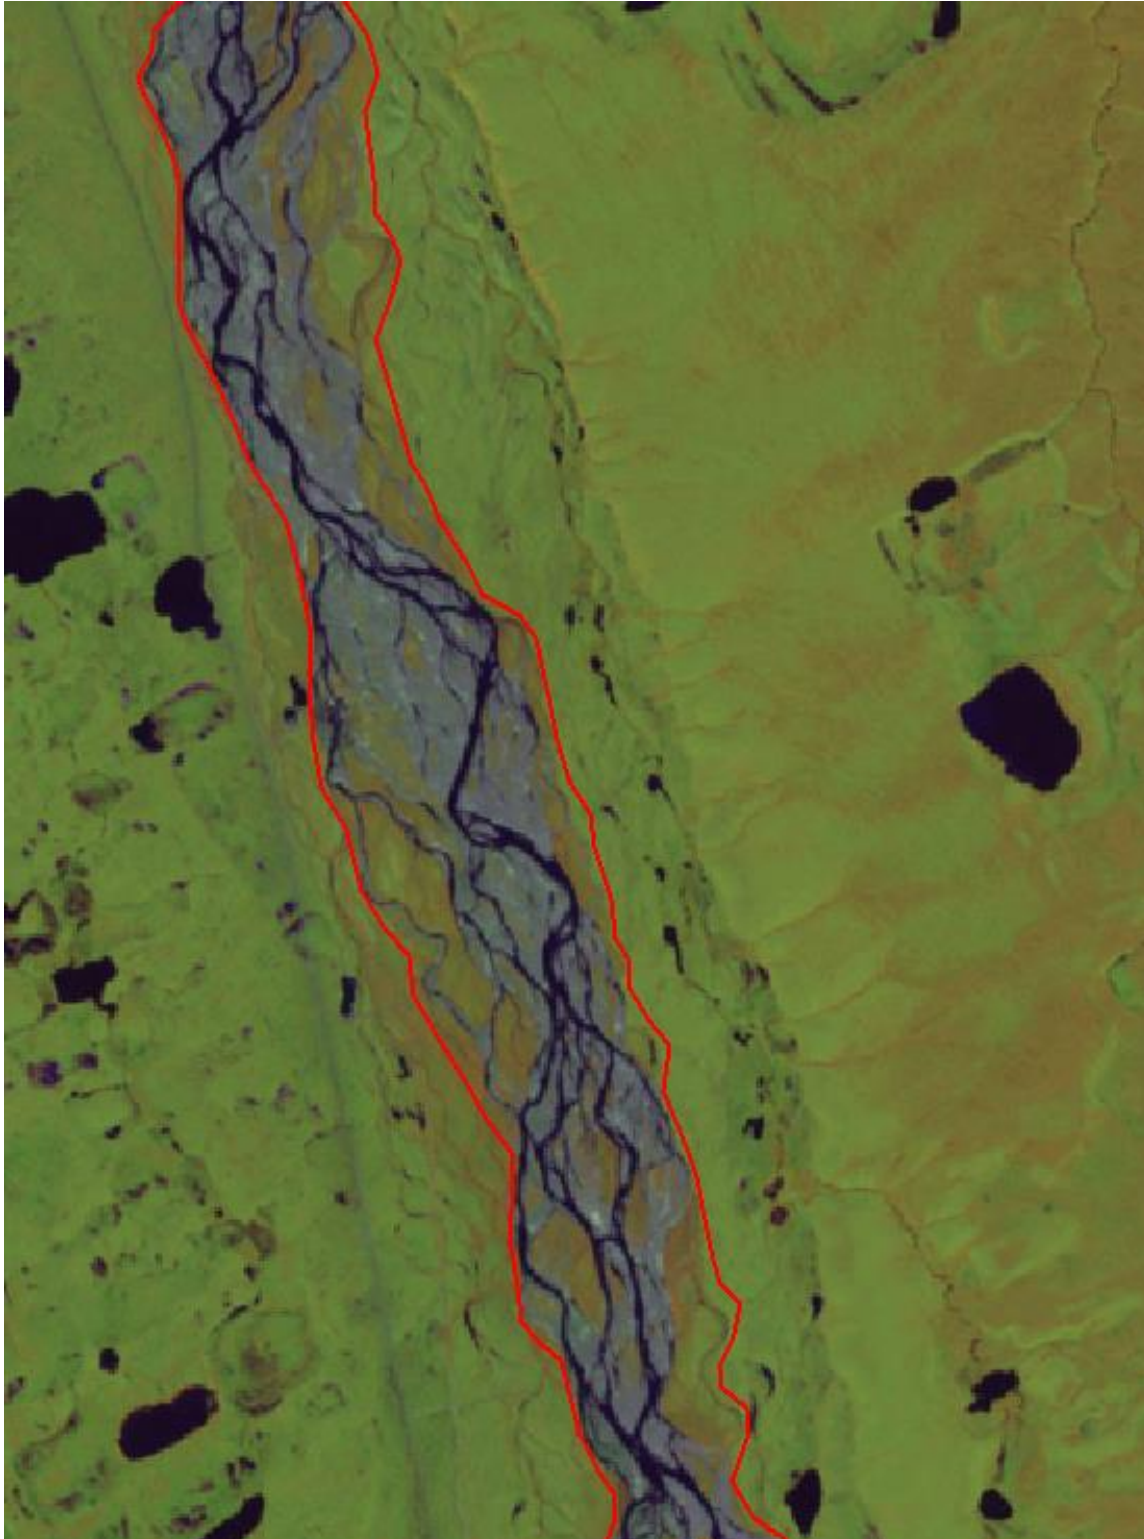
Figure 31. Example of the coarse river channel morphology layer. Background image is a 4+5+3 Landsat-5 TM combination of an August 24, 2007, scene.

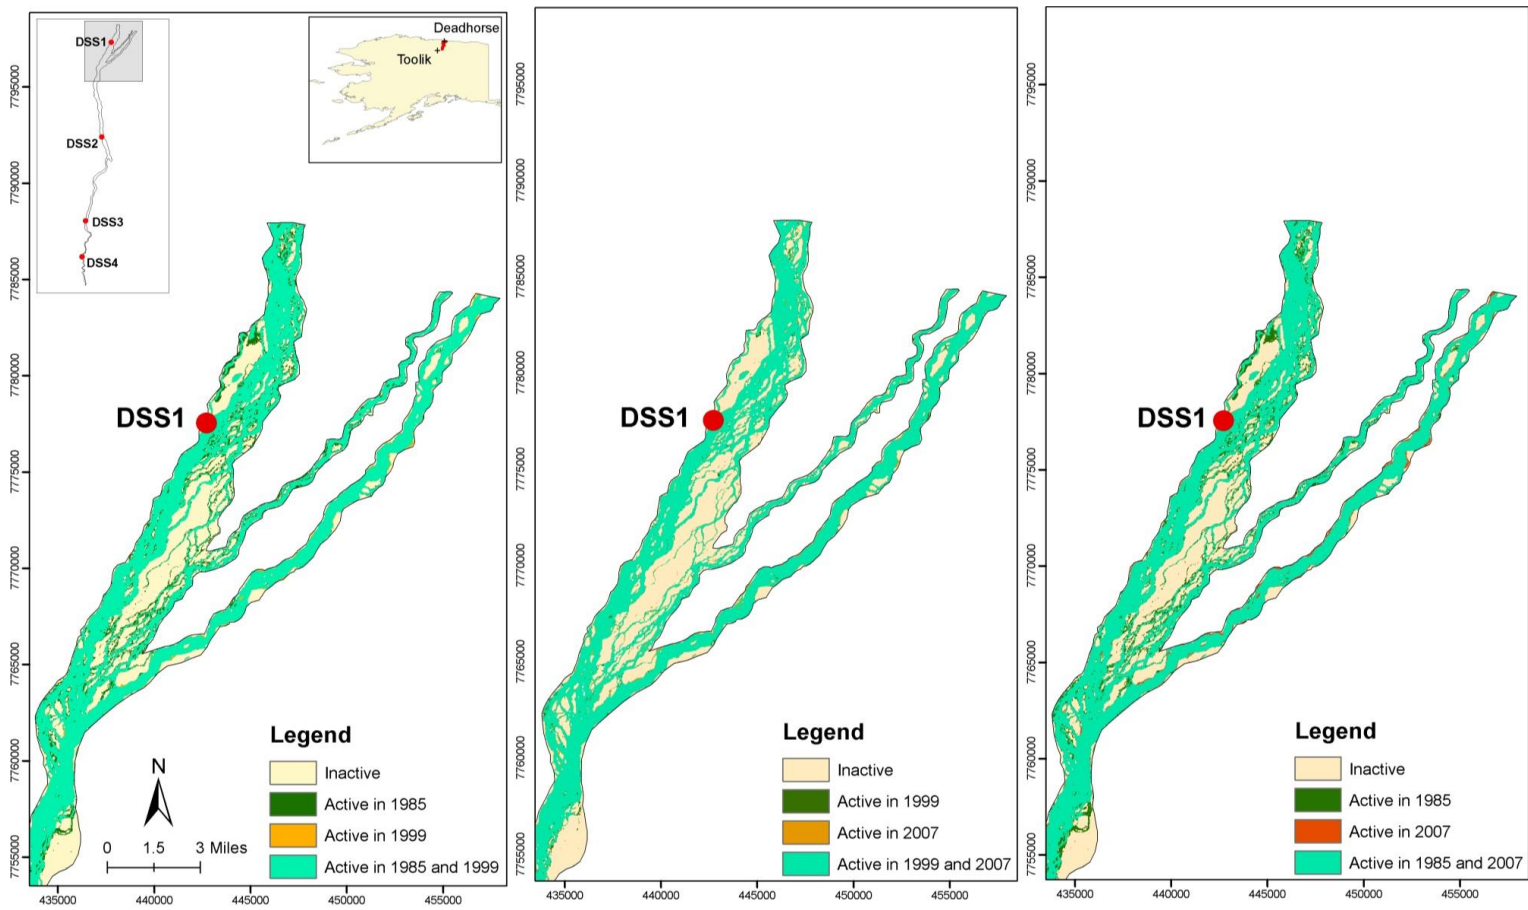
Figure 33. Active river channel changes inlet map from 1985 to 2007 in the vicinity of DSS1. The red dot is the station location. Coordinates in UTM-6N, datum WGS-84.
