**Study of Cathodic Protection Related to Thermal  
Desalination Plant**

**Thesis**

**By  
Nader Abdulaziz Najm-Mohammed**

**Department of Mechanical Engineering,  
University of Glasgow,  
November 1997**

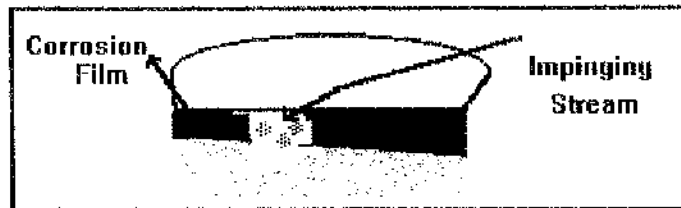
Erosion corrosion is deterioration associated with rapidly flowing fluids and involves both mechanical and chemical modes of attack. Erosion corrosion of metals can result from the removal of the protective film of corrosion products, which serves as a barrier to corrosive attack of some metal<sup>3</sup>. It is more severe when suspended solids (like sand from the seawater intake) are present in the fluid. Erosion corrosion often occurs in the condenser of the heat reject section of an M.S.F plant, containing entrained air, and solid particles, which circulates at very high flow velocity.

Figure 3.6: Erosion corrosion

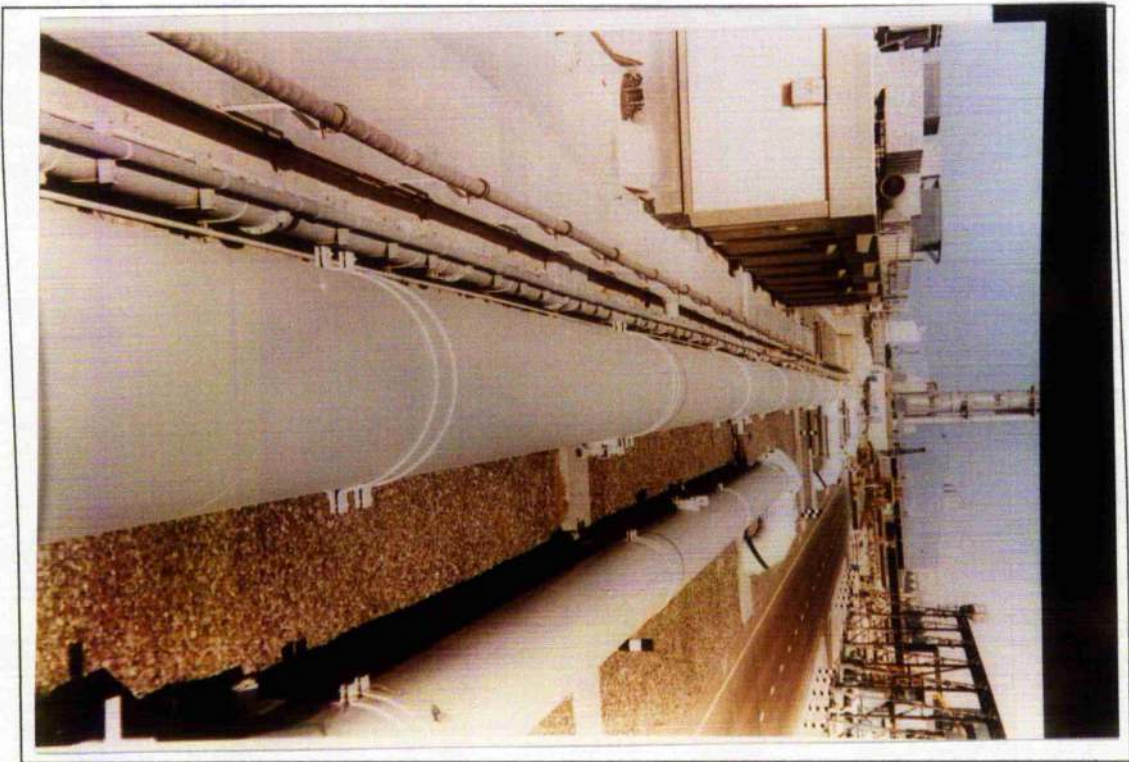
**Figure 7.2: Photo of two seawater headers running parallel to evaporators**

The seawater header (figures 7.2 and 7.3) comprises the common sea water distribution pipes which feed the water from any of the seven sea water supply pumps to any of the six Evaporator and other parts of the smelter. The most recent internal inspection of the seawater header (in its 13<sup>th</sup> year of cathodic protection application) which was carried out as part of this Ph.D. project revealed the following: -

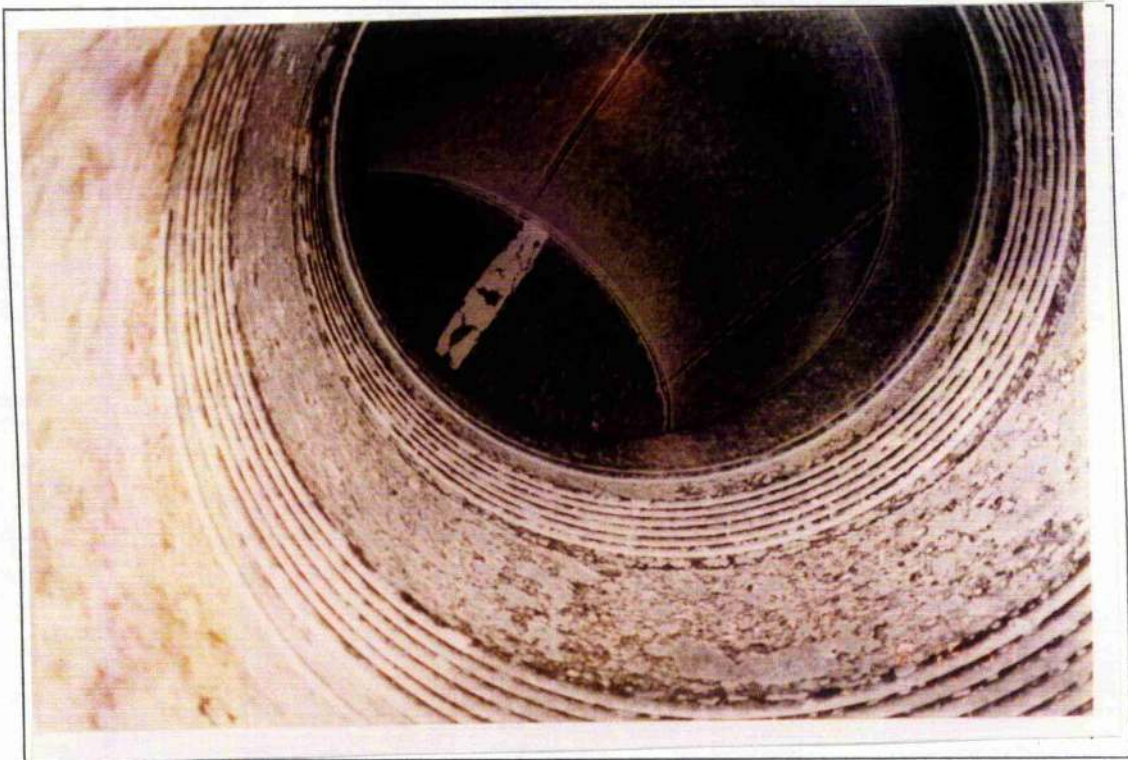
- \* No active corrosion either on the internal pipe surface or at the weld seams, flanges and expansion bellows (figures 7.4 and 7.5).

**Figure 7.4: Photo of seawater internal pipe surface at the expansion bellow**

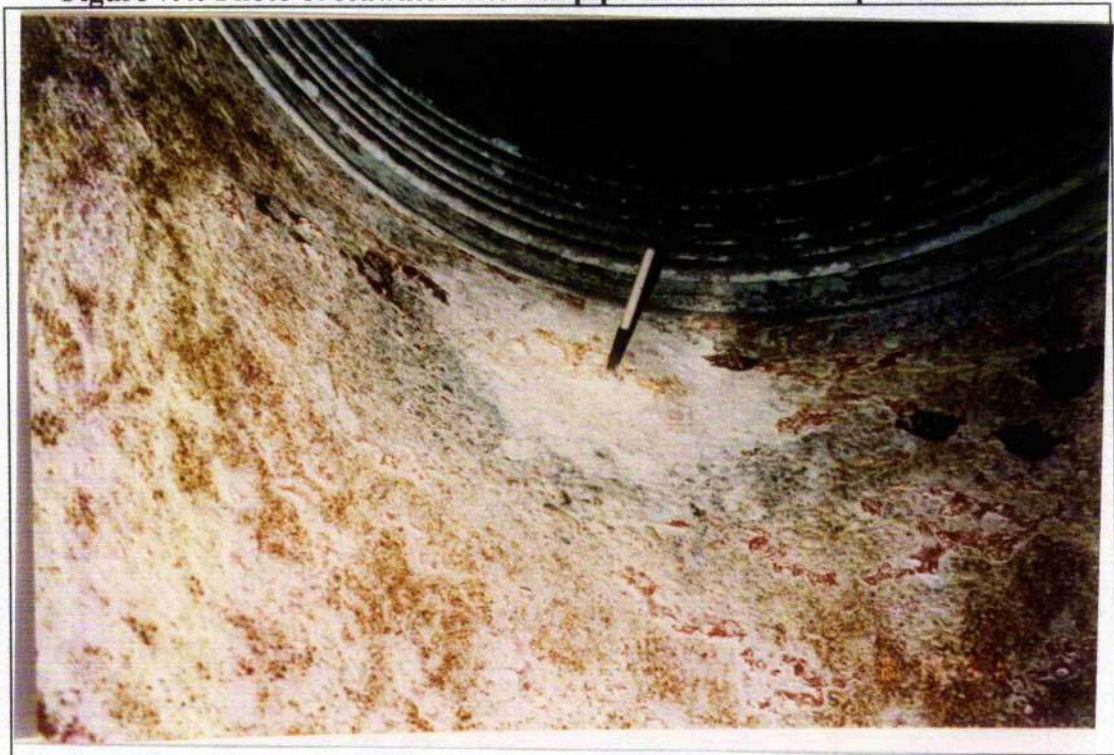
**Figure 7.5: Photo of seawater internal pipe surface next to expansion bellow**

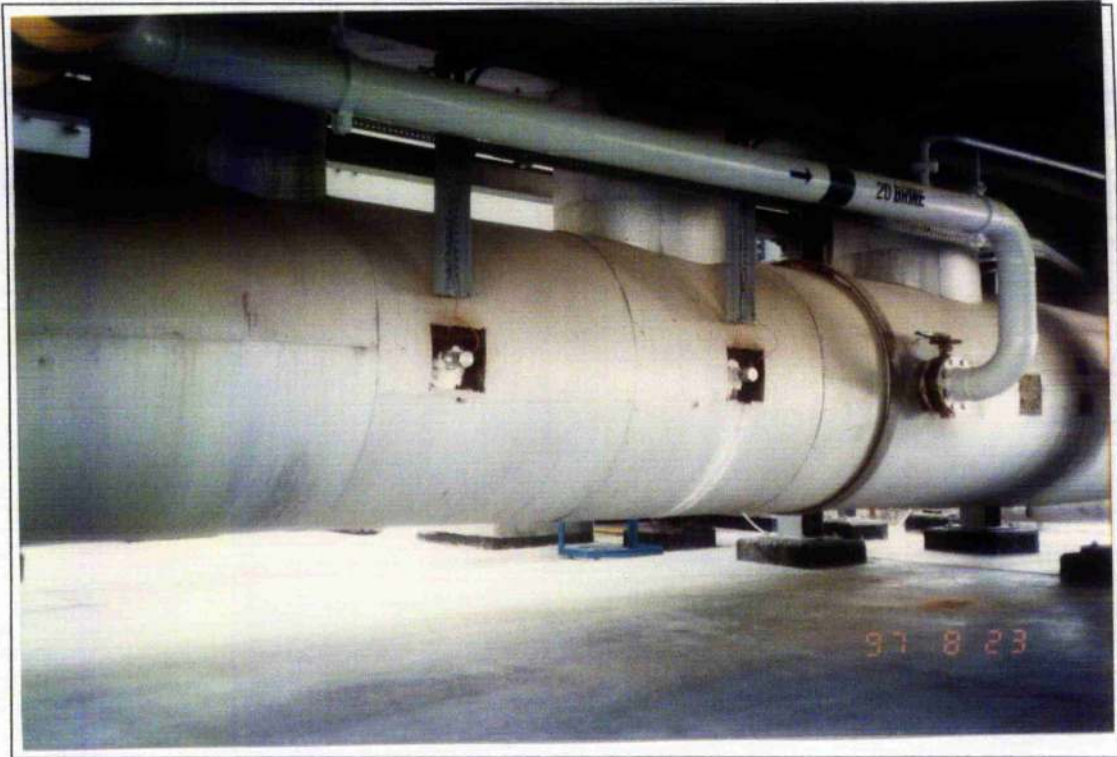
**Figure 7.6: Photo of brine inlet manifold along with interconnection pipelines to flash chamber and also shows the 4 anodes installed in B.I.M**

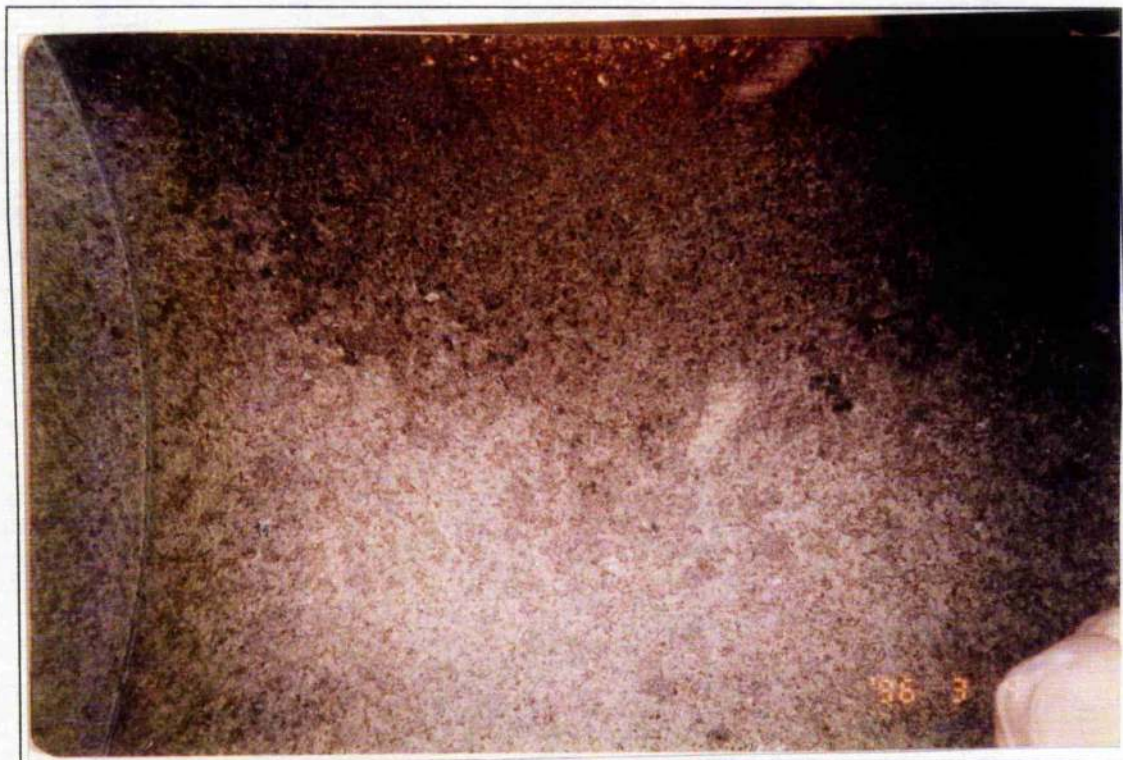
**Figure 7.7: Photo of cavitation attack on B.I.M target plate**

- \* Cathodic protection system is almost 100% effective for the entire internal surfaces of brine inlet manifold as no active corrosion was seen during any internal inspection of the inspected evaporators.
- \* Cavitation attack on the 20 mm thick target plate has not been stopped completely but situation has improved tremendously since commissioning of the present cathodic protection system (figure 7.7).
- \* A slight build up of calcareous deposits, occur time to time around some anodes (figure 7.8). This indicates that the current level is within the optimum level of protection. The formation of such deposit around anodes is believed to be during the use of a degree of overprotection in the cathodic protection supply, just after evaporator off load acid cleaning.

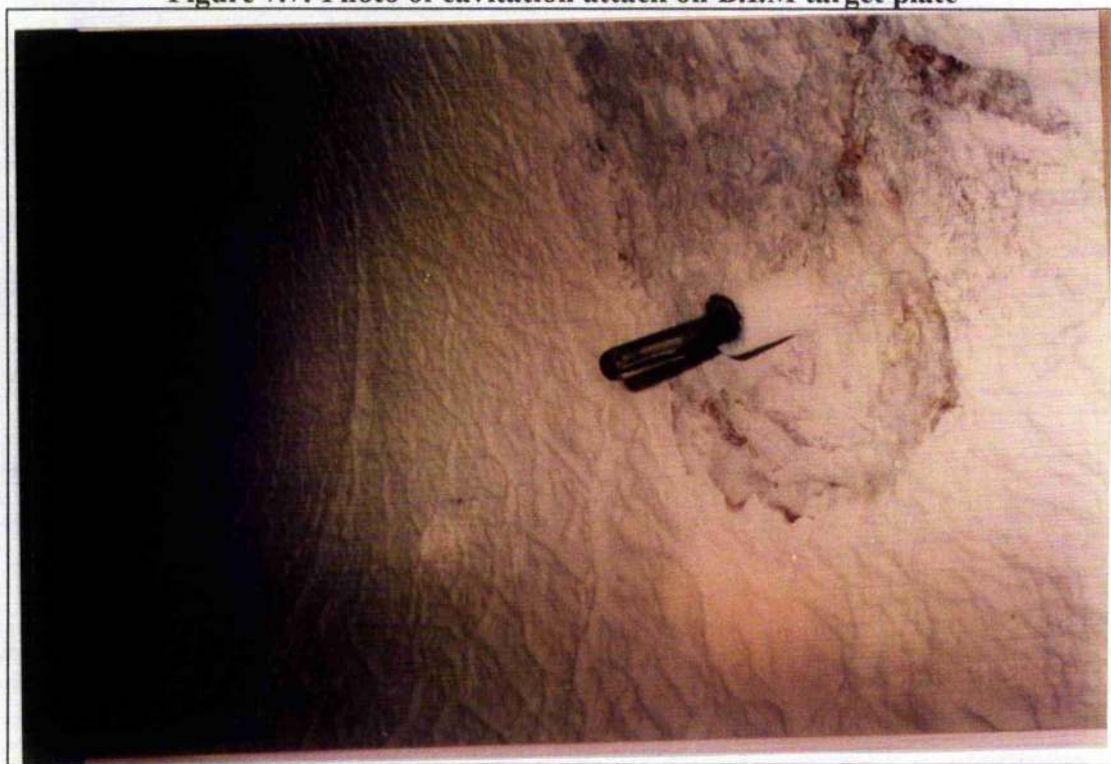
**Figure 7.8: Photo of calcareous deposition around and away from anode**

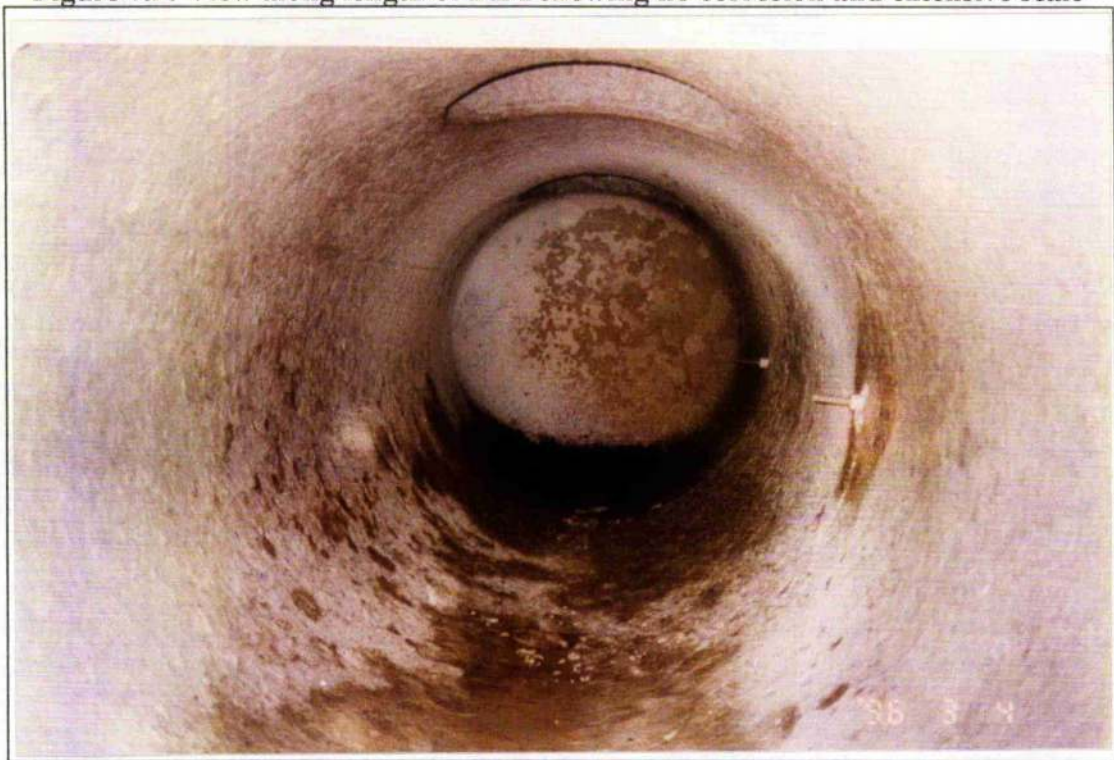
- \* A dense calcareous deposition on carbon steel surface away from the anode site is clearly evident (figures 7.9-7.10). This is a major factor in yielding good cathodic protection performance as it covered entire surface surrounding and away from the anodes. This in principal assists to reduce the applied current demand and hence reduce the operating cost of cathodic protection system. These evidences from inspection have allowed the continued operation until next scheduled shutdown in the occasional case of anode failure because of the beneficial effect of calcareous deposition.

**Figure 7.10: View along length of BIM showing no corrosion and extensive scale**

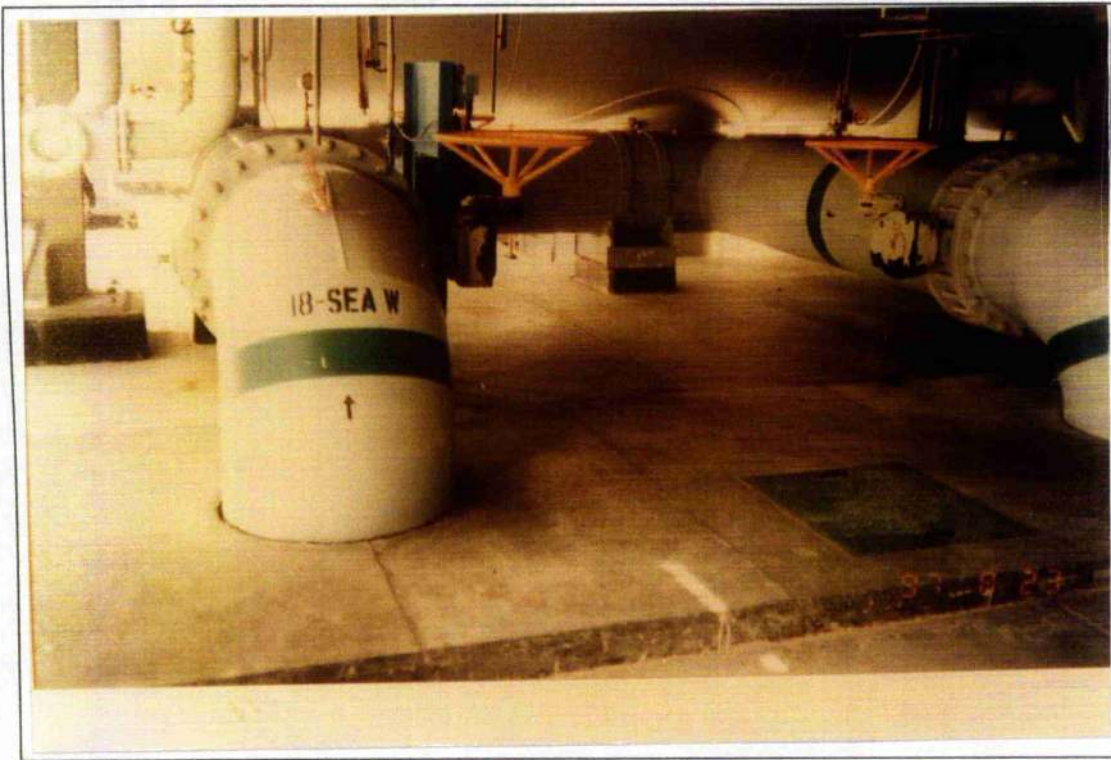
**Figure 7.14: Photo of evaporator feed line**

- Cooling seawater to lowest temperature stage (last heat reject section stage 19, figure 7.12).
- Cooling water outlet (figure 7.13) and evaporator feed line (figure 7.14).
- Brine pump discharge (figure 7.15).
- Brine inlet to last stage of heat recovery section, stage 17 (figure 7.16).

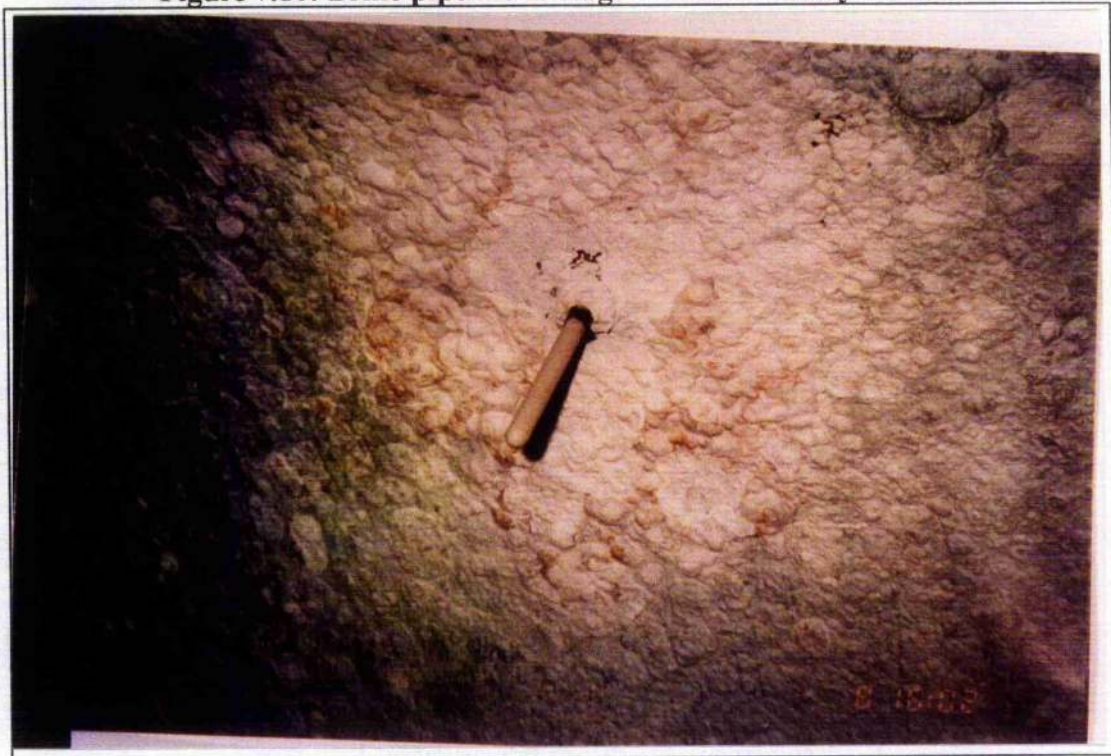
**Figure 7.17: Seawater cooling water inlet (see figure 7.12)**

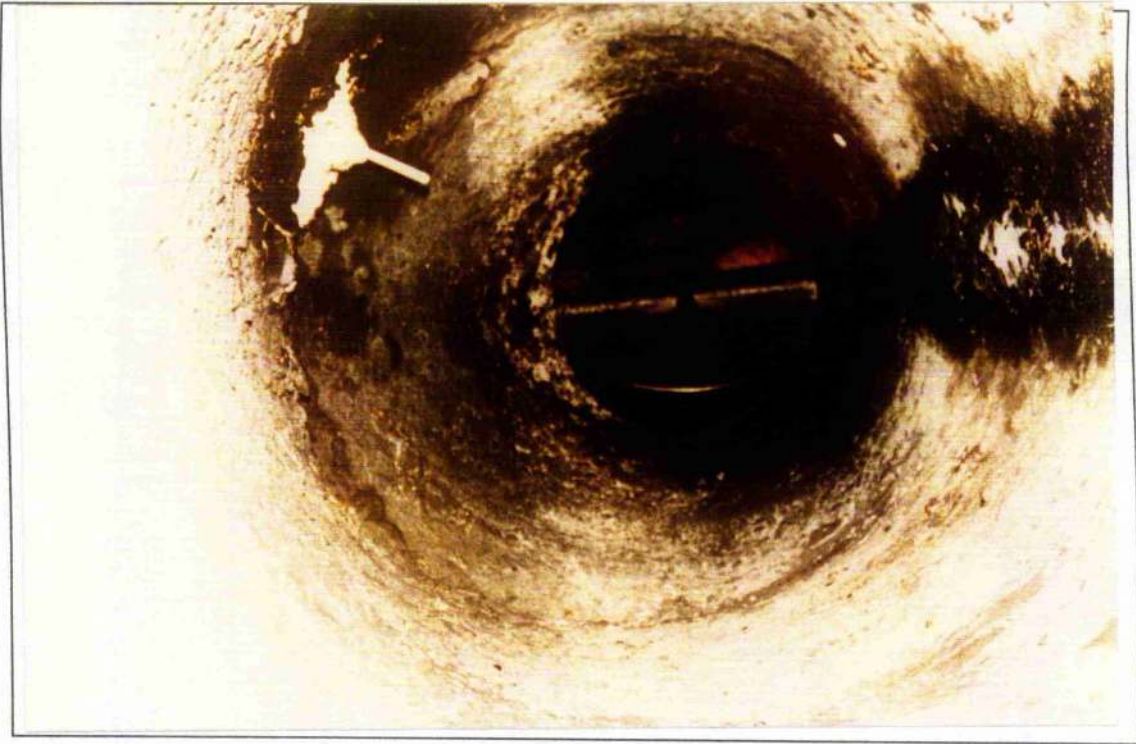
**Figure 7.18: seawater cooling water outlet (see figure 7.13)**

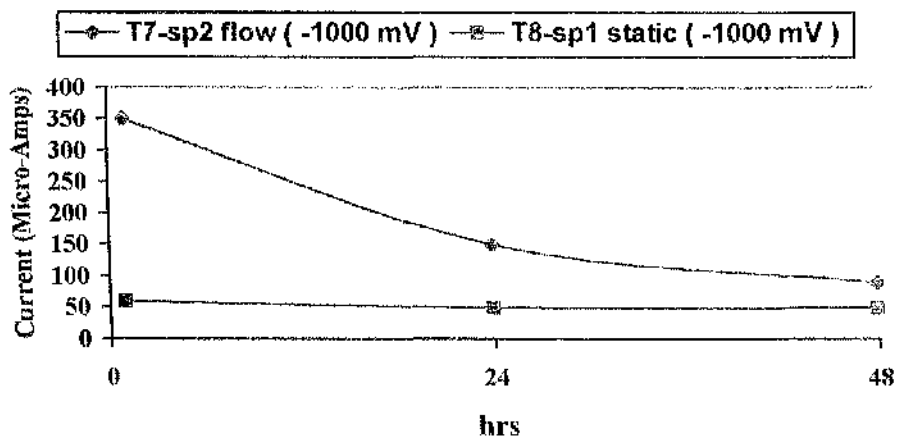
Scale formed during the first 48 hr (scale in test 7 formed in 1 day i.e. rather faster in moderately flowing condition) but was darker in nature. Figure 8.3 shows that the current demand for protecting the 50D specimen was much less when compared to the flow condition of test 7. Static condition does reduce the initial current demand.

Figure 8.3: Flow effect on applied current  
(Comparison between tests 7 and 8)

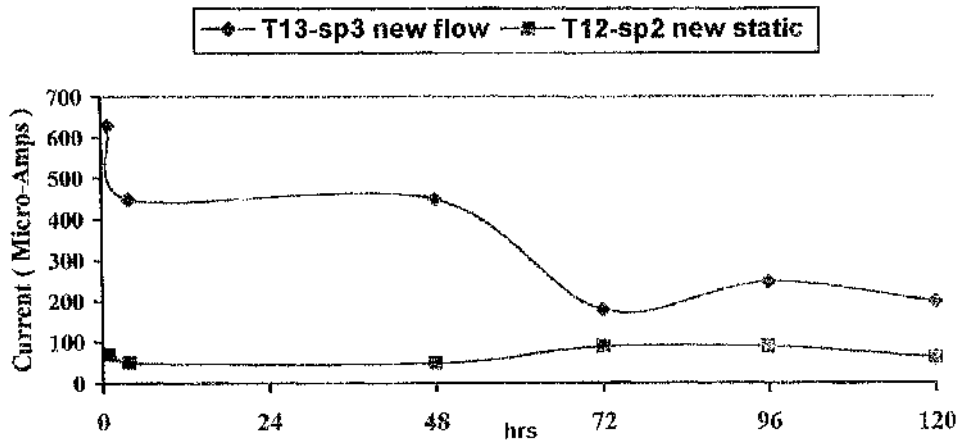
2. Figure 8.10 shows a comparison between static and moderate flow condition and also shows that the difference in current diminishes as the specimen scale up.

Figure 8.10: Effect of flow on system applied current vs. time

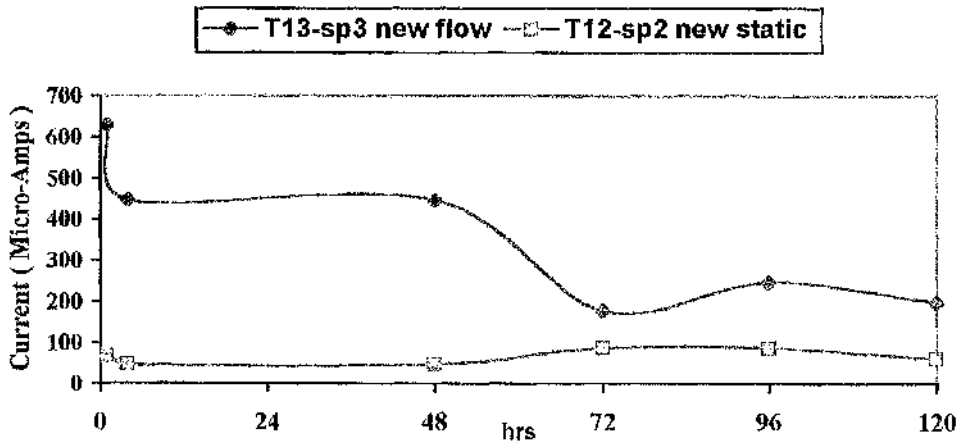
2. Figure 8.10 shows a comparison between static and moderate flow condition and also shows that the difference in current diminishes as the specimen scale up.

Figure 8.10: Effect of flow on system applied current vs. time

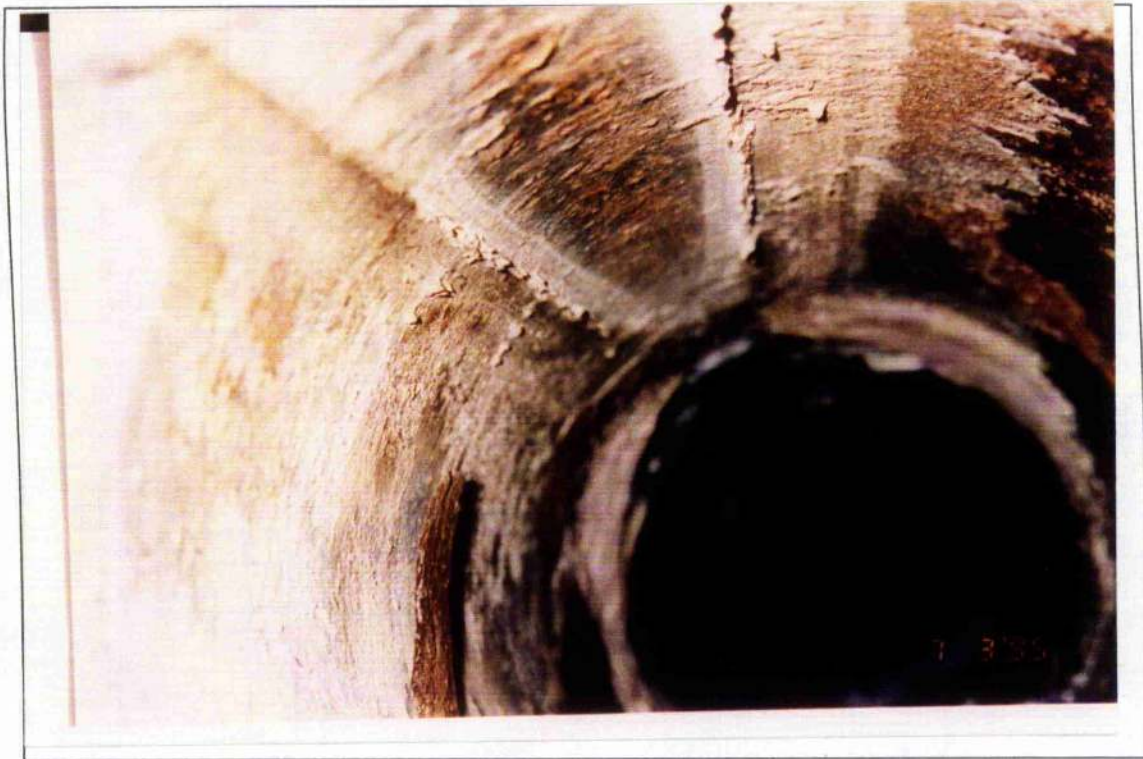
3. Scale precipitation pattern was almost the same as test 16 (namely specimens scaled and not corroded). The scale deposits were distributed evenly over the specimen's surface and had adhered to the surface of specimens for group 'B'. This is mainly due to the followings: -
  - \* Higher contact time between seawater and the protective area, as flow becomes less turbulent along the pipeline and.
  - \* Local potential. Table 8.10 shows that the potential next to the specimens for group 'B' was more negative than in group 'A'.
4. No sign of any calcareous deposits were observed around the anodes.

Figure 8.12: Scale built up on the surface of the test loop pipeline

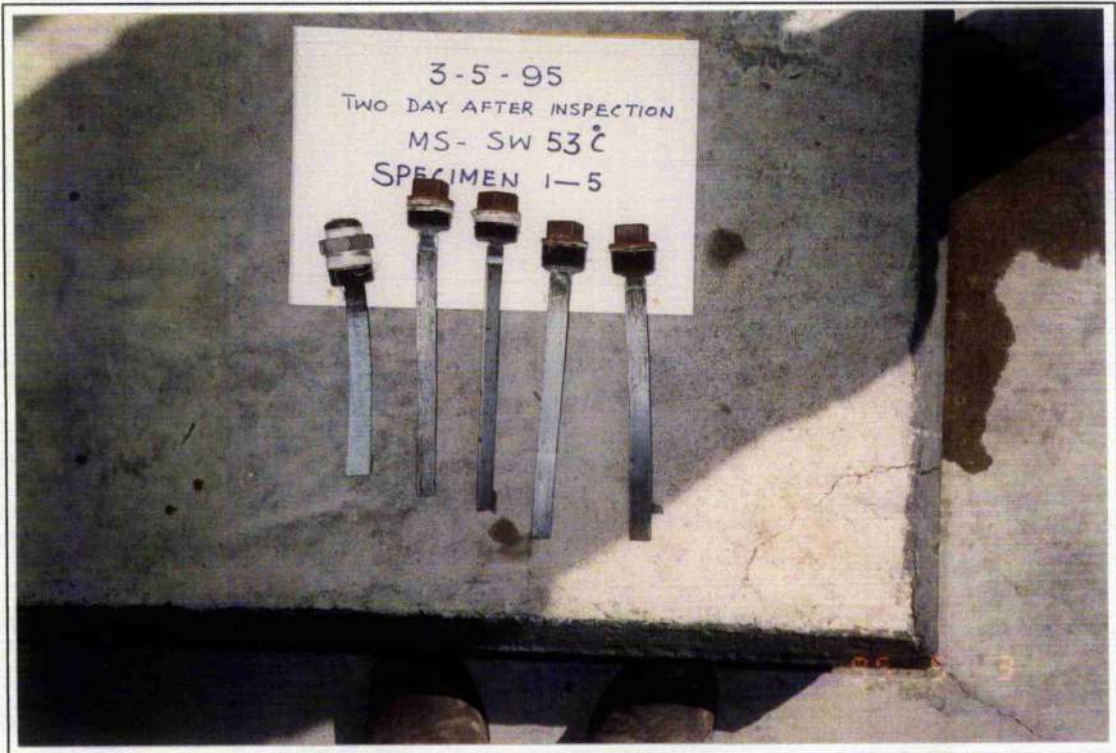
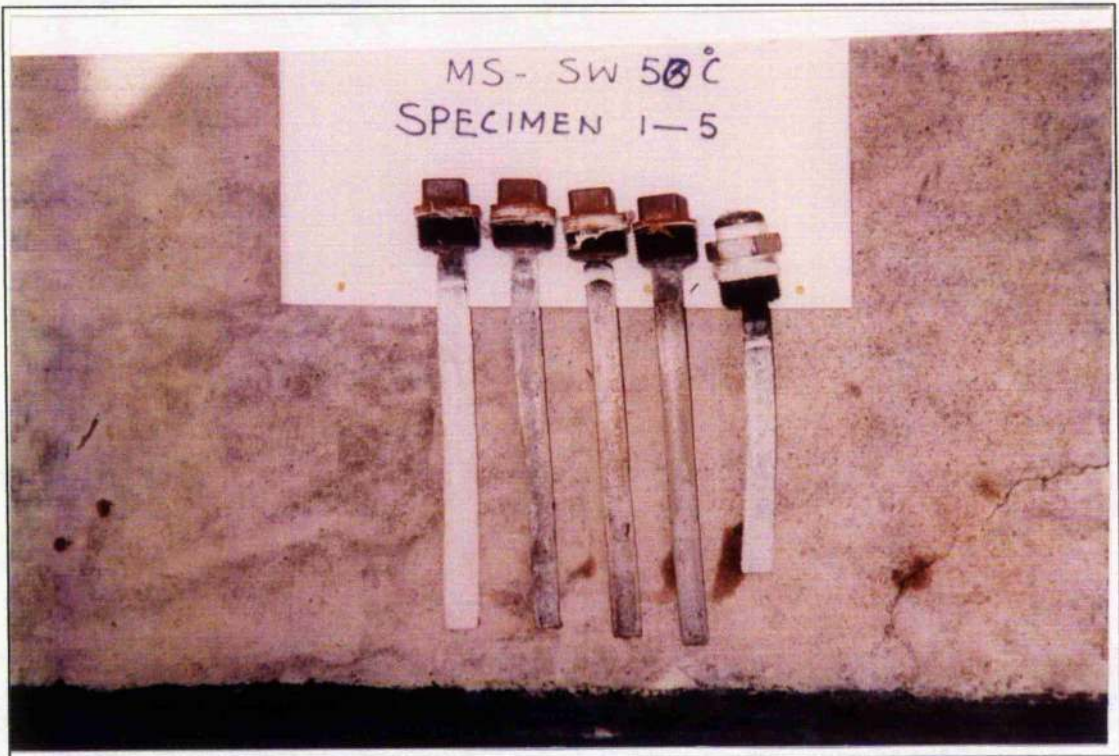
4. Close observation of the rearranged specimen no.5 revealed that the already formed scale at the surface had slightly reduced, but a majority remained untouched.

Figures 8.22 and 8.23: Specimens condition after 2 and 7 days of test 26.

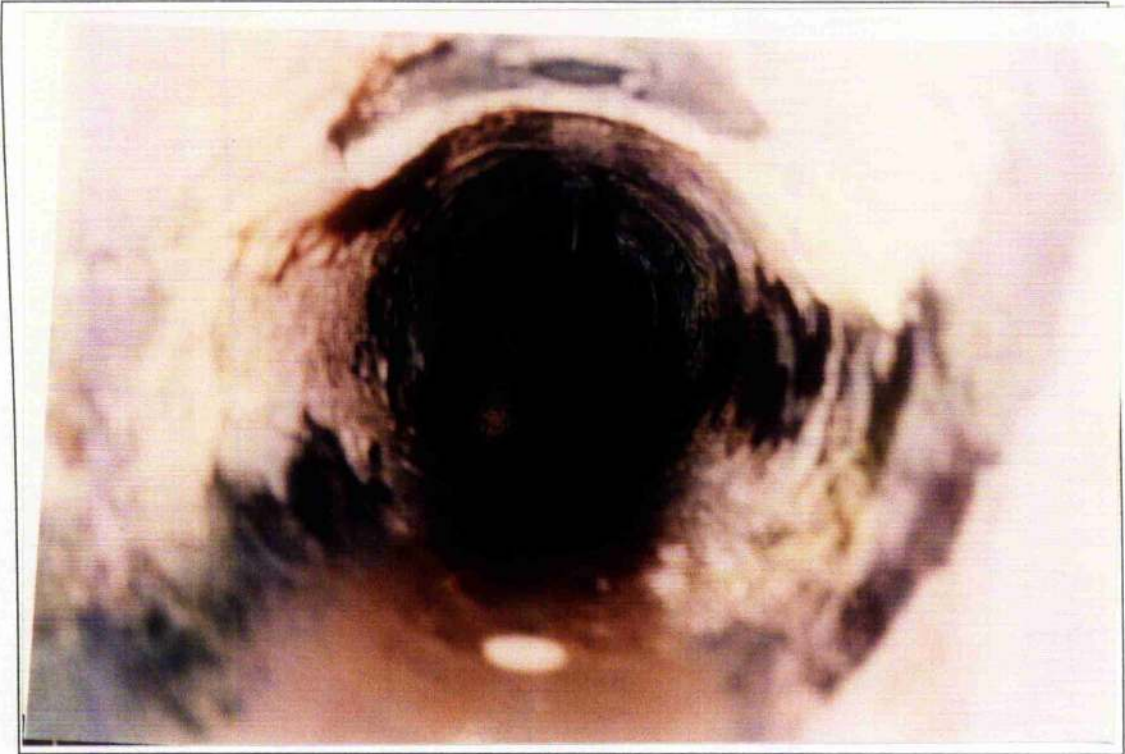
Figures 8.30, 8.31, and 8.32 show the specimens, spool piece and pipeline condition after completion of the test. No corrosion was evident on specimen or inside the spool piece or in the main pipeline. The specimens were covered by a significant scale layer. The interior of the spool piece displayed an excellent uniform layer of scale coating. The main pipeline interior had a much more uniform scale deposit. Table 8.21 shows the summary of the test daily readings. The data indicates that current demand during the test at the same control potential but lower flow rate has no significant effect and remained almost the same when compared to test 27. However, the effect of more negative control potential on applied current was more visible.

Figure 8.32: Pipeline condition at the end of test 29.

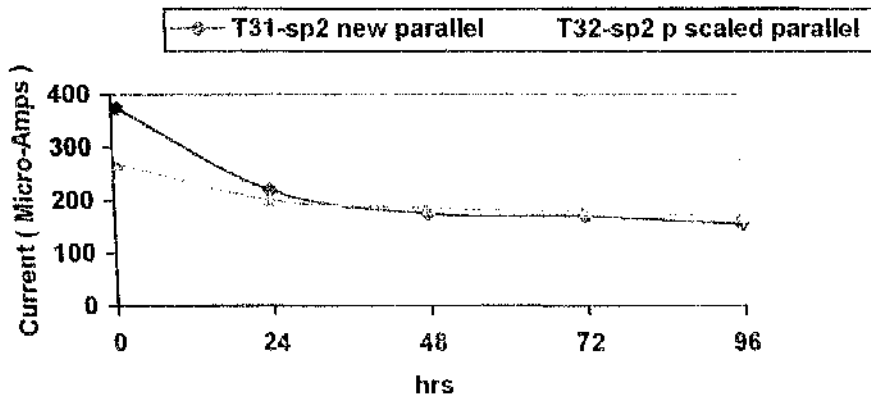
Figure 8.40: Pre-scaling effect on applied current vs. time

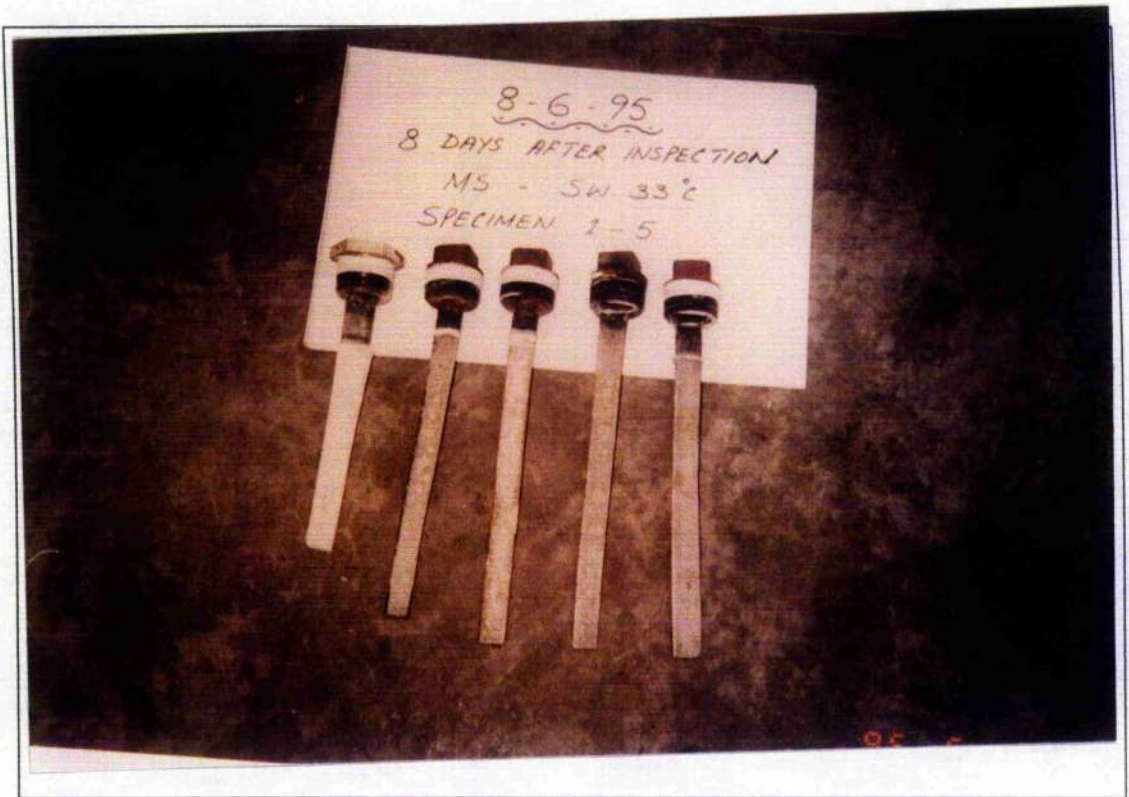
indicates that this factor evidently became less significant with passage of time. Result based on visual inspection of the specimens at the end of test was satisfactory (figure 8.50).

**Figure 8.50: Specimens condition at the end of test 36**

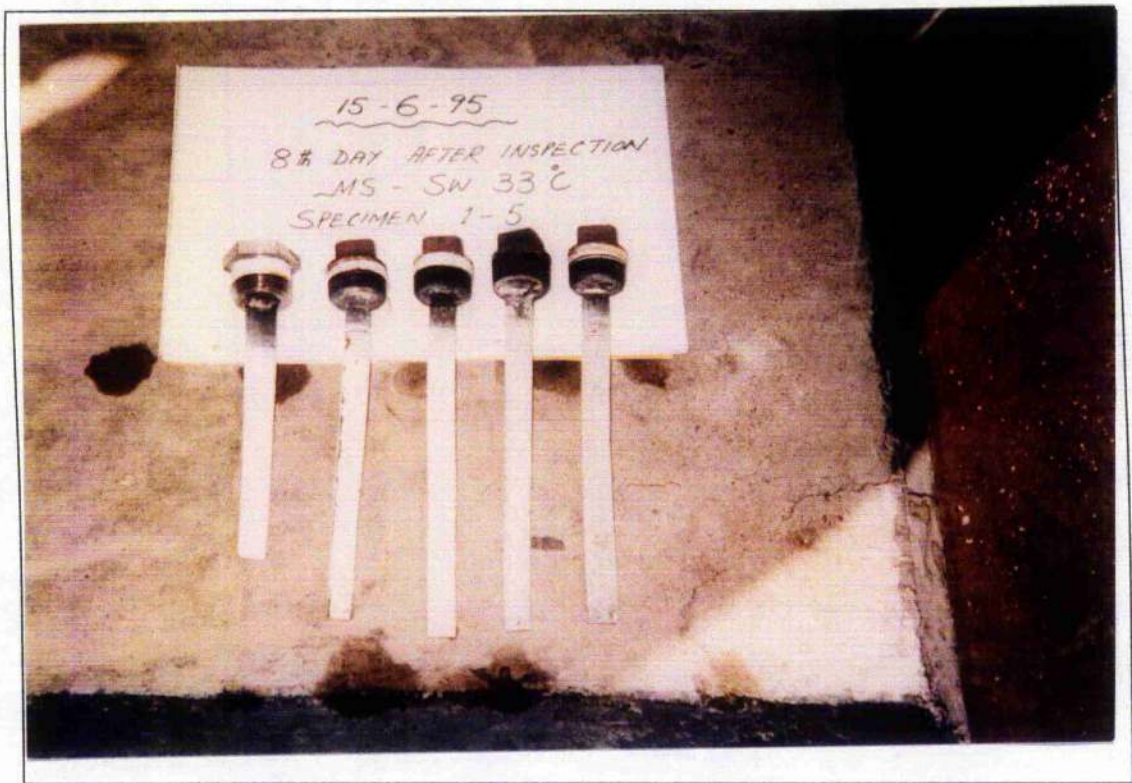
The local potential readings showed the same comparative trend as in test 36 with the values in group 'A' attaining the set value after about 5 to 6 days. Figure 8.52 shows the specimens condition after completion of the test. It revealed that scale precipitation at the surface of the specimens was greater in comparison to test 36, mainly due to control potential being more negative. No sign of corrosion was seen either in any specimen surface or at the loop pipelines including spool piece.

Figure 8.52: Specimen condition at the end of test 37.

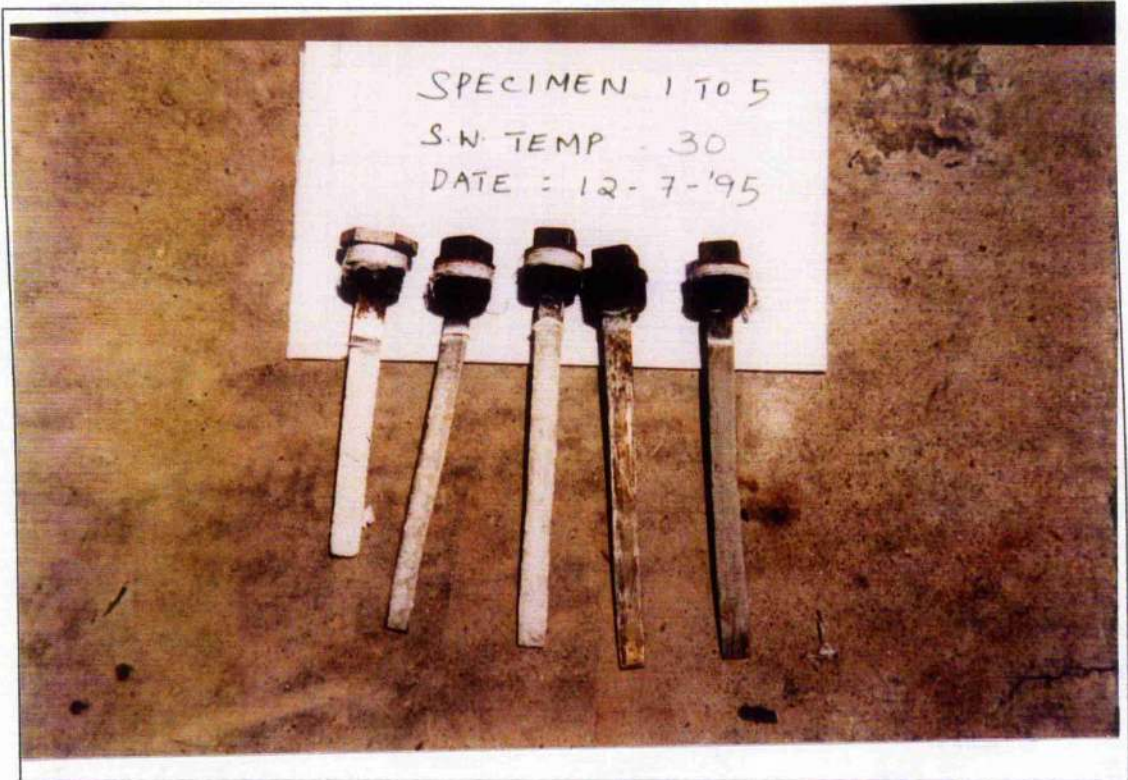
1. Figure 8.59 shows that system was protected, as no sign of corrosion was seen on the surface of the specimens. Scale deposition rate was less when compared to test 29 (figure 8.30).

**Figure 8.59: Specimens condition at the end of test 40**

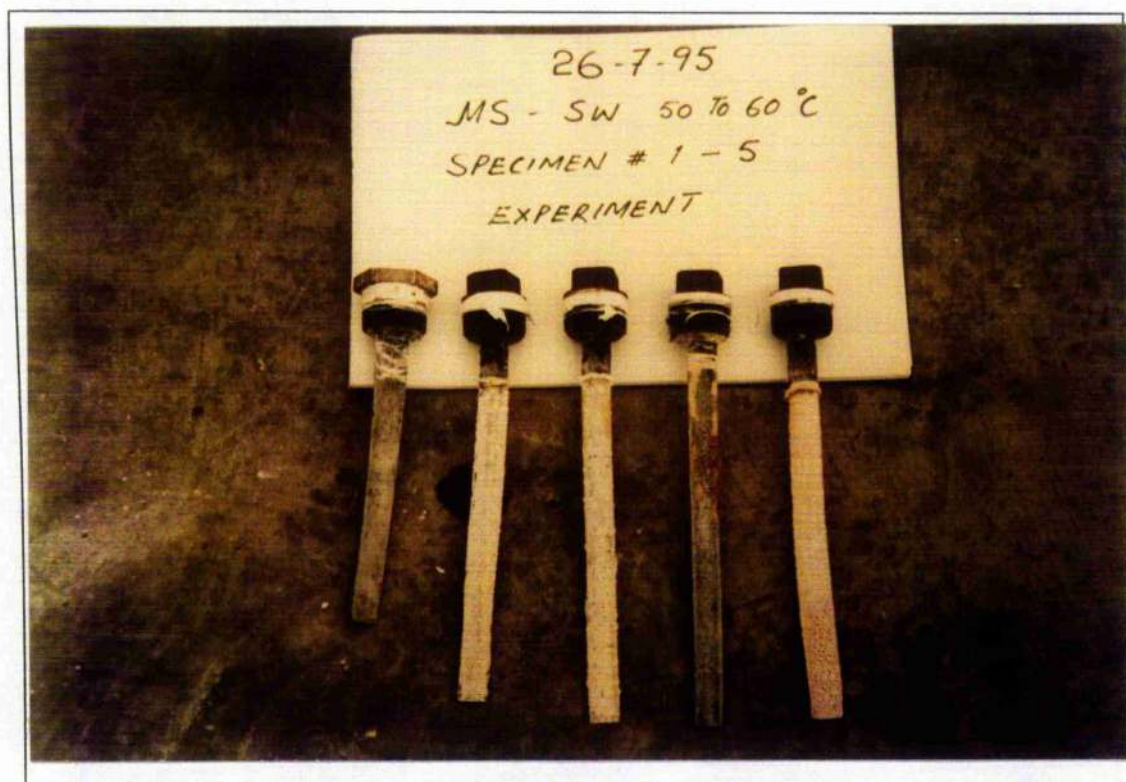
Figure 8.61: Specimens condition after the end of test 41

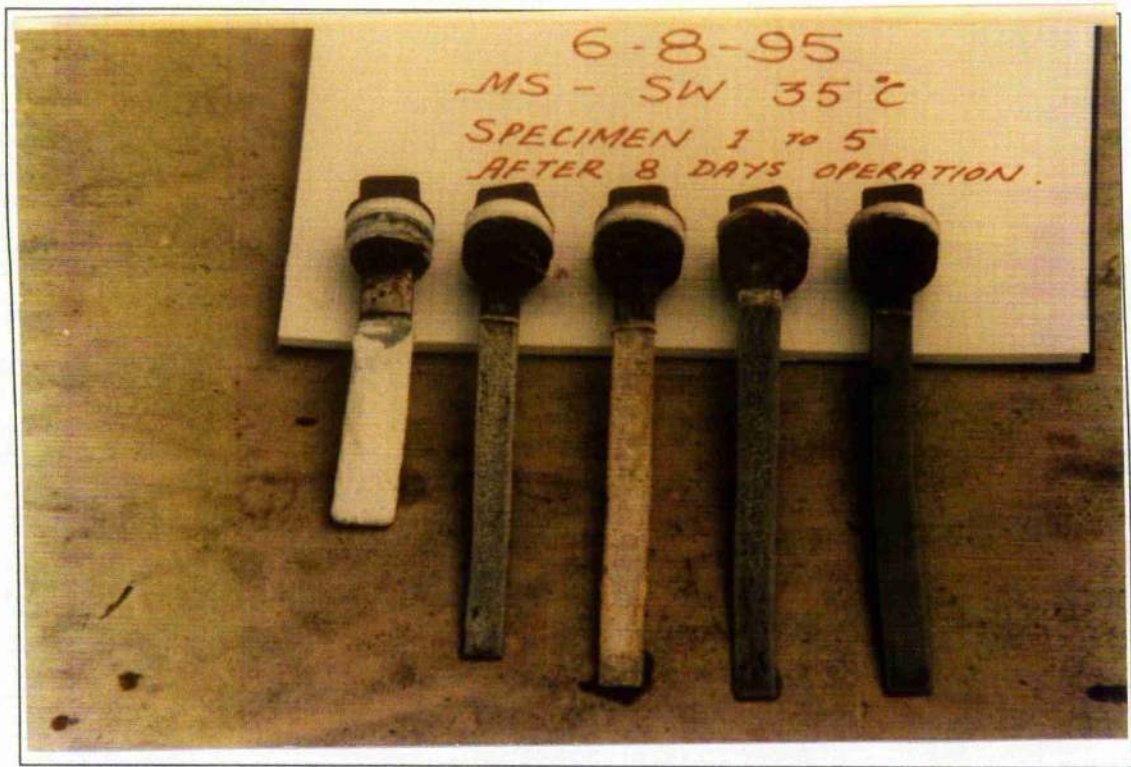
**Figure 8.62: Specimen condition at the end of test 42**

3. System protection was fully achieved as no sign of corrosion was observed at the specimen surfaces.
4. Figure 8.63 illustrates the applied current comparison between test 40 and 42. The current trend shows a good reproducibility of the results. A drop of current from 0.8 to 0.5 amps of test 42 indicated that the loop has been further fouled. In general the rate of scale growth on the surface which is scaled up is much higher than bare metal due to surface roughness.

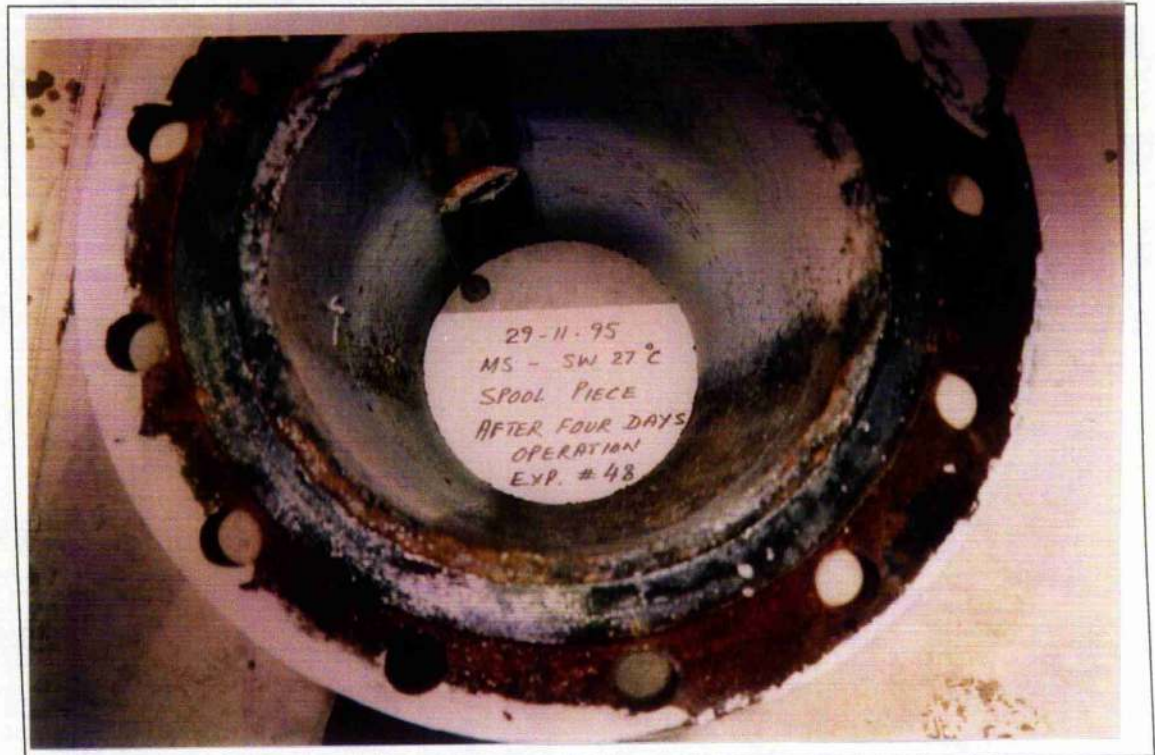
The test was stopped after 3 days because of an anode failure and not surprisingly, there was evidence of slight corrosion on 2 of the specimens. However, the spool piece was in remarkably good condition and was covered completely by scale (figure 8.74). The specimens were cleaned and the test re-started and after one further day (4 days total) the test specimens were checked again to see the conditions of the specimens after replacement of the anode insulation. Scale was found formed on the surface of all the specimens with no sign of corrosion (figure 8.75).

Figures 8.74 and 8.75: Specimens and spool piece condition.

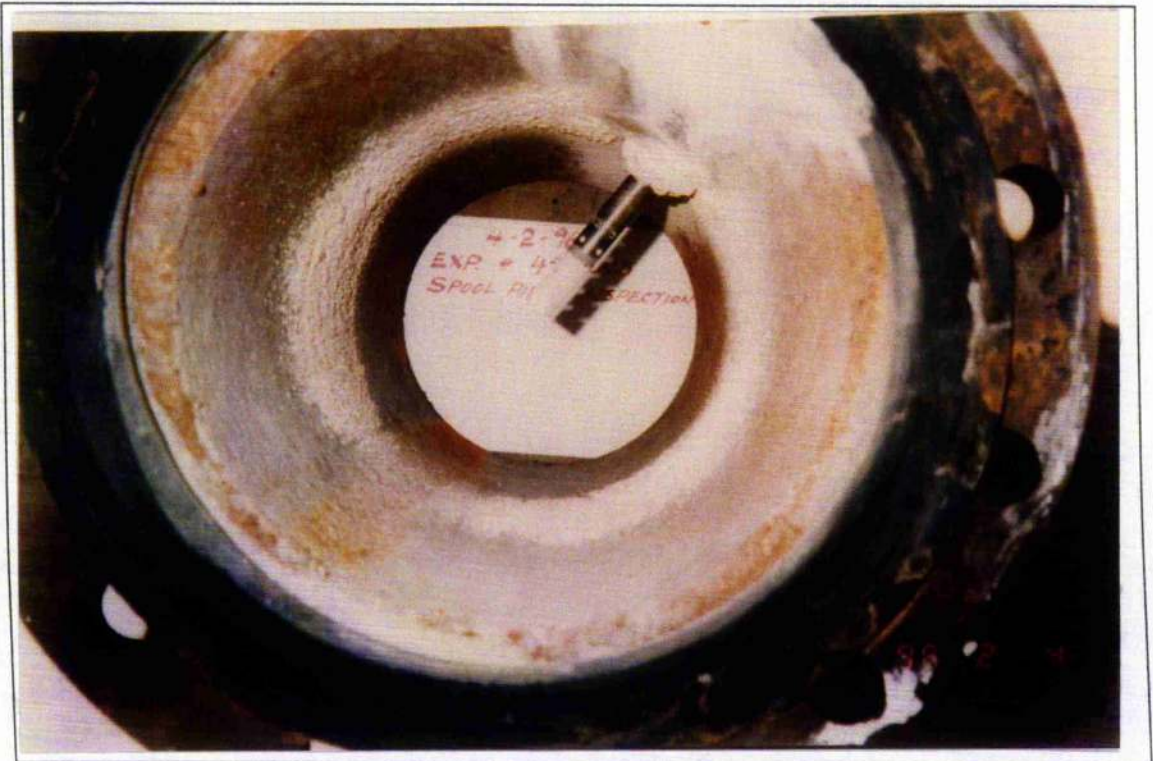
- \* Specimens 1 to 5, no corrosion, specimen surface was coated with a fine layer of scale (figure 8.81).
- \* Spool piece and the pipelines were generally covered with scale and no sign of corrosion (figure 8.82).

Figures 8.81 and 8.82: Specimens and spool piece condition at the end of test 49.
