**Study of Cathodic Protection Related to Thermal  
Desalination Plant**

**Thesis**

**By  
Nader Abdulaziz Najm-Mohammed**

**Department of Mechanical Engineering,  
University of Glasgow,  
November 1997**

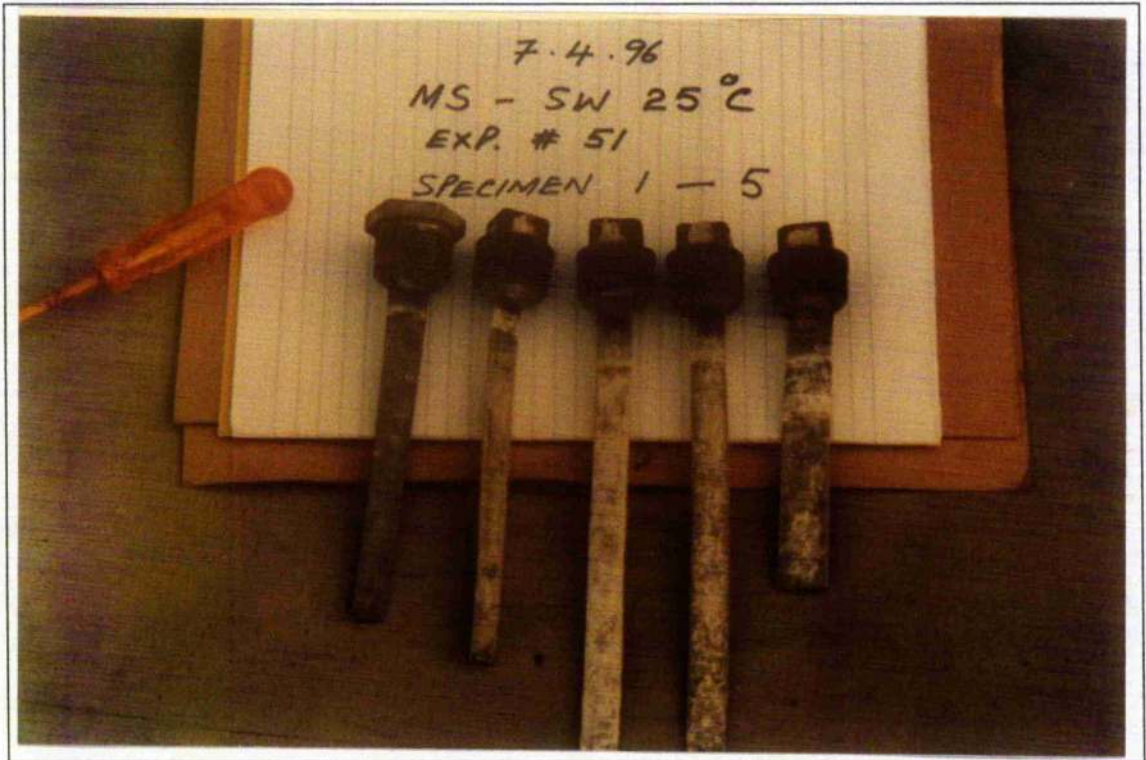
1. Scale deposition rate was found to be sufficient but was less than test 48, mainly due to control potential was set at less negative value than test 48 (figure 8.86).

Figures 8.86: Specimens condition at the end of test 51.

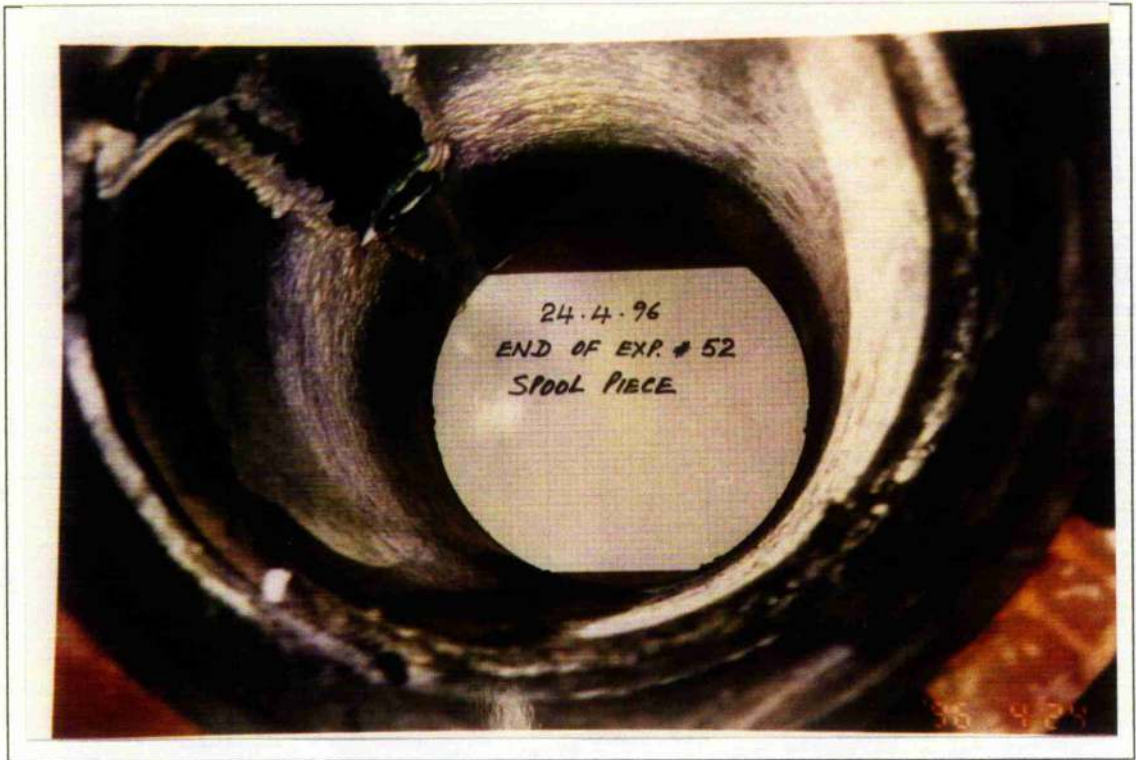
- \* Specimens 1 to 5, no corrosion, but were covered with scale from minor to an average rate.
- \* Spool piece and pipelines were covered with fine layer of scale (figure 8.89).

**Figures 8.89: Spool condition at the end of test 52.**

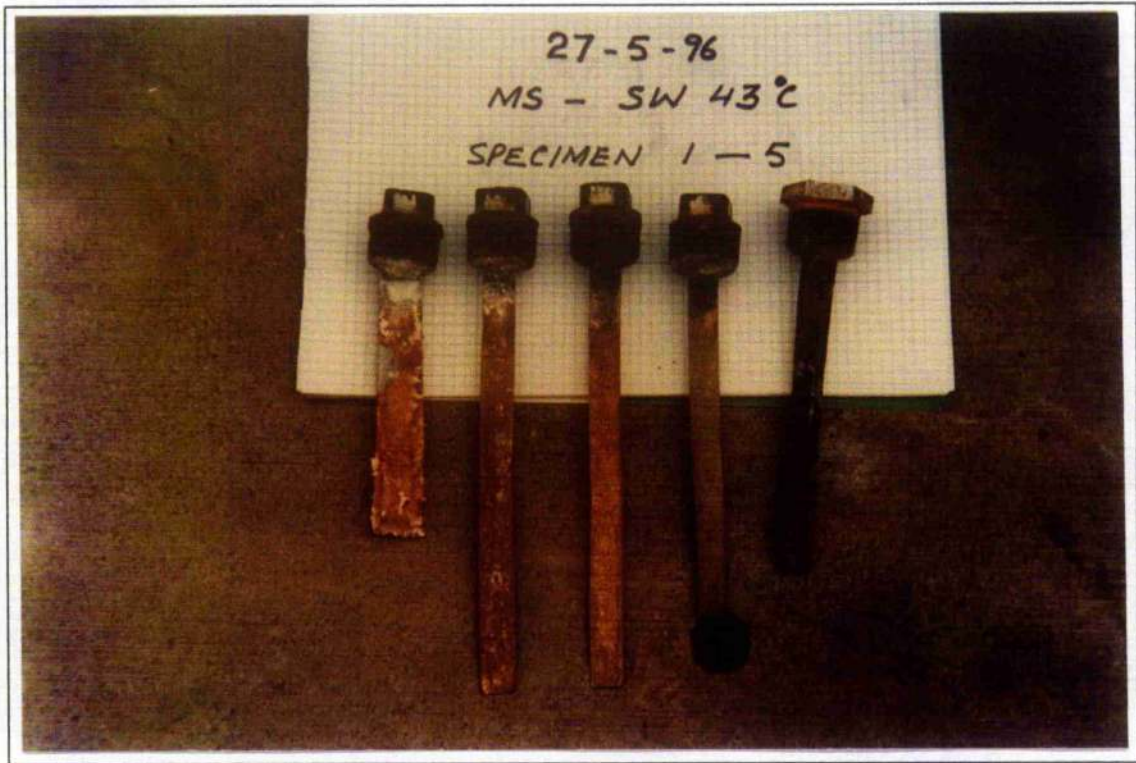
System current leakage was found after 14 days due to fault on the on line impressed current cathodic protection earthing system. This fault resulted in complete failure of the test as required protection of the system was not achieved. As table 8.44 shows, the local potential were all in the active corrosion range throughout the test, confirming that the cathodic protection system was not working. Figure 8.91 shows that the specimens had suffered corrosion.

Figures 8.91: Specimens condition at the end of test 53.

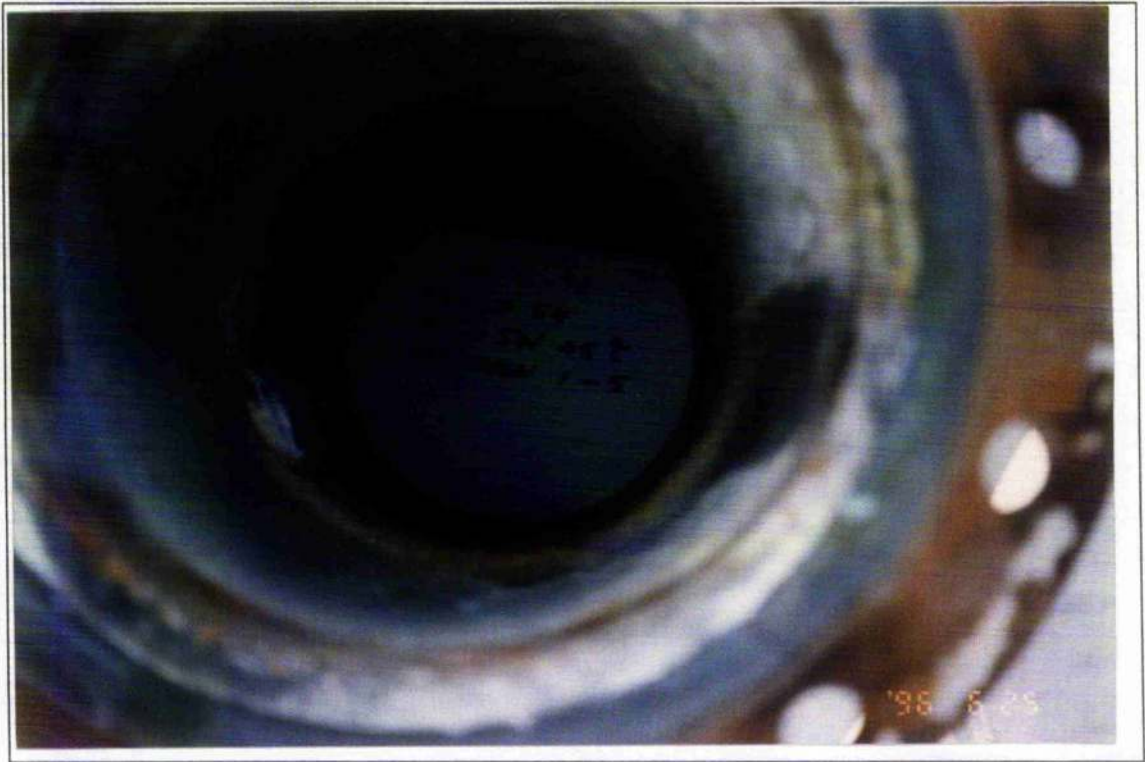
- \* Specimens 1 to 5, no corrosion but were covered with scale from minor to an average rate, a brownish colour on the specimen no 3 is a corrosion product. This is due to circulating tank rubber lining failure.
- \* A thin layer of scale was also found formed on the surfaces of the spool piece and test loop pipelines (figure 8.92).

**Figures 8.92: Spool piece condition at the end of test 54.**

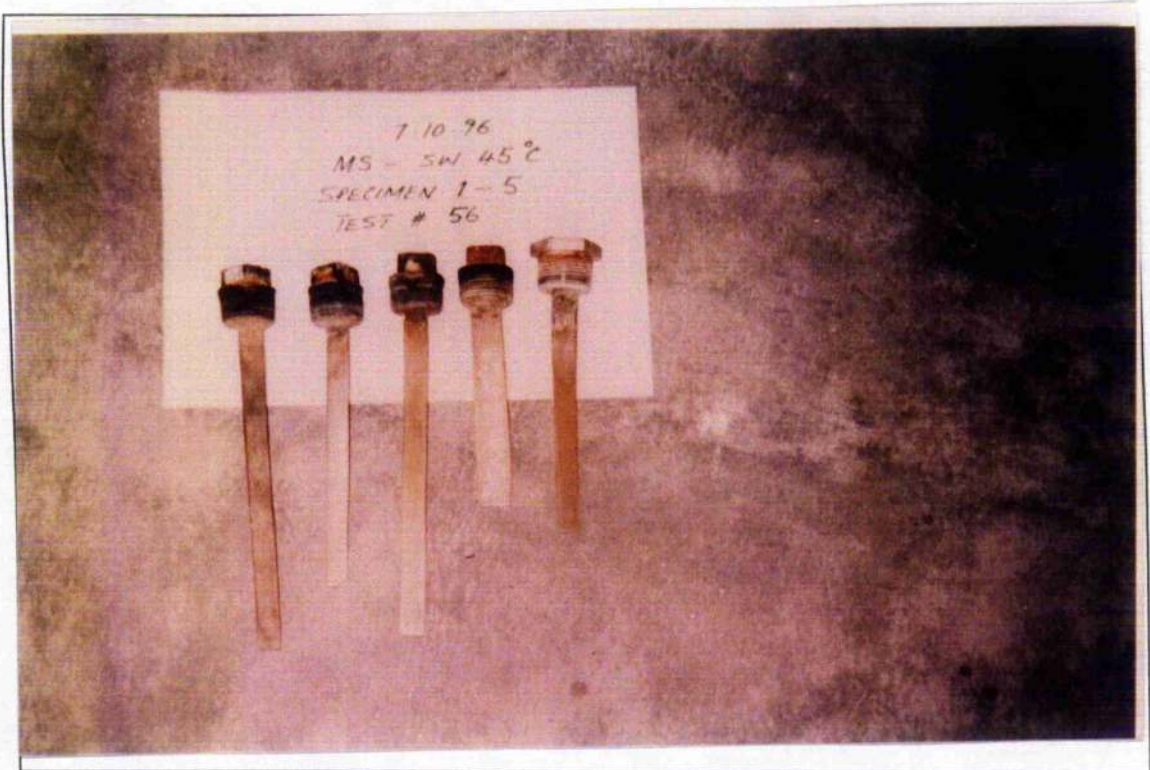
- \* Specimens 1 to 5, no corrosion, minor layer of scale was seen on the surface of the specimens (figure 8.95).
- \* Spool piece and pipelines, no corrosion, thin layer of scale was seen formed.

Figures 8.95: Specimens condition at the end of test 56.

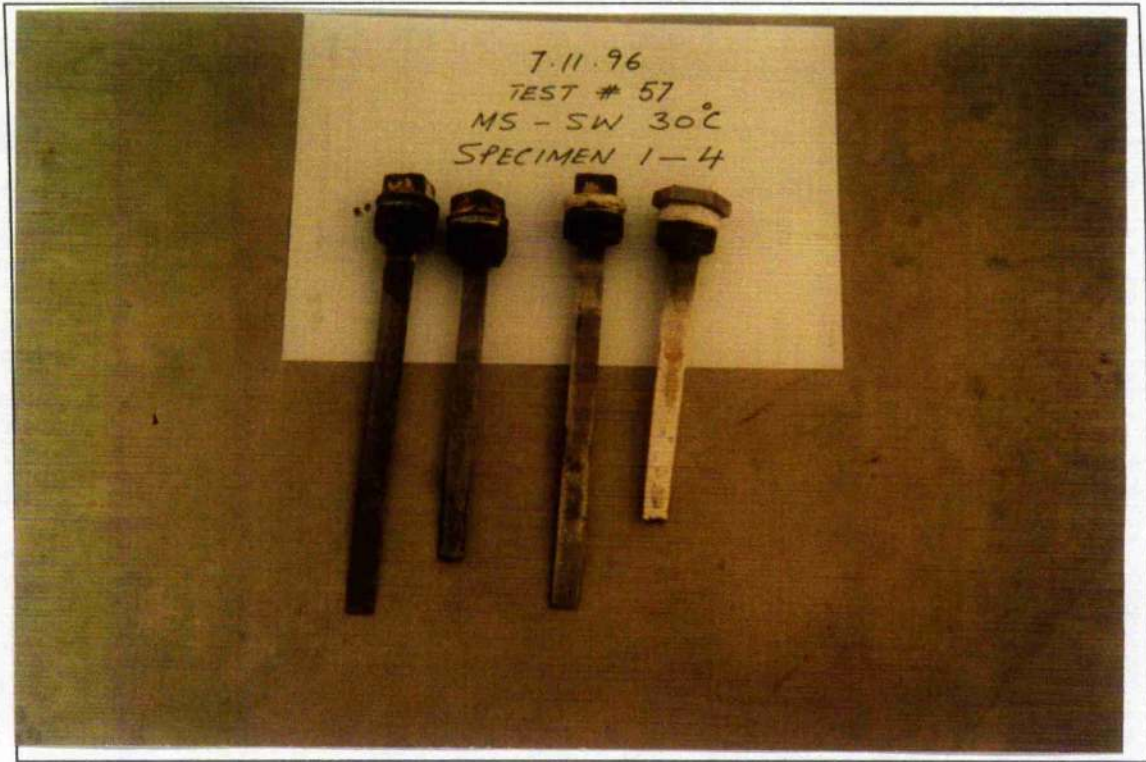
- \* Specimens 1 to 5, no corrosion, scale of different rate was formed on the surface of the specimens (figure 8.97).
- \* Spool piece and pipelines were covered with thin layer of scale.

**Figures 8.97: Specimens condition at the end of test 57.**

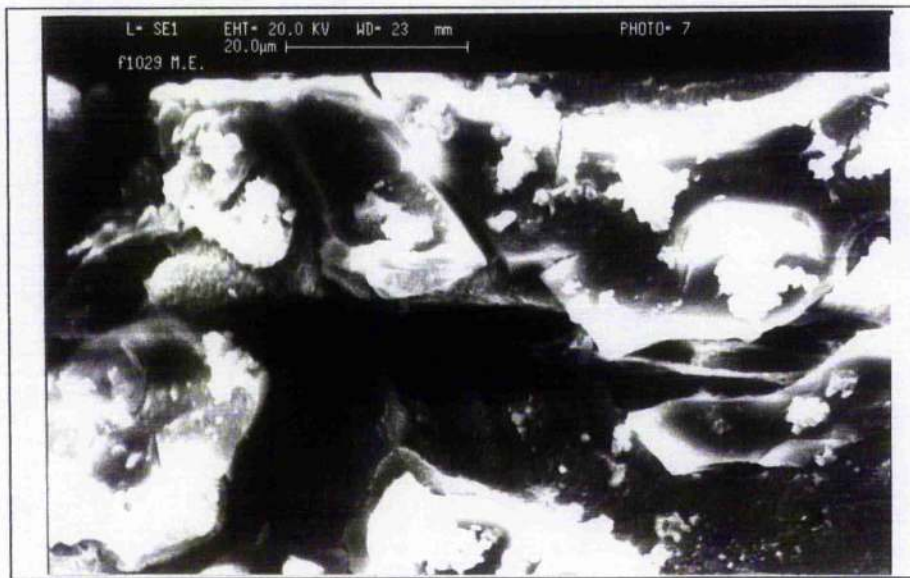
**Figure 9.2: High magnification photo of, Featureless scale, mainly magnesium**

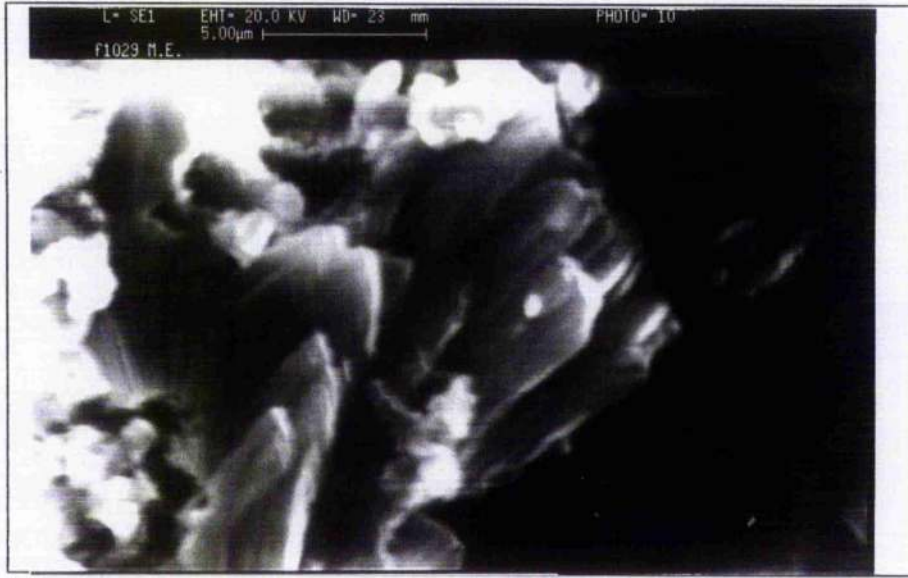
**Figure 9.3: high magnification photo of clumps shape of calcium scale**

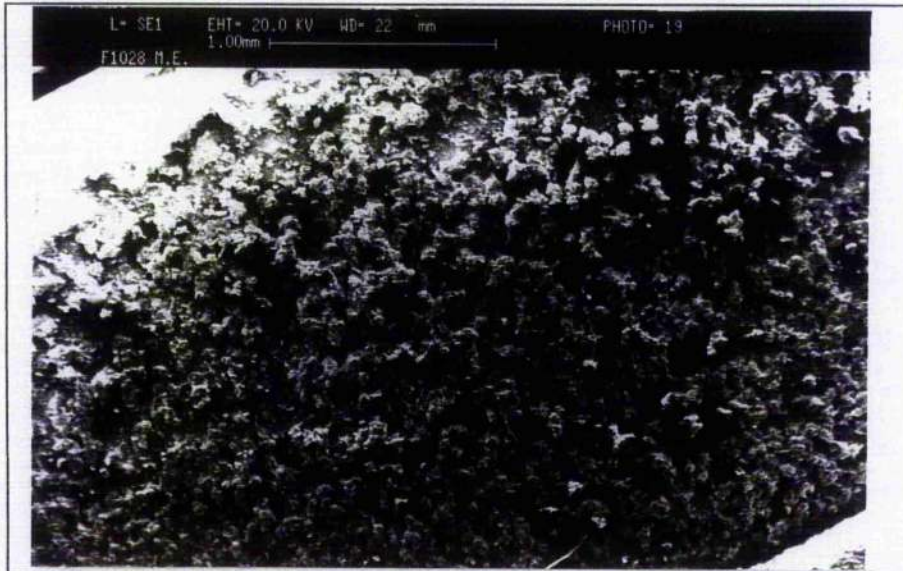
Figure 9.6: Low magnification photo, shows a good coverage of scale deposition over the entire specimen surface

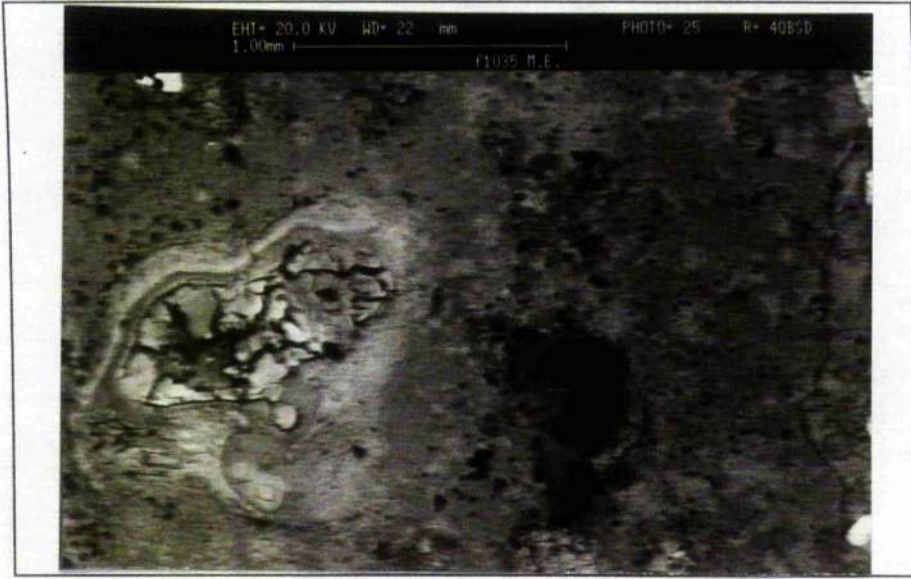
Figure 9.9: Good coverage of scale deposition over the entire specimen surface

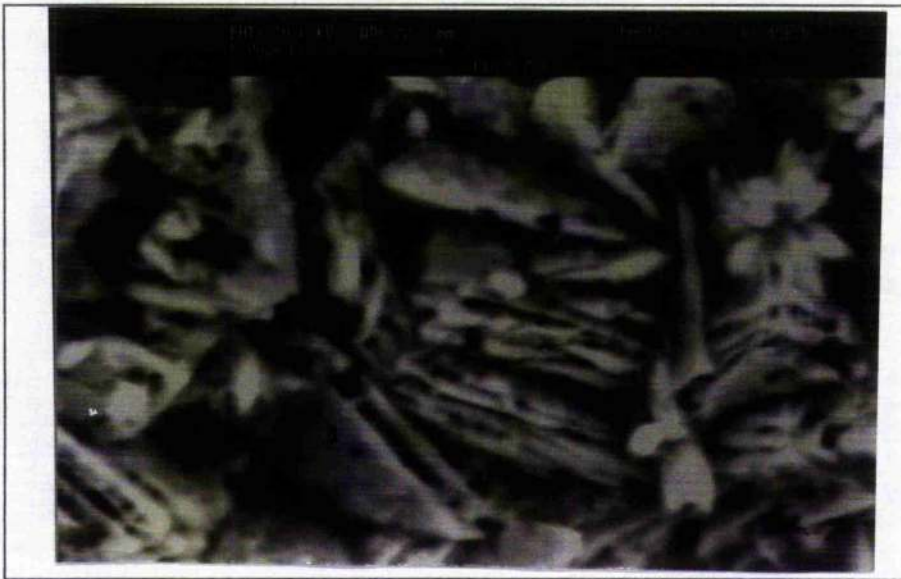
Figure 9.10: high magnification photo of tiny crystal shape calcium scales

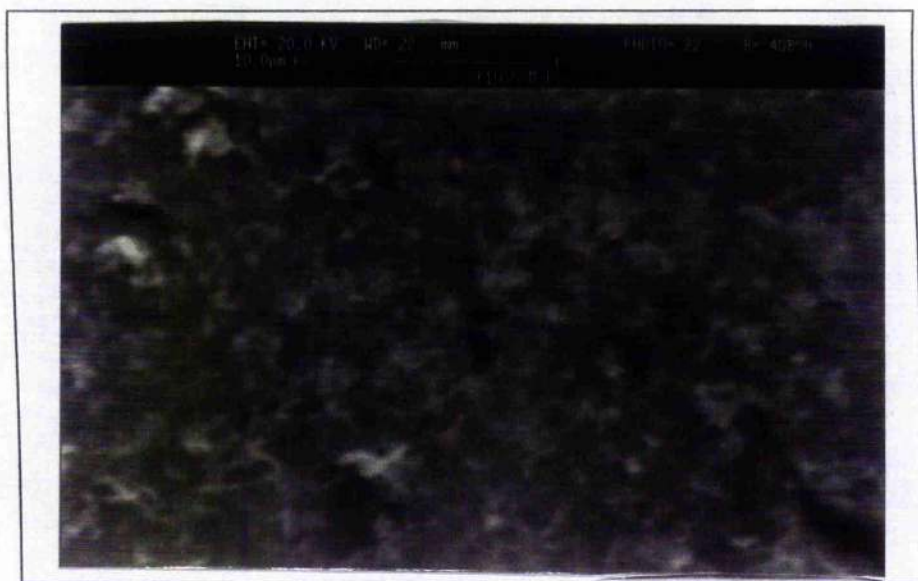
**Figure 9.12: High magnification, photo of featureless scale mainly magnesium**

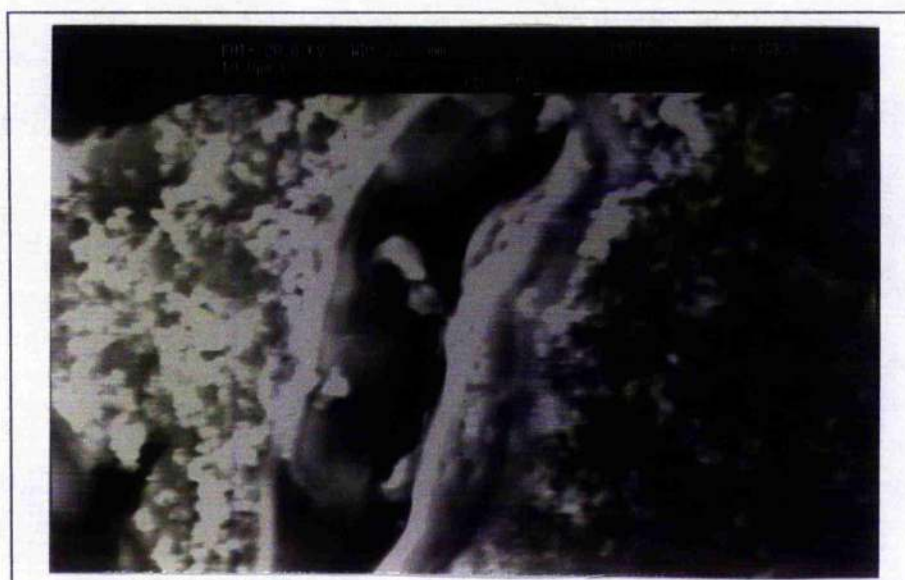
**Figure 9.13: Spalled, featureless scale, mainly magnesium**

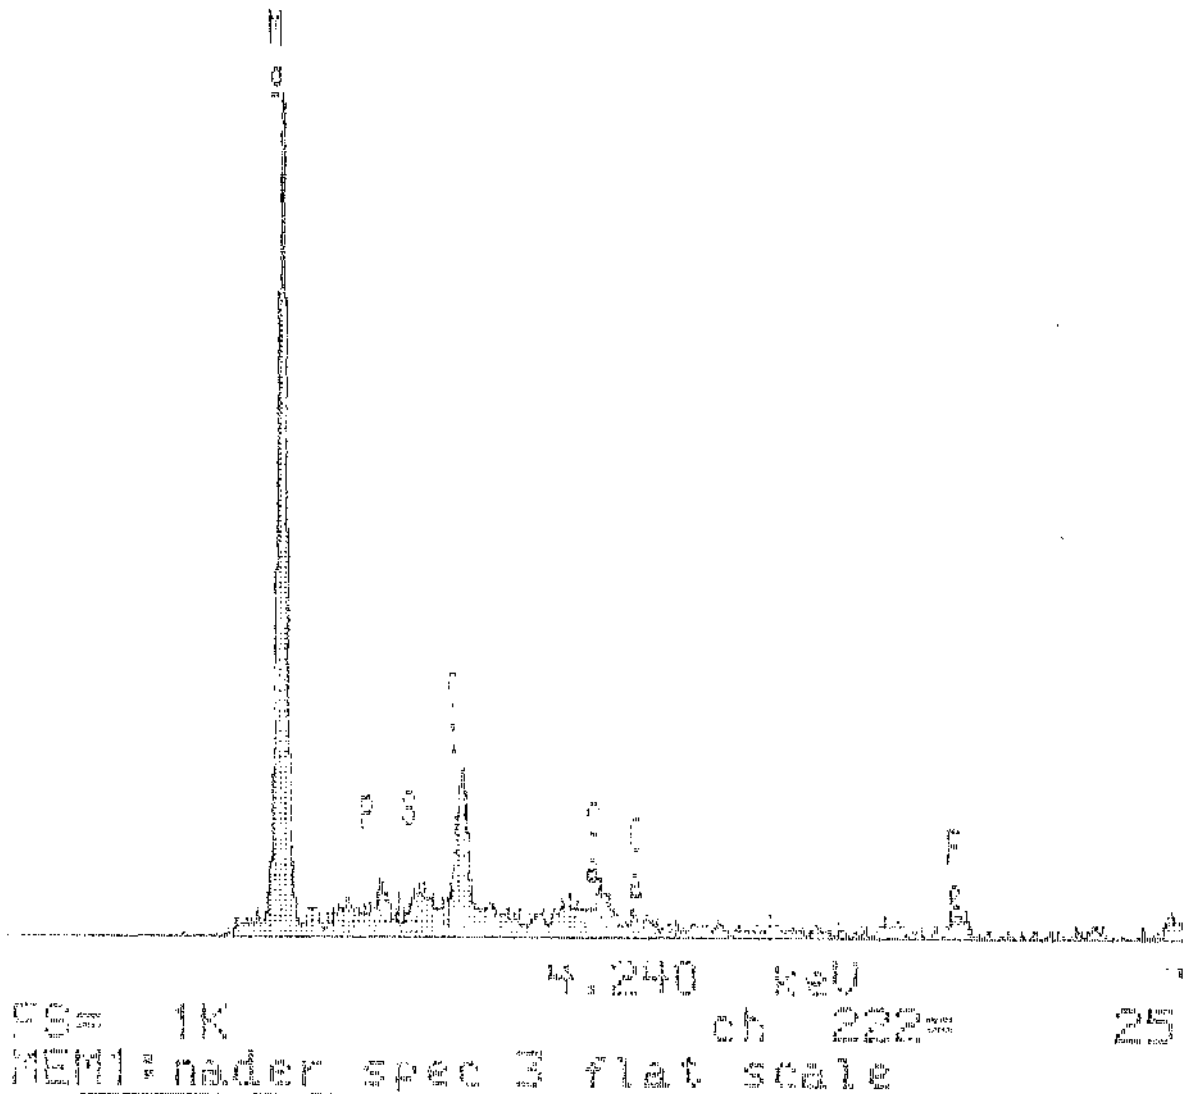
Figure 9.14: Chemical composition of test 11 specimen 1 scale deposit  
 (Reference to figures 9.12)

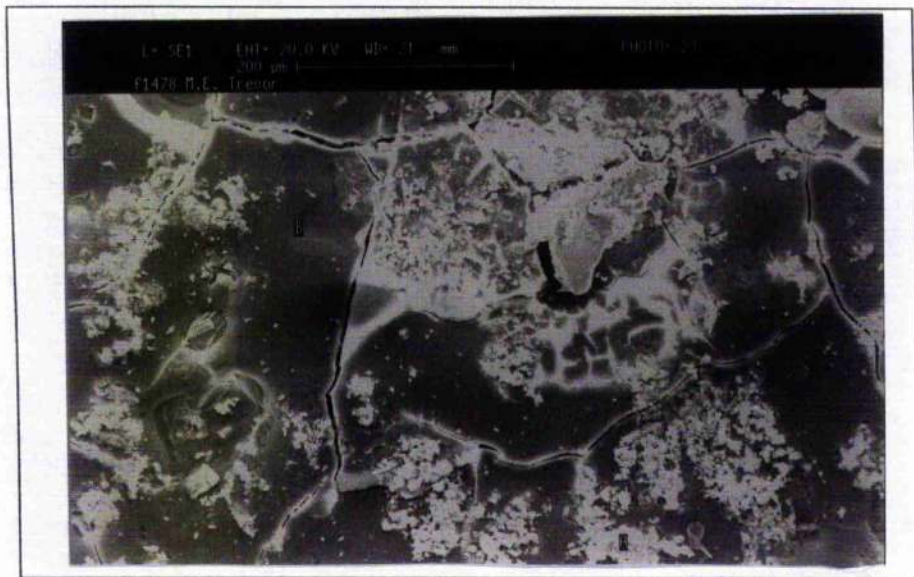
FINDINGS	PHOTO	GRAPH
Good coverage of scale which was featureless (pure magnesium scale, identified as 'B' on figure 9.16) plus clumps(identified as 'A' on figure 9.16) mainly calcium rich with traces of Mg.	Figures 9.16, 9.17	Figures 9.18 9.19

**Figure 9.16: Low magnification shows good coverage of scale mainly featureless (pure magnesium, which identified as 'A')**

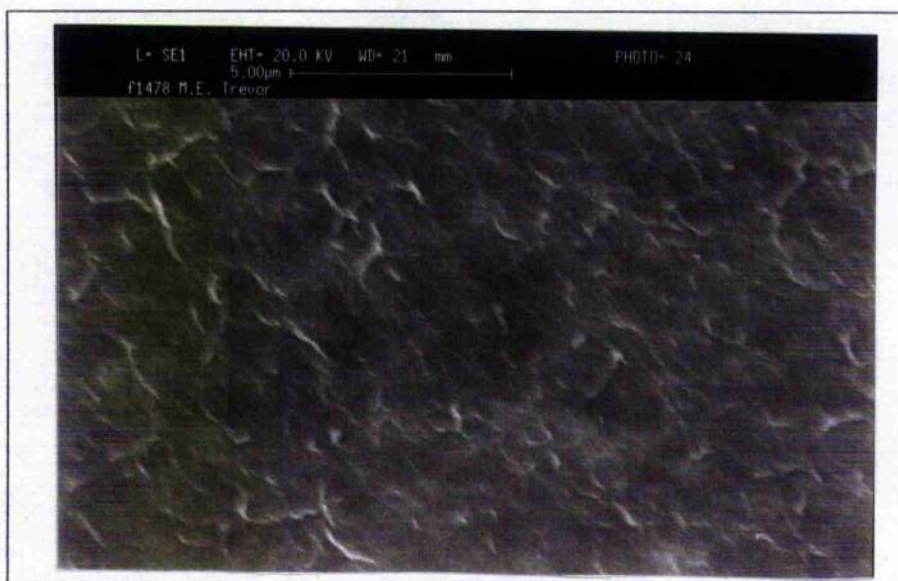
**Figure 9.17: High magnification shows featureless type scale (Pure magnesium, which identified as 'A' on figure 9.16)**

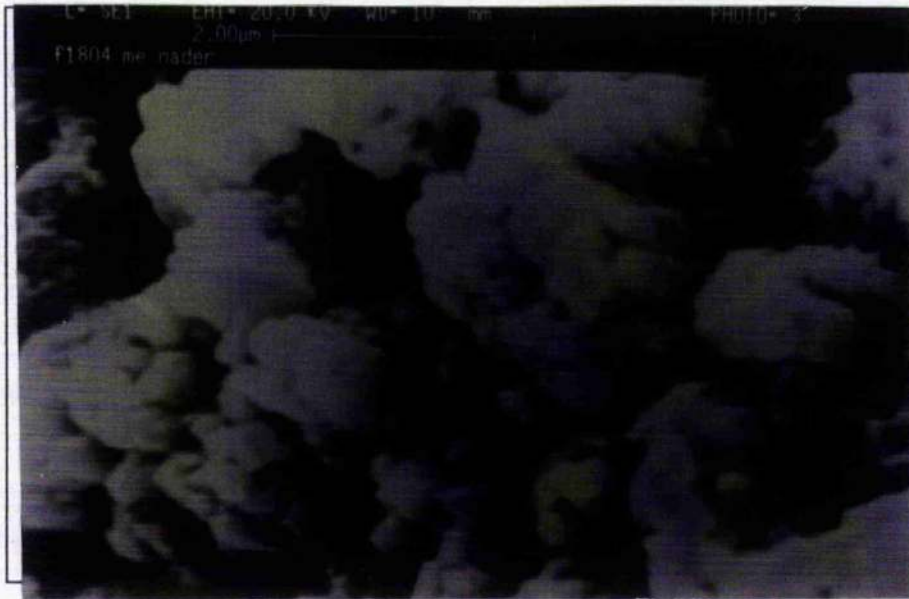
Figure 9.21: High magnification photo of specimen shows clumps pure calcium scale of crystals

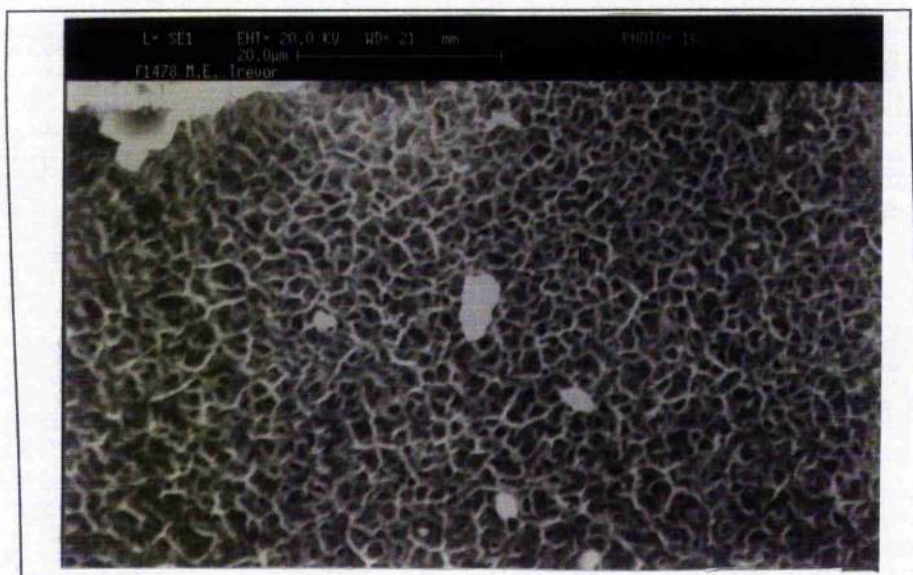
**Figure 9.24: Low magnification of smooth background, indicates a honeycomb type shape (pure magnesium)**

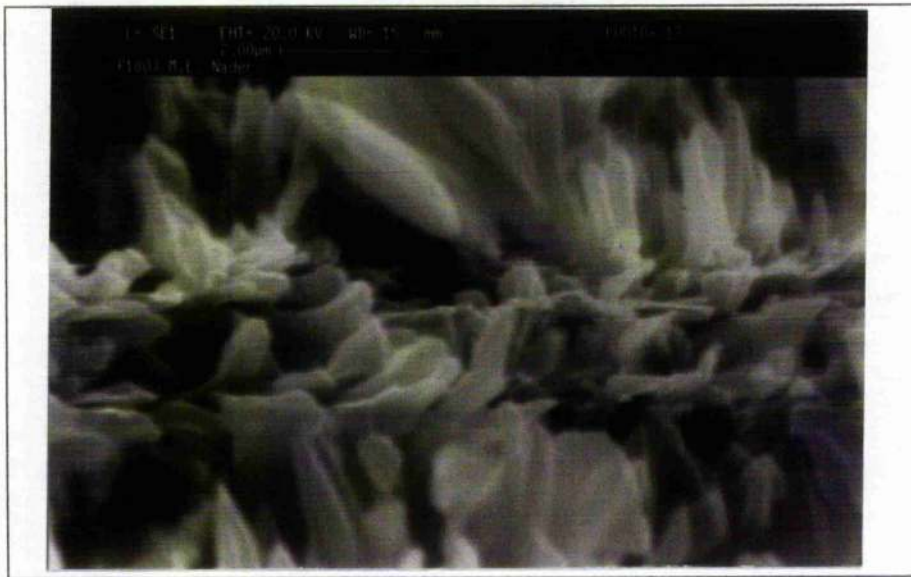
Figure 9.27: High magnification of an area shows, a coarse column-like crystals (Mg rich + Ca)

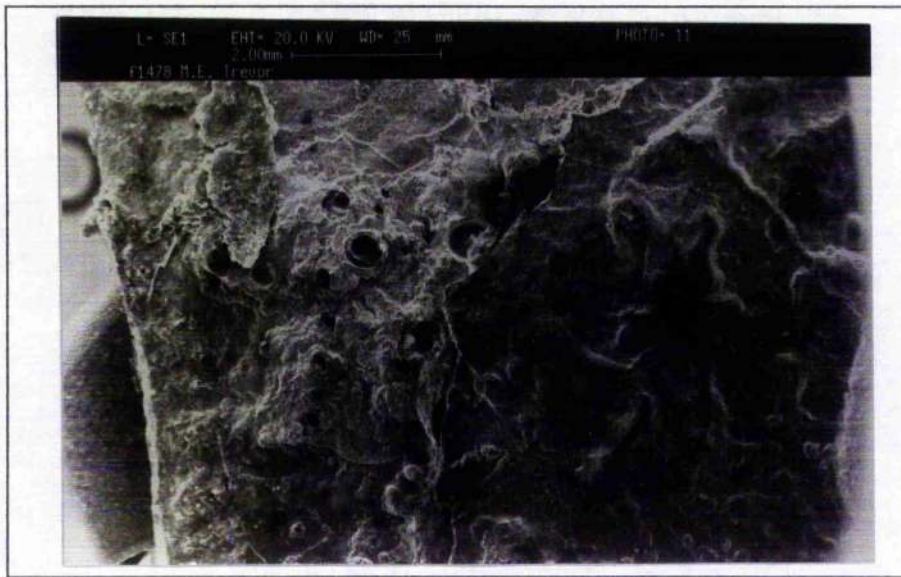
FINDINGS	PHOTO (figure)	GRAPH (figure)
<u>Top surface of scale</u>		
Two distinct types of region	9.29	
1. Coarse crystals (pure calcium). At high magnification inter-particle pores. In some area, clear pores	9.33	
2. Finer acicular crystals (Mg-rich)	9.31, 9.32 9.27	9.28
<u>Bottom surface of scale</u>	9.34, 9.35	9.36
Featureless shape with network of pores magnesium rich

**Figure 9.31: Low magnification of an area shows clear pores on the surface of the scale**

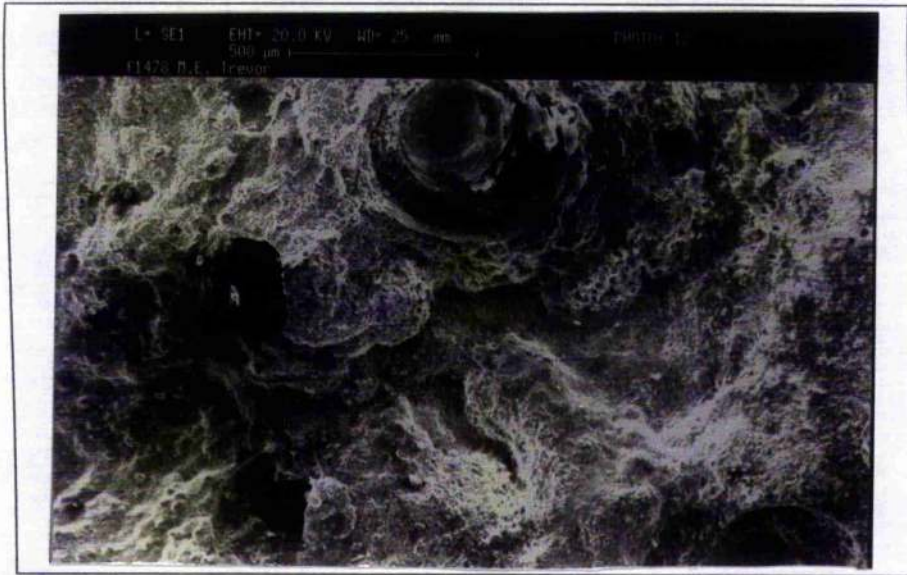
**Figure 9.32: High magnification of an area of figure 9.31**

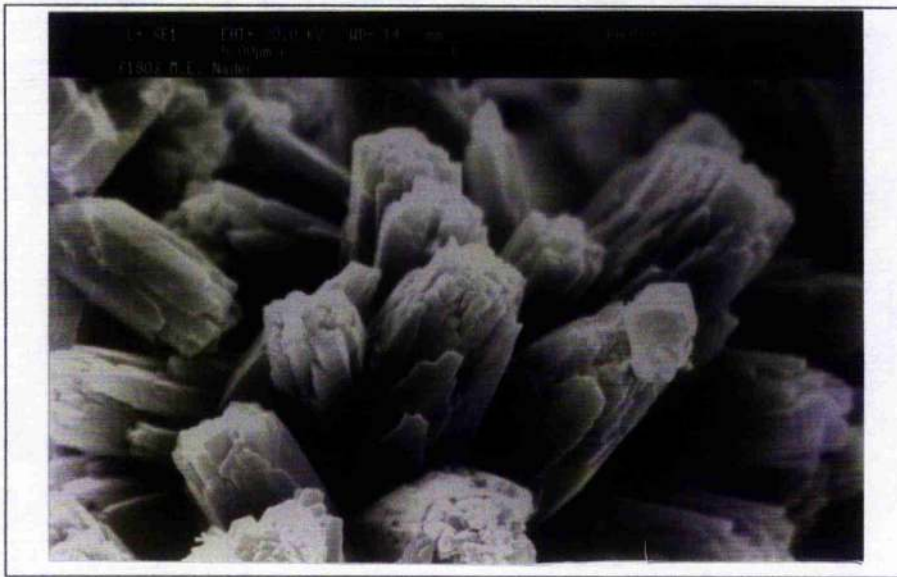
**Figure 9.33: High magnification of an area of figure 9.32**

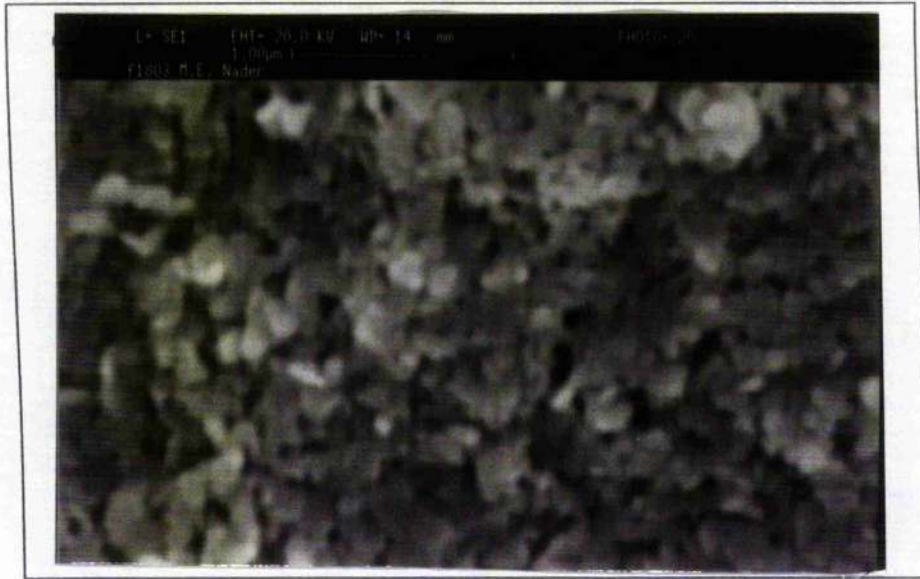
**Figure 9.34: High magnification of an area shows featureless scale and network of pores (magnesium rich)**

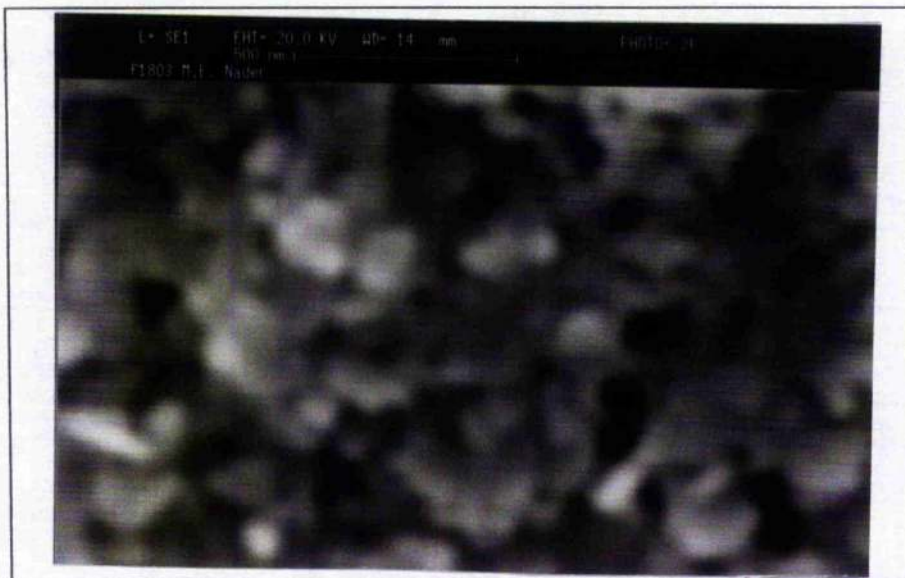
**Figure 9.35: High magnification of an area shows featureless scale and network of pores (magnesium rich)**

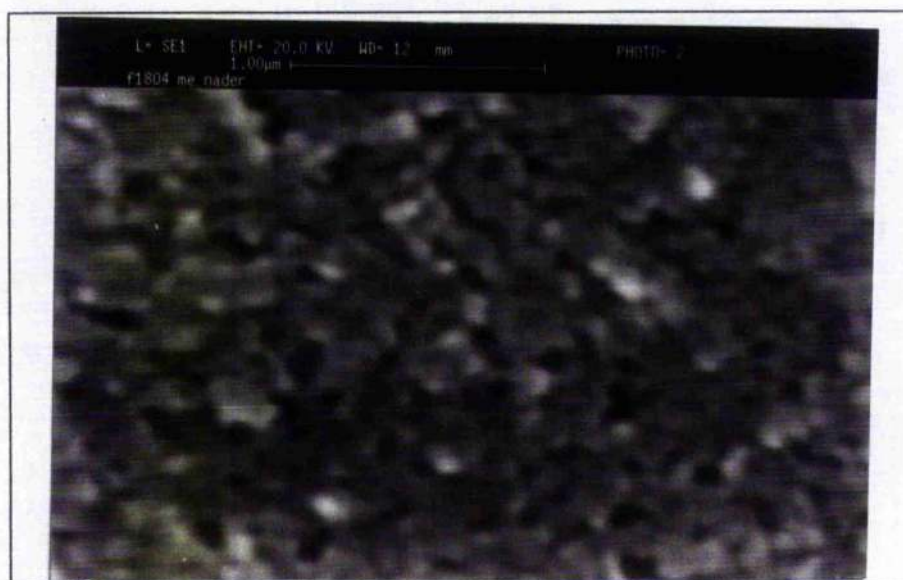
Figure 9.37: High magnification of an area shows featureless scale and network of pores

Figure 9.38: Chemical composition of test 55 specimen 4 bottom, scale deposit  
 (Reference to figures 9.37)

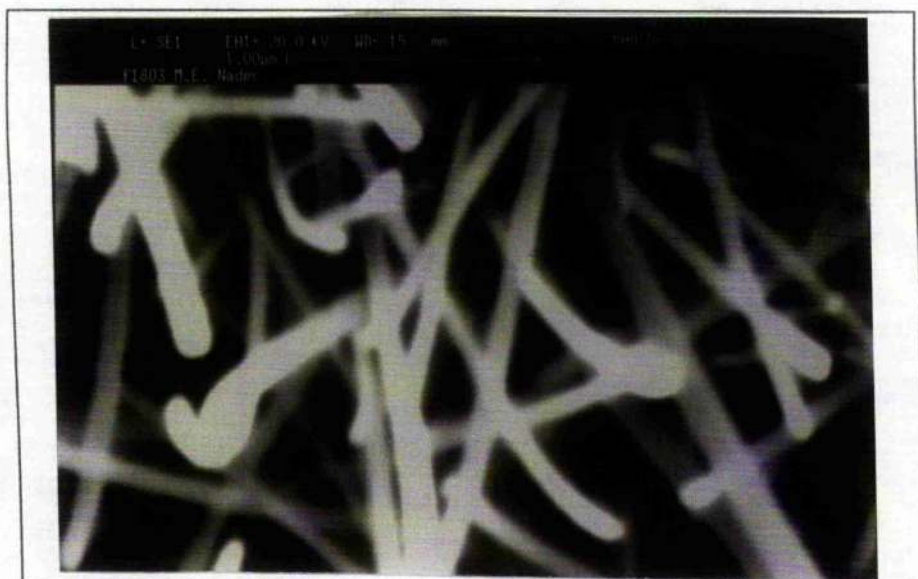
**Figure 9.42: High magnification of an area shows network of mesh-like crystals**

FINDINGS	PHOTO (figure)	GRAPH (figure)
At low magnification an extensive area was seen to be covered with needle-like crystals	9.41	N/A
At high magnification the needle-like crystals was appeared to be mesh-like (magnesium rich and traces of calcium)	9.42, 9.43	N/A

- b. The magnesium scale often appeared to be featureless but examples of crystal shapes (but different) were found. Thus test 55 showed needle like or mesh-like crystals, but test 43 revealed a honeycomb structure.

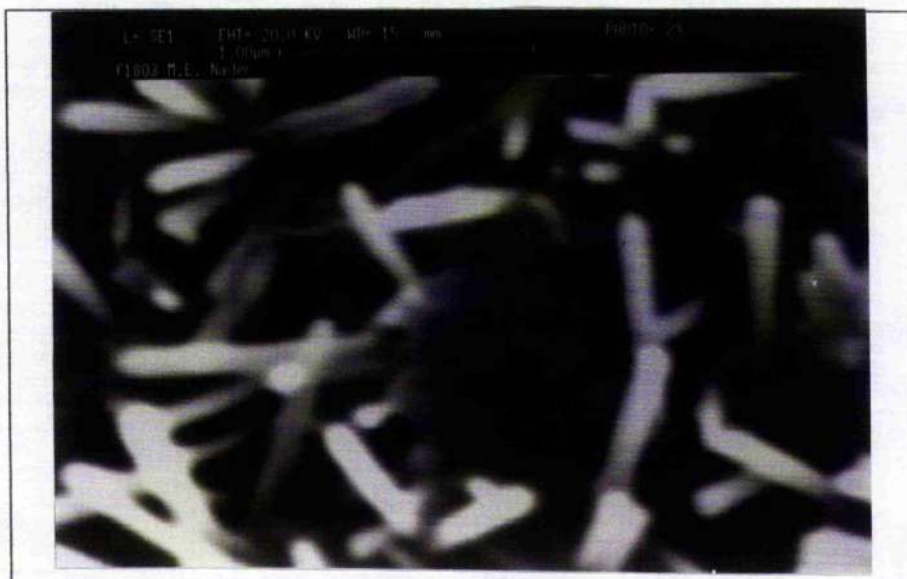
**Figure 9.43: High magnification of an area shows network of mesh-like crystals**

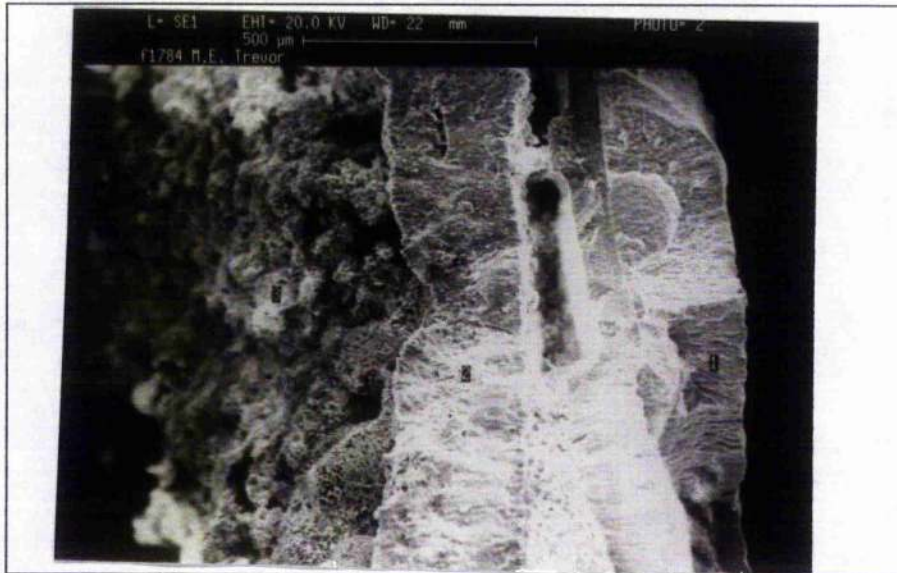
Figure 9.44: Cross-section photo of test 57 specimen 4 shows multi-layers of scale

FINDINGS	PHOTO (figure)	GRAPH (figure)
Several layers of scale was seen at low magnification	9.44	N/A
High magnification of region 1 of figure 9.44, shows a featureless shape which is magnesium rich	9.45	9.46
High magnification of region 2 of figure 9.44, shows needle-like shape crystals which are rich in calcium plus tiny magnesium	9.47	9.48
High magnification of region 3 of figure 9.44, shows column-like crystals shape which is calcium rich and traces of magnesium	9.49	9.50

overlying region of the aragonite form of  $\text{CaCO}_3$ . This findings extends the contribution made previously by Mental et al<sup>35</sup> who reported a similar scale structure but just for the restricted conditions of  $-900$  mV Ag/AgCl and 24 to 28 °C. In the current research this scale structure was observed for applied potential covering the range  $-800$  to  $-1100$  mV and over the temperature range 25-60 °C. Thus the uncertainty in much of the previous literature concerning the make-up of calcareous scales has been clarified. However, it still remains to characterize the scale structure and composition formed at less-negative potential than  $-900$  mV. In this respect it is of interest to point out that, some time ago<sup>36</sup>, there was a report that the uniform deposit formed at  $-700$ mV (SCE) comprised a Ca-rich scale containing no Mg. Moreover recent work<sup>37</sup> has detected a 2-layer scale ( $\text{Mg}(\text{OH})_2$  / aragonite) when stainless steel was cathodically polarized to  $-1000$  mV (SCE) but that cathodic protection to  $-600$  mV resulted in simply a  $\text{CaCO}_3$  (aragonite) scale containing no sign of Mg.

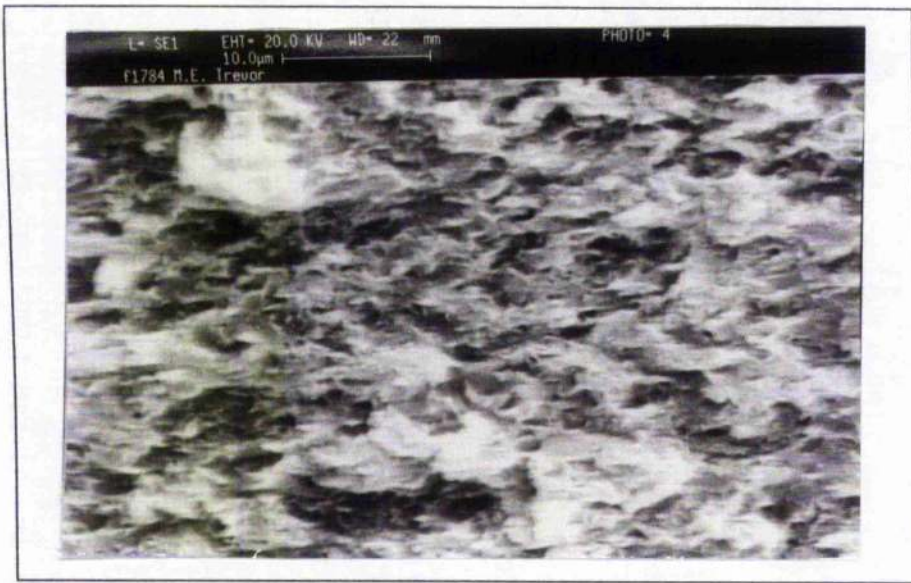
**Figure 9.45:** High magnification of area 1 of figures 9.44 shows featureless scale

Figure 9.46: Chemical composition of test 57 specimen 4 cross section of region 1, scale deposit (reference to figures 9.44)

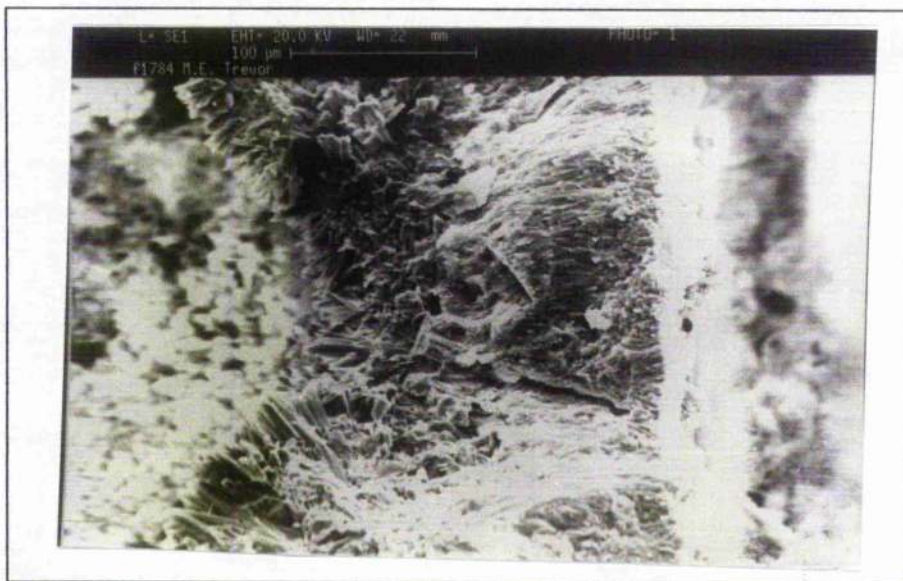
**Figure 9.47:** High magnification of area 2 of figure 9.44 shows needle-like crystal

**Figure 9.48: Chemical composition of test 57 specimen 4 cross section of region 2, scale deposit (reference to figures 9.44)**
