## USGS/TWRI Research Progress Report

### POST-RESTORATION EVALUATION OF URBAN STREAMS IN CENTRAL TEXAS

Megan D. Meier and Anne Chin

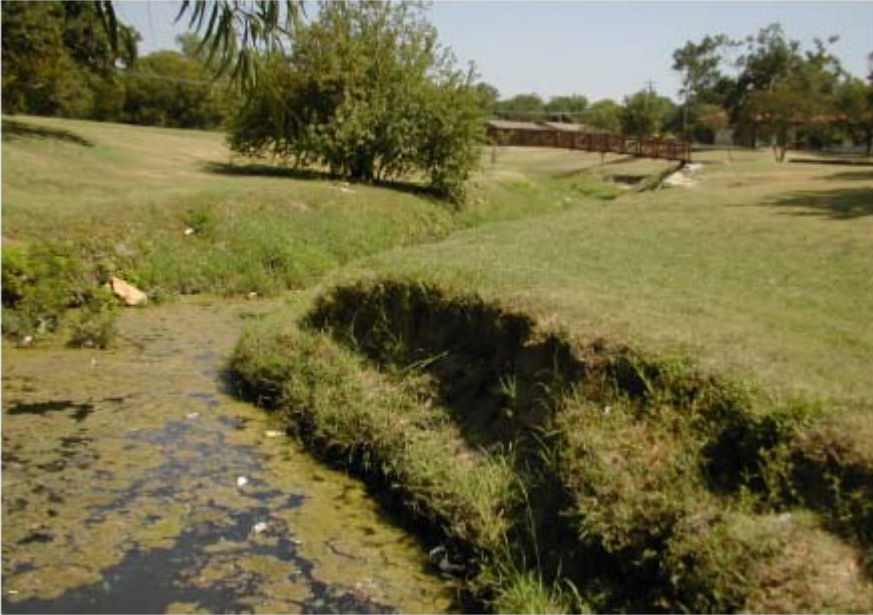
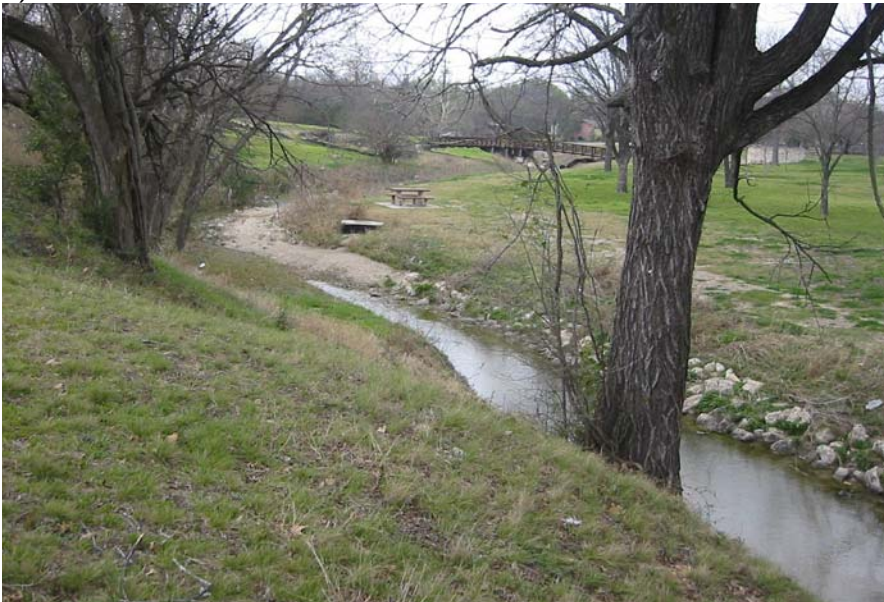
Figure 2. Tannehill Branch Creek at Bartholomew Park a) before restoration in 2003 (M. Rotar) and b) after restoration in 2007.

- Drainage area is approximately 10 km<sup>2</sup> (Fig. 1)
- Main land use is residential.
- The restored reach is ~ 710 m.
- The lower reach was restored in 2001 and an upper reach was completed in 2006.

- The channel was reconstructed using rock to armor banks and to provide grade control within the channel. Native vegetation was also planted (Fig. 2)

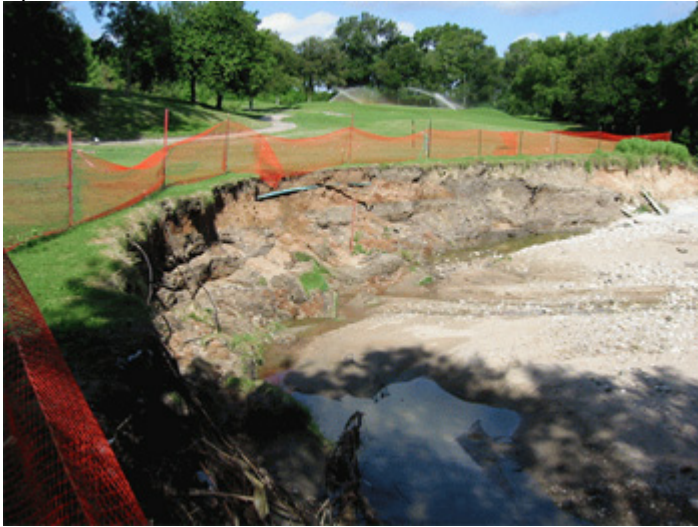
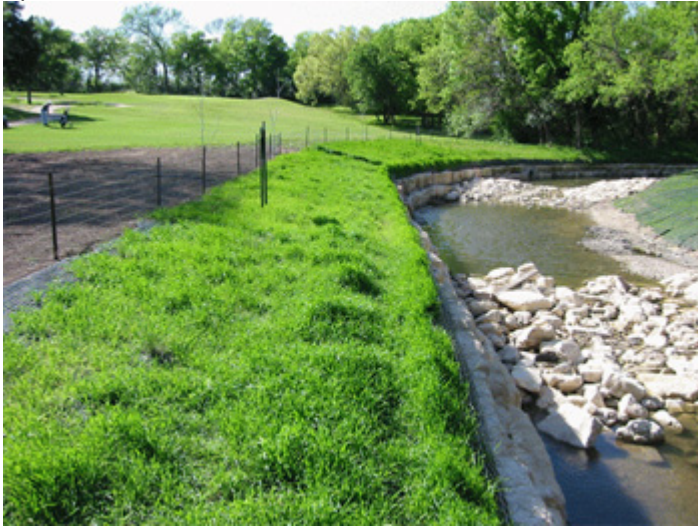
Figure 3. Tannehill Branch Creek at Lovell Drive a) before restoration and b) after restoration, both from 2005 (City of Austin, 2001b).

- Site is located next to Morris Williams Golf Course on Lovell Drive (Fig. 1).
- Restoration of a ~100 m reach was completed in 2005.
- The channel was reconstructed using rock armor along the meander bend and installation of a pool-riffle system. Native vegetation was also planted (Fig. 3)

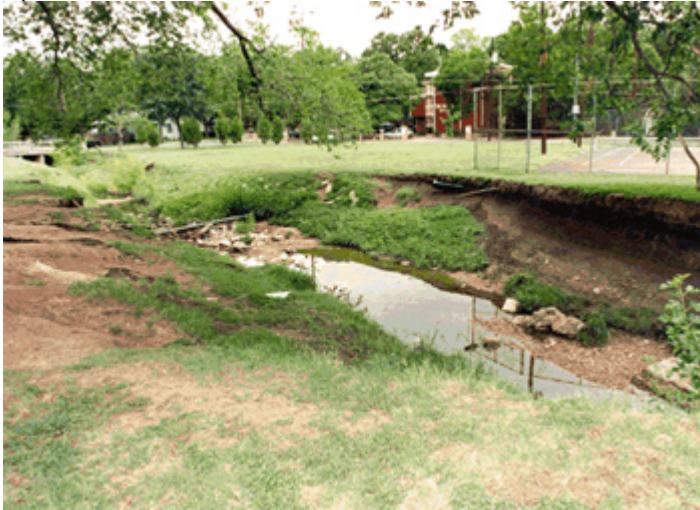
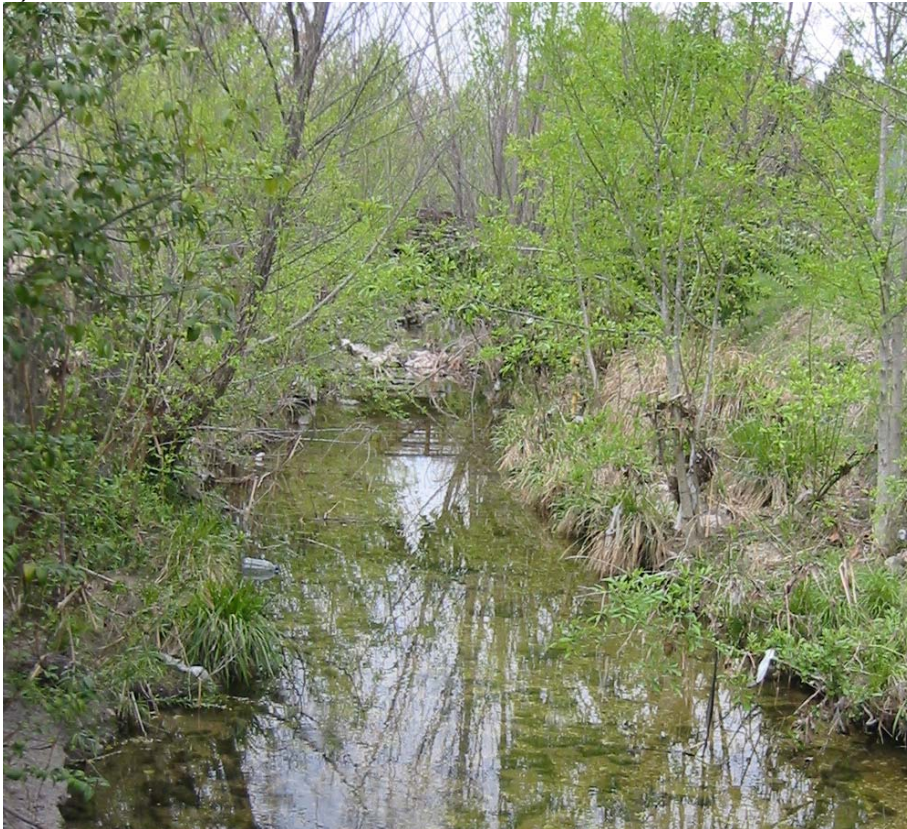
Figure 4. Waller Creek at Shipe Park a) before restoration in 1997 (City of Austin, 2001b) and b) after restoration in 2007.

- This site is located within one of the most urbanized watersheds in Austin, containing the University of Texas and the State Capitol building (Fig. 1)
- Drainage area is approximately 16 km<sup>2</sup>
- Restoration of a 95 m reach was completed in 1998.
- Rock armor and native vegetation stabilized channel banks. A pool-riffle system was also constructed to protect the stream bed (Fig. 4).
