**Designing for Deck Stress Over Precast Panels In Negative Moment
Regions**

Thesis

The University of Texas at Austin

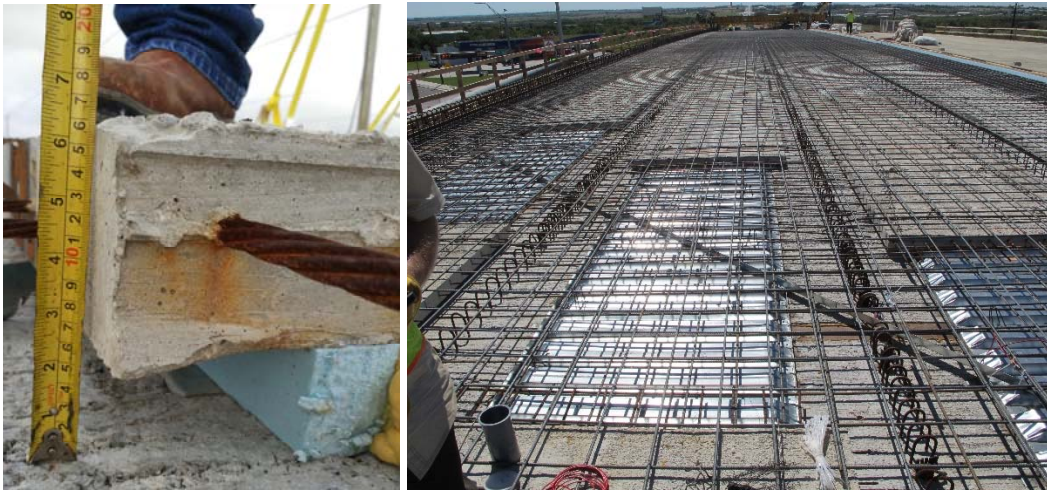
Figure 2.1 shows a series of pictures that demonstrate the configuration of the PCPs and the support conditions in the field. Figure 2.1a shows that PCPs in the state that they are often delivered to the field. Most PCPs are prestressed in the direction that spans between adjacent girders. Approximately 3-4 inches of the prestressing strand protrudes from the panels as can be seen in Figure 2.1a. The girders are typically erected as shown in Figure 2.1b, after which the PCPs are installed along the length.

Figure 2.1c shows the bedding strip installed on the girders supporting the PCP. The bedding strip material can be cut to the required thickness to position a given concrete panel to the proper elevation. In most instances, the bedding strip height is typically in the range of 0.5” thick to 4 inches thick. After the PCPs have been fully installed, the transverse and longitudinal deck reinforcing is added to the bridge as shown in Figure 2.1d. The bridge in Figure 2.1d had a support skew of approximately 45 degrees and the TxDOT detail in this condition utilizes permanent metal deck forms (PMDF) around the support region. In bridges with normal supports, the PCPs will be provided all the way up to the support region with no PMDF utilized.

(a) PCP on Site

(b) Girders before PCP

(c) PCP Bedding Strip

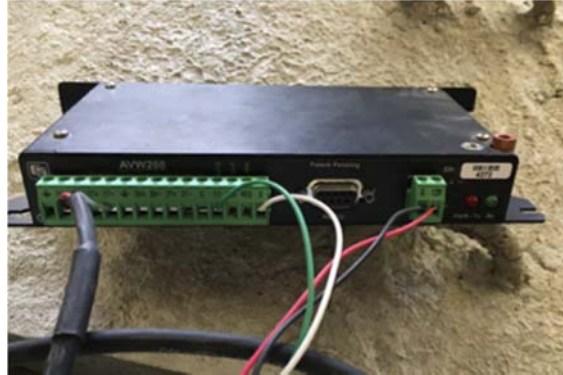
Figure 3.4: AVW200 Analyzer

Once the Multiplexer completes its cycle, the data is input to the raw data processing unit. The AVW200 Analyzer, shown in Figure 3.4, is a processor that interprets the frequency readings collected from the Vibrating Wire Gage and converts it into different tables of strains and temperature. The Analyzer has two input ports that gages can connect directly into. However, the Multiplexer was used to increase the capacity of usable gages. If needed, two Multiplexers can be used for a maximum of 32 gages.

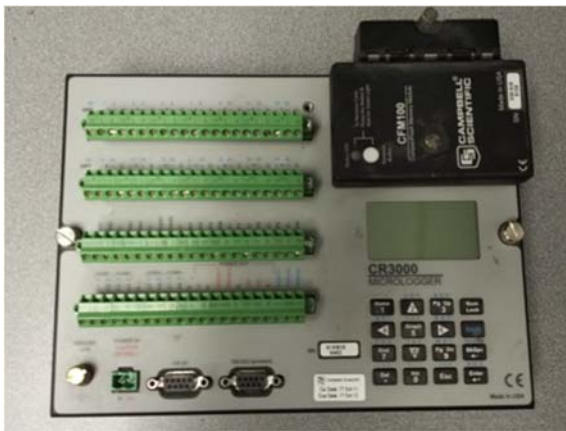
Figure 3.5: CR3000 Data Logger

The information is then transmitted to the core of the logging system. The Campbell Scientific CR-3000 Data Logger, shown in Figure 3.5, is the central control of the whole system that runs the user's custom program, initiates the readings, records the data, powers the connected modules, and relays information to the communication devices. If wireless communication was not necessary, data can be downloaded directly from the logger. Operating the Data Logger is the Campbell Scientific PC400 interface software. This software creates a user defined program to direct the logger as necessary.

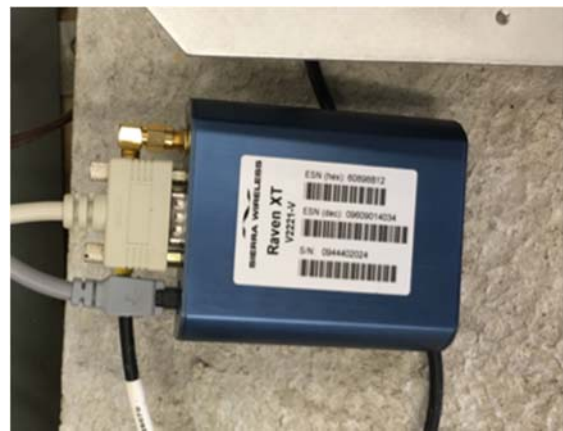
Figure 3.6: Raven XT Modem

For the system used in this study, wireless communication from the logger was set up to enable access to the data from any location. The Raven XT phone modem and antenna, shown in Figure 3.6 and Figure 3.7, allow data to be collected from anywhere with Internet connection. The collection of data is generally the largest drain on the battery, but is necessary to collect every few days. If the data logger loses power at any point, all non-collected data is lost. The data collected shows the raw strain and temperature measurements from the gages as well as the voltage level for the power supply.

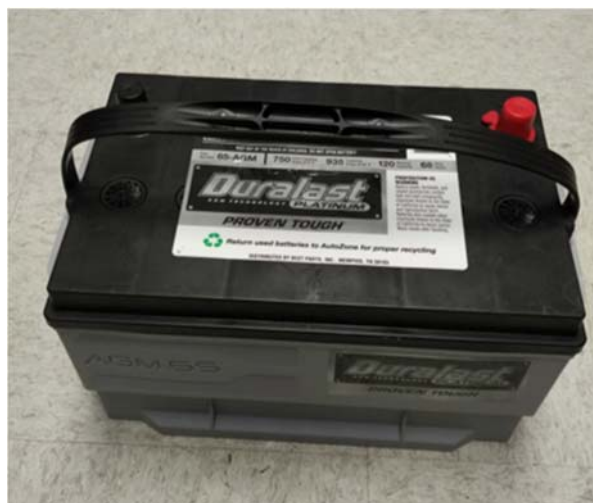
Figure 3.8: AGM Battery

The logging system must have a secure power supply while being in a remote location. To minimize trips to the site, two Platinum Duracell AGM 12V 68Ah automotive batteries, shown in Figure 3.8, were chosen to power the system. The batteries used in the instrumentation could last approximately six weeks when data was recorded approximately once per hour. For a higher frequency, the battery life is less. The batteries were connected in parallel to increase their power capacity. Increasing the power capacity maximized the lifespan and minimized extra trips to exchange the batteries. The batteries were connected to the Data Logger through a charge regulator to avoid a power surge that would damage the system.

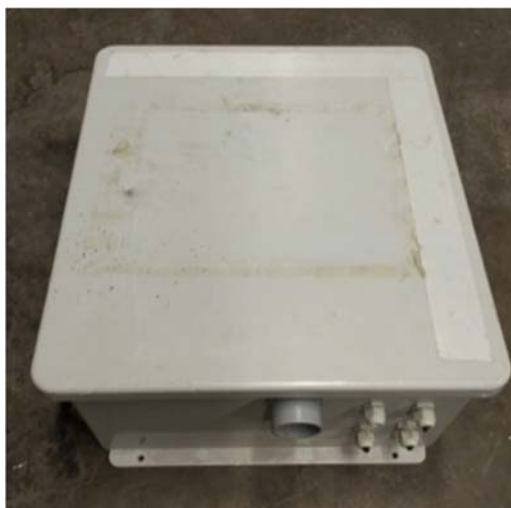
Figure 3 9: Protective Housing Box

Since the equipment is electronic, it had to be covered and protected from any water and debris damage. Plastic storage containers, shown in Figure 3.9, were used to house the equipment. Separate storage boxes were used for the batteries and the data logging equipment. All devices used for the data logger were secured to a removable bottom in the container using small bolts. This limited the equipment from moving around and getting damaged as well as helping with organization. The wires from the VWGs were routed through a hole in the container, and then sealed using latex caulk. Desiccant bags were placed around the Data Logger to absorb any moisture that entered the housing unit.

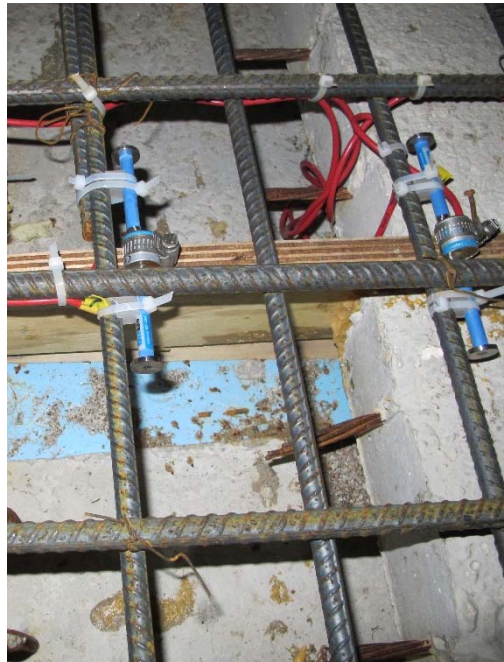
Figure 3.11: Gages Secured to Reinforcement

Collectively, these minimized the opportunity for anyone to snag the wires. If the wires did get caught, the loops provided strain relief by providing slack to minimize damage to the gage or it moving from its intended position.

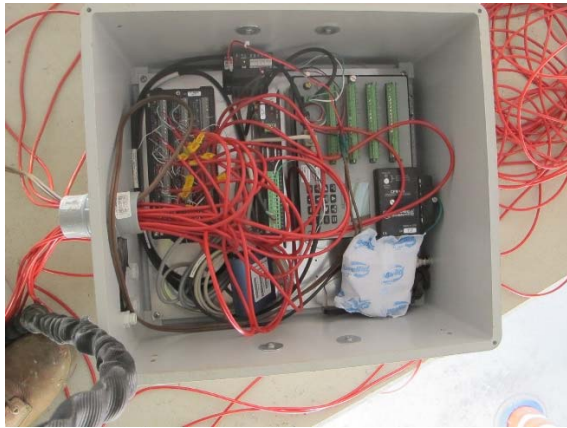
Figure 3.12: Wires in the Housing Box

center of the bent to avoid obstructing construction and falling off the edge. The battery housing was placed next to the data logger housing. Once the housing boxes were in place, the gage wires were routed through an opening in the box and connected to the appropriate channels. Tags were placed on the gage wires prior to installment to ensure each gage location matched the recording channel. Tags were marked at the beginning of the wire near the gage and at the end where it plugged into the multiplexer. Once all of the gages were attached to the Multiplexer, the wires were coiled and placed as neatly as possible in the housing box as shown in Figures 3.12 and 3.13.

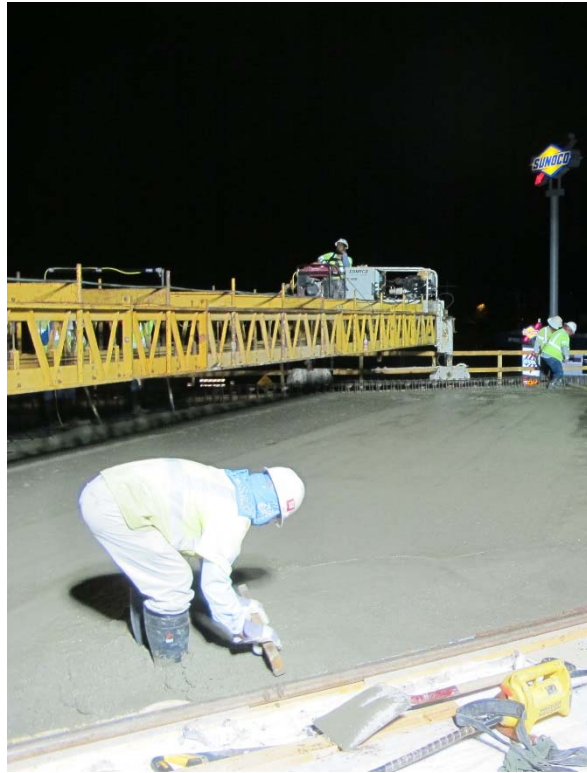
Figure 3.14: Bridge Screed

The contractor made use of several pieces of equipment to obtain a good finish on the concrete deck. Figure 3.14 shows the concrete finishing machine (screed) that maintains the proper deck thickness and good finish to the deck. The screed travels along the bridge on rails placed at the two edges of the bridge. The rails are checked using a GPS surveying range finder. This ensures the screed creates a uniform top-of-slab elevation at any point along the rails. The screed rails are attached to brackets on the side of the bridge as to not interfere with any of the cast concrete.

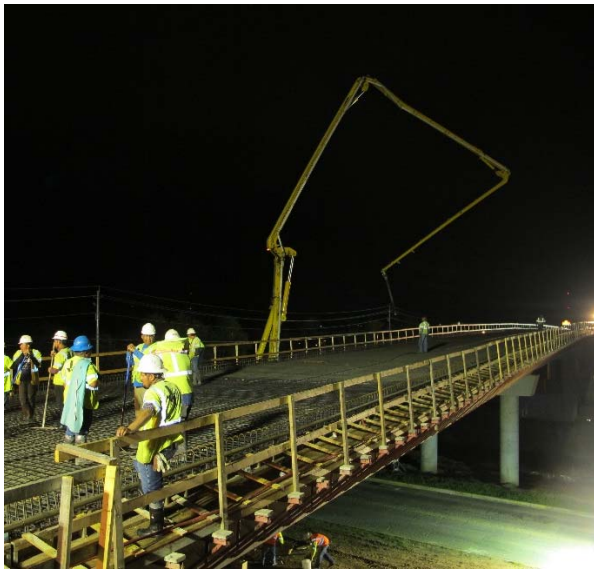
Figure 3.15: Concrete Pump Truck

The concrete was delivered to the deck via pump-truck shown in Figures 3.15 and 3.16. Pump trucks can deliver concrete at a rate of approximately 180 yd³/hr. This volume of concrete is fast moving and continuous as long as concrete trucks are available. The high impact from concrete at that rate can lead to damage to the gages if proper care is not taken.

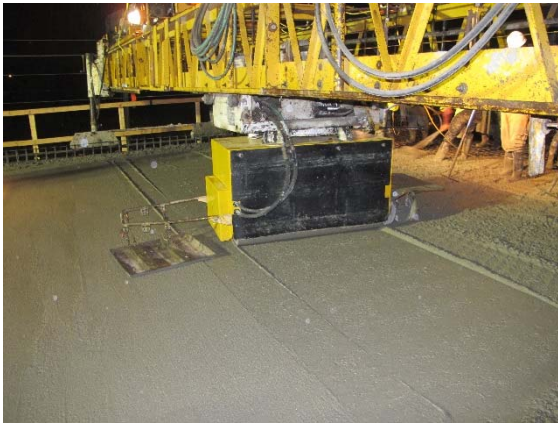
Figure 3.17: Finish Carriage

As the concrete is poured, concrete vibrators consolidate the mixture to the bottom of the deck. As the bridge screed moves along the length of the girders, a finish carriage alternates back and forth in the transverse direction. The finish carriage, shown in Figure 3.17, is made up of rotating augers to consolidate the top surface of concrete and a drag plate to flatten the surface. Any low spots in the concrete that were not

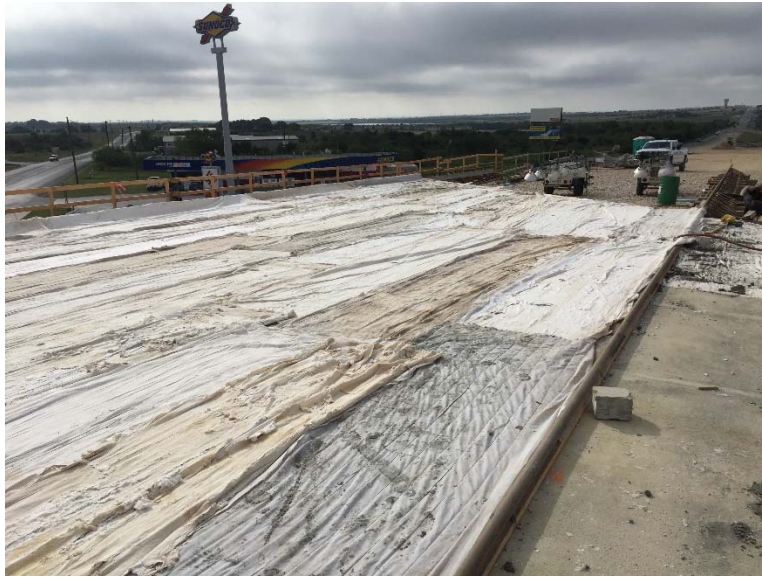
Figure 3.19: Burlap Covering

To finish the concrete surface, the contractor placed a wet burlap covering on the concrete as shown in Figure 3.19. This wet surface helps to retain the moisture. The reduction in rate of moisture loss helps to reduce cracking and prevents a strain gradient forming through the deck. The burlap is typically left on for one to two weeks.

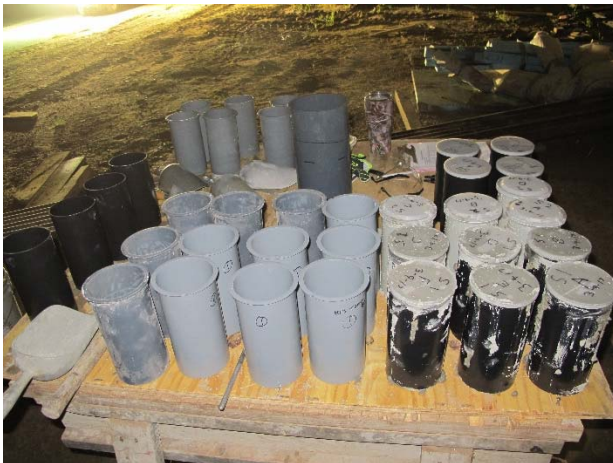
Figure 3.20: Cylinder Testing

Concrete test cylinders were taken so as to provide material testing samples of the concrete over the gages. A concrete mix design of 4 ksi is specified for the bridge deck, but to represent the exact concrete in the area of monitoring, the concrete at the gages was recorded and tested as shown in Figures 3.20 and 3.21. A concrete slump test as well as 4 in. concrete cylinders were made following the ASTM C39 and C143 standards.

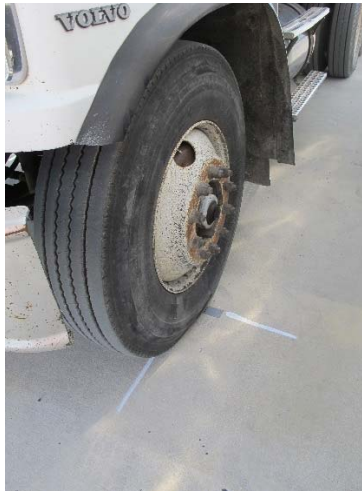
Figure 3.22: Tire Location Mark

locations, five truck configurations were used to maximize both the negative moment at the gage location and the mid-span deflections of each span. The mark was made using lines to center the tire from the side and the front as shown in Figure 3. 22.

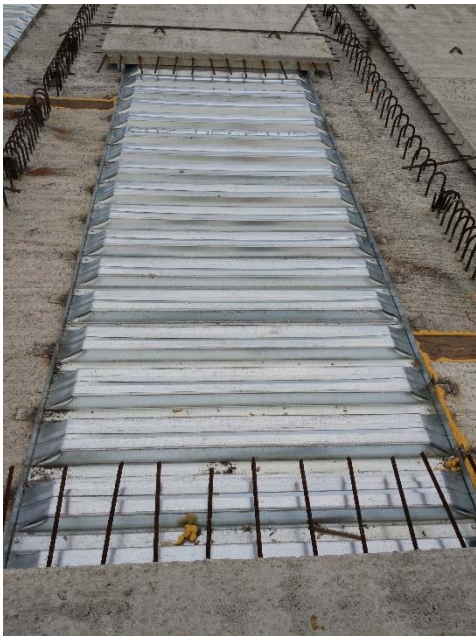
Figure 3.27: Permanent Metal Deck Form

Before the instrumentation installation, a site visit helped to evaluate what the options were for the gages. After getting to the site, it was apparent that the PCP's were not continuous over the bent. Due to the harsh skew of the bridge, Permanent Metal Deck Forms (PMDF) as shown in Figure 3.27 and 3.28, were used over the bents in accordance with standard TxDOT details. This altered the section over the bent as the deck acted as a full depth cast-in-place deck. This did not align to the original intent of the project, but still provided beneficial data for comparisons of bridge behavior.

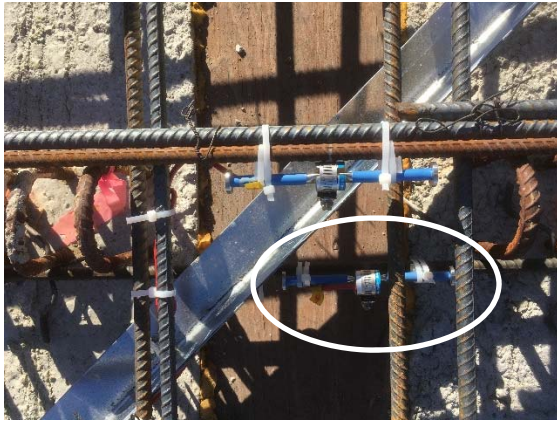
Figure 3.30: Top and Bottom Gages

Crack formers were used to be able to control the location of cracks. As the bridge was inspected, a two-inch steel angle was placed as a crack former from the bottom of the deck. This angle ran along the centerline of the bent and was directly between the ends of the girders. The location proved to be an issue and interfered with the intended gage locations. Since it was at the bottom of the deck and at the center of the bent, the bottom gage had opposition to where the gage was intended to be placed. To be able to capture a strain gradient through the depth of the deck, the gages were placed immediately next to the angle as shown in Figure 3.30, in an attempt to best represent the intended strains. Because of the shift in the bottom gage, the gage for the top of the deck was shifted to match the location.

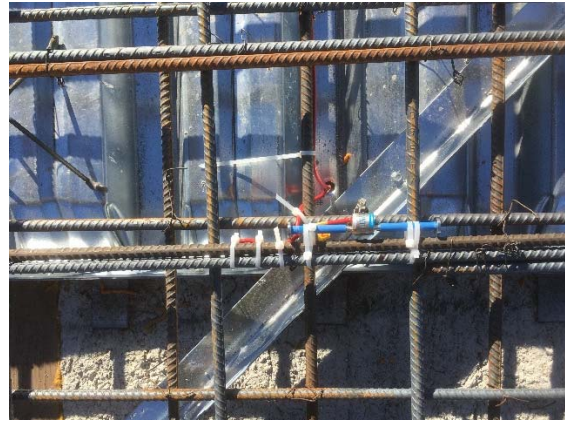
Figure 3.31: Gage at the Edge of Girder

As described in the previous sections, the additional steel was bundled to the existing reinforcement (#4 @ 9 in. each direction). Once bundled, the gages and wires were secured using zip ties as shown in Figure 3.31. When exiting the bottom of the deck, the wires needed to be protected from being cut by the sharp edges of the PMDF. A silicone sealant was used to secure the wires from movement and avoid being cut by the metal, shown in Figure 3.32.

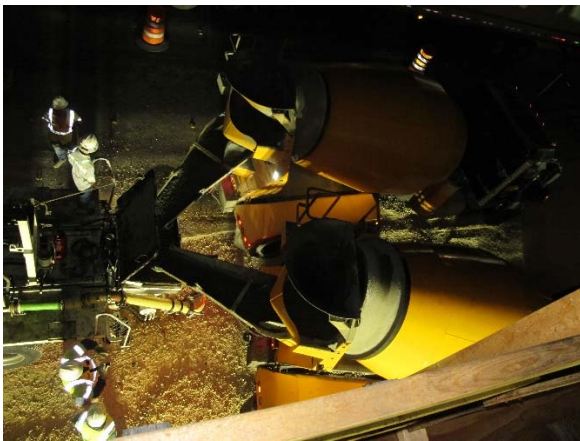
Figure 3.33: Concrete Trucks

The casting of the deck occurred on October 15th at 2 am with the use of a pump truck shown in Figure 3.33. Before any casting began, the gages were checked to ensure proper function, as well as secure any gages or wires that had become loose as shown in Figure 3.34. No obstructions or interferences with the gages was noticed during the cast.

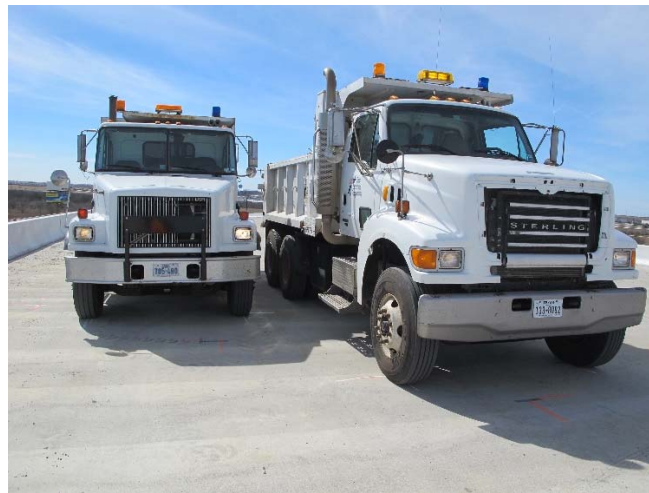
Figure 3.37: Side-by-Side Trucks (offset by skew angle)

The bridge was marked for the truck locations the day before testing to minimize the time of testing and to minimize errors. During the test, trucks were guided to the marked spots to ensure their position. Since the bridge was at a 45 degree skew, the mid-span of the girders were not side-by-side. The trucks matched the skew angle as shown in Figures 3.37.

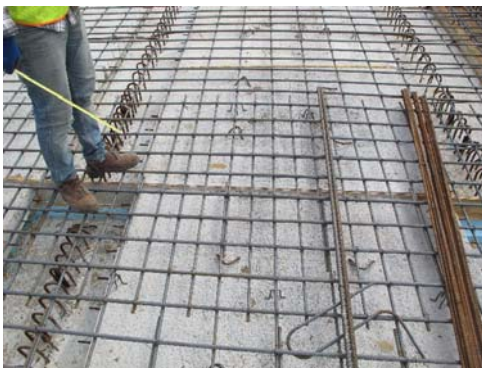
Figure 3.40: Additional Reinforcement

The top mat reinforcement was used over the length of the bridge, with the transverse steel on top. The reinforcement remained constant over the whole bridge other than over the bents where intermediate 5 ft. #4 bars had been added at 4.5” spacing between the standard bars as shown in Figure 3.40. These were placed in accordance to TxDOT’s details for PCP over bents as shown in Figure 3.41, in anticipation of controlling cracks forming at that location.

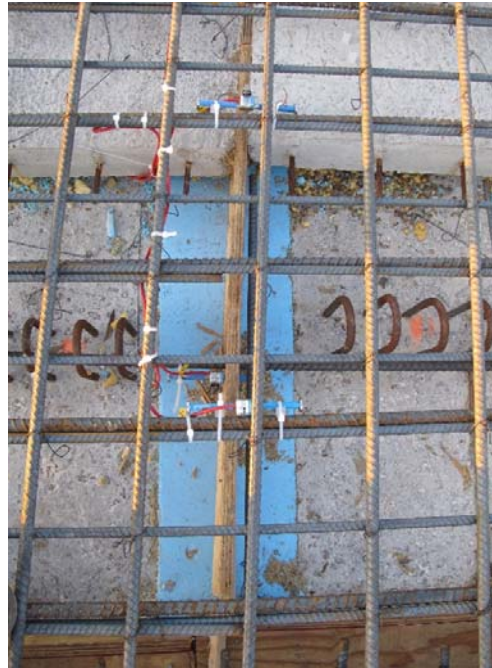
Figure 3.43: Wood Crack Former

The crack former in this bridge differed from the previous since the PCP were continuous across the length of the bridge. Over the center of the bent, a $\frac{3}{4}$ in. timber board was secured between two panels as shown in Figure 3.43. The wood extended from the top of the girders to one inch above the panels, and was continuous across the width of the deck. This strip created a weak joint in the deck for a crack to form. The gages were placed directly over the crack former to ensure the gage captured the strain across the crack.

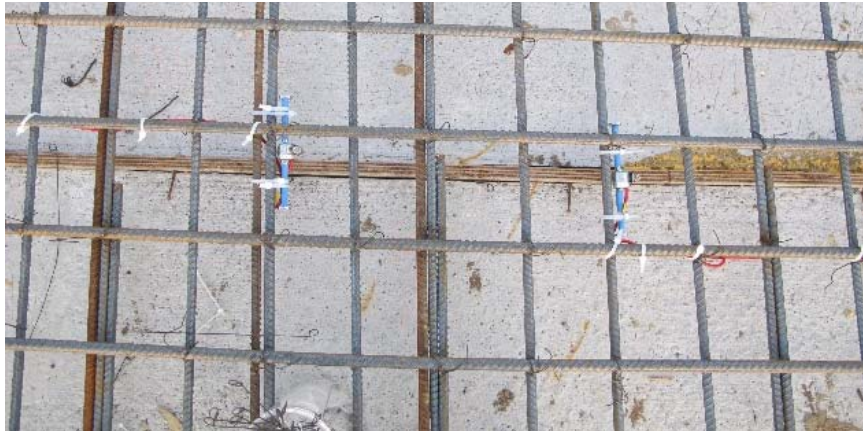
Figure 3.44: Top Layer Gages over the Crack Former

The top layer gages had no interference with the crack former as the longitudinal reinforcement remained above the strip, and were carefully placed directly over the crack former to ensure the gages captured the strain across the crack as shown in Figure 3.44. For the strain gradient, the bottom layer gages had to pass through the timber board as shown in Figure 3.45. With permission of the contractor, holes were drilled in the wood to allow enough clearance for the gage and the attached reinforcement bar to fit through the wood strip.

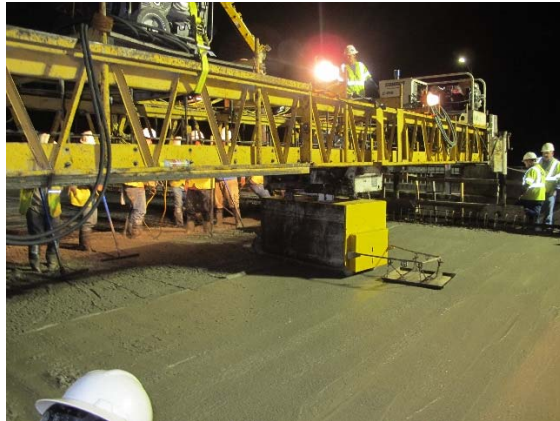
Figure 3.46: Screed Bridge

The concrete cast occurred on March 13th at 2 am. Since the contractor for the bridges in Bastrop and San Marcos were the same, similar procedures, shown in Figure 3.46, were conducted for the casting of the deck. However, collecting material testing samples differed from San Marcos. In addition to the twelve 4-inch concrete cylinders, Modulus of Rupture beams were cast to get more samples for tension testing. The concrete had a slump of 4.5 in.

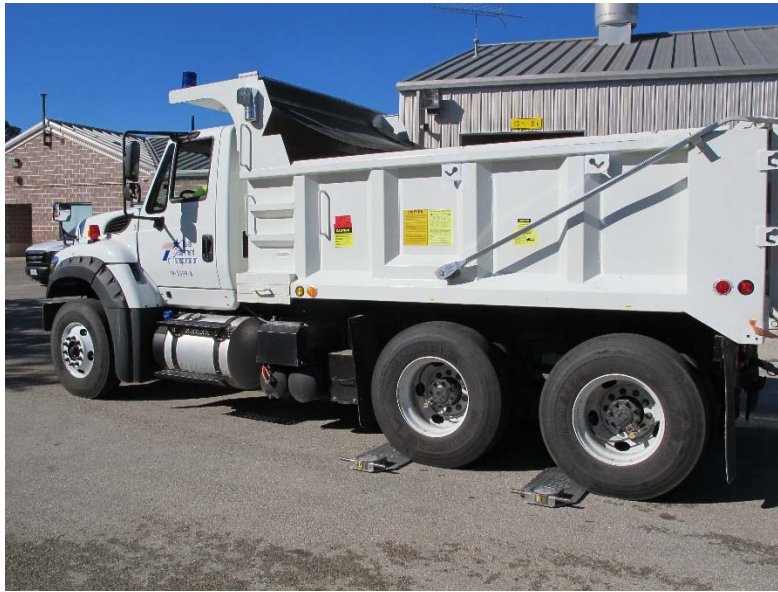
Figure 3.47: Single Tire Scales

Live load testing was conducted with the same five configurations. Two trucks were provided by the local TxDOT Maintenance Facility. Since there was no DOT Inspection Station nearby, the county Commercial Vehicle Enforcement (CVE) Patrol Officer assisted in getting axle weights. The officer used single tire scales to measure the axle load as shown in Figure 3.47. Dimensions and axle loads are given in Figure 3.48.

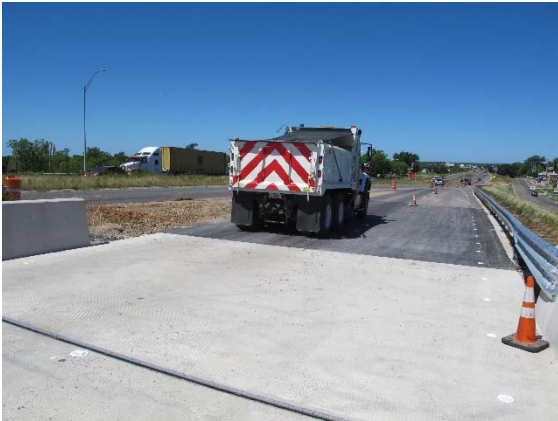
Figure 3.50: Removal of Truck from Span

The deck was marked and the trucks were guided to their locations. After each reading, the trucks were moved completely off the span before moving to the next position as shown in Figure 3.50.

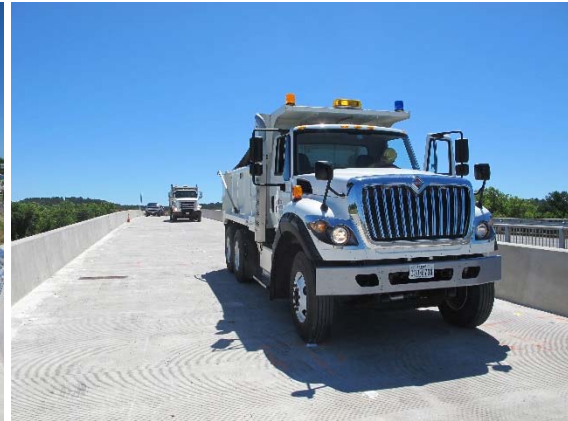
Figure 3.51: Single Girder Configuration

Each instrumented girder required trucks to be centered over the girder centerline as shown in Figure 3.51. Since the exterior girder was at the edge, the trucks were moved as close to the guard rail as possible as shown in Figure 3.52. The strain from the exterior girder will be accounted for in relation to the location of the truck. The side-by-side position had to be carefully done as there was not much additional room as shown in Figure 3.53.

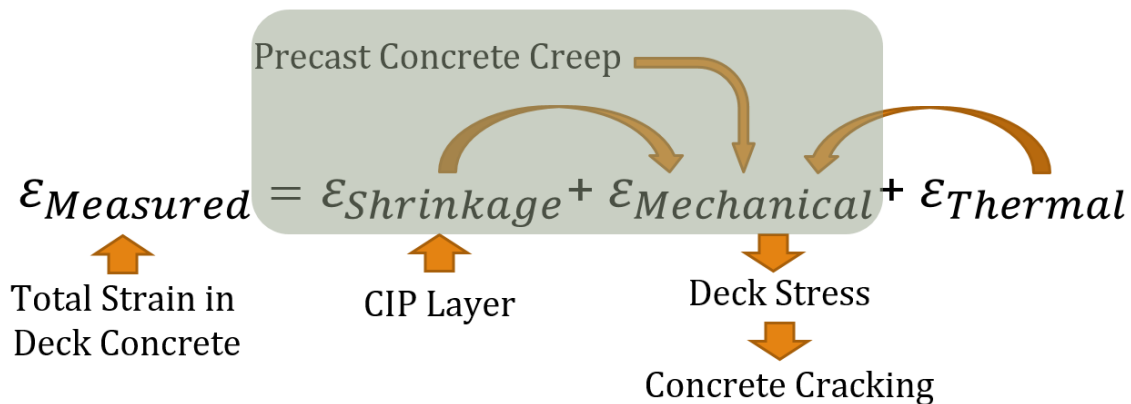
Figure 4.1: Strain Sources

concrete material to expand, while decreases in the temperature cause the material to contract. The strain rate is generally dependent on the aggregate used in the concrete mix. In general, there are two volumetric changes that are of interest with the concrete, and they are referred to creep and shrinkage. Creep strains occur due to the connection between the CIP layer and precast elements that utilize pre-stressing. Shrinkage is the main contribution to deck strains, and cause concrete to shrink as the cement paste dries. Typically, the majority of the shrinkage occurs within the first few weeks after casting. A complexity of this shrinkage issues in these bridges are the significant difference in the age of the concrete between the precast concrete girder, the PCPs, and the cast-in-place (CIP) portion of the deck. Often the precast elements are months older than the CIP layer and have already experienced the majority of their shrinkage. The restraint of shrinkage from boundary conditions between the CIP and precast elements may induce cracking.

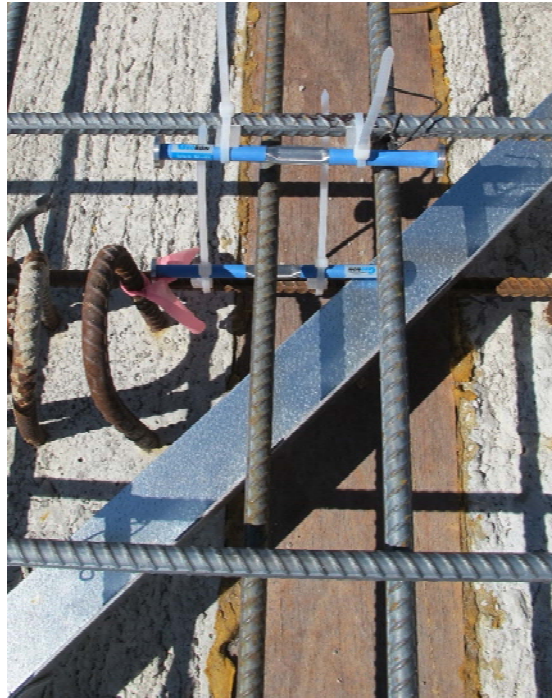
Figure 4.4: Offset Gages

Some issues occurred at some of the instrumentation locations as some of the gages did not capture the strain across the crack due to the gage placement location as well as the placement of the crack former. In an attempt to capture the strain gradient through the depth of the slab, gages over the girder were placed in the top and bottom reinforcement layers. Due to the presence of a steel angle in center of the bent at the bottom of the deck, the gages were offset from the angle. As a result, this offset caused the gages 4, 7, 8, 11, and 12 to be next to the crack, as shown in Figure 4.4, rather than centered across it. Gage 10 also missed the crack. This is believed to be either from the misplacement of the gage or from the location of the zip strip placed in the top of the deck. Figure 4.5 shows which gages did not capture the strains across the crack.

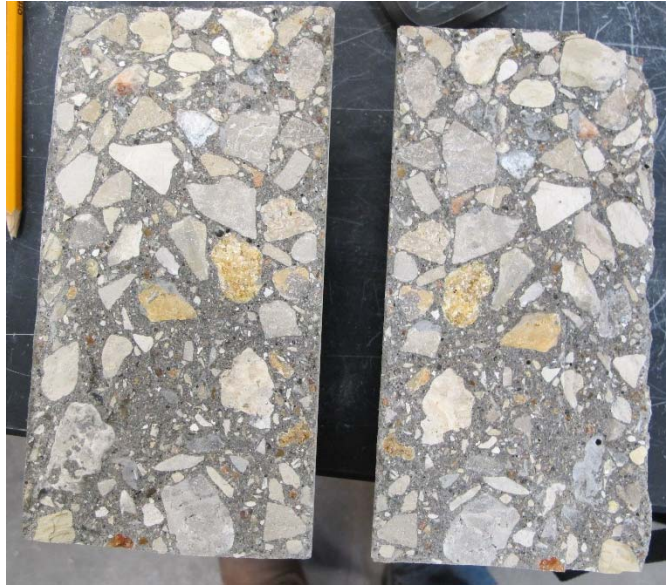
Figure 4.13: Material Testing

the gages. Split cylinder tests were used to determine the tensile strength of the concrete. Figure 4.13 shows one of the specimens following the test. The fracture in some of the aggregate indicates a high strength concrete was used for the deck. This also shows what type of aggregate was used.

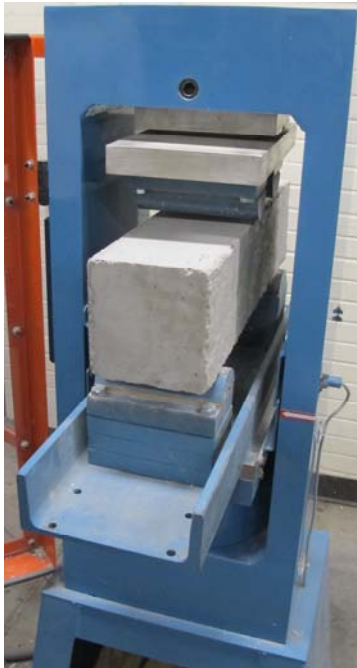
Figure 4.27: Modulus of Rupture Test

Material tests were conducted to get the strength of concrete. In addition to the tension tests performed for the San Marcos Bridge, a Modulus of Rupture Beam Test, shown in Figure 4.27, was conducted for flexural tensile capacities. Figure 4.28 shows the fractured specimen from the split cylinder tests. The fracture through the aggregate indicates a high strength concrete was used for the deck, shown in. This also shows what type of aggregate was used.

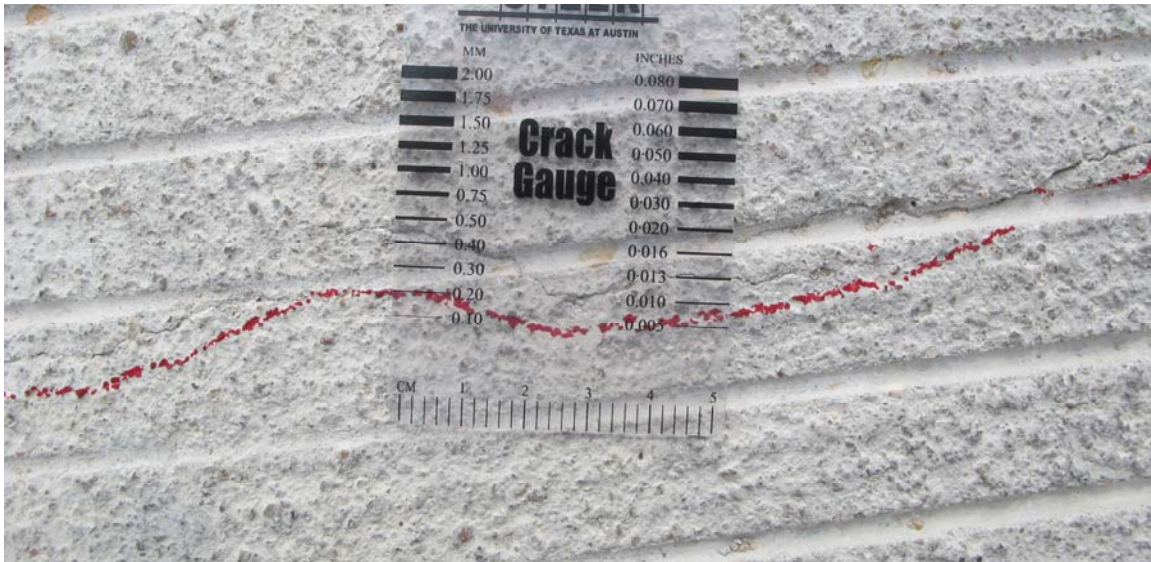
Figure 4.31: Crack Width

The surface of the deck had already been textured by saw cut grooves making the visibility of cracks difficult. However, careful examination identified any cracks in the deck to be recorded before and during the live load tests. A single continuous crack propagated across the centerline of the bent before the tests started. Similar to San

Marcos, the hairline crack was hardly measureable shown in Figure 4.31. This line was traced to indicate the existing crack. During the test, no additional cracks formed.
