Investigating the performance of floodway in an extreme flood event

Weena Lokuge

Lokuge, Weena and Setunge, Sujeeva and Karunasena, Warna (2014) *Investigating the performance of floodway in an extreme flood event*. In: First International Conference on Infrastructure Failures and Consequences, 16-20 Jul 2014, Melbourne, Australia .

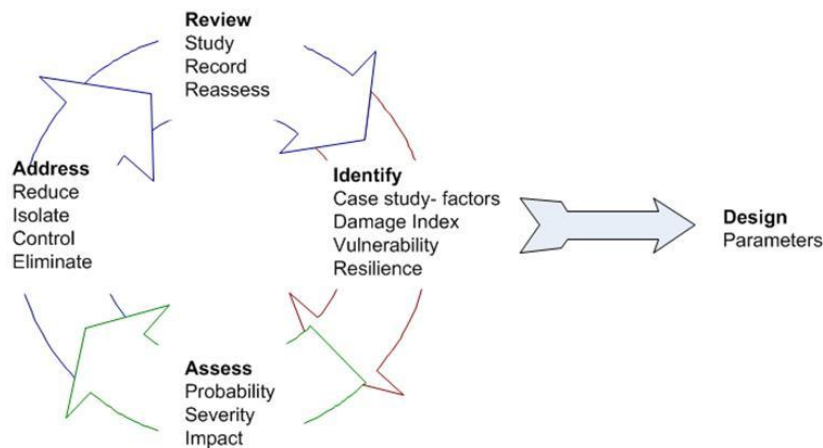
Figure 2: Delivering resilience

Delivering resilience is a cycle of identification, assessment, addressing and reviewing (Hudson et al., 2012). This research paper aims at the identification stage of this cycle as shown in Figure 2. At the identification stage, a case study should be selected to analyse the parameters that are affecting the functionality of the infrastructure and to find the impact of the element failure towards the overall performance of the infrastructure. Although resilience and vulnerability are widely accepted terms to decide the performance of a structure, the authors have investigated the use of damage index instead. Nishijima and Faber (2009) used a damage index to evaluate the performance of buildings and it relies on the construction cost per square metre and a replacement ratio which is approximately equal to the costs relative to the cost of replacing a median-sized family home. In this research damage index for the infrastructure is defined as:

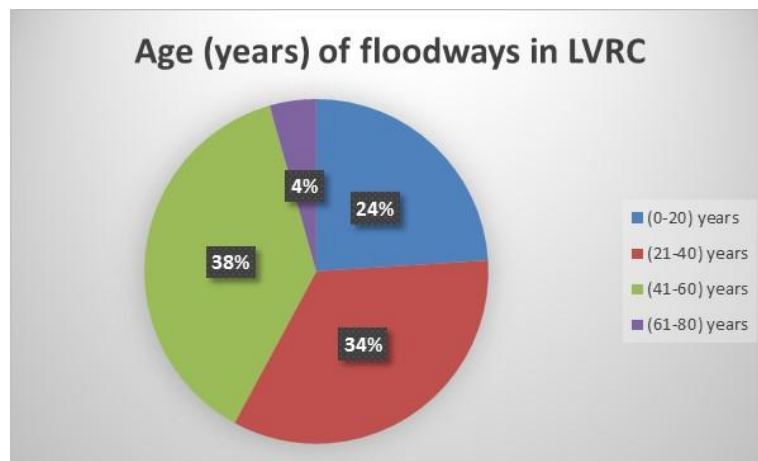
Figure 4: Age of floodway in LVRC area

There were 347 floodway all together in the Lockyer Valley Regional Council area and 64 of them were completely damaged and needed repair due to the 2013 floods. Majority of the floodway in the region are 20-60 years old (Figure 4).

- Most of the completely damaged floodway in the region are more than 60 years old. This possibly is related to a number of factors which require further research such as: construction practices adopted during the construction of the aging bridges, possible strengthening after a previous disaster event etc.

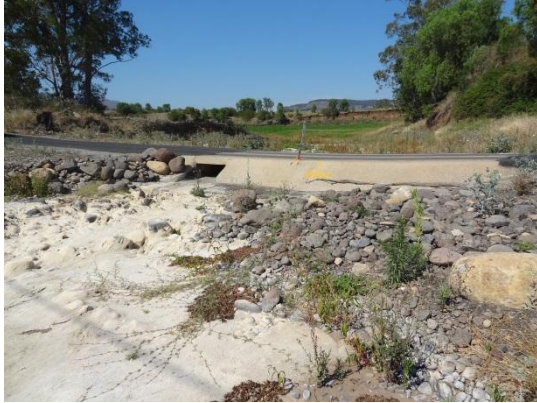
The damaged floodway were assessed by LVRC and it was found out that the damage to asset was due to various reasons as shown in Figure 5. Worst case scenario was that the floodway was completely washed away without leaving any information to judge the type of infrastructure. Common failure type was the damage on upstream or downstream rock structure. Sometimes the surface of the floodway was undermined and cracks could be visible.

Undermined and cracked

- Floodway washout/moved – For most of the floodway in this category, original assessments were unsure of damage to floodway as they were still under water. Subsequent inspections have revealed that the floodway to be seriously undermined and cracked. Partial or complete replacement of floodway is required and sometimes floodway needs to be extended. Apron is normally damaged and needs to be repaired/replaced.

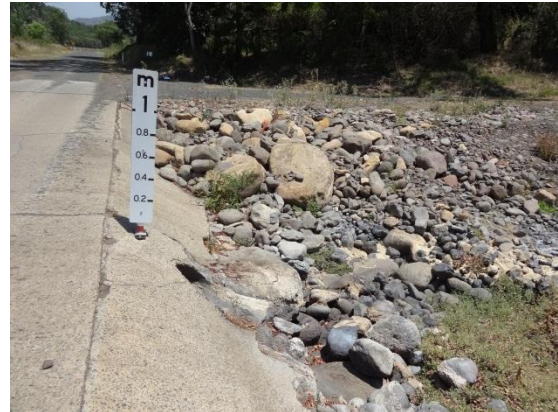
Rock protection structure damaged

- Aprons in both the upstream and downstream sides of floodway were damaged/washed away due to the heavy debris load and high water velocities. In order to repair these, Rock Protection (Bulk fill or armour washout areas with rock/boulder protection) was used in conjunction with geotextile fabric.

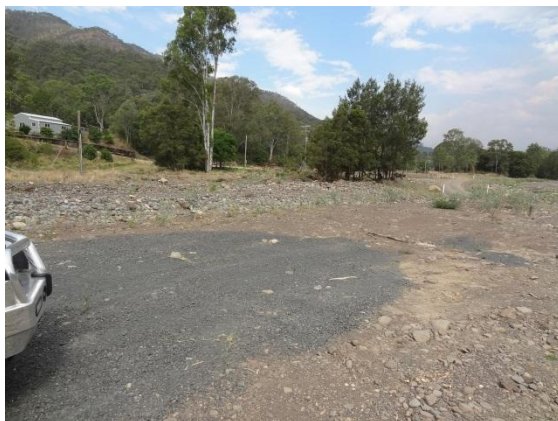
Unsure of road alignment and what infrastructure was there before

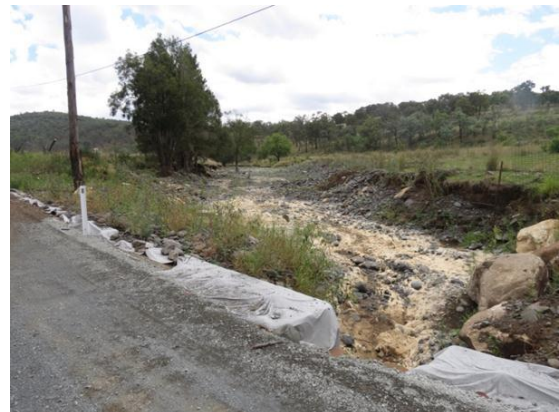
Damaged at upstream

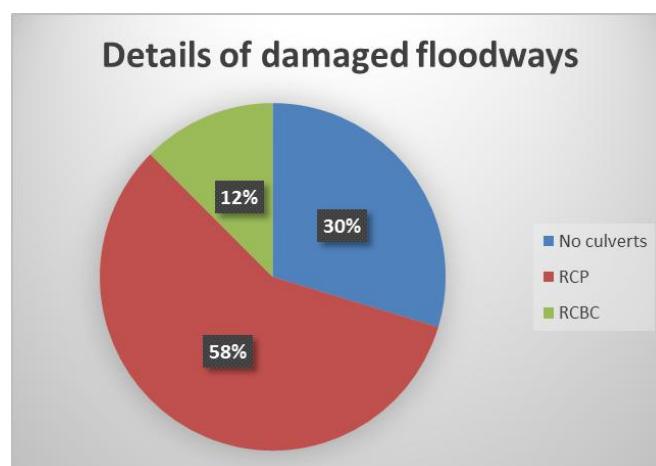
Figure 6: Culvert details for damaged floodway

Available inspection data for the completely damaged floodway were analysed to identify a general trend for the failure. These floodway either did not have culverts or they had Reinforced Concrete Pipe culverts (RCP) or Reinforced Concrete Box Culverts (RCBC). It can be seen from Figure 6 that most of the completely damaged floodway had RCP culverts.

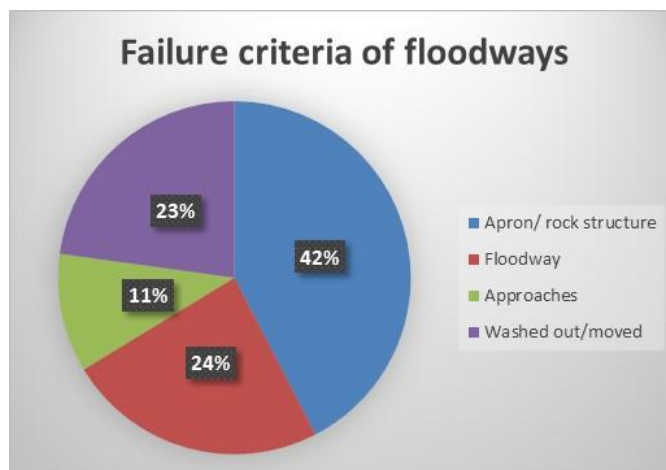
Figure 7: Floodway damaged due to different failure mechanisms

Inspection data records for all the damaged floodway were analysed to identify the element failure towards the overall performance of that particular floodway (Figure 7). It can be seen that the majority of the floodway were damaged due to the failure of the aprons.

When the failure mechanisms are analysed for the damaged floodway in LVRC area, it can be seen that majority of them were damaged due to the heavy impact loads experienced due to large boulders came with the flood and also excessive debris has damaged the floodway aprons which is the most expensive element to be replaced/ repaired. Therefore it is important to include the structural design aspect together with the hydraulic design aspect when formulating design guidelines for floodway.
