CONCRETE CENTRAL SAFETY BARRIERS IN CONSTRAINED ROAD ENVIRONMENT

October 2014

Katherine Holzner

This study assesses the implication of introducing a concrete central safety barrier (CCSB) into an already substandard, complex road environment by assessing the before-and-after performance of nine concrete central safety barrier sites.

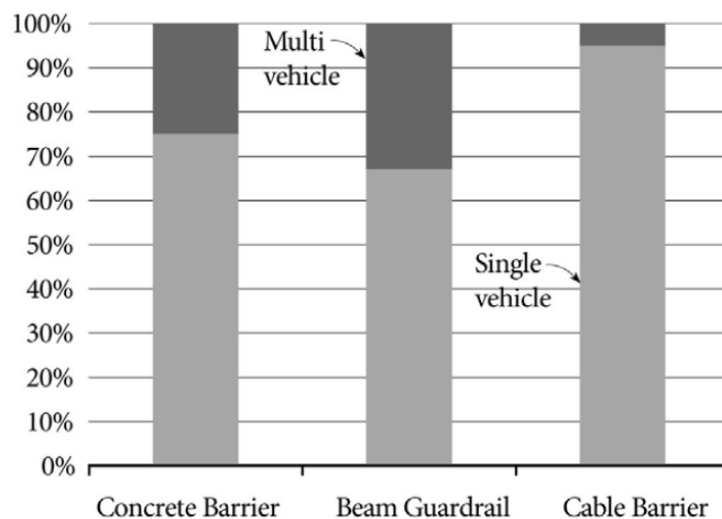
Figure 1 – Single and multi-vehicle collisions (WSDOT, 2006)

In the same study it was found that occupants striking concrete or beam guardrail were more likely to be killed or severely injured when compared to wire rope barrier system. Interestingly, this was mainly attributed to redirecting the errant vehicle back into an adjacent vehicle, rather than from the initial collision with the barrier. Accordingly, the study summarised the distribution of single vehicle and multi vehicle crashes. This has been reproduced in Figure 1.

From this it can be deduced that collision with an adjacent vehicle after being redirected could have high severity. There is little documented regarding multi-vehicle collision post barrier redirection in Austroads guidelines (2009).

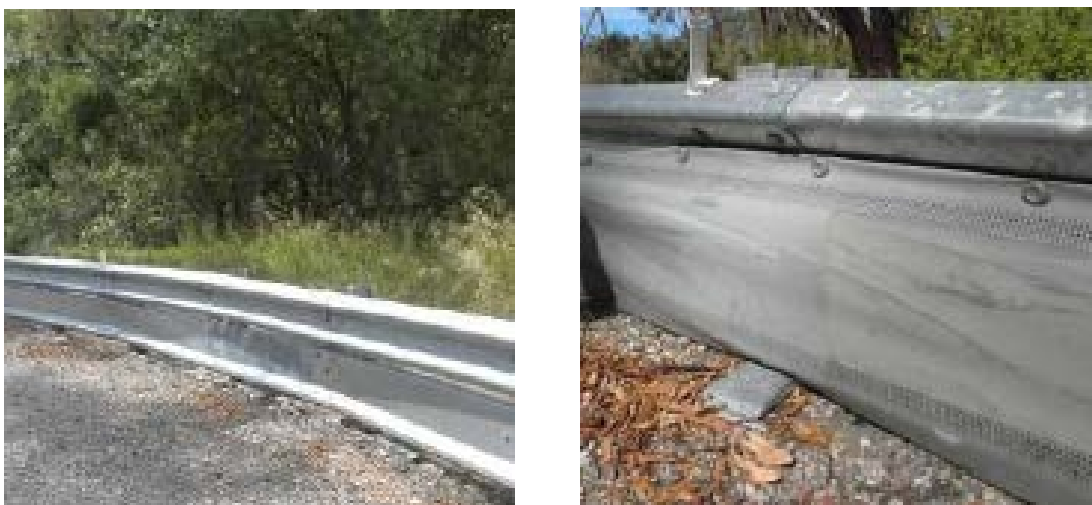
Figure 4 – W-beam retrofitted with rubrail and flexible mesh (Anderson et al, 2012)

Guardrail systems can be improved with the retrofit of a rub-rail or flexible mesh motorcycle protection systems shown in Figure 4. These systems protect an errant rider from the metal posts. The protection systems are gaining popularity within NSW and interstate.

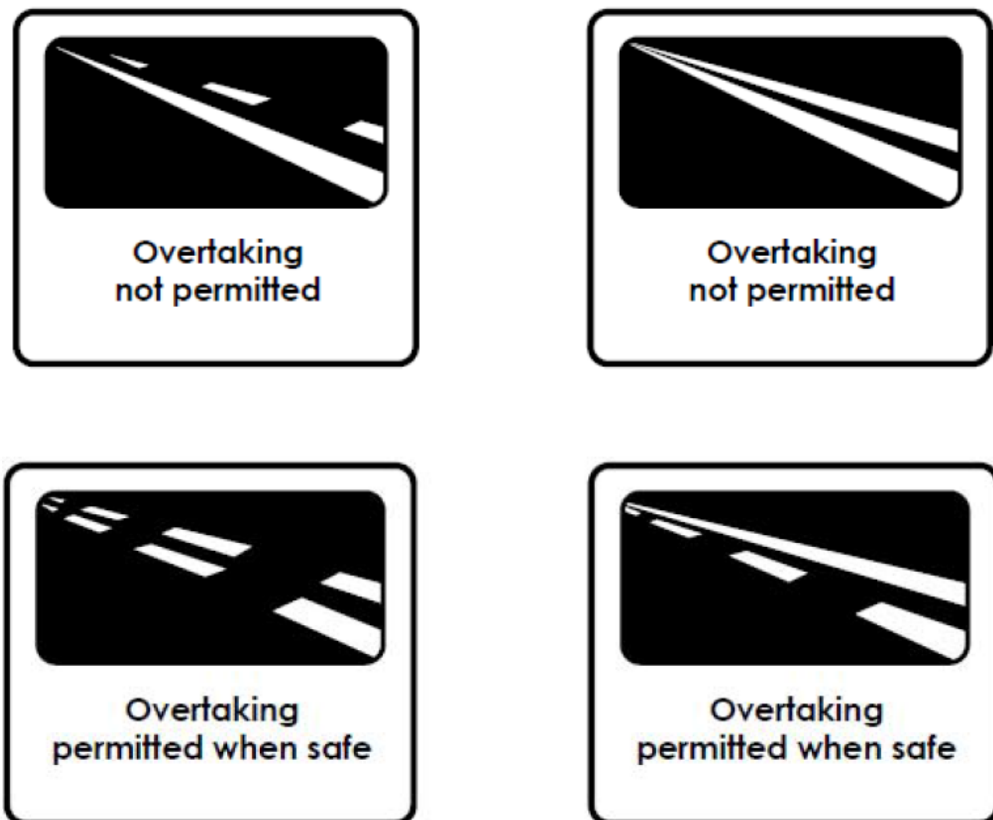
Figure 6 – Line marking scheme for wide centreline (NSW Centre for Road Safety, 2011)

The intent of a wide centreline is to provide recoverable area in the centre of the roadway (Levett, 2009). The rumble strips target fatigued or distracted drivers. Wide centreline treatments are suitable for long stretches of road which do not have extensive auxiliary overtaking opportunity.

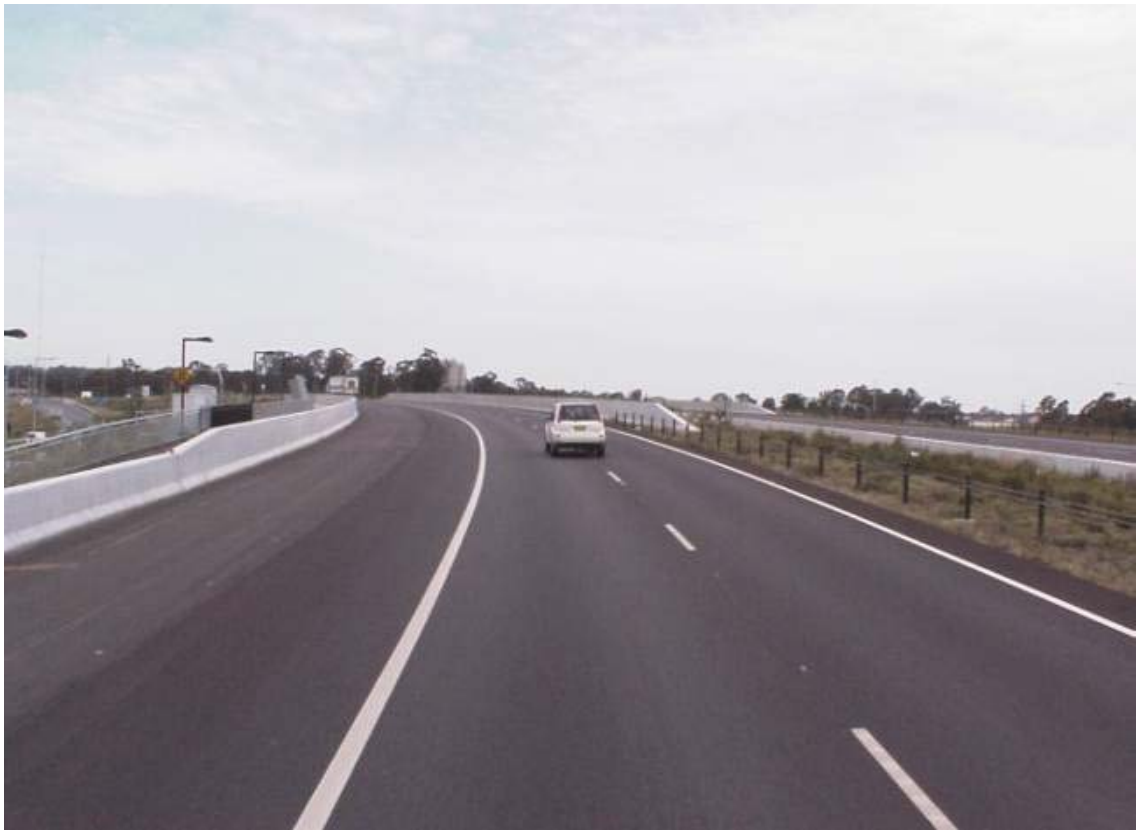
Figure 8 – SD widening on the Sydney Ring Road (Arndt et al, 2009)

Wide shoulders may give the impression of an overtaking or travel lane which may lead to crashes. The width may also give rise to more severe high entry angle crashes (Austroads, 2009).

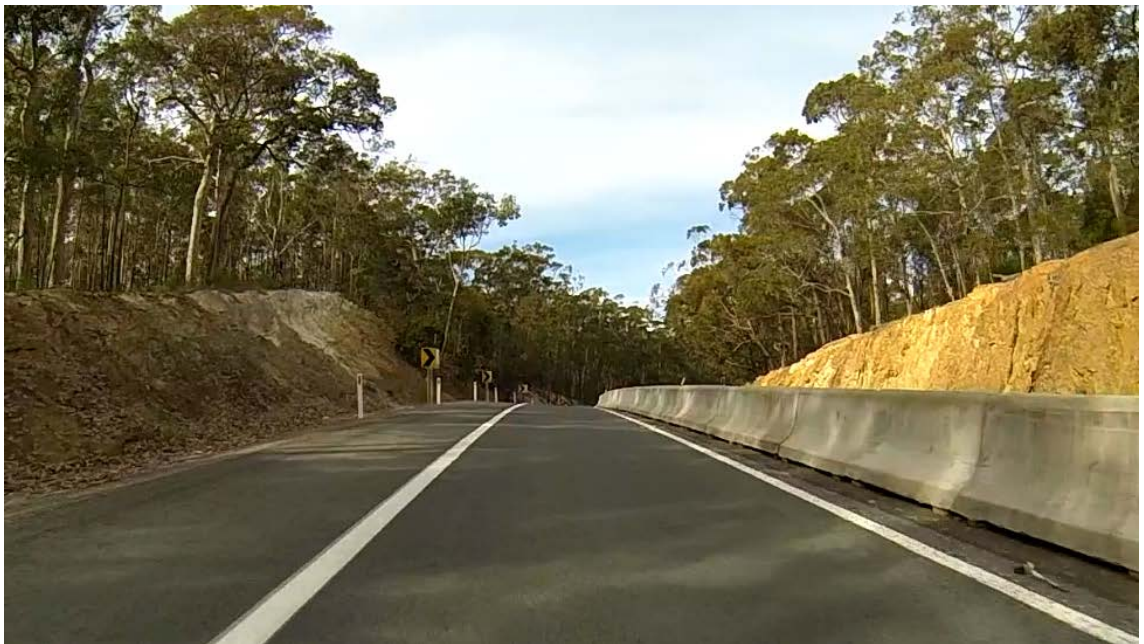
Figure 11 – Horizontal curve concealed by sharp vertical crest on southbound carriageway, Princes Highway, Dalmeny.

WRSB was considered for use as the central barrier treatment but was not pursued due to the tight horizontal radius curves at the site.

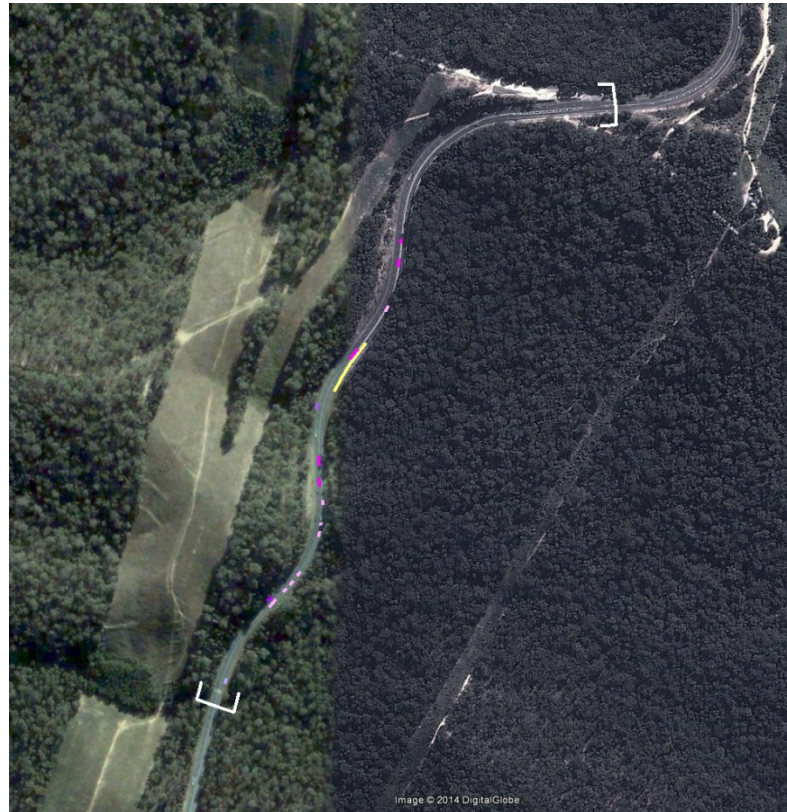
Figure 12 – Batemans Bay site observations

There was evidence of vehicle ramping on the bottom slope of the barrier profile as shown in Figure 12.

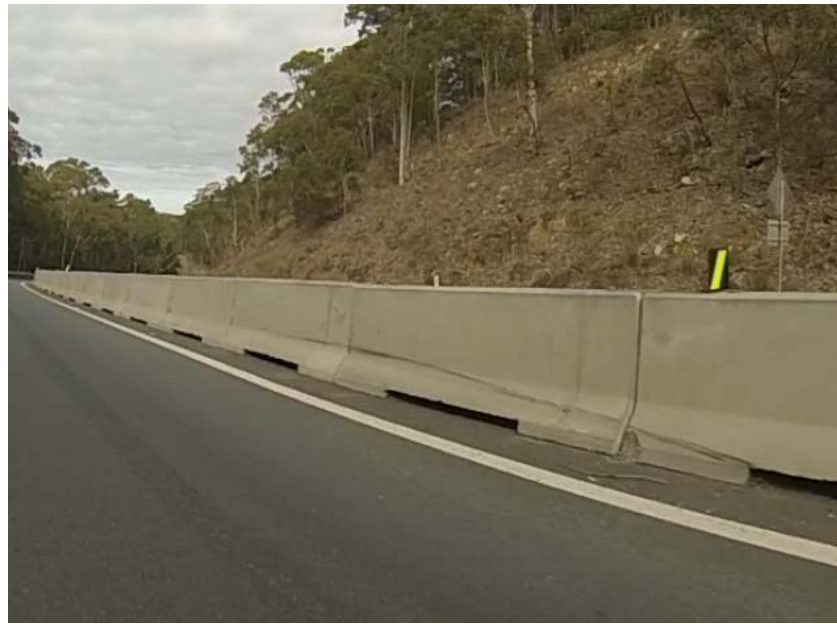
Figure 13 – Batemans Bay central safety barrier ramping

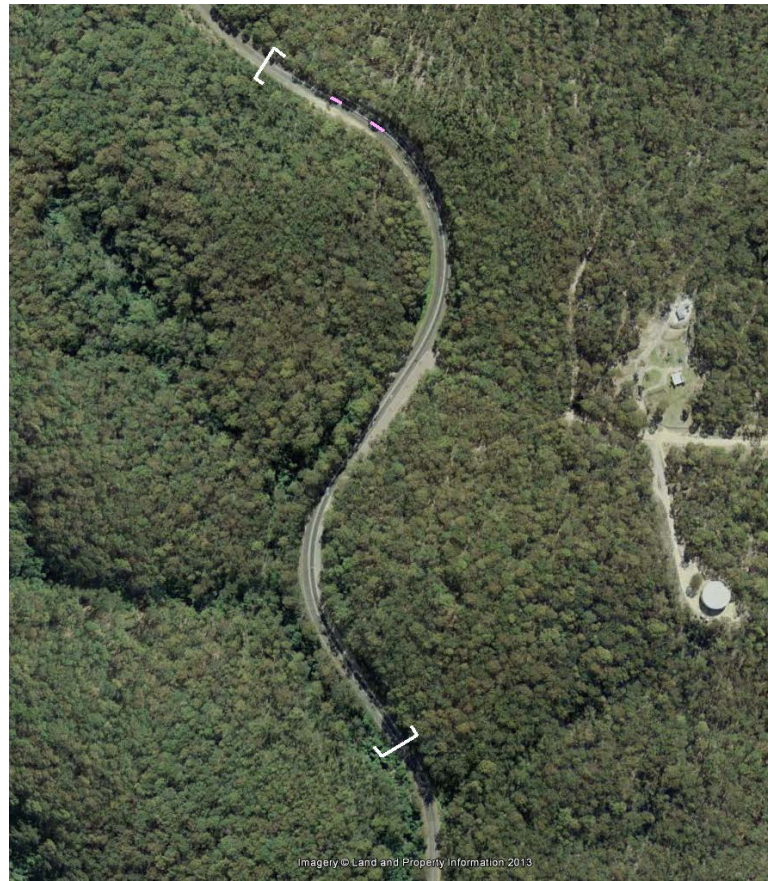
Figure 15 – Dalmeny site observation

The collision markings mapped from the site visit, as shown in Figure 15, indicate there have been a number of minor or near-miss hits not recorded in CrashLink. These are mainly concentrated around curve three in the southbound direction. Curve three is a left hand bend in the southbound direction. There were previously crashes recorded on this curve in the same direction.

In reference to the CrashLink pre- and post-installation maps, crashes have been mitigated on curve two. The site analysis, shown in Figure 15, revealed barrier damage which was consistent with the post-installation crash location on curve one.

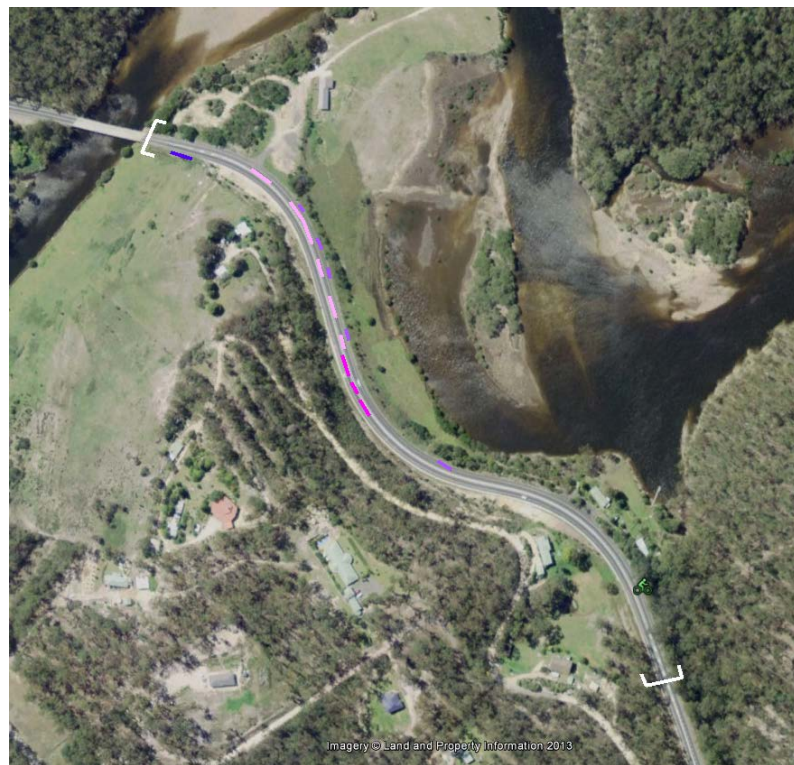
Figure 16 – Dalmeny site observation

Pre-installation, crashes were mainly centred around curve one and curve three. Post-installation, crashes are concentrated at curve one and curve two. This is consistent with the site observations of barrier damage shown in Figure 16, where barrier damage is mainly on curve one and two.

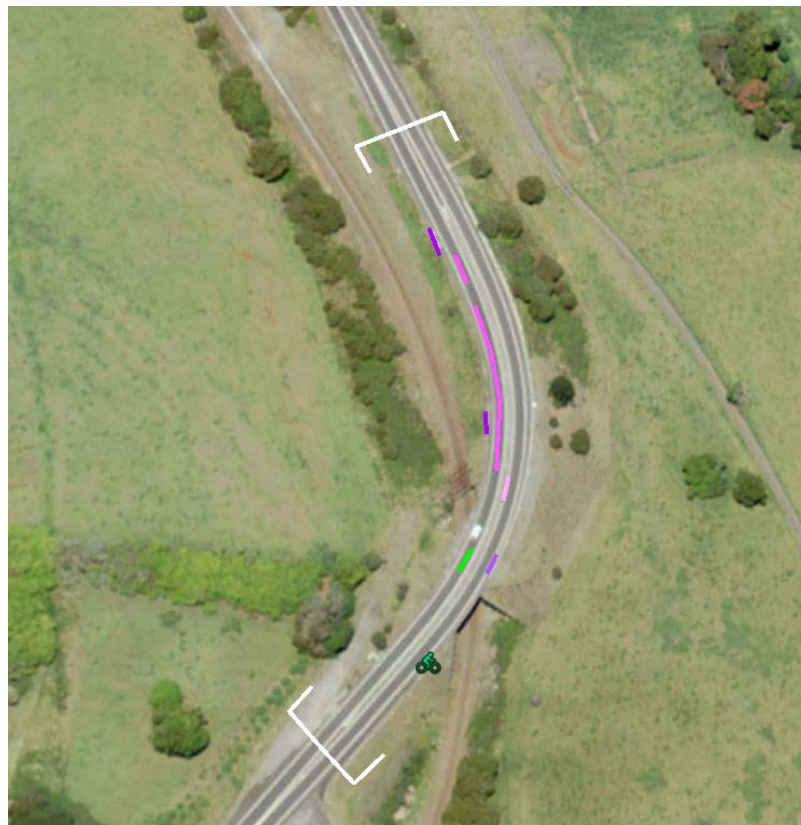
Figure 18 – Robertson site observations

Although no crashes have been recorded in CrashLink there have been a number of collisions at the site, shown in Figure 18. These collisions have mainly occurred in the eastbound direction into the CCSB.

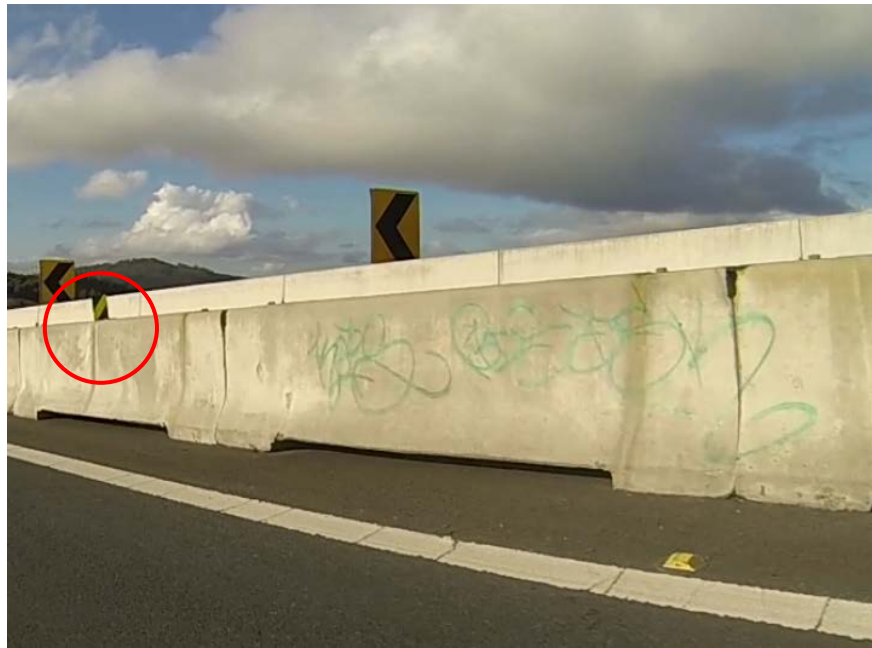
Figure 19 – Robertson graffiti and metal curve alignment markings fixed to the central barrier (red)

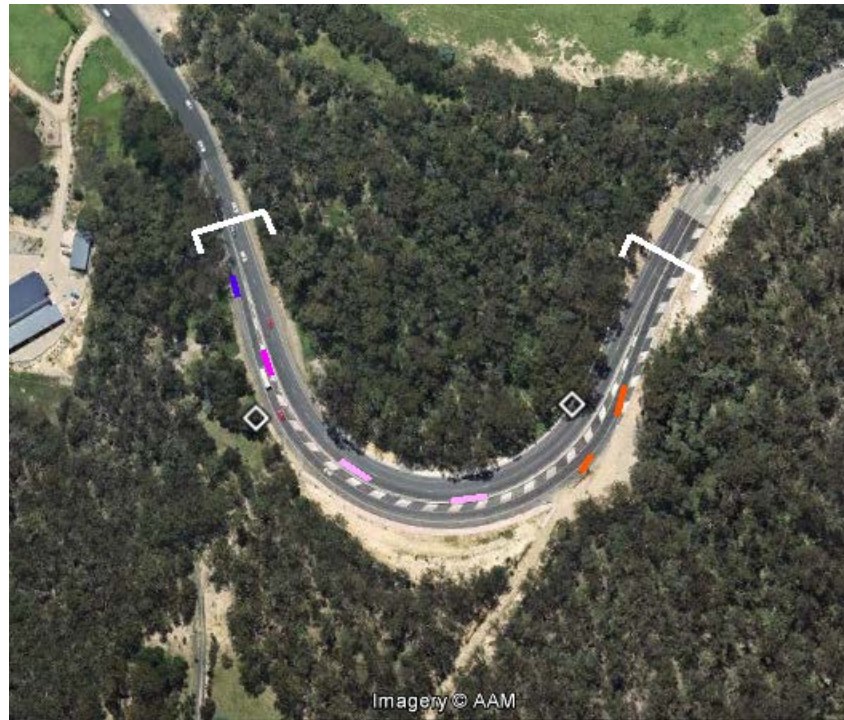
Figure 21 - Mount Victoria Pass (bottom) site observations – with westbound nearside chevron

Most crashes are concentrated around the apex of the curve, mostly in the westbound direction. The site observations as shown in Figure 21 indicate there have been crashes on the eastbound carriageway. The curve is very sharp even for a vehicle approaching on an upgrade. It appears control can be lost toward the back of the curve, into the barrier.

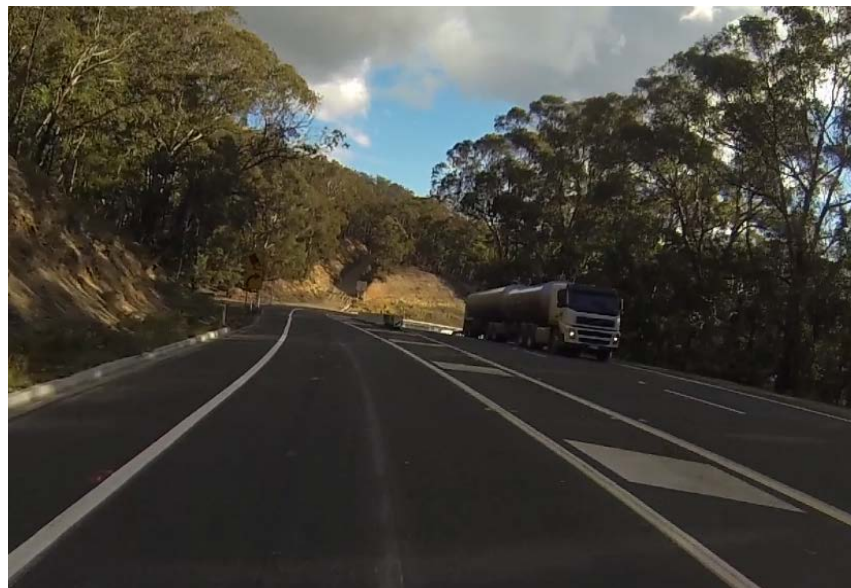
Figure 22 – Mount Victoria Pass (bottom) removed chevron, westbound approach

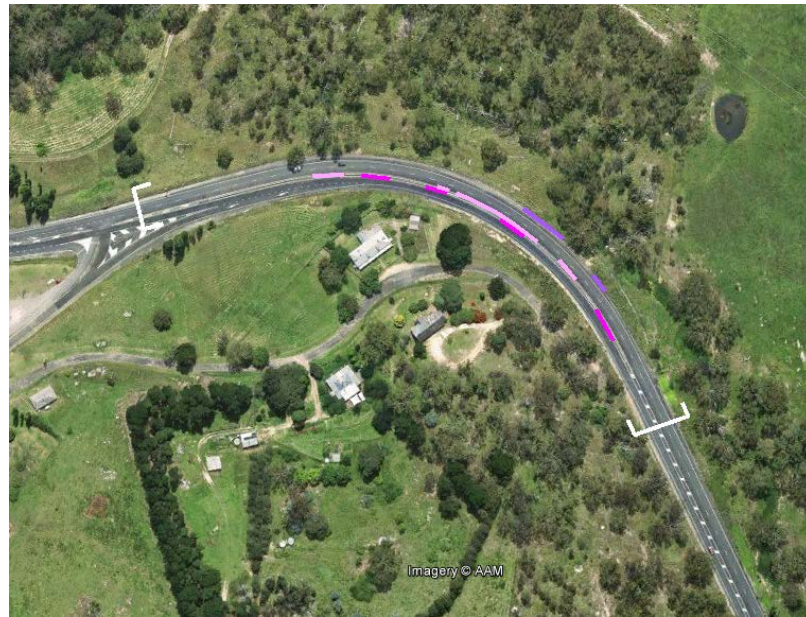
Figure 23 – Hartley site observations

Observed hits on the barrier, depicted in Figure 23, show more collisions with the barrier for eastbound travelling vehicles. This is inconsistent with the CrashLink data but is consistent with the pre-installation data. It is possible that vehicles are still overcorrecting into the barrier resulting in property damage and the vehicle remaining driveable.

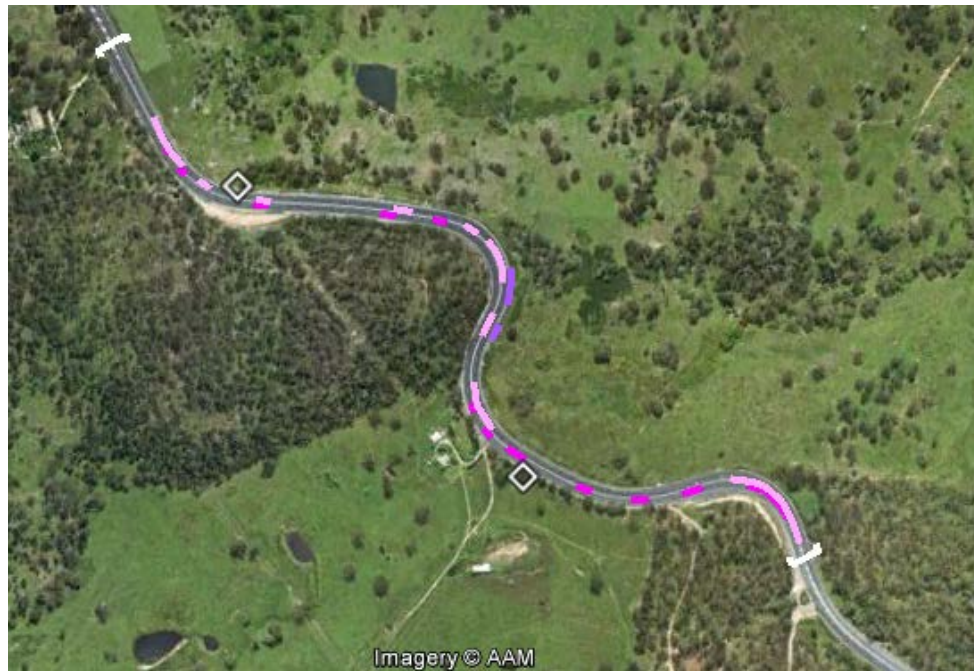
Figure 24 – River Lett Hill site observations

Most crashes are concentrated around the apex of the curve, mostly in the westbound direction post-installation. The site observations, as shown in Figure 24, are consistent with the CrashLink data, with collisions being scattered throughout the entire site but concentrated around the curves.

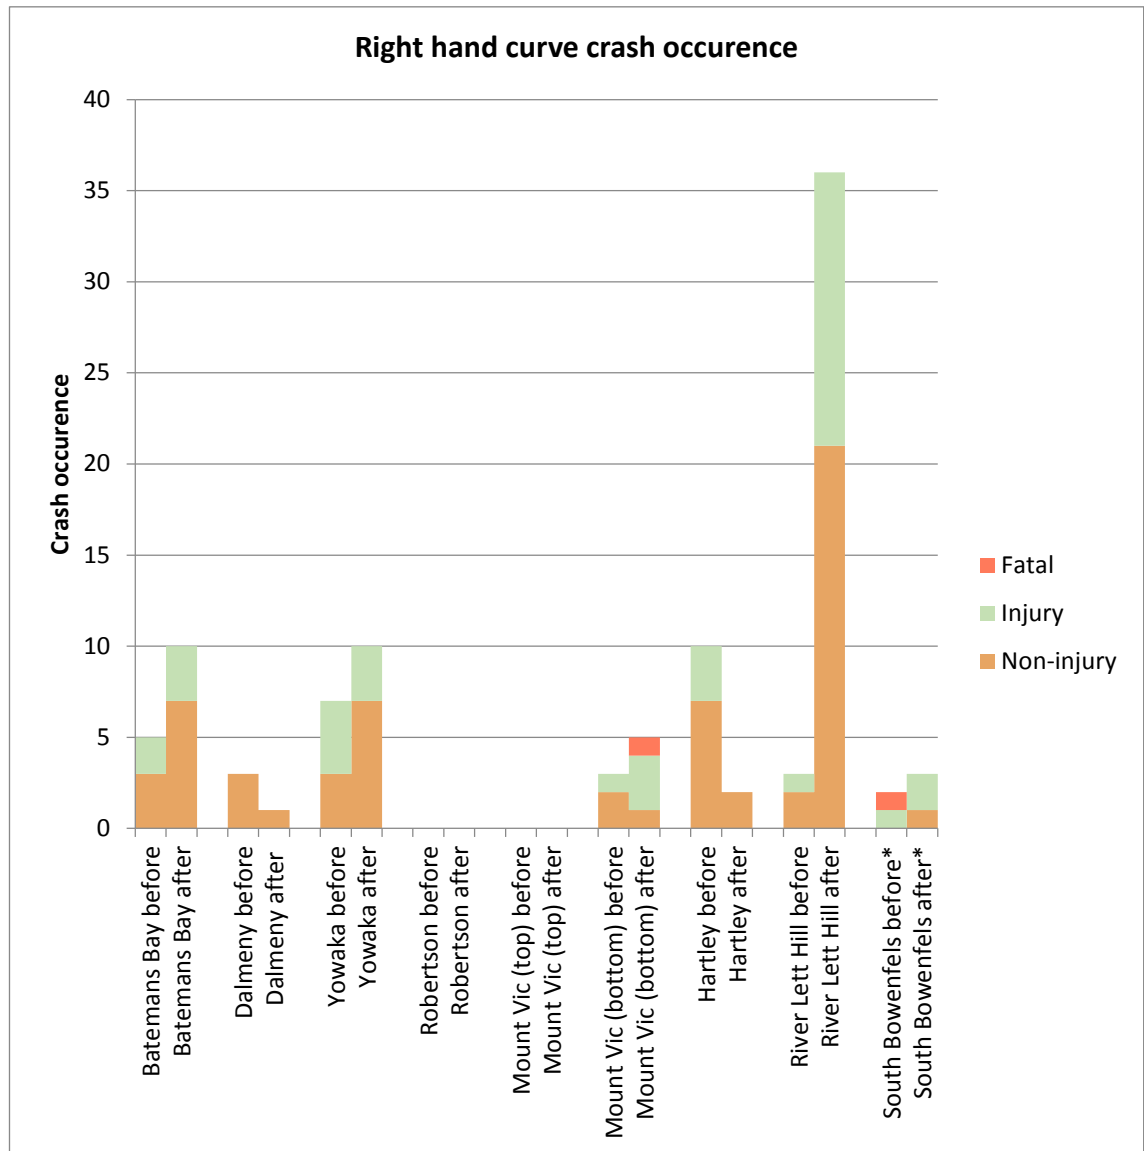
Figure 31 – Right hand curve crash incidence

The SD analysis consisted of a right hand curve analysis for all sites, shown in Figure 31 and Figure 32.

Five of the nine sites analysed had an increase in crash incidence. Of those five sites, two had a decrease in severity.

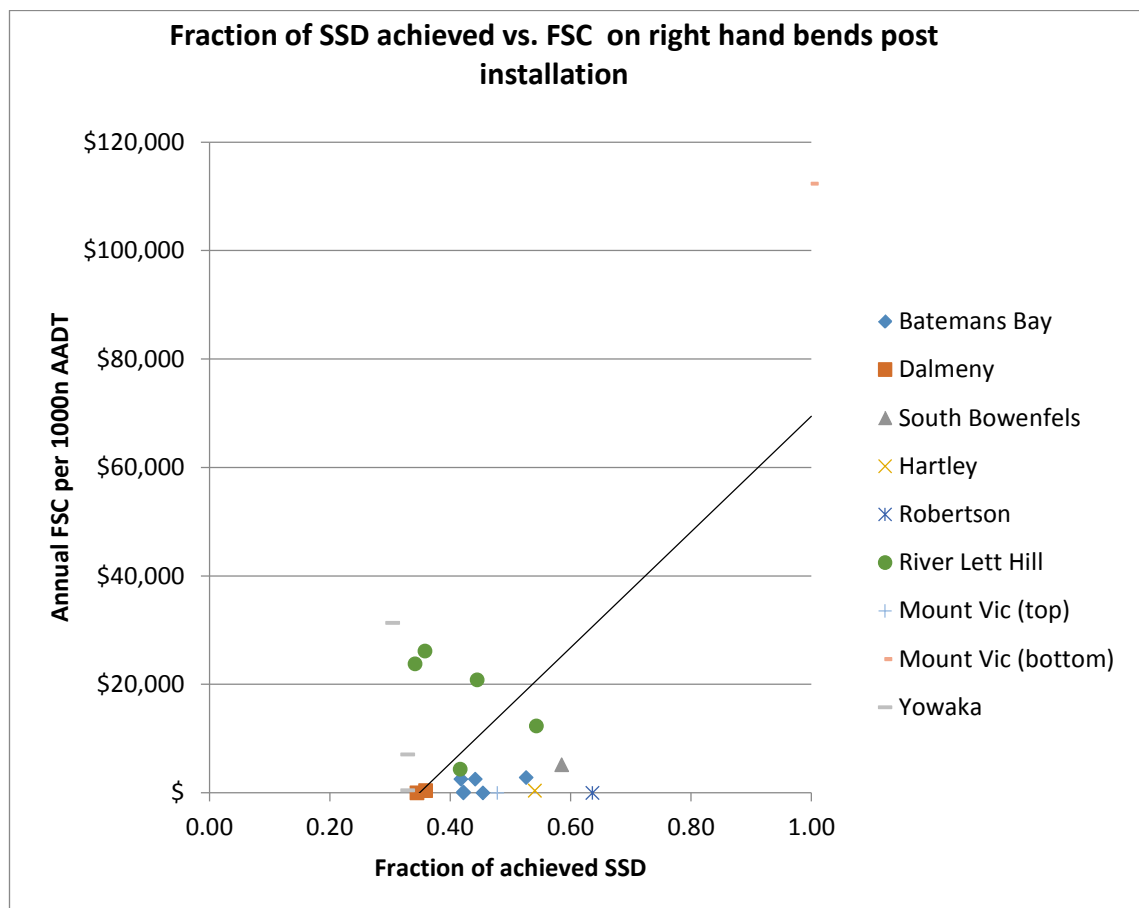
Figure 33 – SSD vs. factored severity crash costs

Figure 33 and Figure 34 attempts to demonstrate any relationship between the fraction of SSD achieved versus crashes and costs respectively.

Figure 33 does not show a clear relationship between the fraction of SSD achieved and road safety which has been measured as factored severity crash costs. The high gradient, positive trend line was not expected. For the sites analysed, the trend line indicates that

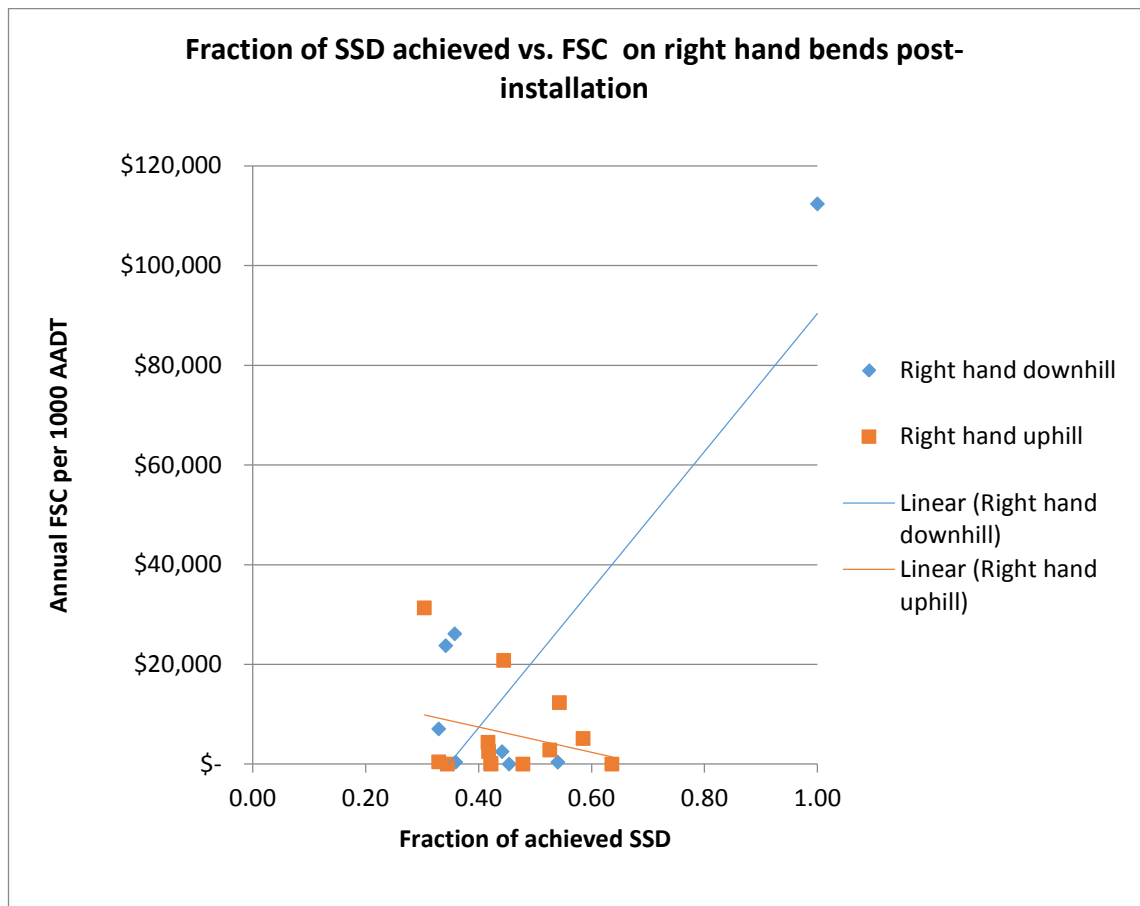
Figure 34 – Reproduced SSD vs. factored severity crash costs with uphill and downhill vertical grading highlighted

The fatal crash, discussed further in section 5.3.6 was at the bottom of a steep grade. With this knowledge Figure 31 was reproduced, shown in Figure 34 with formatting divided based on the right hand curve location being on uphill or downhill vertical gradient.

Figure 34 demonstrated that there are two different trends for uphill and downhill right hand bends. The uphill trend is more in keeping with the expectation that the lower the SSD available the higher the risk of crashes. The downhill trend could be indicating a higher risk of crashes at the bottom of steep grades, but as the degree of downhill grade nor the horizontal radius are not directly incorporated into this graph this cannot be conclusively connected.

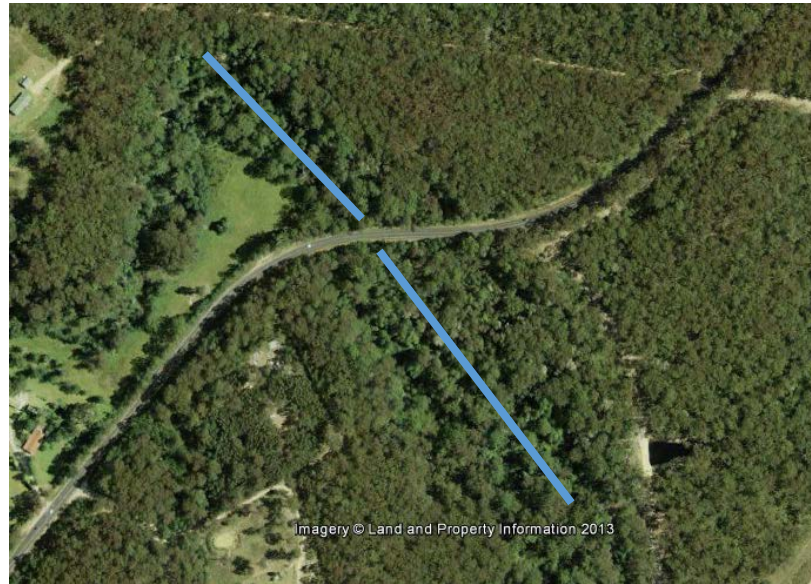
- Narrow bridge (10m formation width)
- Unprotected roadside hazards such as non-frangible trees, culvert headwalls etc. within clear zone.
- Non-traversable batters in close proximity to travel lane (greater than 4:1)
- Insufficient shoulder widths (2m shoulders)
- There are areas of unsealed wide verge areas which could be pertinent to road widening.

Figure 35 – Princes Highway, East Lynne reverse curves over Middle Creek
