Behaviour of Infilled Rehabilitation System with Composites for Steel Pipe

A dissertation submitted for the award of

DOCTOR OF PHILOSOPHY

Faculty of Health, Engineering & Sciences
UNIVERSITY OF SOUTHERN QUEENSLAND

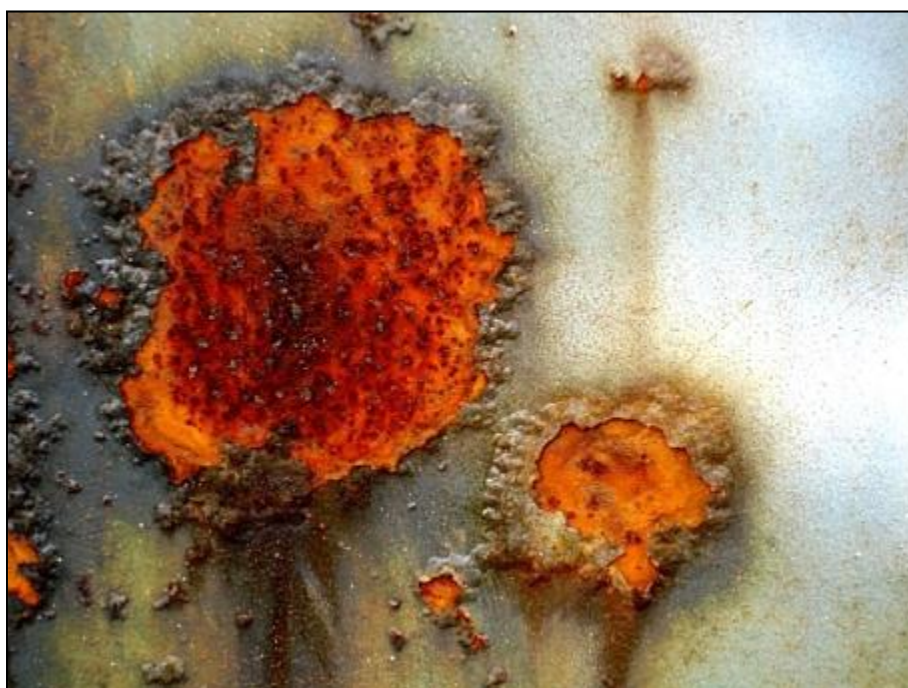
Figure 1.1 Mechanism of steel corrosion in saline environment (Kopeliovich 2009)

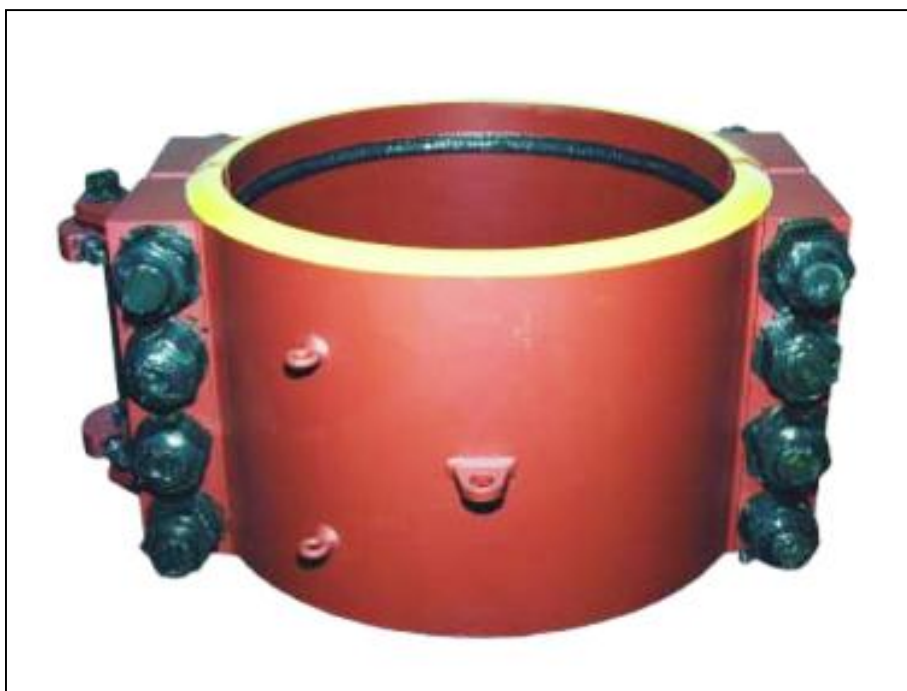
Figure 1.4 PLIDCO Split+Sleeve repair clamp (PLIDCO Split+Sleeve 2012)

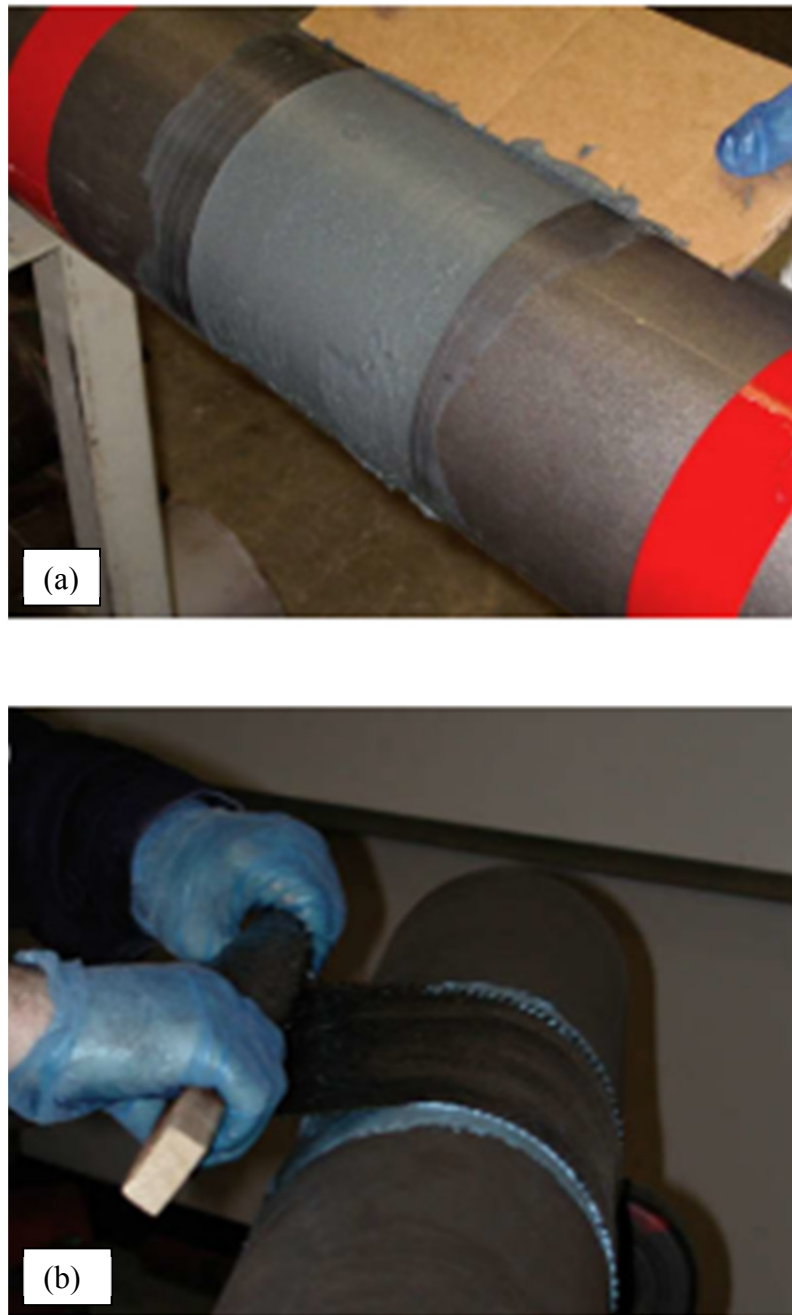
Figure 2.6 Pipe exterior repair process using infill and flexible wrap (a) Filling defect with putty (b) Wrapping epoxy wetted carbon fabric around the defect (Duell et al. 2008)

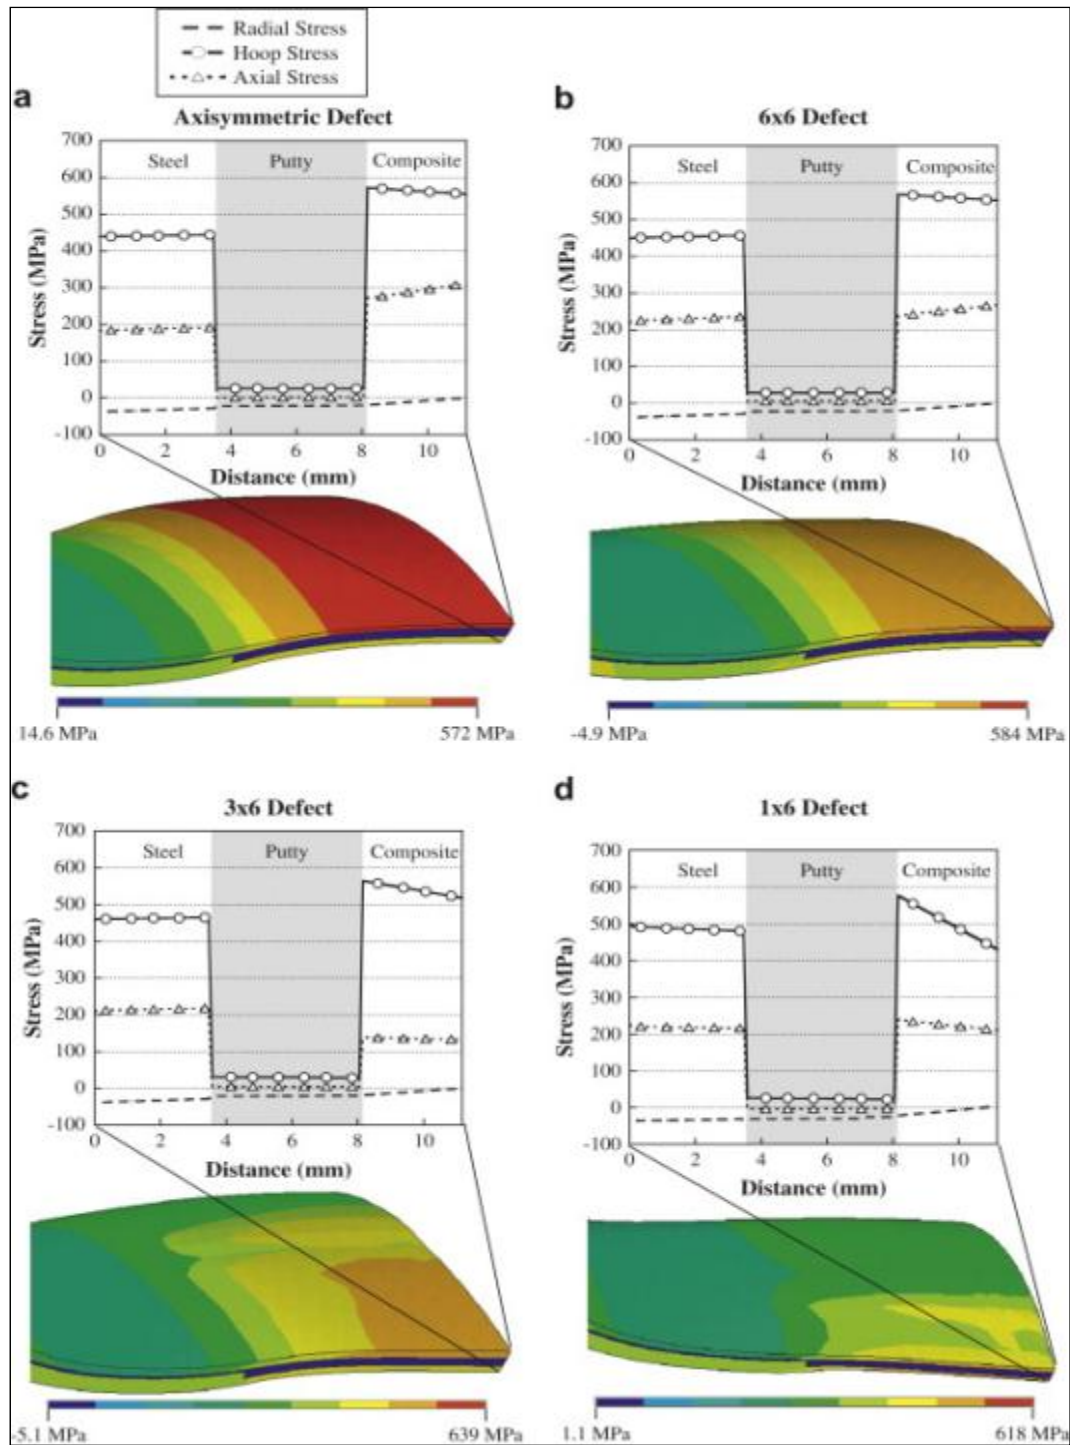
Figure 2.11 FEA predicted radial, hoop, and axial stress at the centre of the 50% wall loss defect from the inside of the pipe wall to the outside of the composite wrap at burst pressure (Duell et al. 2008)

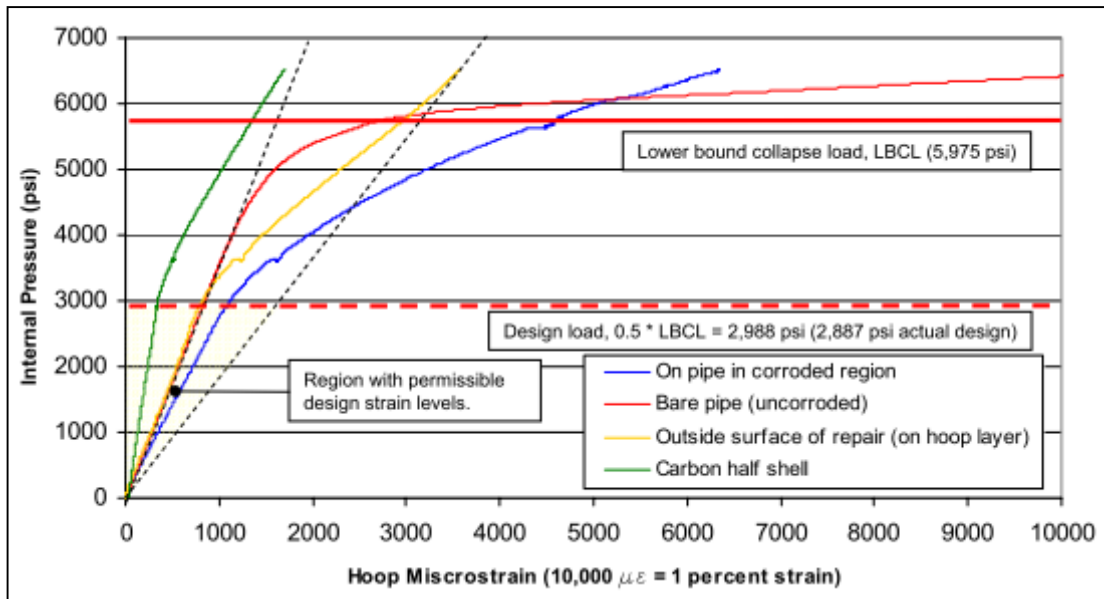
Figure 2.12 Circumferential strain as a function of internal pressure applied to repair systems (Alexander 2007)

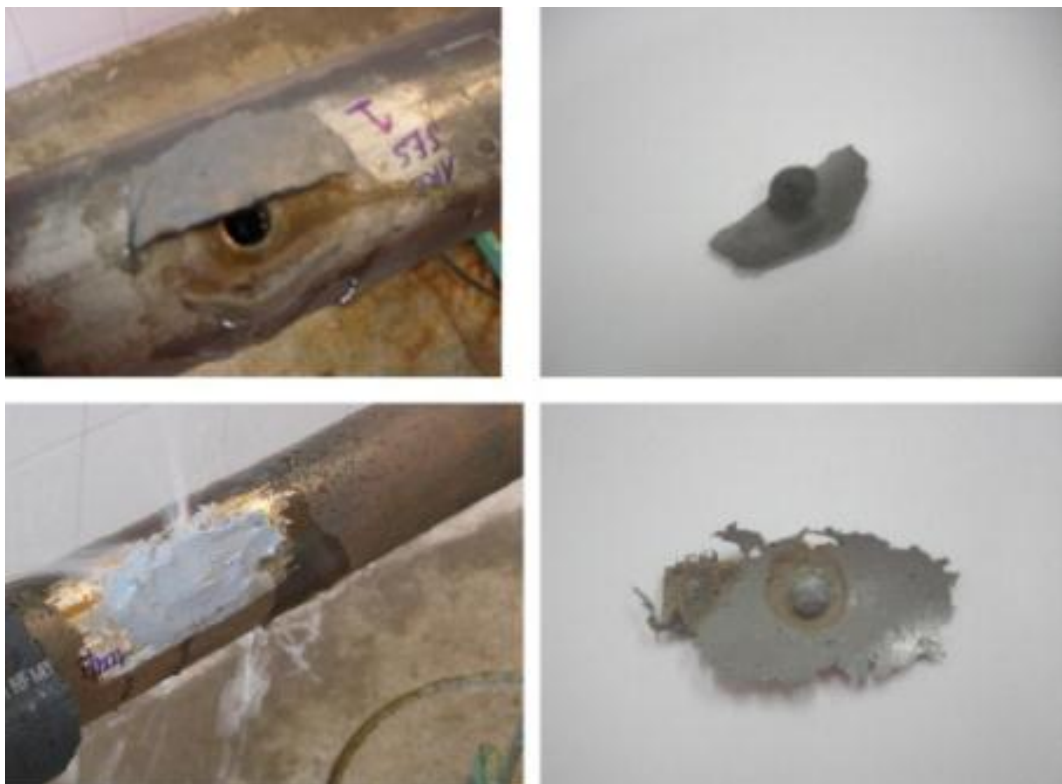
Figure 2.13 Failure of epoxy repair (Mattos et al. 2012)

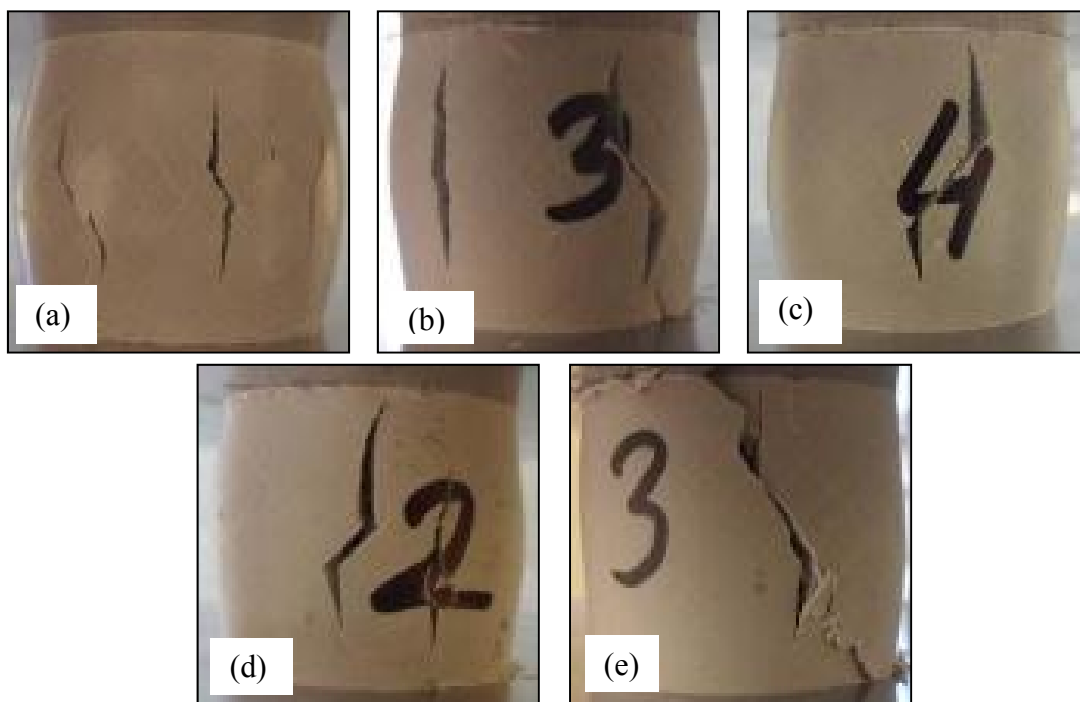
Figure 3.25 Effect of curing age on compressive failures of the 25 mm specimens of grout C; (a) 1-day, (b) 3-day, (c) 7-day, (d) 14-day and (e) 28-day

transverse corners of the specimen. The failure in the 14- and 28-day specimens of grout E is sudden and produces a crushing sound. The failure pattern of the compressive specimens of grouts D and E are comparable to the failure of the filled polymer for pile rehabilitation (Sirimanna et al. 2010).

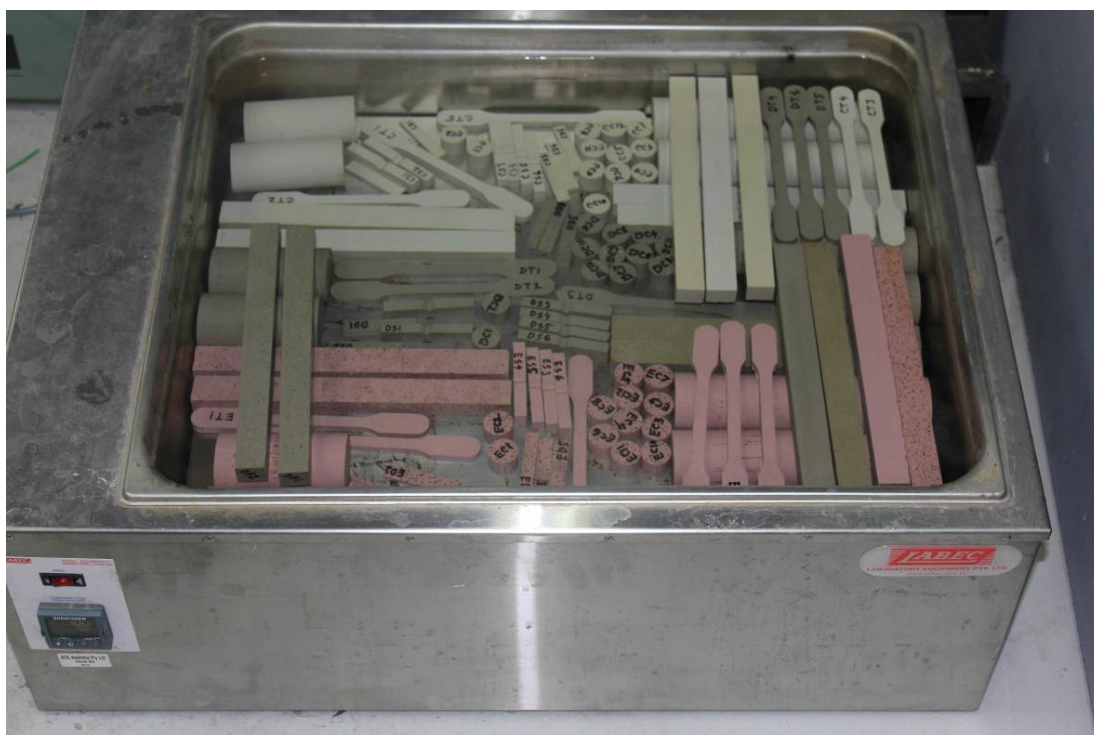
Figure 4.2 Grout specimens being conditioned at the water bath
