Deriving Damage Indices for Concrete Girder Bridges subjected to Flood Loading

Key Words: Bridge, Flood, ANSYS, Damage Curves

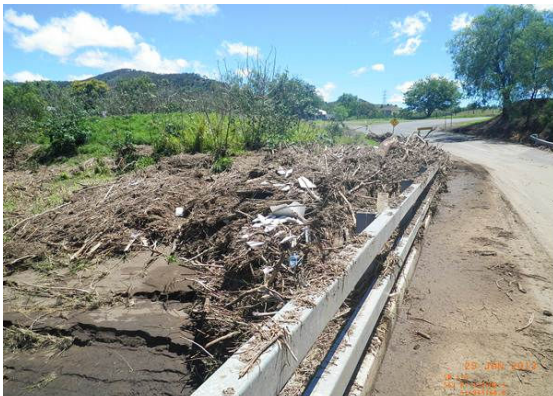
Figure 1: Damaged Bridges in Lockyer Valley Region in Queensland

Bridge could damage in many ways when it is under an extreme flood event. Farook, Lokuge [4]. If the bridge is completely inundated during the flood, the damage to the bridge depends on the length of time it was submerged as well as the types of debris collected around or passing the bridge components. Extra care should be taken to inspect the supports of the bridges, even after the flood water recedes. Approaches of a bridge could be damaged due to debris impact, settlement or depressions. Debris against substructure and superstructure, bank erosion and damage to scour protection will damage the waterways. Bridge substructure could fail due to movement of abutments, wing walls, piers, rotation of piers and missing, damaged dislodged or poorly seating of the bearings while the superstructure could fail due to the debris on deck, rotation of deck, dipping of deck over piers or damage of girders. Pritchard [5] identified that urban debris such as cars; containers etc. and the insufficient bridge span to through that debris were the main cause for damaging bridges aftermath of 2011/2012 extreme flood events in Queensland. Figure 1 depicts some the damaged bridges from Lockyer Valley Region in Queensland.

Analysis on the performance of bridges under 2011/2013 flood in Lockyer Valley Region, Queensland Farook, Lokuge [4] indicates that the bridge deck is the most commonly affected component followed by the bridge approach, pier/abutment scouring, cracks in the abutment wing walls and misalignment of abutment

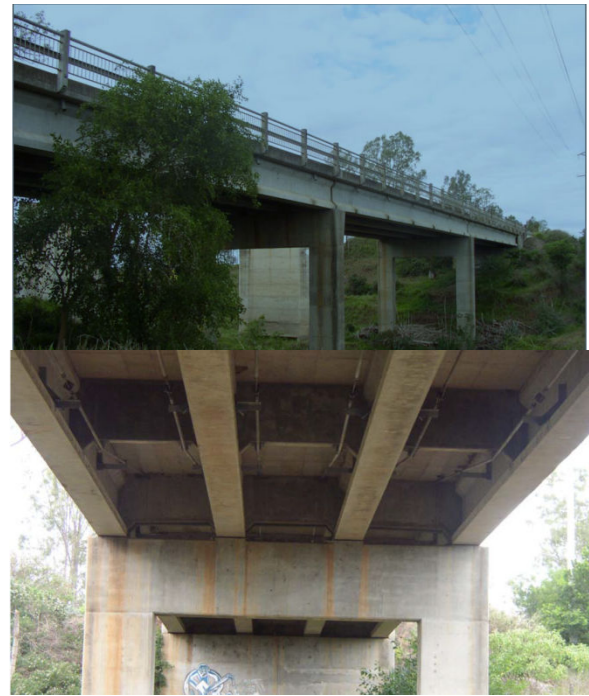
Figure 2: Tent hill Creek Bridge Configuration

For the purpose of modelling the bridge, a bridge that carries a state route of Ipswich-Toowoomba road over Tenthill Creek in Gatton, Queensland, Australia has been selected. This is a simple span reinforced concrete, prestressed I-girder bridge built in 1970's. The bridge is 82.15m long and about 8.6m wide and is supported by a total of 12 pre-stressed 27.38m long beams over three spans of 27.38m. The beams are supported by two abutments and two headstocks.

General purpose finite element software, ANSYS has been used to model the bridge deck and to analyse the flood loading effect on to it. The middle span of bridge deck was analysed. All four girders were assumed simply supported and rest on the headstock of the piers. Self-weight of the bridge and the flood loads acting laterally to one of the end girder were considered in the analysis. The flood load was fed as a pressure on the face of the end girder. The bridge deck (I-girder) has been analysed using ANSYS. Figure 2 illustrates the Tenthill Creek bridge configuration. Section details of the bridge deck and the girder is given in Figure 3.

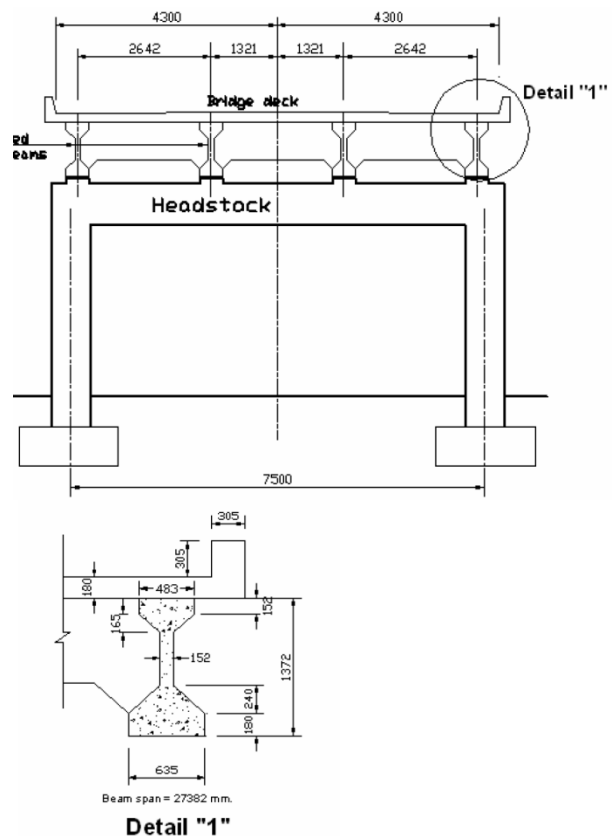
Figure 3: section details of a longitudinal prestressed I-girder beam. Nezamian and Setunge [8]

A typical beam section of the headstock is shown in Figure 3. The positive and negative flexural and shear capacities of the section were calculated in

accordance with Australian standards (AS3600, 1988). The nominal steel rebars areas; nominal steel yield strength of 400 MPa for longitudinal reinforcement and 240 MPa for shear reinforcement and nominal concrete compressive strength of 20 MPa were used in the section capacity analysis. The degradation due to corrosion of the steel and creep and shrinkage of the concrete were ignored. Using an excel sheet, the existing moment capacity of the concrete girder section was found to be 600kNm.

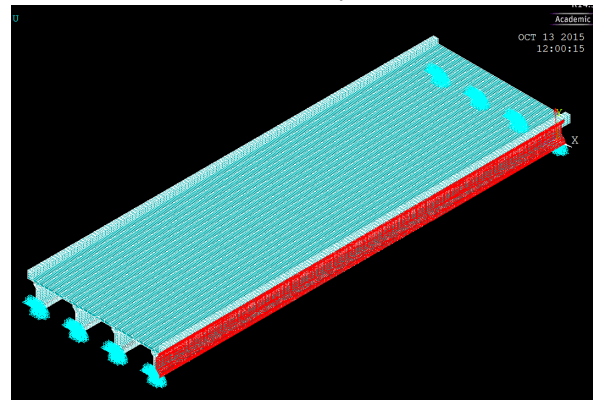
Figure 4: ANSYS bridge Deck Model

ANSYS model was run for different flood velocities ranging from 0.5m/s to 5.0m/s in steps of 0.50m/s increment. Figure 4 depicts the bridge deck model used in the analysis.

Horizontal support reaction of the end girder was obtained each time from the ANSYS Postprocessor. Using these reaction values flood induced bending moment of the end girder was calculated with the help of an excel sheet as shown in table 3

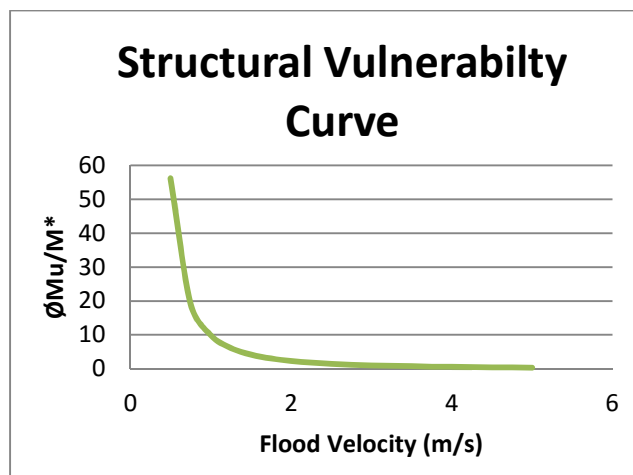
Figure 5: Structural vulnerability Curve for Tent hill Creek Concrete Girder Bridge

Structural Vulnerability curve for this girder bridge is drawn as shown in figure 5.

critical flood velocity to satisfy this condition could be read from the above structural vulnerability curve. For the bridge considered in this case study, the critical flood velocity is read as 2.75 m/s. Outcomes will enable identification of the vulnerable girder bridges in the road networks and will assist road authorities to make optimised hardening decisions. On the other hand, emergency management services will be able to avoid vulnerable structures in determining evacuation routes.
